Re: Update Preliminary Ecological Appraisal for Proposed Development at The Gig House, Chilton Street, Clare, Suffolk, CO10 8QS.

Introduction & Methodology

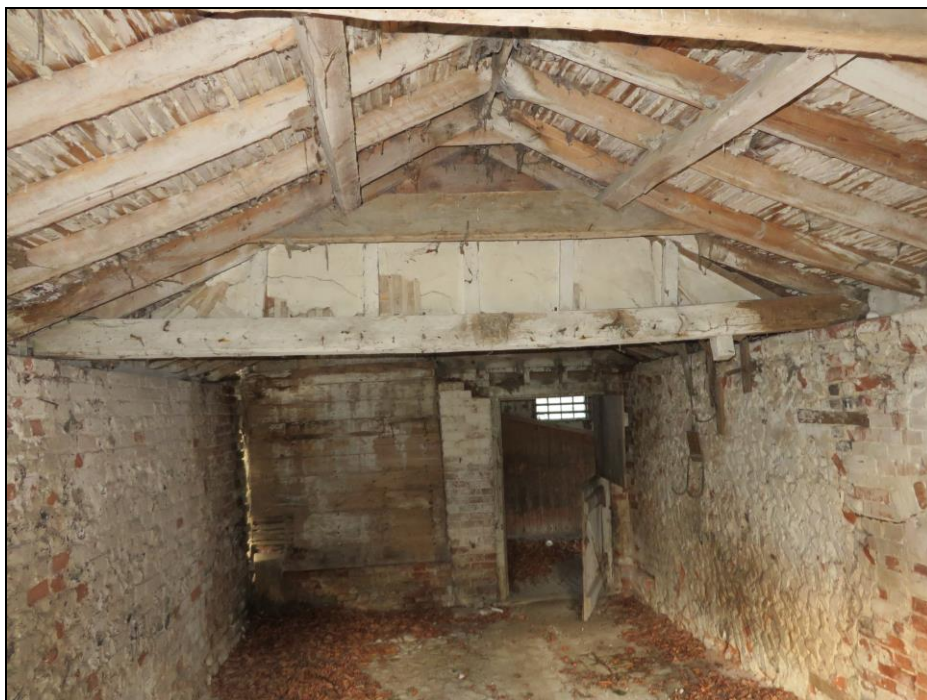
The house was a double-storey, timber frame structure with wattle and daub walls and a pitched, tiled roof. A cellar was present under the house and a brick and flint garage was attached to the southern elevation of the house.

Photograph 3: Inside the garage attached to The Gig House, Chilton Street. 8th December 2014.

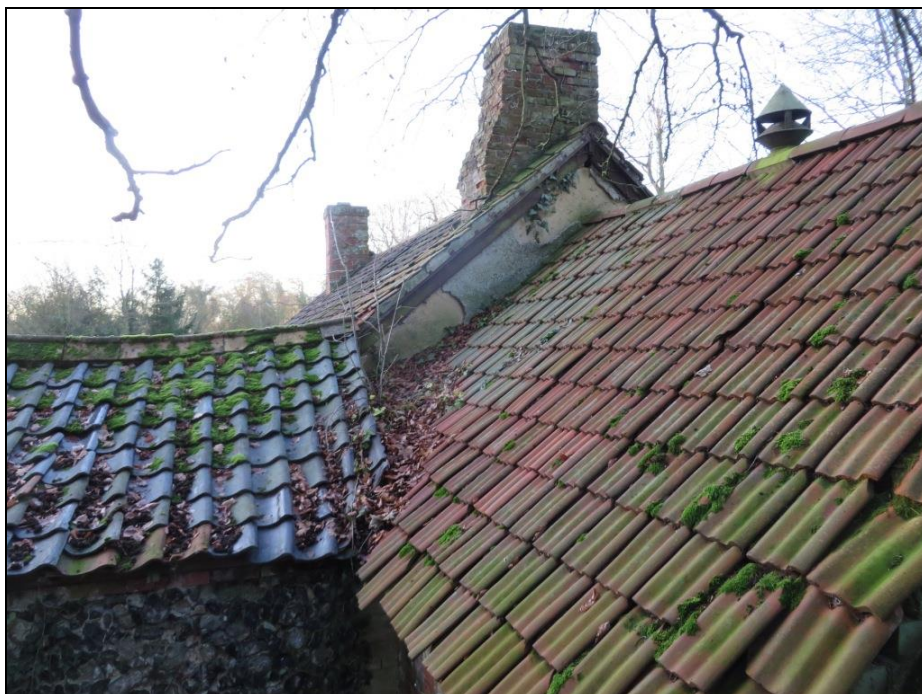
Photograph 4: Roof of The Gig House and attached garage Chilton Street. 8th December 2014.

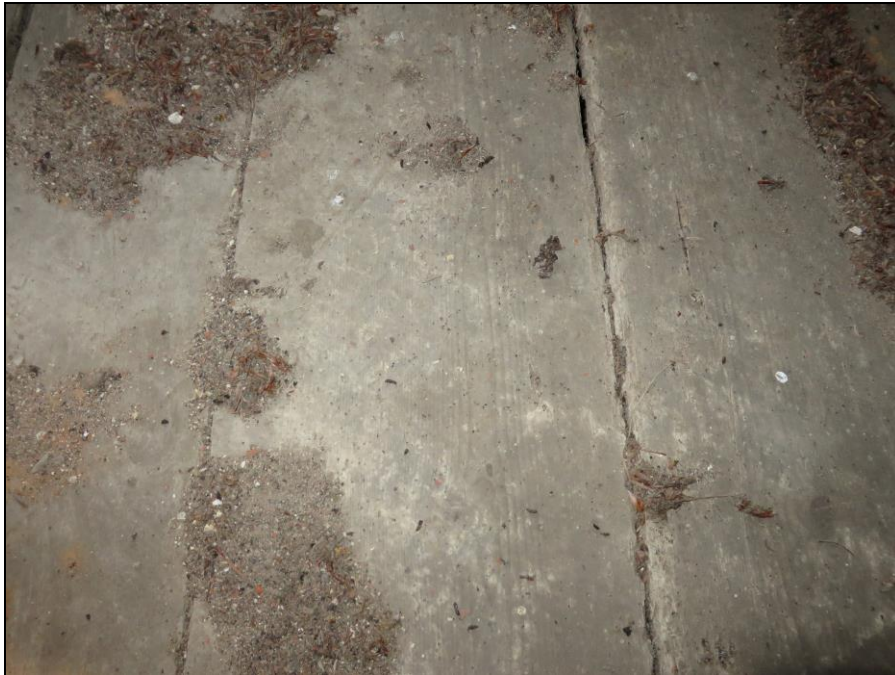
The house and attached garage were considered potentially suitable for roosting bats. One brown long-eared *Plecotus auritus* bat was discovered behind some peeling plaster on the ground floor in 2014 & 2024. Two groupings of bat droppings (approximately 10-20 per pile), consistent in appearance to brown long-eared droppings, were observed on the first floor at the eastern and western ends of the building (2014). Fewer droppings were discovered in 2024.

Photograph 5: Bat droppings inside the first floor at the western end of The Gig House, Chilton Street. 8th December 2014.

A Natural England bat licence will be required for works to proceed legally. To prevent harm to bats and provide alternative roosting habitat the below should be followed:

- Demolition works commencing in weather conditions suitable for active bats (several consecutive nights above 7C), to prevent encountering hibernating bats during works;
- Prior to the commencement of development works bat boxes should be erected on nearby trees. The boxes should include three 1FD Schwegler bat boxes and one 1FW Schwegler hibernation bat box. The boxes should be positioned high on the trees (above 4m) with the 1FD boxes facing a mixture of southerly, easterly and westerly directions and the 1FW box facing a northerly direction;
- Development works should then commence with a soft strip of building under supervision by a bat licensed ecologist. The ecologist should inspect all roof areas and other potential roosting locations. If bats are discovered during the supervised soft strip they should be safely relocated into one of the installed bat boxes;

- Following building restoration two 1FR Schwegler bat tubes should be installed into the walls of the new building to provide permanent roosting habitat into the future. One tube should facing a southerly direction, the second tube should be facing a easterly direction close to vegetation. The boxes should be installed high on the new building (ideally just below the roofline) and away from light sources or doorways;

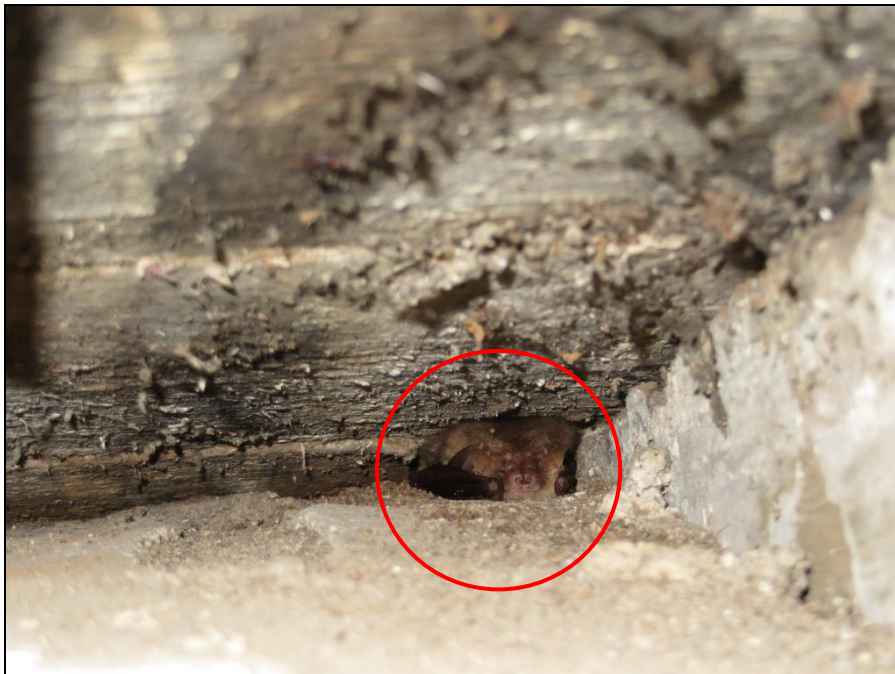
Photograph 6: Roosting brown long-eared bat under peeling plaster on the ground floor of The Gig House, Chilton Street. 8th December 2014.

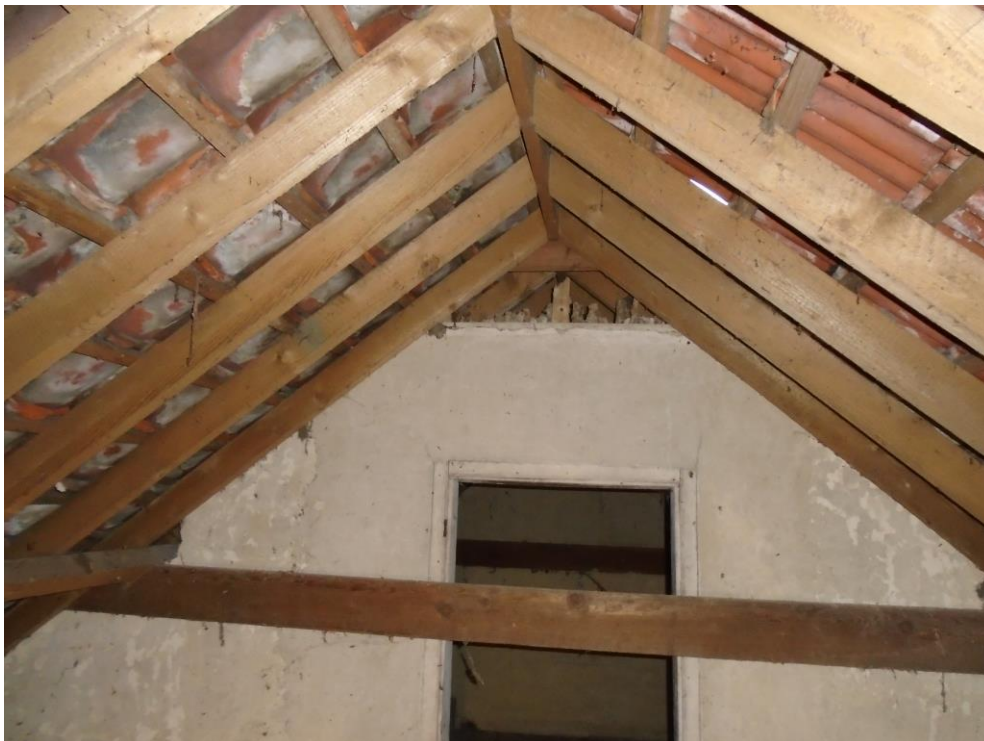
Photograph 8: Inside the first floor at The Gig House, Chilton Street. 6th February 2024.

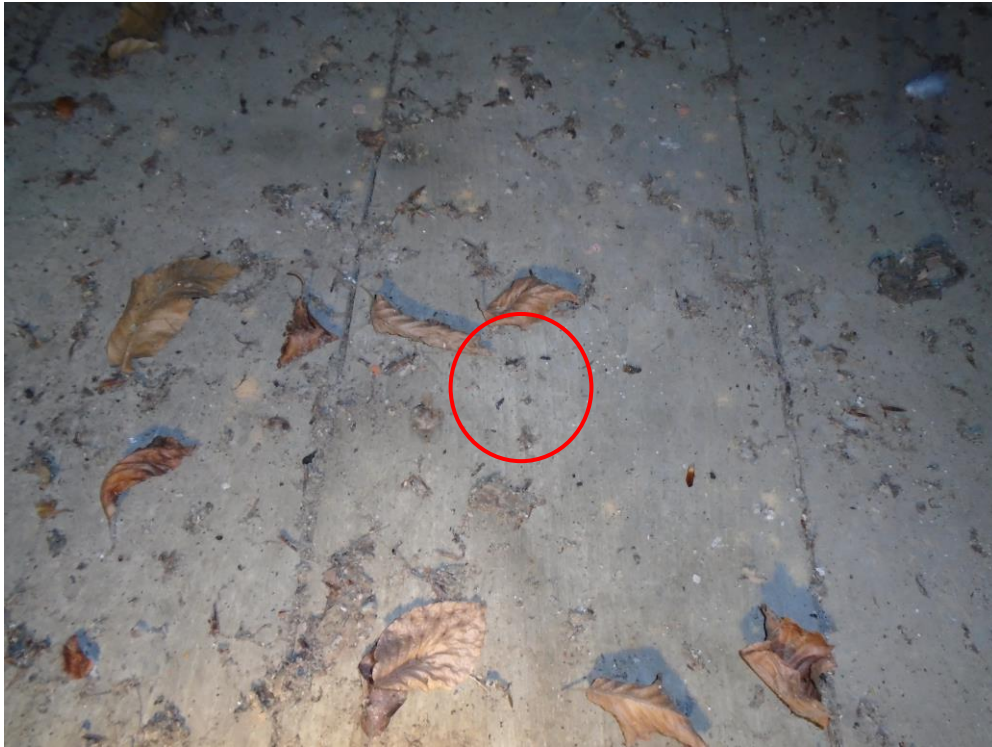
Photograph 9: Bat droppings on the floor at The Gig House, Chilton Street. 6th February 2024.

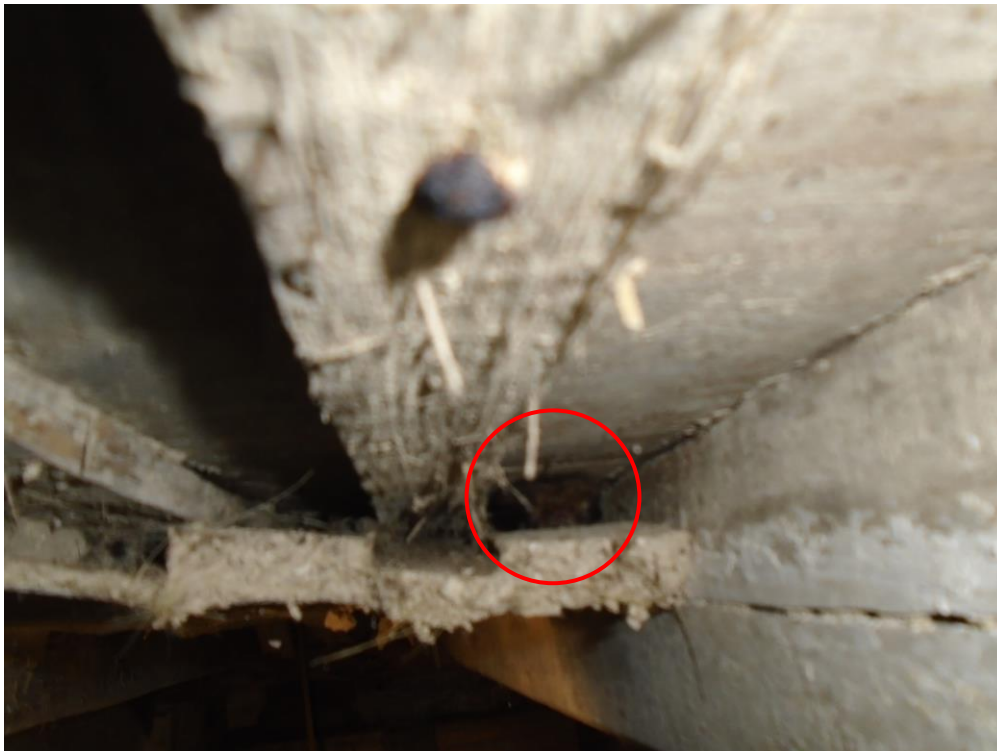
Photograph 10: Roosting brown long-eared bat under peeling plaster on the ground floor of The Gig House, Chilton Street. 8th of December 2014.
