**Waterside Farm,
Bodkin Lane, Out Rawcliffe,
Preston, Lancashire
PR3 6TL**

**Preliminary Survey & Assessment
in Respect of Bat Species,
and Nesting Birds (including Barn Owl).**

Echo Calls Bat Surveys

6th February 2024

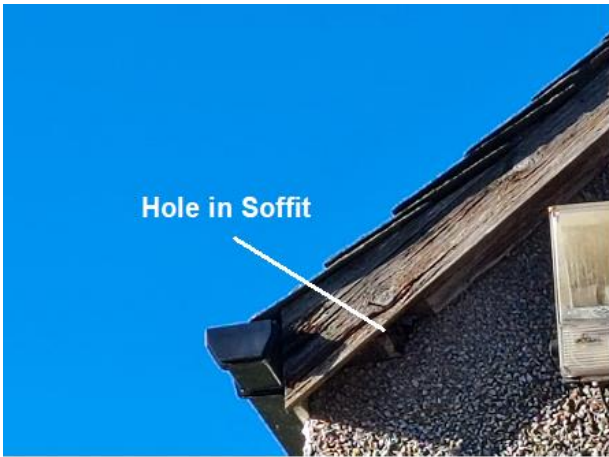
PHOTO 1

- There was a hole in the soffit at the south-eastern corner of the eastern extension, and this hadn't been there during the 2022 survey, However, an inspection of the hole using an endoscope, and a visible search of both the wall and roof around it, and the floor beneath it, found neither bat droppings, any invertebrate prey remains, or neither urine or fur grease staining, and therefore the hole was thought to be of low bat roosting suitability refer to **fig 3, 4 and 5**, and **photo 1**).

Hole in Soffit

South-eastern Corner of Eastern Extension

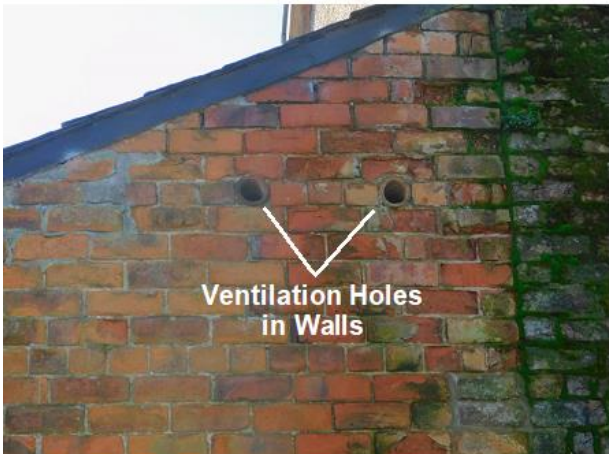
PHOTO 5

- There were ventilation holes in both the northern and southern elevations of the eastern extension, also there were gaps in an open louvre panel in the northern elevation of the barn, and a gap over the entrance door, also more ventilation holes in the northern elevation of the barn, however, close inspection of all these holes and the walls, doors near them, and the floor beneath them, using close-focus binoculars and also by sight, found them all to be either internally meshed, cobwebbed, full of debris, or of insufficient depth to offer any bat roosting potential, nor were there any signs of bat droppings, or remains of invertebrate prey, nor any grease marks from repeated contact, or passage through the holes and gaps on the walls and floor beneath, and it was deemed therefore, that bats had not used any of the holes for roosting or access purposes and were of low roosting suitability, (refer to **fig 3, 4 and 5** and **photos 4, 5, 7, 8, 26 and 27**).

Ventilation Holes
in Walls

Upper Northern Elevation of Eastern Extension

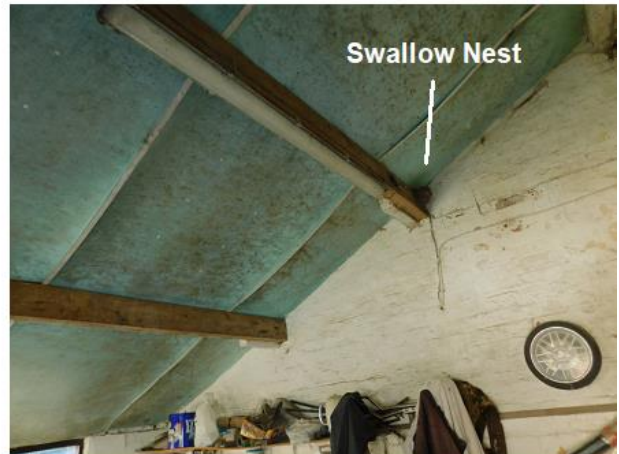
PHOTO 6

- A single swallow nest was found attached to a beam in the eastern extension. It was surmised that this nest had been used continually during each nesting season since it was first observed (11th February 202), and that this nesting opportunity would be lost when the building is demolished, (refer to **figs 3, 4 and 5**, and **photo 6**).

Swallow Nest

Underside of Eastern Extension Roof

5.7 This is particularly important in relation to the swallow nest, found in the barn during the survey undertaken on 11th February 2021. Also, during the current survey carried out on 30th January 2024, it was noticed that the nest was still there, and although it was not currently occupied, it was thought to have been used during the 2023 nesting season. It was concluded, that this future nesting opportunity would be lost during the planned schedule for modernisation, it is recommended therefore, that some No 10 Schwegler swallow nests, and also a mixture of open fronted and hole fronted boxes, are to be erected amongst the neighbouring buildings and the surrounding foliage, to mitigate for potential loss of these nesting opportunities, both during and after the development, to encourage and enhance future colonisation and nesting by bird species, and obtain a further net gain in biodiversity, (refer to **Appendix 8** for details).

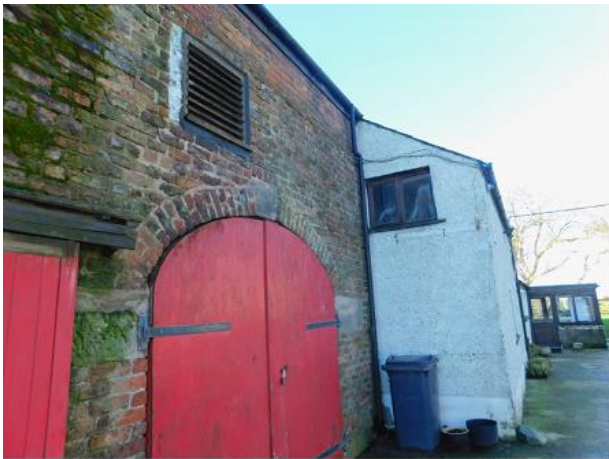
PHOTO 7
View Along Northern Barn Elevation

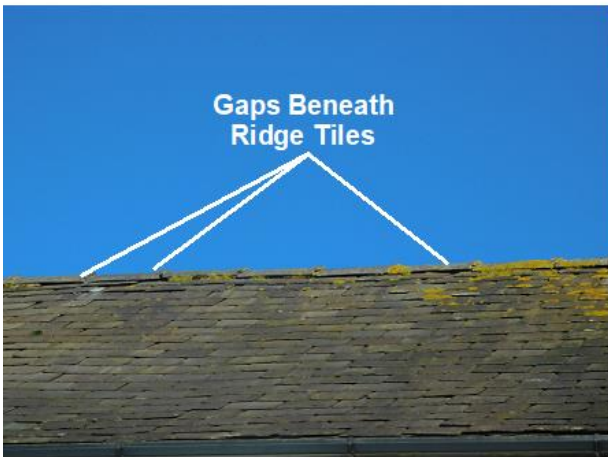
PHOTO 23
Part of Southern Main Building Roof

- Part way along the ridge of the main farmhouse roof, some of the mortar parging beneath the tiles had become dislodged, leaving potential gaps beneath the tiles, however a close inspection of the gaps using close-focus binoculars, and also the roof beneath them found no evidence to suggest that bats have used these gaps, for either roosting or entrance purposes, and therefore they were deemed to be of low roosting potential, (refer to **fig 3, 4 and 5**, and **photo 23**).

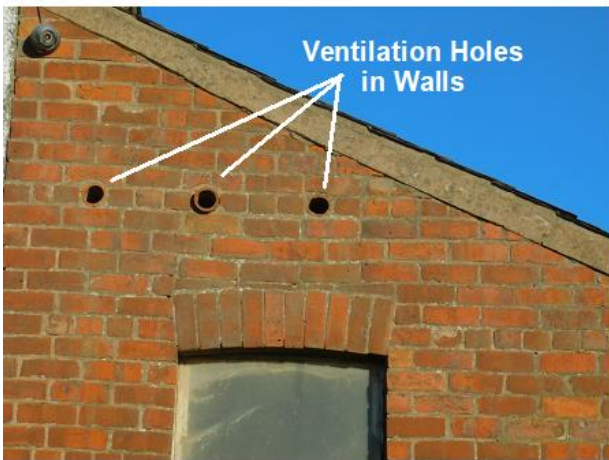
PHOTO 27
Upper Southern Elevation of Eastern Extension

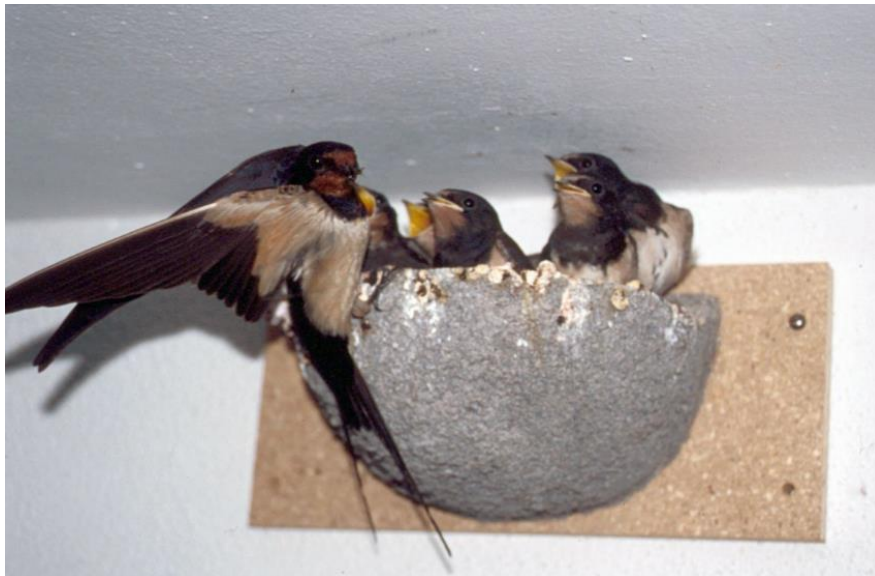
8.1 Schwegler No 10 Swallow Nest.

Ideally, the Swallow Nest should be placed inside outbuildings such as sheds, barns or stables, however, there should always be unrestricted access for the birds through an open window or skylight. Swallows are sociable birds, but multiple nests should not be placed at less than 1m intervals.

These Woodcrete nest boxes are famous for their durability - lasting for at least 20-25 years. Woodcrete is a blend of wood, concrete and clay which will not rot, leak, crack or warp. They are backed by leading ornithologists, nature conservation organisations, government agencies and forestry experts. Schwegler boxes have the highest occupation rates of all nest boxes and are carefully designed to mimic natural nest sites and provide a stable environment for chick rearing and winter roosting.
