## The Grange, Gardham Lane Bewholme

Bat Survey, August 2019.

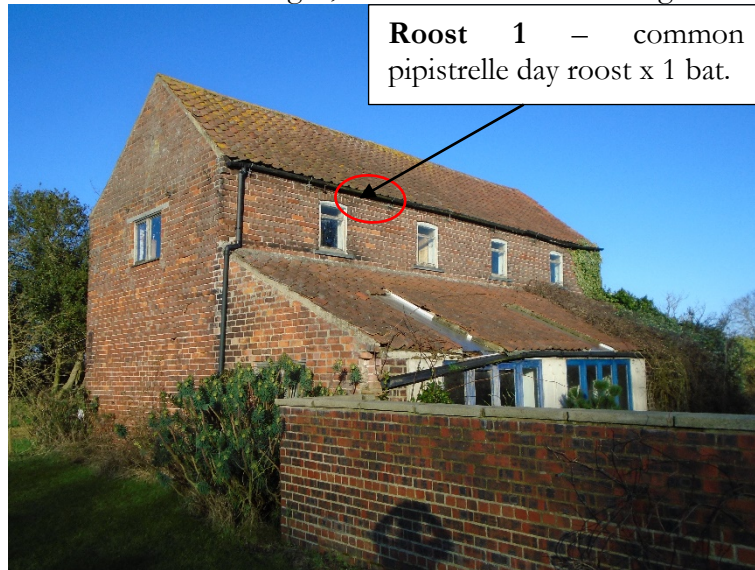
Plate 4 – outbuilding B, south elevation and west gable.

- Gaps beneath the ridge tiles where mortar has been displaced.
- There are no missing ridge tiles.
- Loose fitting pan tiles with gaps beneath.
- Gaps in missing mortar below gable tiles.
- Gaps above the eaves.
- Missing mortar in the brick work.
- Gaps adjacent to timber doors and timber windows.
- Gaps adjacent to and within timber lintels.
- Gaps behind timber barge boards.
- Gaps above the internal wall plates.
- Gaps between felt and pan tiles above.
- Gaps in the internal brick work.
- Access into the building is provided by gaps above the eaves.

- The following bat roosts were observed:
  - **Roost 1** – common pipistrelle roost located in a gap above the eaves on the south elevation of outbuilding B. The roost contains 1 bat (see 5.5 plate 4).

7.8.1 Wold Ecology recommends that two Schwegler 1FQ bat boxes are sited on the south elevation and west gable of outbuilding B; close to existing roost sites. Schwegler Bat Boxes are recommended and well tested boxes. The boxes should be located close to the roof line or ridge apex.

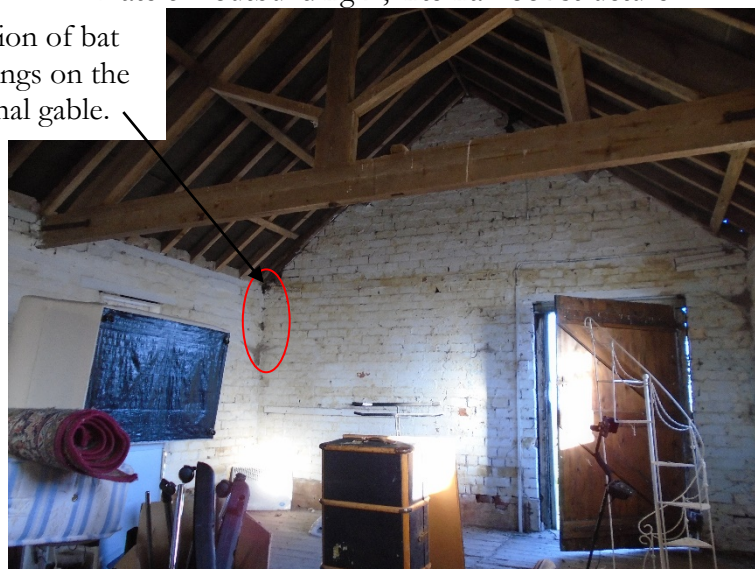
Plate 6 – outbuilding B, internal roof structure.

- There was no open doors/window access into the building.
- Ivy *Hedera helix* is growing on the building but is of insufficient structure to support roosting bats.
- The following evidence of bats was observed:
  - 15 bat droppings were observed on the first floor of the outbuilding. The location of the bat droppings suggests an internal roost located above the wall plate on the east gable.
  - 10 bat droppings were observed on the first floor of the outbuilding. The location of the bat droppings suggests an internal roost located above the internal eaves on the south elevation – roost 1.
  - A scattering of bat droppings was observed throughout the first floor of the outbuilding.
- The outbuilding has been assessed as having a HIGH SUITABILITY to support bats.

Location of bat droppings on the internal gable.

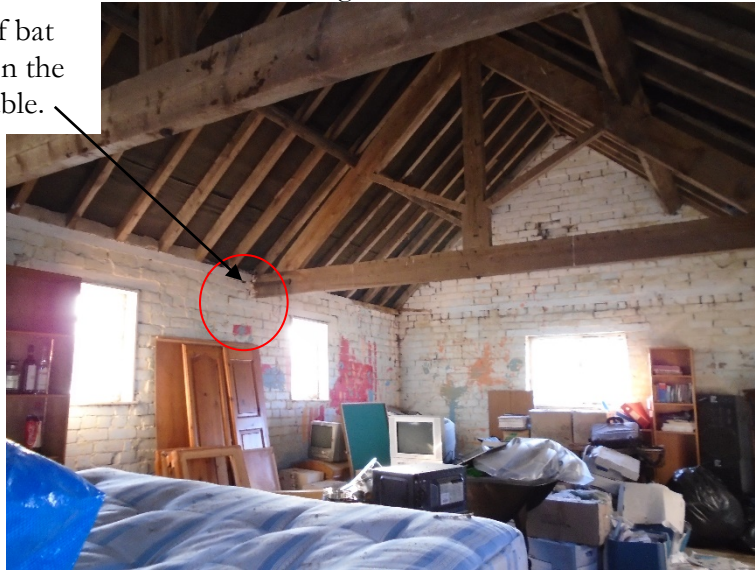
Plate 7 – outbuilding B, internal roof structure.

Location of bat droppings on the internal gable.
