Ecological Report

Outline Bat Mitigation and Compensation Strategy

Land on the south-east side of A12
Old Ipswich Road
Ardleigh
Essex
CO7 7QW

230961-ED-04a

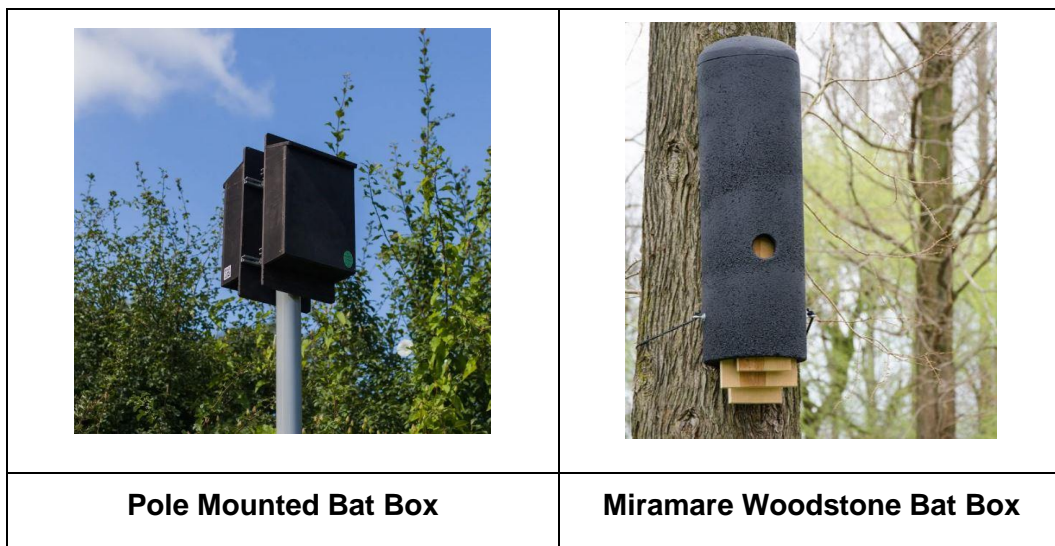
- 3.18 To replace roosting crevices present on the building, two suitable bat boxes will be installed on mature trees within the site. The proposed model is the Miramare Woodstone Bat Box, which is designed to be suitable for species which are most commonly found roosting in buildings in the UK, including common and soprano pipistrelle bats. This bat box is designed to be mounted onto trees. This box does not require any maintenance as the droppings fall out of the entrance. These boxes will be installed along the eastern boundary facing south and east to provide a direct flight path to areas of suitable habitat, away from the A12 and any artificial lighting.
- 3.19 The recommended bat boxes are shown below (alternatives may be used if approved by an ecologist prior):

- 3.16 To provide replacement common or soprano pipistrelle bat roosting opportunities before destruction of the existing roost, a pole-mounted bat box will be installed in a suitable location towards the north-east of the site. The proposed model is the 'Pole Mounted Maternity Bat Box' on a 3-metre pole. This box is a large three crevice box which is designed for colonies of crevice-dwelling bats such as pipistrelles. The pole-mounted box will be installed in a location where disturbance during the demolition and construction stages will be minimised. The box will face south and the location will be chosen so that it receives maximum sunlight and is not shaded by surrounding trees or structures. This box will also provide a location to move relocated bats to during building demolition.

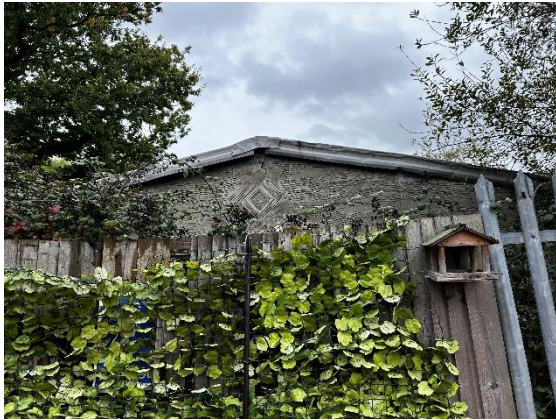
- 2.2 Building B4 was assessed as having moderate potential for roosting bats due to the presence of potential roost features such as cracks in blockwork, and access between roof tiles and timber boarding. Also, internal inspection was not possible so that bat roosting potential could not be ruled out.

Photo 1 – Crevices under fascia of Building B4

- 3.12 The bat mitigation and compensation strategy will include the following measures:
- Ecologist supervision when dismantling potential bat roost features.

- 3.13 Since retention of the existing bat roost features within the proposed development is not possible, compensatory bat roost features will be created within the site. Suitable roost features must be in place and ready for use by bats before the destruction of existing bat roosts. Additional roost features will then be included within the structure of the new building during the construction phase.

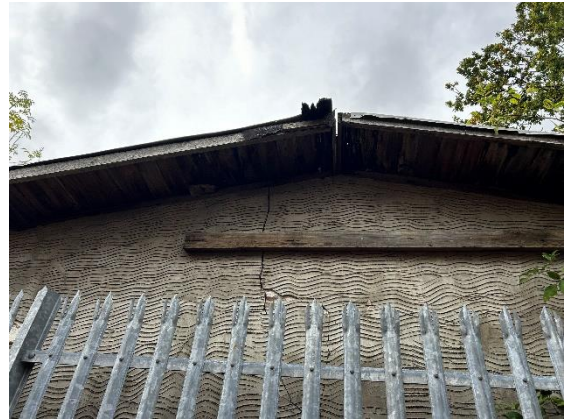
Photo 2 – Access points on Building B4

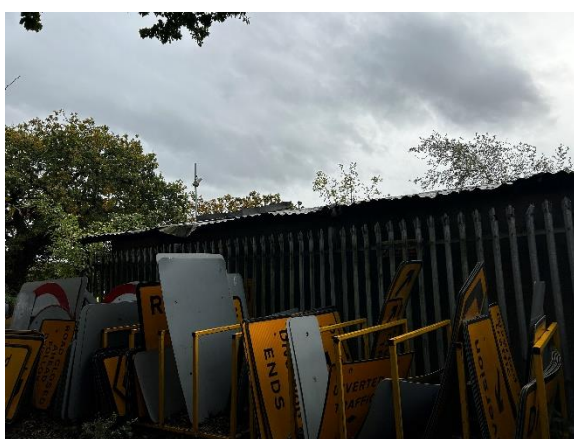
Photo 3 – Northern elevation of B4

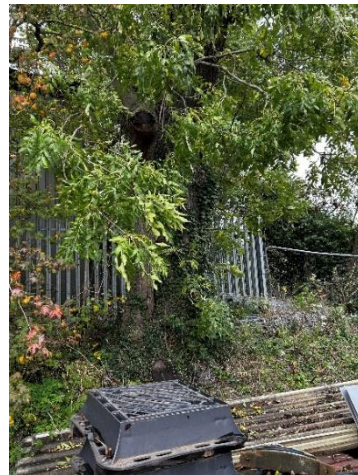
retained within the development. Climbed inspection of T8 assessed the tree as offering limited suitability for roosting bats (PRF-I). As such a pre-works inspection is recommended to ensure no bats are present prior to felling.

Photo 4 – Tree T8

- 3.9 Climbed inspection was undertaken on 19th December 2023 of tree T8 to confirm if features identified on the tree during the ground level inspection provide suitable opportunities for roosting bats (see section 2.12).
