Phase 1 Desk Study

Welling United Football Club - Welling

LUSTRE
CONSULTING

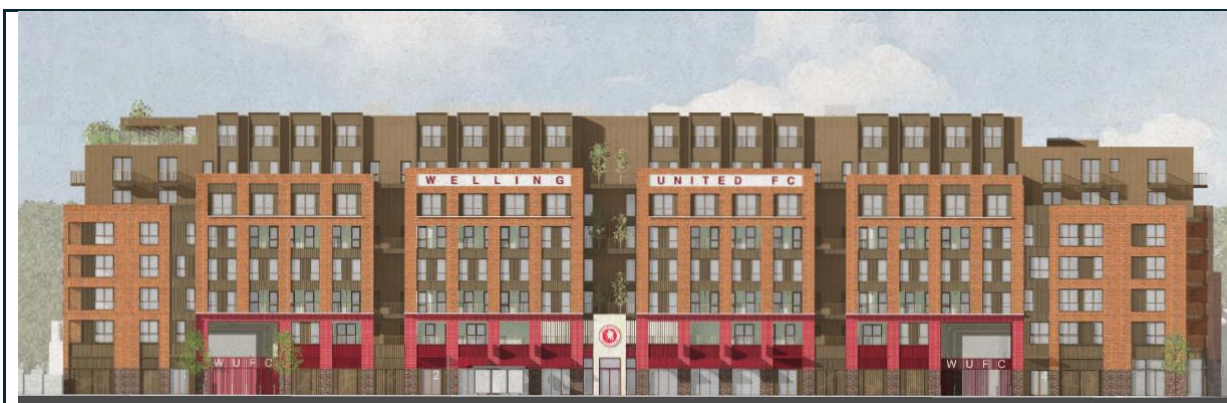
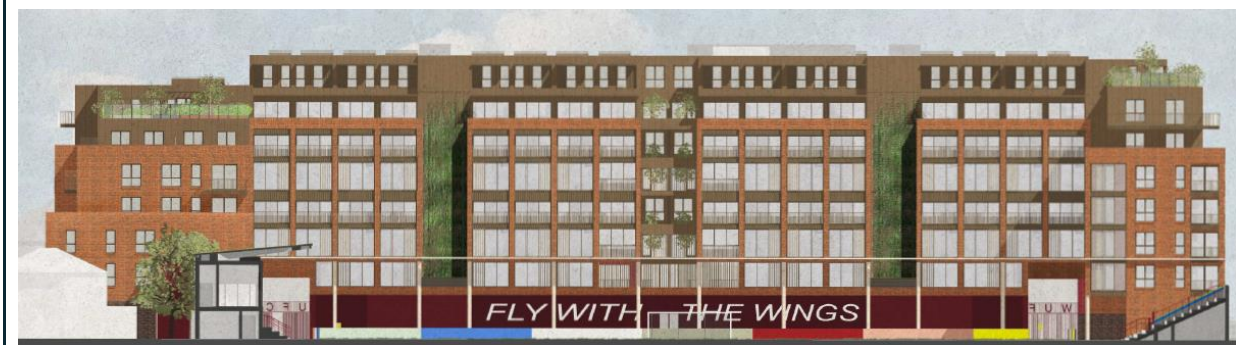
Figure 2 Proposed Development Plan

Front Elevation

Rear Elevation

balconies / terraces and / or roof gardens and soft landscaped amenity space will be provided. Some soft verges, parking, access, and a new landscaped pitch are proposed. Proposed visuals for the scheme are presented in Figure 2.

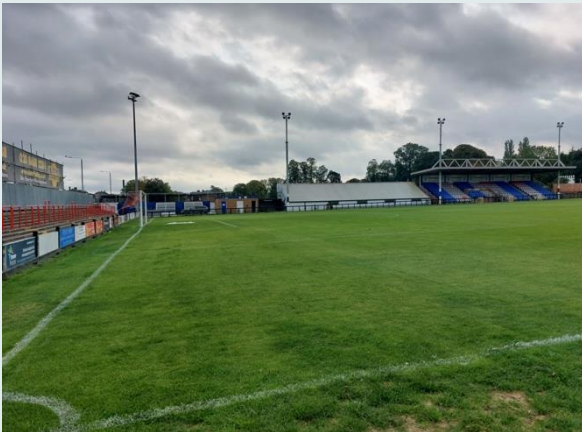
View of the standing terraces, pitch and stands on site

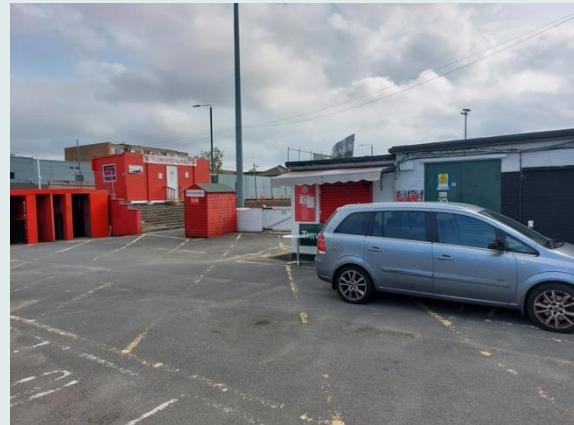
View of the Travis Perkins bar, shop, and electrical sub-station at the north of the site

- 2.19 A potential source of PCBs was identified on site relating to an electricity sub-station at the north of the site, adjacent to the Travis Perkins bar. The sub-station was locked and access to this infrastructure was restricted. No evidence of staining or leakage was noted on site associated with this infrastructure.
- 2.20 No other specific POP point sources were identified during the site inspection that could have adversely impacted soils on site. No nearby off-site electrical sub-stations were identified by Envirocheck.

- ▶ A programme of Phase 2 Site Investigation is recommended which would aim to confirm a limited thickness of Made Ground on site and the absence of significant contamination. The investigation can be limited but should focus on the location of the existing buildings and structures, the heating oil tank and parking areas and around the electrical sub-station on site. This will be used to refine the risk

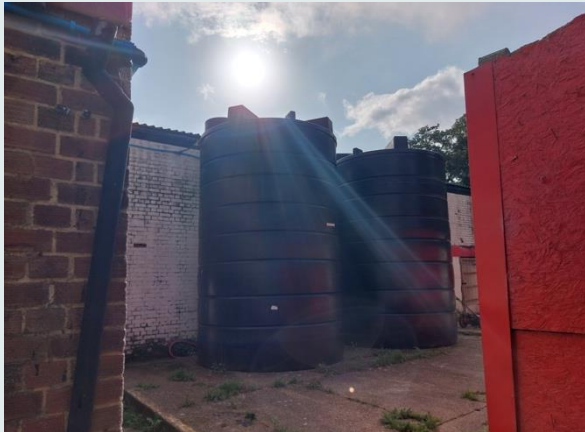
Black silos on site (collecting rainwater)

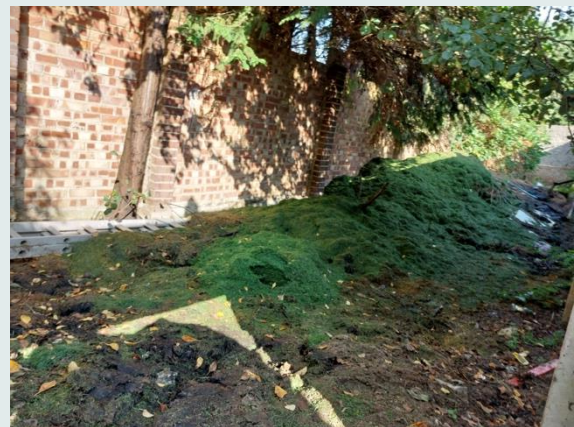
Grass cuttings from the football pitch
decomposing within an unused area of the site

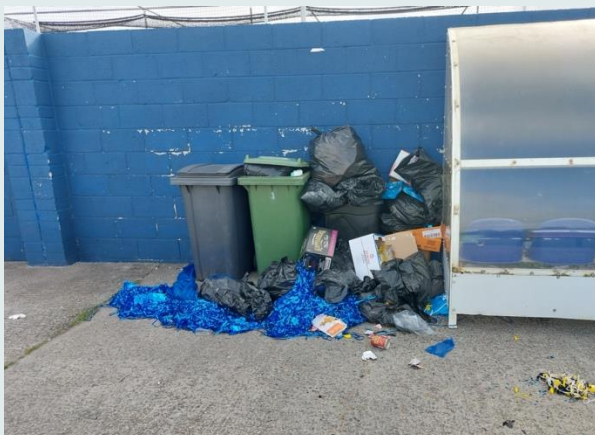
- 2.18 Wastes generated on site are likely removed by a licensed waste carrier. From the observations made on site, housekeeping appears to be generally poor.

Overflowing bins and waste on site
