## **Extended Phase 1 Habitat Survey**

### **Welling United Football Club**

**Park View Road  
Welling  
Bexley  
DA16 1SY**

23-011  
November 2023

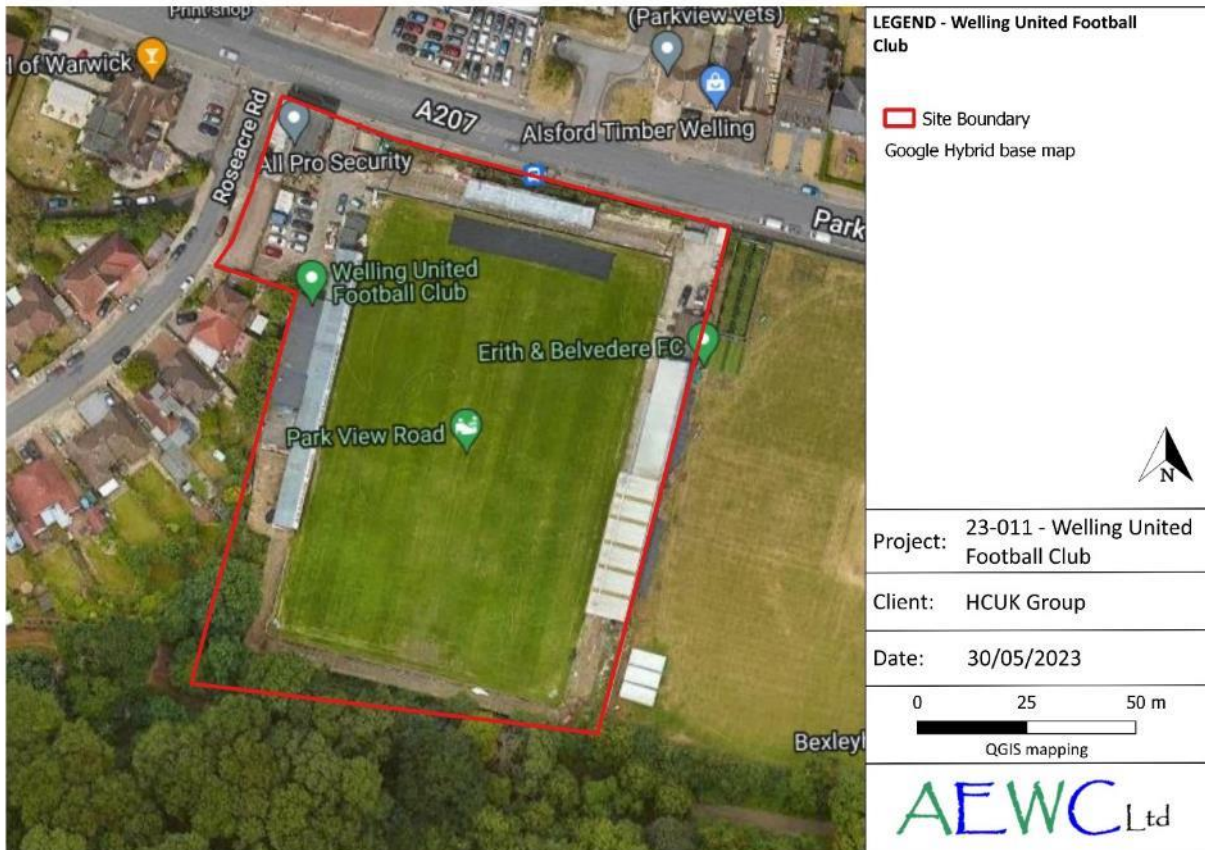
**FIGURE 2 : AERIAL VIEW OF THE SITE SHOWING THE SITE BOUNDARY**

- 2.3 The site is approximately 1.2ha and largely comprises buildings, hardstanding, modified grassland within the pitch and narrow bands along the southern edges of the site containing low ruderal vegetation and a small woodland patch. See Figure 2.

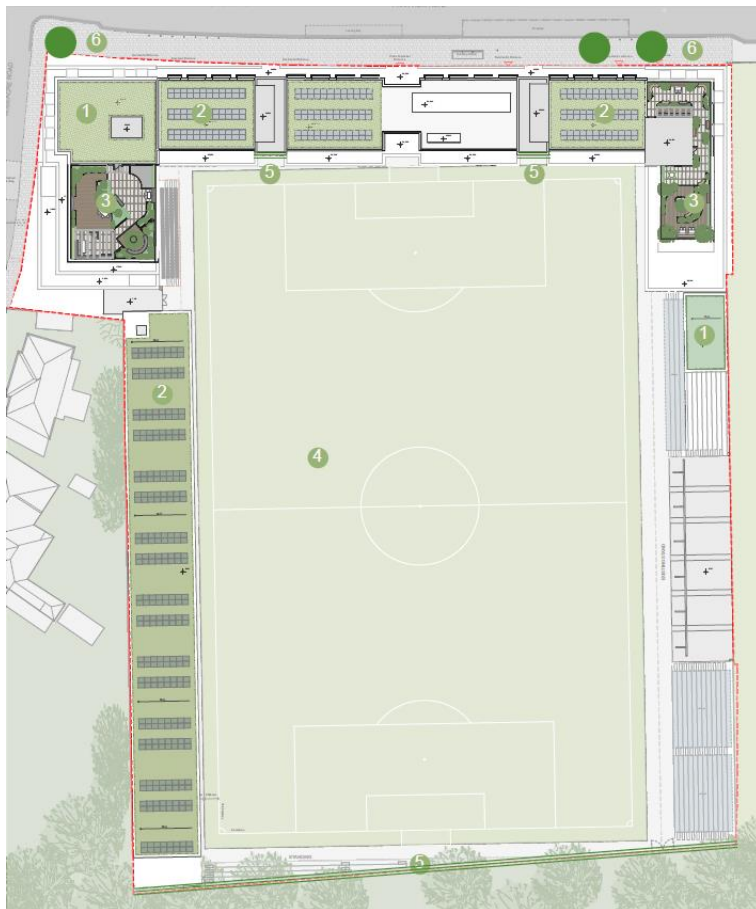
**FIGURE 3 : PROPOSED PLANS**

- 2.4 The proposed development plan involves extensive refurbishment to the existing site, which will include: replacement of the existing pitch with a 3G synthetic pitch on a slightly altered footprint, retention and refurbishment of the stand and adjacent hall on the eastern side of the pitch, demolition of the remaining buildings and structures to facilitate construction of new club and hospitality facilities along the western side of the site, and a new multi-storey residential development wrapping around the northern end of the site, providing 104 residential units with commercial units at ground floor level. This will involve the removal of predominantly buildings, hardstanding and modified grassland, as well as small areas of scattered ruderal and scrub vegetation and a small patch of young woodland. The development will include tree planting

along the front façade of the new residential building, green roofing on all buildings and a green wall along the southern side of the site. The majority of the habitat area on site will be affected by these proposals.

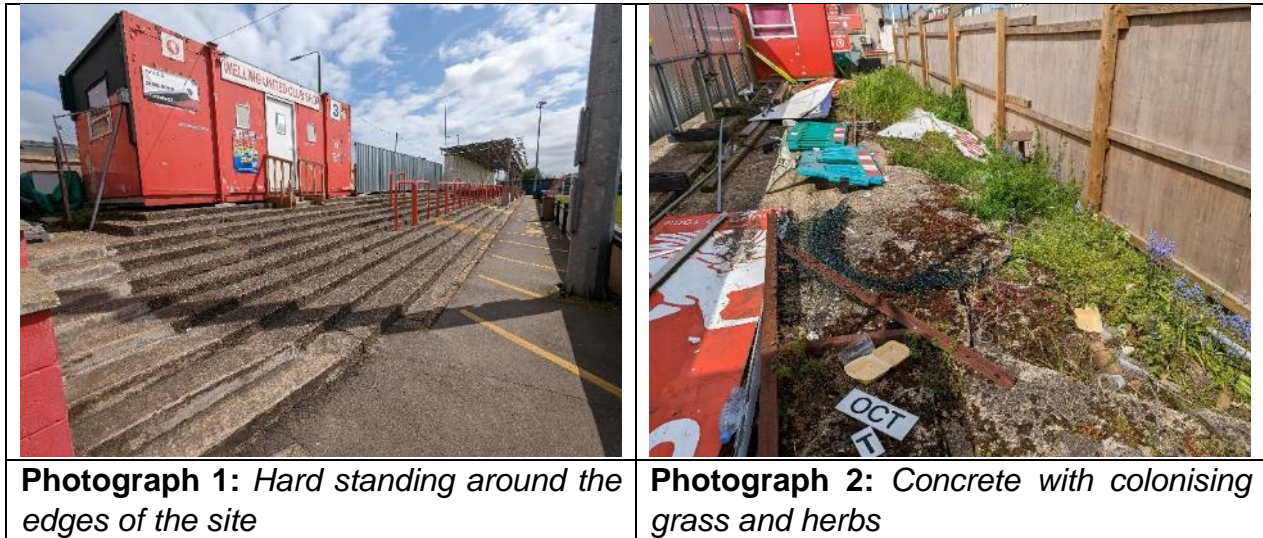
- 5.15 The hard standing on site comprises areas of tarmac parking and walkway in the north and north-west of the site, and extensive concrete access, walkways, courtyard and terraced stands/seating around the edges of the site and around the buildings. Along the northern site boundary, a narrow band of concrete hoarded off from the public has begun to be colonised by small clumps of barren brome *Anisantha sterilis* and herbaceous species including self-heal *Prunella vulgaris*, herb Robert *Geranium robertianum*, speedwell *Veronica spp.*, small-flowered cranesbill *Geranium pusillum*, dandelion *Taraxacum spp.*, Spanish bluebells *Hyacinthoides hispanica* and white dead-nettle *Lamium album*, as well as ruderals including nettle *Urtica dioica* and cleavers *Galium aparine*. The clumps are small and scattered and the area is well

isolated by extensive hard standing from other habitat in the wider area, therefore is not considered suitable to support protected species.

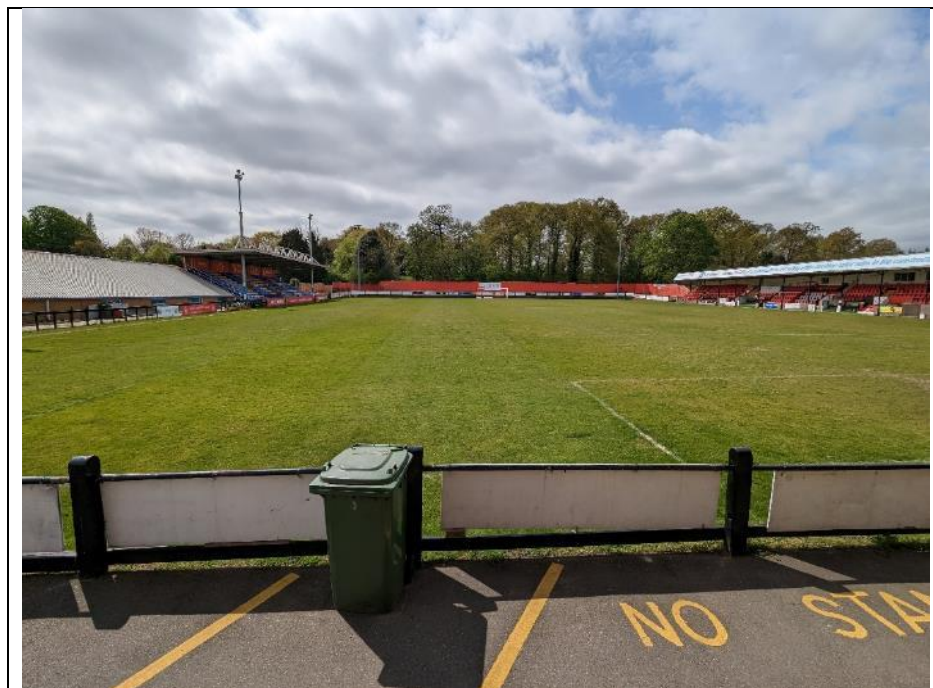
5.16 A large football pitch is present in the centre of the site, this comprises annual meadow grass *Poa annua* maintained as a very short sward. No other grass or herb species are present on the pitch.

**Photograph 3:** Looking south-west across the pitch

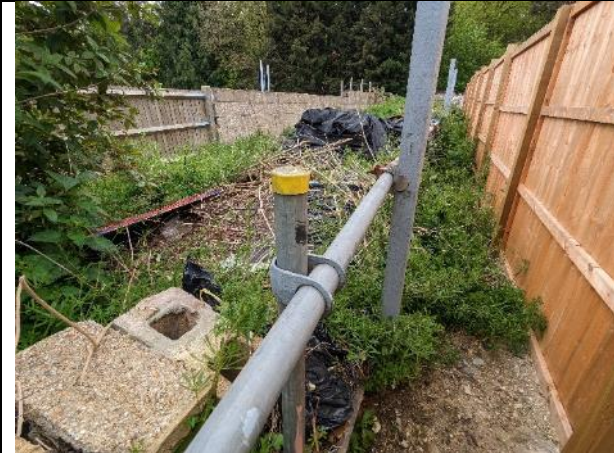
**Photograph 4:** *Dumped materials and ruderal vegetation in the south-east of the site*

5.17 A narrow band around the southern edge of the site is hoarded off from the public; this area contains frequent dumped materials including plastics, metal, timber, and some areas of bare ground and has been colonised to varying degrees by low ruderal vegetation, predominantly nettle and cleavers with infrequent self-heal, in addition to two small butterfly bush *Buddleia davidii* on the eastern side of the site. There are

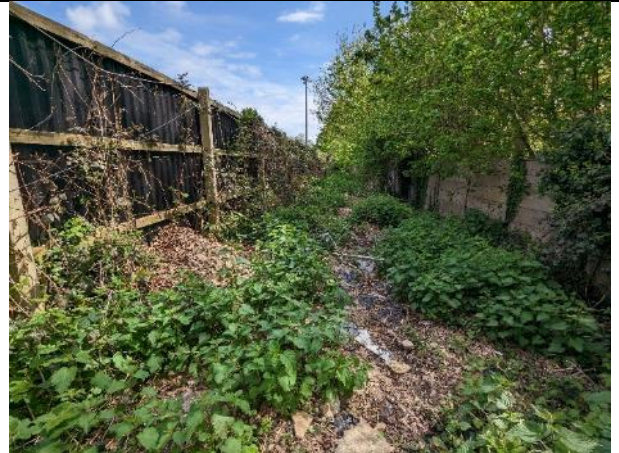
**Photograph 5:** *Rubbish and ruderal vegetation along the southern boundary*

areas of scattered ivy *Hedera helix* and bramble *Rubus fruticosus* growing on the fence line along the southern boundary of the site. Missing panels on the southern fence line enable human access into these areas and evidence of antisocial behaviour was noted such as a small fire pit and discarded rubbish on site. These areas hold potential for foraging and refuge by reptiles, amphibians and small mammals, with the ivy over the fence additionally suitable for nesting birds.

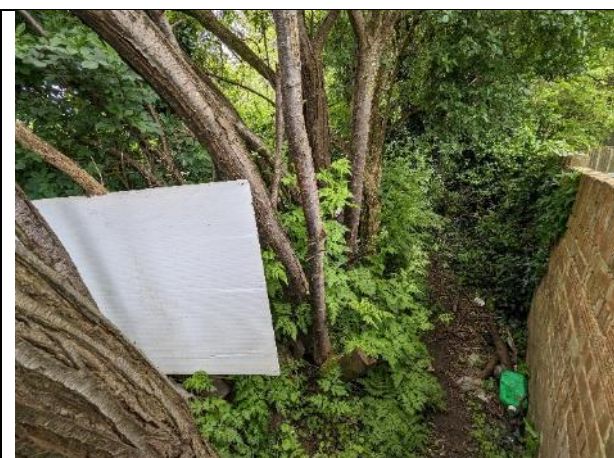
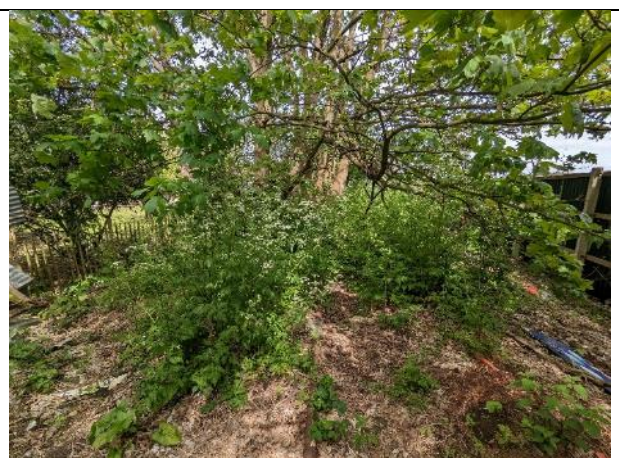
5.18 A very small clump of woodland is present within the narrow, hoarded area along the western boundary; this comprises two multi-stemmed sycamore *Acer pseudoplatanus* trees and a low number of smaller sycamore, elder *Sambucus nigra* and cherry *Prunus spp.* trees, with an understorey of ivy, cow parsley *Anthriscus sylvestris* and some bramble. In the south-western corner of the site is an area with bare ground, sparse nettle, cow parsley and some ground ivy *Glechoma hederacea*, and a single sycamore tree. The small woodland clump holds potential for nesting birds and foraging bats and offers foraging and/or refuge potential for small mammals, amphibians and reptiles.

- 6.15 The deciduous woodland habitat within the site is smaller than is indicated on MAGIC mapping system and is partially separated from the deciduous woodland adjoining the site by a more sparsely vegetated area. In addition, the invasive species cherry laurel and snowberry that are present between the on-site and off-site areas of deciduous woodland are known to spread prolifically and are likely to degrade the condition of the woodland over time.

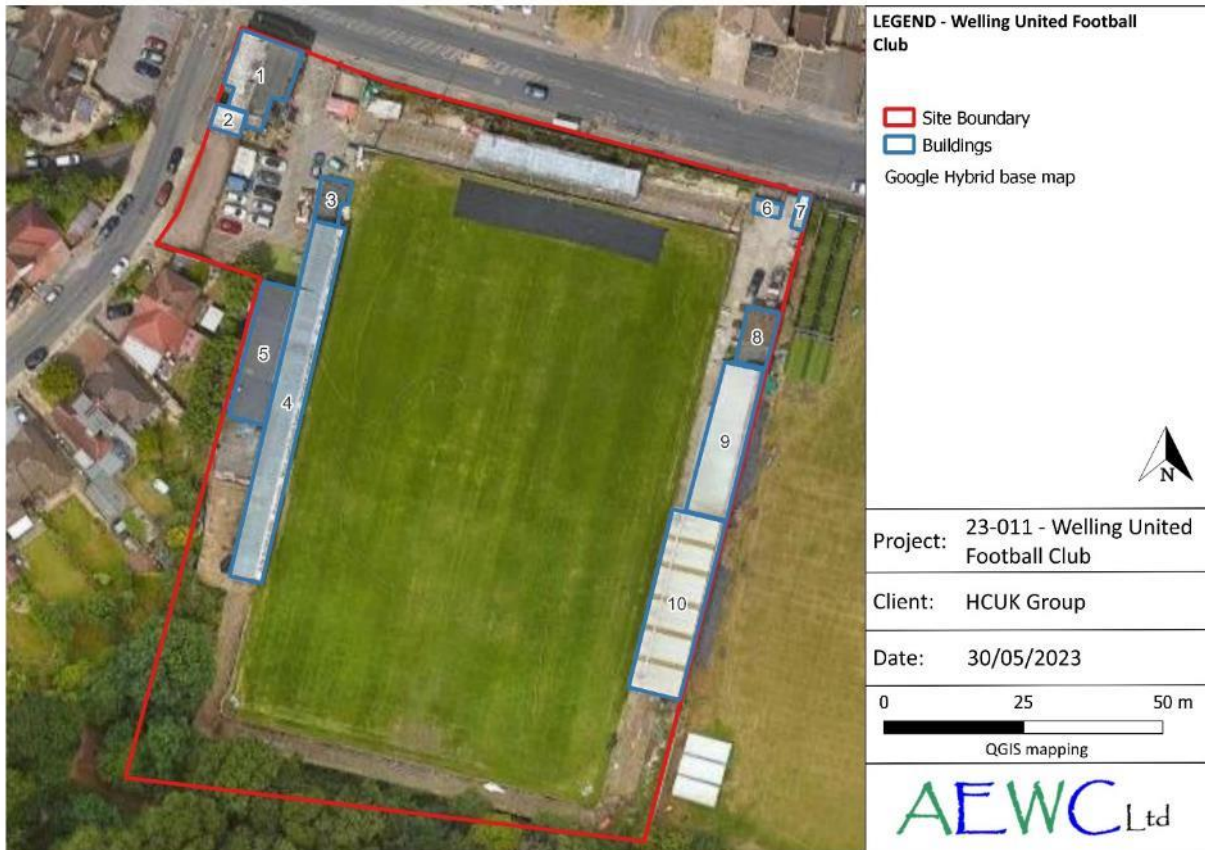
5.42 Ten buildings were assessed for evidence of, or potential for, roosting bats (Figure 6).

**FIGURE 6 : AERIAL VIEW OF THE SITE SHOWING THE BUILDINGS SUBJECT TO SURVEY**

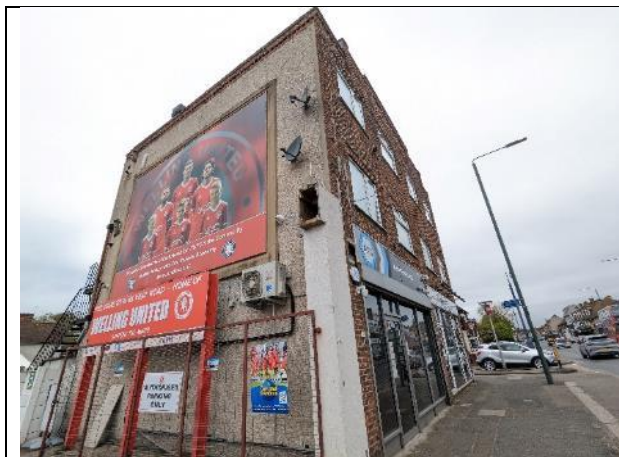
**Photograph 8:** Northern and eastern elevations of Building 1

5.43 This is a three-storey block of flats with commercial units at ground floor level. The walls are rendered with pebble-dash and the roof is flat and clad in bituminous felt. The fascias were found to be well-fitted throughout with no gaps evident that could provide access for bats. On the northern elevation, a gap alongside commercial signage provided easy access into a cavity formed by the I-beam and signage. No bats or evidence of bats were identified present within the cavity.

5.44 No internal access to this building was possible, however it is considered unlikely that a void space is present as the building has a flat roof.

- 6.19 Building 1 and Buildings 3 to 10 were found to have negligible suitability for roosting bats due to a lack of suitable roosting features and therefore there are considered to be no constraints regarding the demolition of these buildings.
- 6.20 **Building 2 was identified as having low potential to support roosting bats due to the presence of gaps at the fascia on the eastern elevation. A minimum of one emergence survey is therefore required,** to confirm presence or increase confidence in a result of likely absence of bats.
- 6.21 The emergence survey must be carried out in the peak season of mid-May to mid-August. **If bats are found, sufficient surveys will be required in order to confirm**

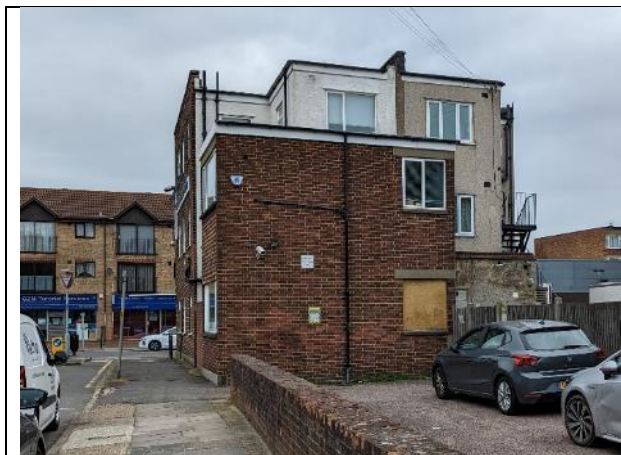
**Photograph 10:** Southern elevation of Building 2

5.45 This is a double-storey block of flats with a flat bituminous roof attached to the southern elevation of Building 1. The brick walls are part-rendered in pebbledash and there is a section of modern hanging tiles on the western elevation between the lower and upper windows.

5.46 The hanging tiles are even and tight-fitting and the fascias flush with the wall on the southern and western sides. On the eastern elevation, the gaps are present in the fascia at both corners which could provide access for bats to roost. No access to the rear of the building was possible to enable close inspection of these crevices with a torch or endoscope.

- Building 2 has low potential to support roosting, **a minimum of one emergence survey is required to confirm presence or increase confidence in a result of likely absence of bats.**

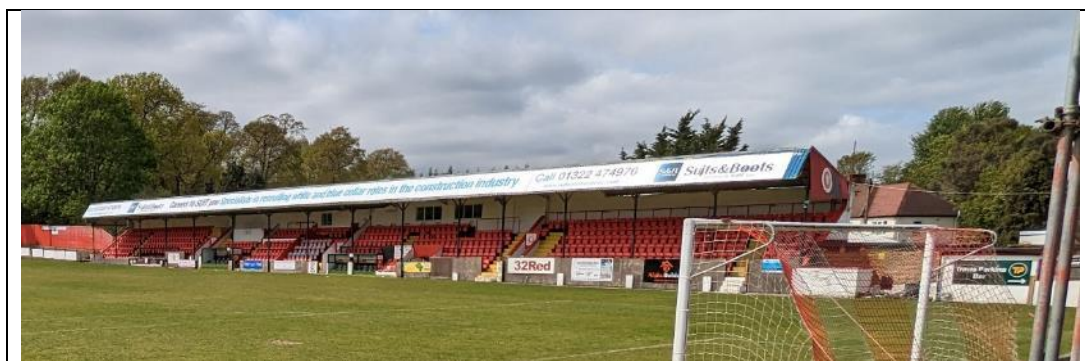
**Photograph 12:** Eastern elevation of Buildings 3 and 4

5.47 This is a single-storey brick building with a flat roof clad in bituminous felt. The roof and fascias were found to be tight-fitting with no gaps present suitable for use by bats. No internal void is present in the building.

5.48 This is the large stand along the western side of the pitch, it is brick-built and encompasses a double-storey rear wall supporting a corrugated metal roof which shades the sloped seating on the upper floor. Below this, the ground floor is continuous with Building 5. The ground floor area had no access points suitable for use by bats, whilst the upper stand area is open-sided, bright and draughty and considered unsuitable for bats.

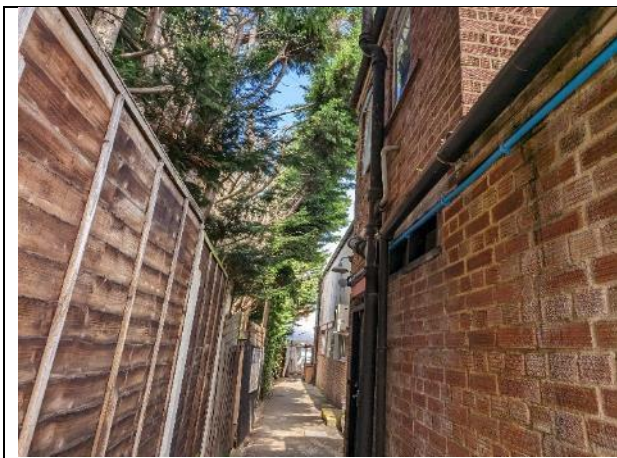
**Photograph 13:** *Western elevation of Building 5*

5.49 This is a double-storey brick building with a flat roof clad in bituminous felt. At the southern end is a single-storey section with a sloped roof of corrugated composite sheeting. The fascia on the single-storey section is flush with the wall and whilst the corrugated roof forms natural crevices along the western elevation, these were heavily cobwebbed and filled with debris.

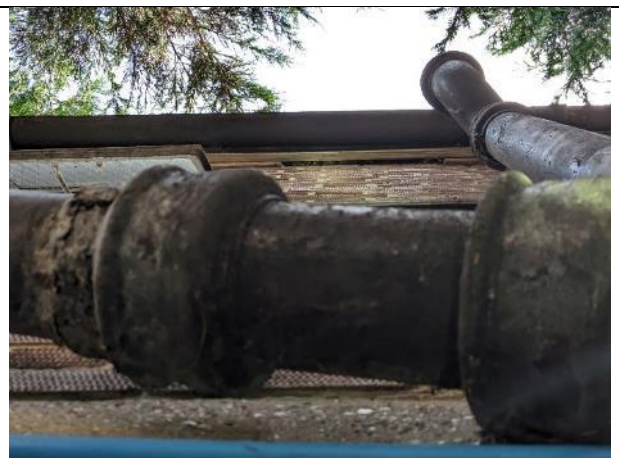
**Photograph 14:** *Gaps beneath fascia on Building 5*

5.50 On the double-storey section of Building 5, several small gaps were noted beneath the fascia along the western elevation. These crevices were all found to be filled with thick, debris-filled cobwebbing and were additionally heavily shaded by the neighbouring conifer tree line to the west, reducing the suitability for roosting bats. A small void was present in part of Building 5, this could only be accessed in the vicinity of the boiler that was being repaired at the time, and the underside of the roof within the void was covered in thick and dusty cobwebbing.

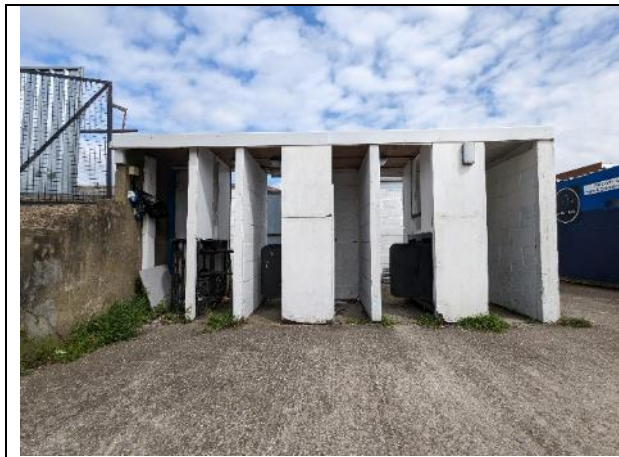
**Photograph 15:** *Southern elevation of Building 6*

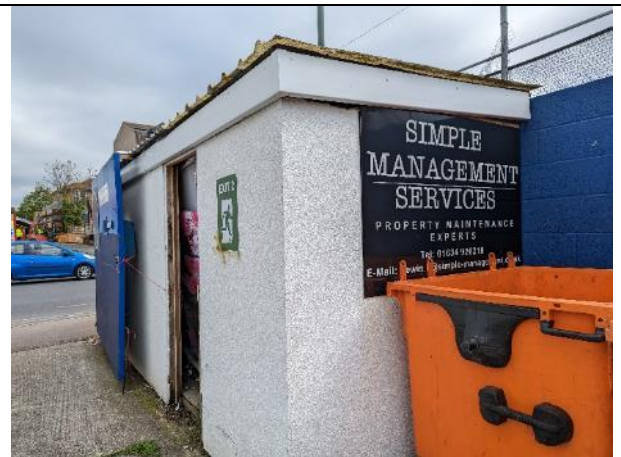
**Photograph 16:** *Southern and western elevations of Building 7*

5.52 This is a small block building with flat timber roof clad in bituminous felt and additionally covered over with corrugated Perspex. A partially open doorway and gaps at the wall top where the roof has warped would allow access into the interior for bats and birds. Internally, the roof lacks suitable roosting crevices for bats and there is evidence of damp ingress at the roof.

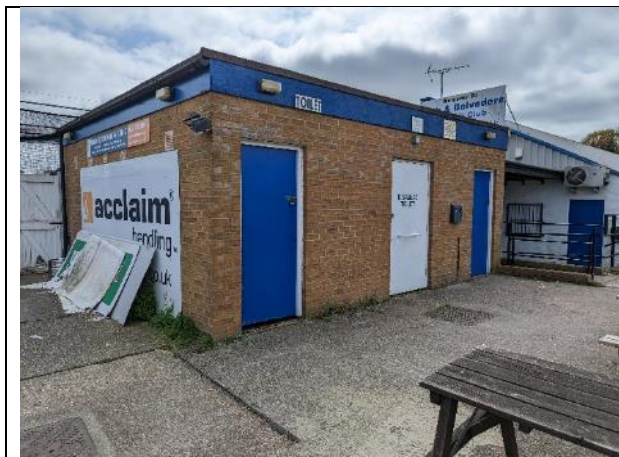
**Photograph 17:** *Northern and western elevations of Building 8*

5.53 This is a single-storey, brick-built toilet block with a flat roof of bituminous felt. The building is in good condition with tight-fitting fascias and no access points suitable for bats were noted.

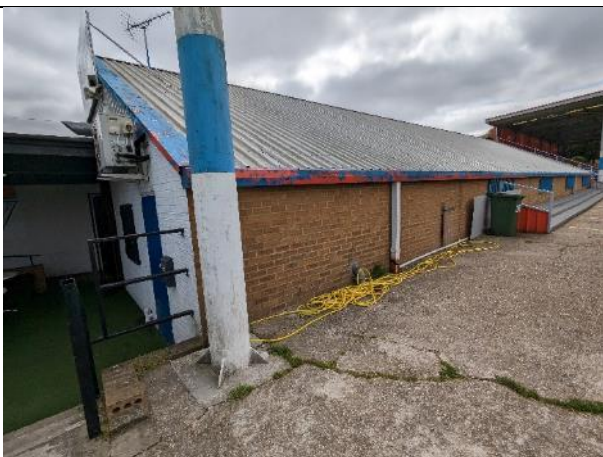
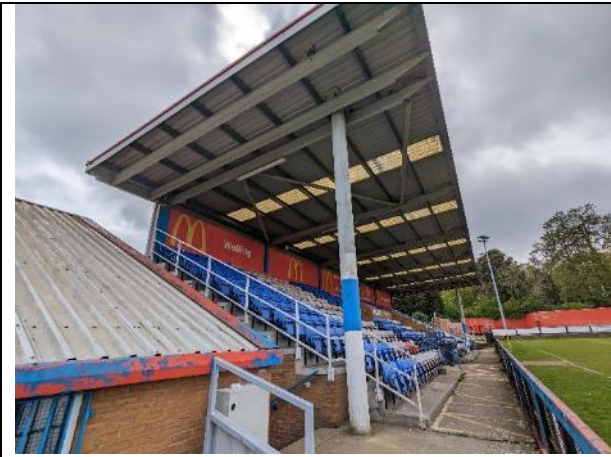
5.55 This is a brick-built stand supporting a sloped roof of corrugated metal. This building links to Building 9 and the ground floor rooms are continuous between the two. No access points were identified around the exterior of Building 10.

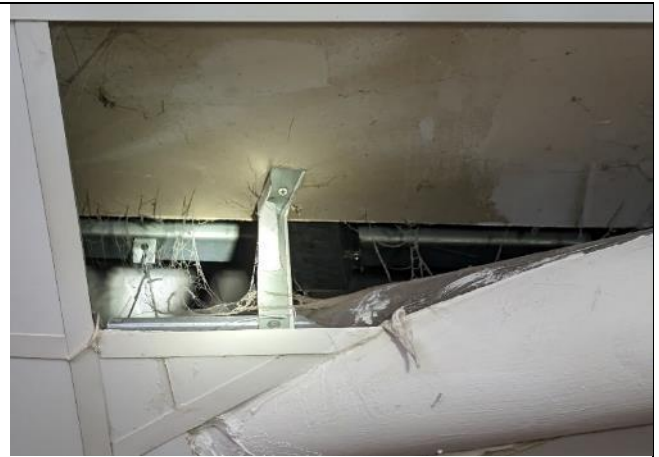
**Photograph 20:** *Cobwebbed void within Buildings 9 and 10*

5.56 Internally, a suspended ceiling creates an asymmetric roof void in both buildings, which could be seen and inspected in several places where ceiling tiles had been dislodged. A proportion of the void appears to have been insulated with spray foam insulation. Other areas had no spray foam visible, although thick cobwebbing could be seen.

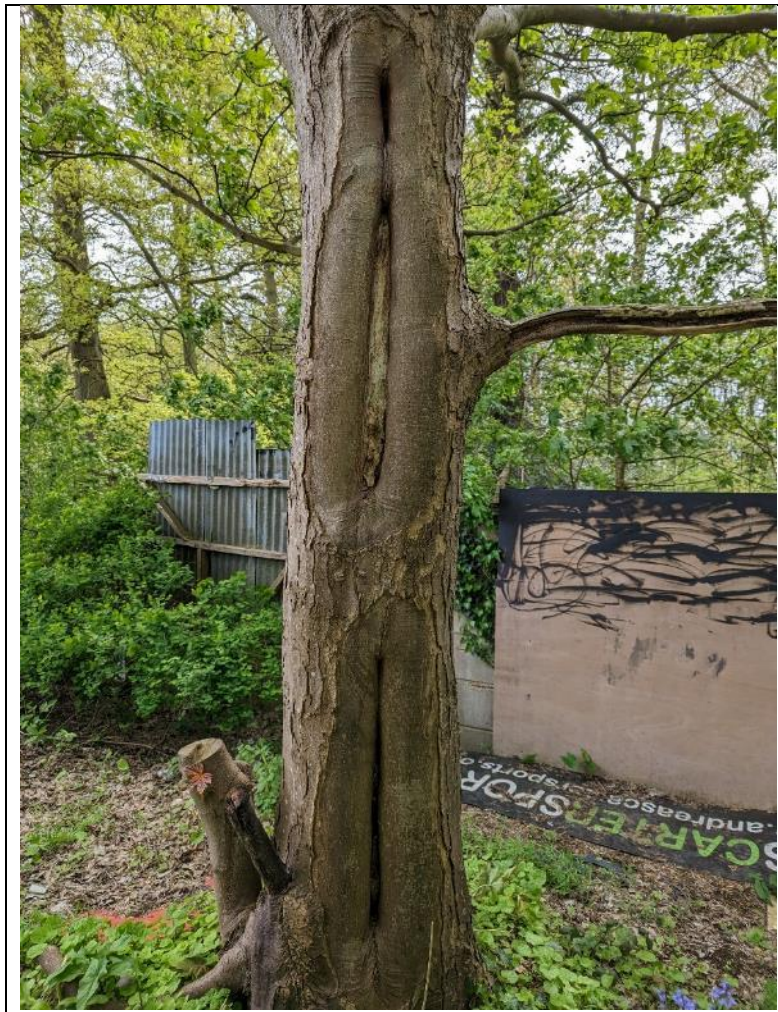
**Photograph 21:** *Tree 1 with keyhole features*

5.57 This is a single sycamore in the south-western corner of the site, with keyhole features in the process of forming. At present, the heartwood has not yet rotted away sufficiently to provide much more than shallow and exposed crevices, suitable only as a very opportunistic roost for crevice-dwelling species.

- 6.22 **One sycamore tree on site was found to have keyhole features with low potential for bats.** In line with the Good Practice Guidelines, no further surveys for bats will be required if any of the trees are to be removed, however **the tree with low potential must be soft-felled under supervision of a licensed ecologist.**
