Bat Survey Report

Welling United Football Club

**Park View Road
Welling
Bexley
DA16 1SY**

23-011
July 2023

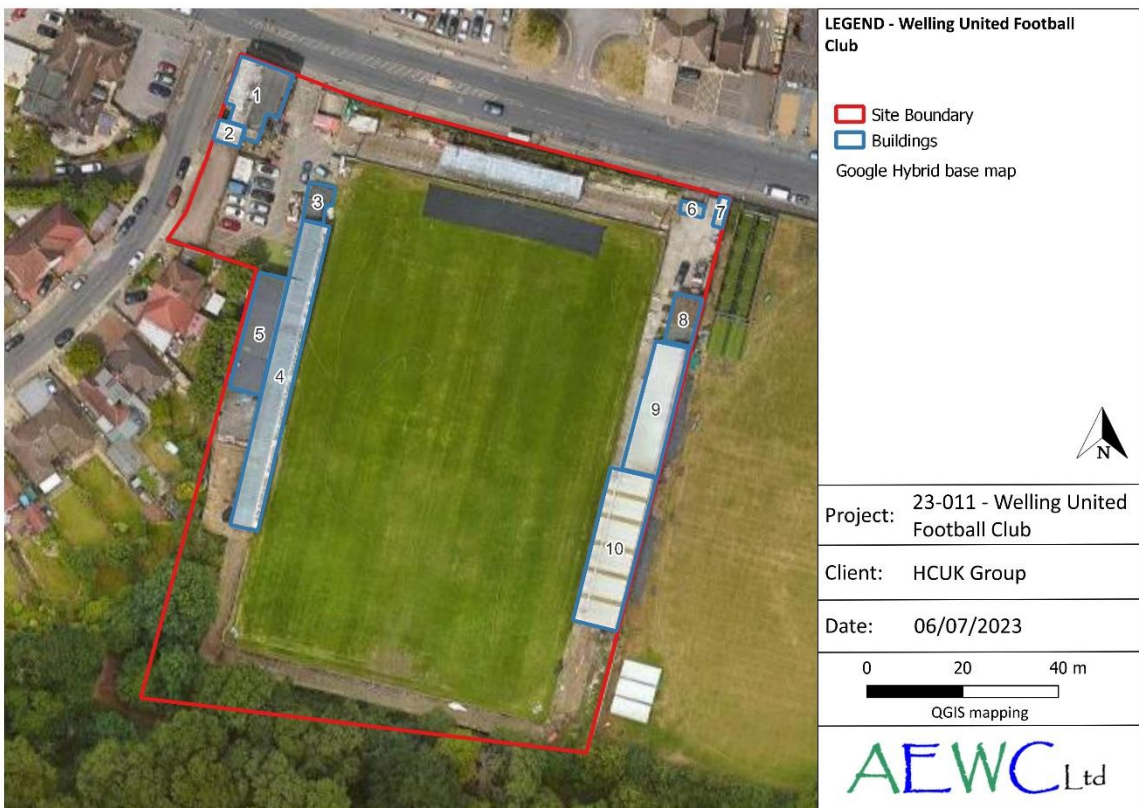
FIGURE 2: SHOWING BUILDING 2 SUBJECT TO SURVEY WITHIN THE SITE BOUNDARY.

1.8 The site comprises a football pitch and associated buildings with overgrown vegetation around the southern boundaries of the site. See Figure 2.

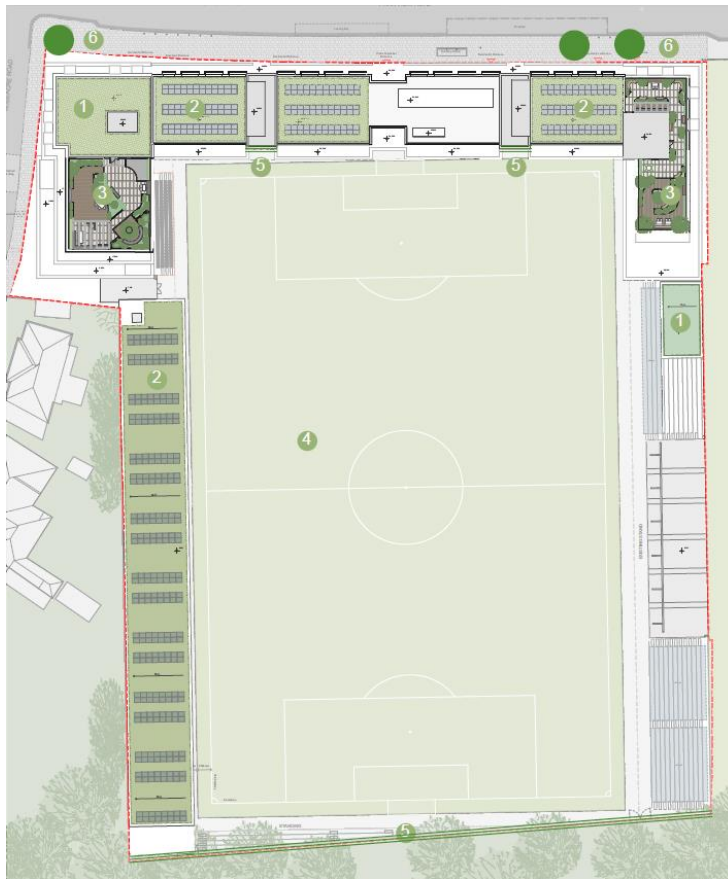
FIGURE 3: SHOWING THE PROPOSED PLANS.

- 1.13 The proposed development plan involves extensive refurbishment to the existing site, which will include the demolition of Building 2 to facilitate the construction of the new club and hospitality facilities.

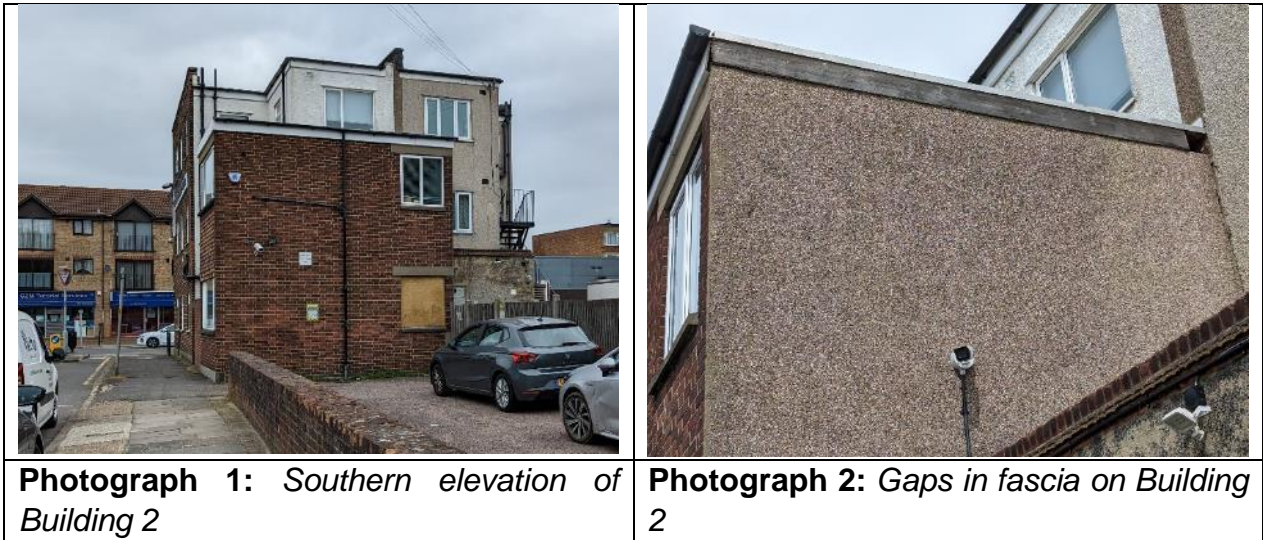
- 4.1 Building 2 is a double-storey block of flats with a flat bituminous roof attached to the southern elevation of Building 1. The brick walls are part-rendered in pebbledash and there is a section of modern hanging tiles on the western elevation between the lower and upper windows.
- 4.2 The hanging tiles are even and tight-fitting and the fascias flush with the wall on the southern and western sides. On the eastern elevation, the gaps are present in the fascia at both corners which could provide access for bats to roost. No access to the rear of the building was possible to enable close inspection of these crevices with a torch or endoscope.

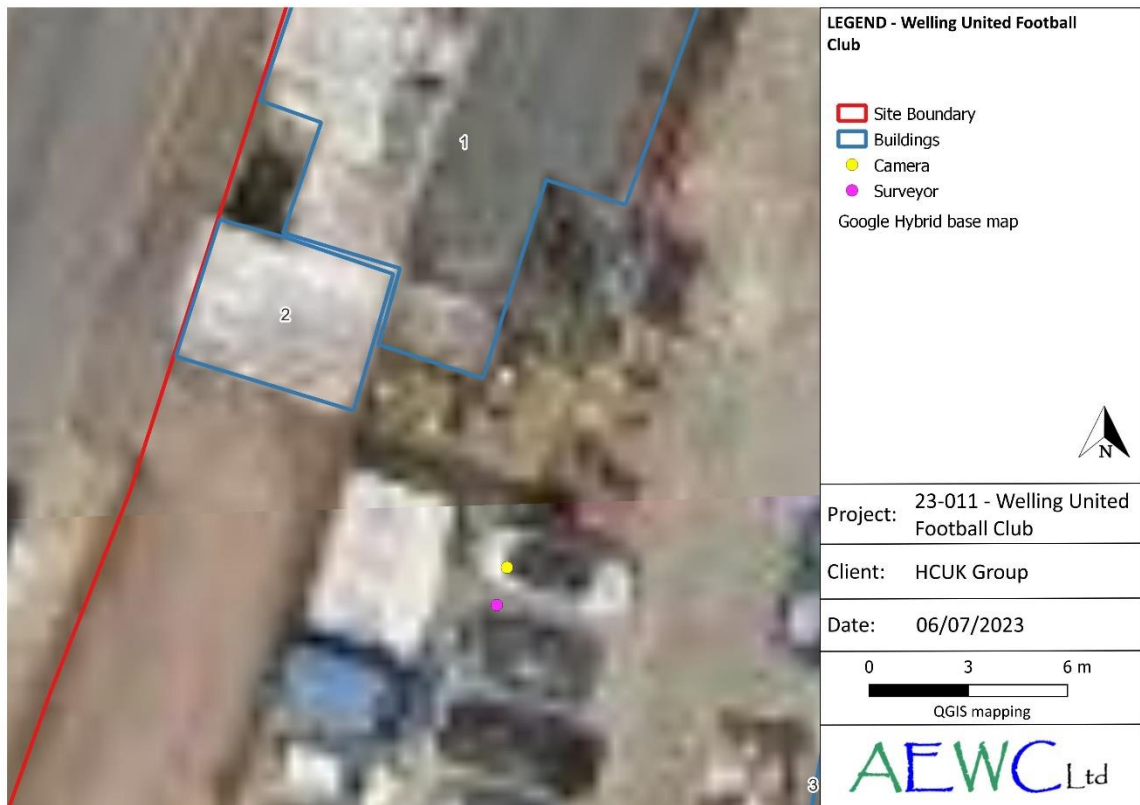
FIGURE 4: SHOWING POSITIONS OF THE SURVEYOR AND NIGHT VISION CAMERA DURING THE JUNE EMERGENCE SURVEY.

- 2.5 One surveyor and one professional night vision camera was used for the emergence survey (Figure 4). The surveyor and camera were positioned to get a good all-round view of the building with a particular focus on the eastern elevation where potential roost features were identified present.

- 4.3 **27th June 2023** – Weather conditions were good for the survey (21°C and overcast with a slight breeze) and any bats still present were likely to be active. The survey recorded two common pipistrelles (*Pipistrellus pipistrellus*) commuting past the eastern elevation of the building from south to north. No bats were recorded to emerge from Building 2, and the survey recorded no other bat activity.
- 4.4 A diagram showing the locations of the surveyor and night vision camera during the evening survey can be seen in Figure 4 below.

- 5.2 Building 2 was considered to have low potential to support roosting bats, however **bats were not found during the emergence survey and, as such, there are no known constraints regarding these species and the proposed development.**
