The Ecology Co-op

Ref: 330 Grove Street, Petworth. Updated assessment.

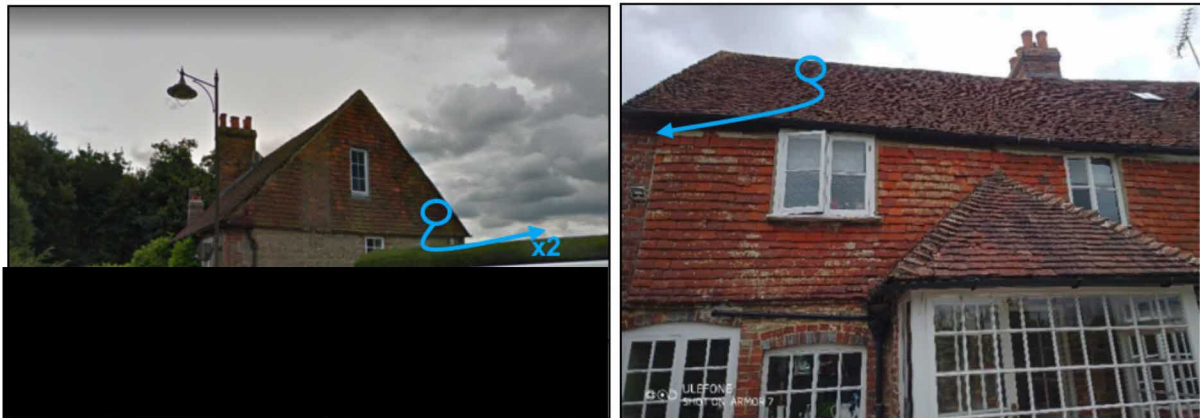
The emergence surveys undertaken by the Ecology Co-op in 2021 and 2022 confirmed the presence of two common pipistrelle bat roosts – one at the hanging tiles on the northern elevation of the property and one from the western roof pitch (see figure 1 below).

Figure 1. the location of two emerging common pipistrelle bats from the northern roof pitch (left image) and one common pipistrelle bat from near the ridge of the western roof pitch (right image).

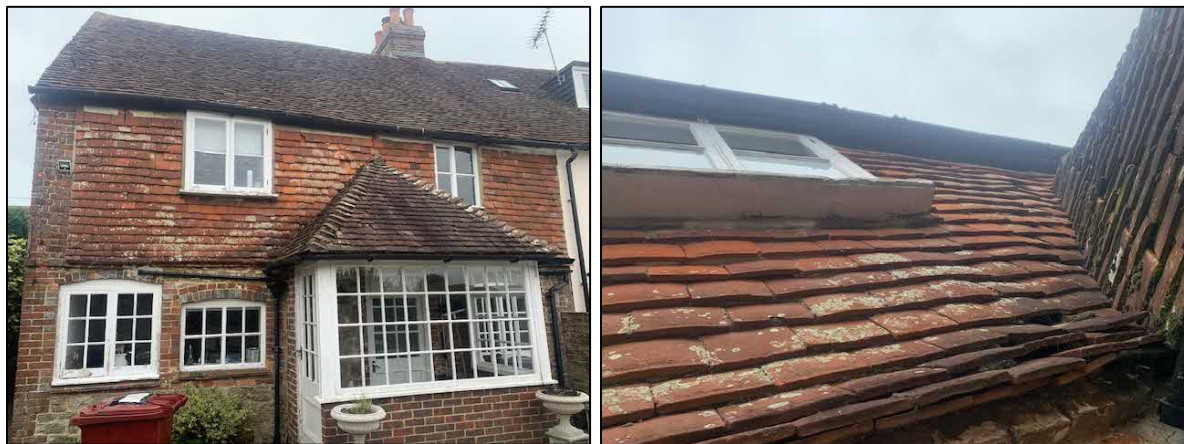
My assessment established that the property remains in a near identical condition to that described in the report by AEWC and the Ecology Co-op bat emergence survey report. No significant evidence of roosting bats was identified, though one pipistrelle sized bat dropping was visible on a hanging tile on the western face of the property. Using a high-powered torch to illuminate crevices behind hanging tiles, no bat droppings were visible behind the tiles themselves and no other evidence of bats was identified.

Photographs 1 & 2. The western face of the property and evidence of tile gaps visible at the property consistent with descriptions from the bat scoping report by AEWC.

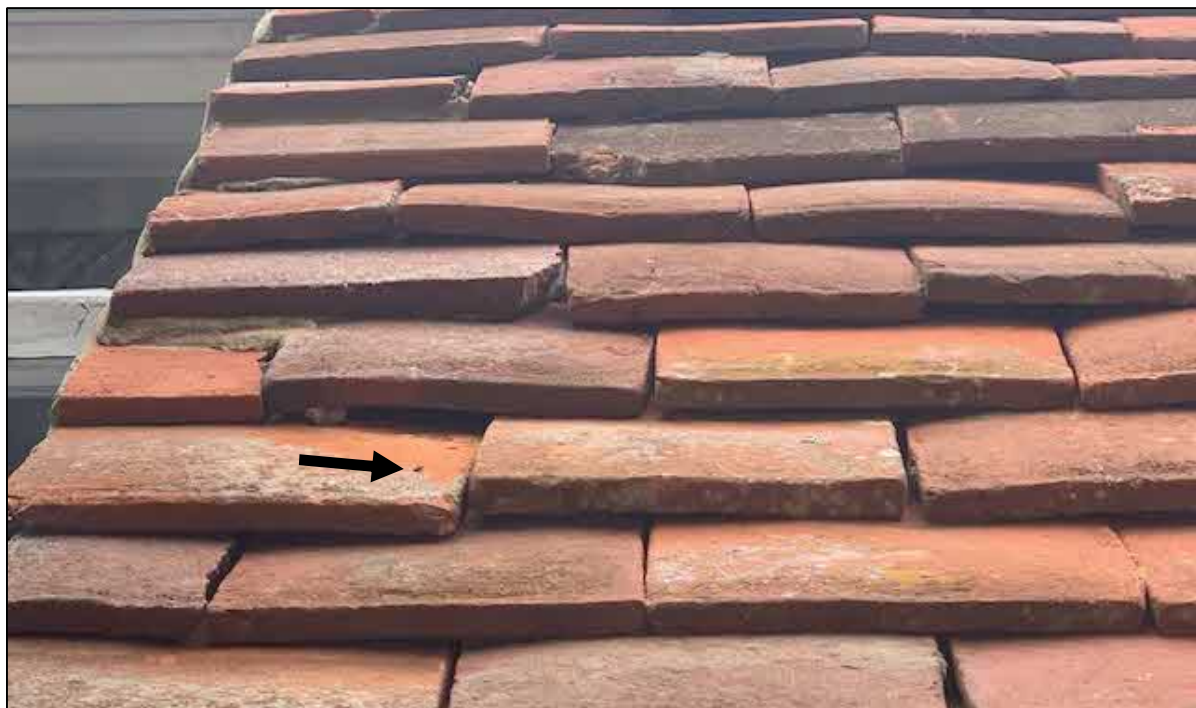
Photograph 3. A single pipistrelle sized bat dropping visible on a hanging tile on the western face of the building (identified with a black arrow).

I am happy that the bat emergence survey report from 2022 produced by the Ecology Co-op is still acceptable to inform a planning determination for the proposed modifications to this property, as the data would be credible to inform an EPS license and satisfy the 3 derogation tests according to the Conservation of Habitats and Species Regulations (under Regulation 53 (2) (e)).

It should be noted however that the time that is likely to pass between the determination date and when the licensable work can be implemented means that a top-up bat emergence survey will be necessary to inform an EPS license. As the emergence survey report by the Ecology Co-op from 2022 identified only a single common pipistrelle bat roost that would be directly impacted (with the roost behind the north-facing hanging tiles remaining unaffected), the proposals are eligible for a 'Bat Mitigation Class License (BMCL), which is a faster method of licensing impacts to bat roosts of common species and of lower conservation significance.
