### 5.3 Historic Joinery.

## 5.4. Surviving Timber-Frame Roof in the Attic: Construction Types.

## 5.8 Levels of Significance

### **6.0 Impact of Proposals on Significance.**

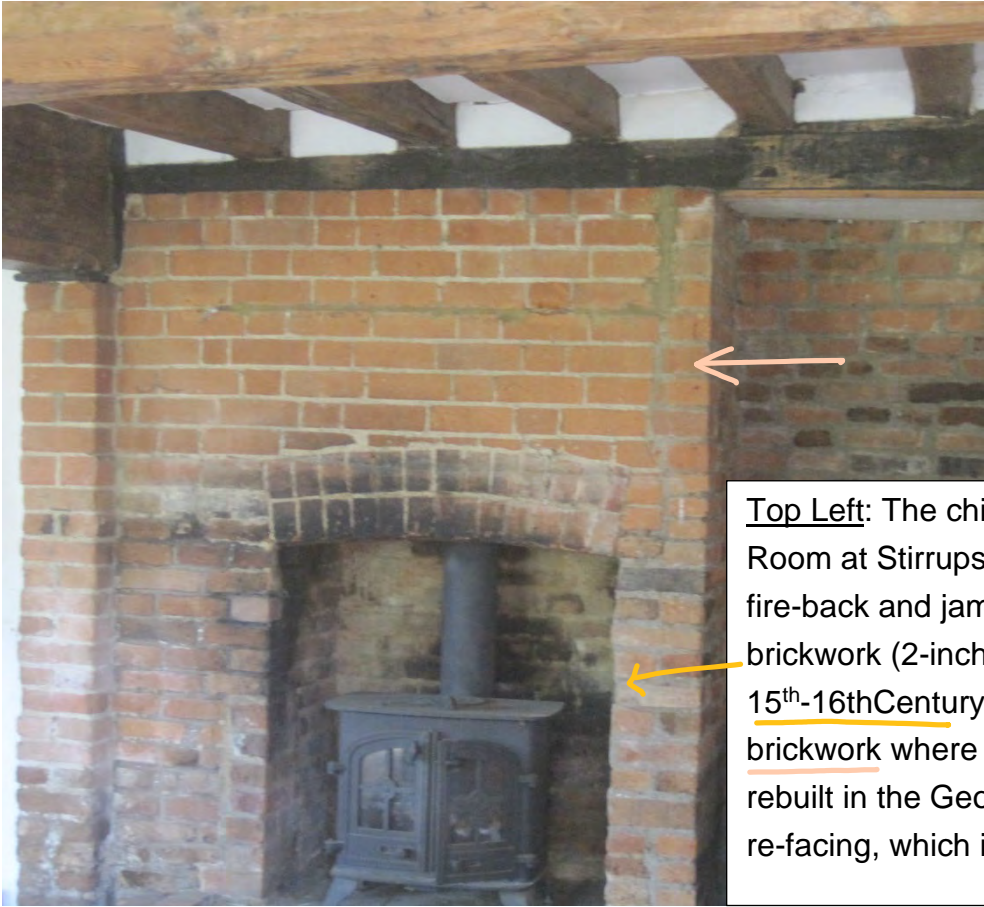
Top Left: The chimneybreast in the Living Room at Stirrups, near Mapledurham. The fire-back and jambs still have original brickwork (2-inch, hand-made) from the 15<sup>th</sup>-16th Century. Above, the larger 18<sup>th</sup>-C. brickwork where the chimneybreast was rebuilt in the Georgian era, matching the re-facing, which is similar at Grove Street.

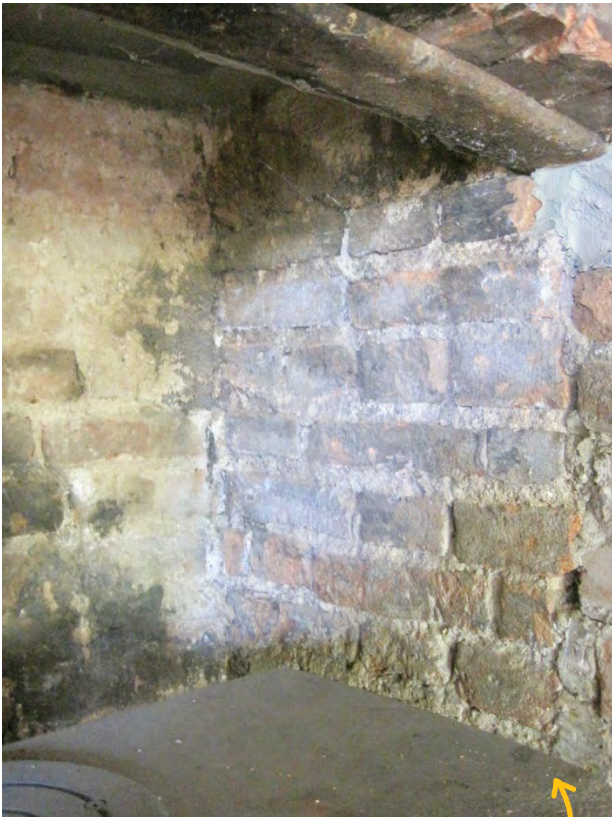
Bottom Left: the side walls and fire-back in the chimneybreast at Stirrups. These are Tudor era bricks.

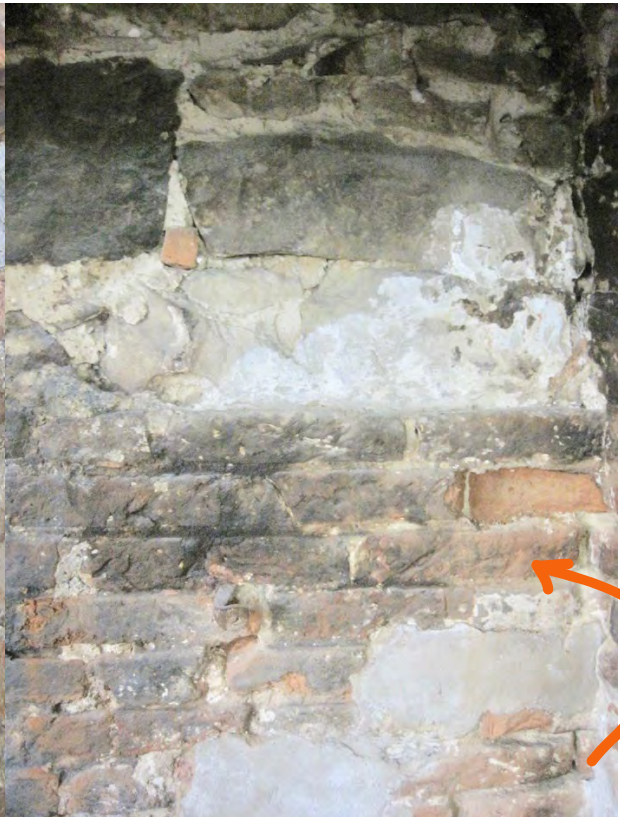
Above, Right: the 2-inch hand-made bricks in Living Room chimneybreast at 330 Grove Street Petworth.

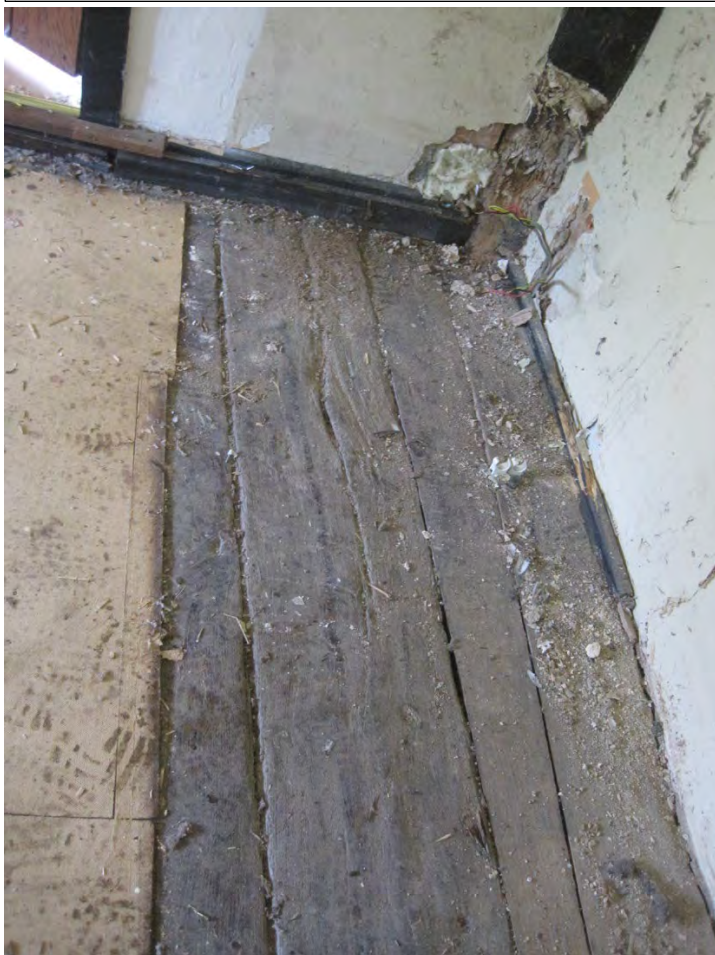
#### Top Left: Stirrups, Oxfordshire.

The original 11-inch oak floor-boards which survive under modern plyboard underlay for the 20thC. carpets.

These wide floor-boards date from the 17<sup>th</sup>-Century, or earlier. Because pit-sawn boards were so labour-intensive, large sections were used in order to reduce the effort of sawing.

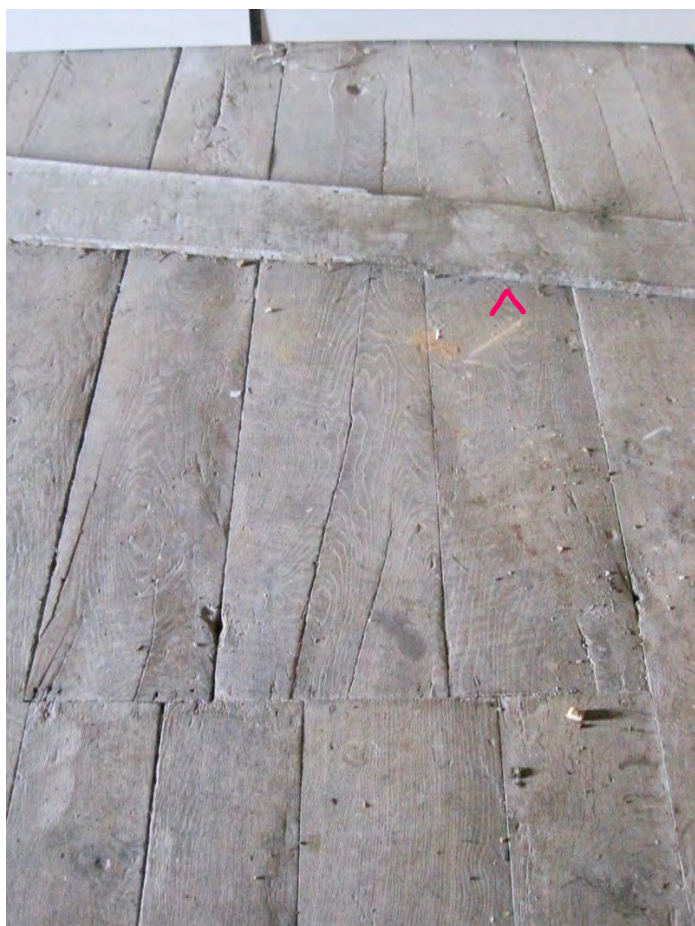
#### Left: Attic at 330 Grove Street, Petworth.

Here, it is interesting to compare these oak floorboards with the prestigious estate house in Oxfordshire at Stirrups (Grade II\* Listed). The mismatched run of boards may suggest a possible original location where a rear stair was run; however, in any case, this ancient floor covering indicates that the attic was used as a bedroom and that it may have been in use as early as the 17<sup>th</sup>-Century. This floor may be original, or it may suggest a late 16thC date for the construction of this estate cottage, with 'improvements' in the 17thC. The board lying horizontally above appears to be a dislodged roof timber, given the tenon on one end. Carpenter's marks are clearly visible and are shown later in this report [page 46].

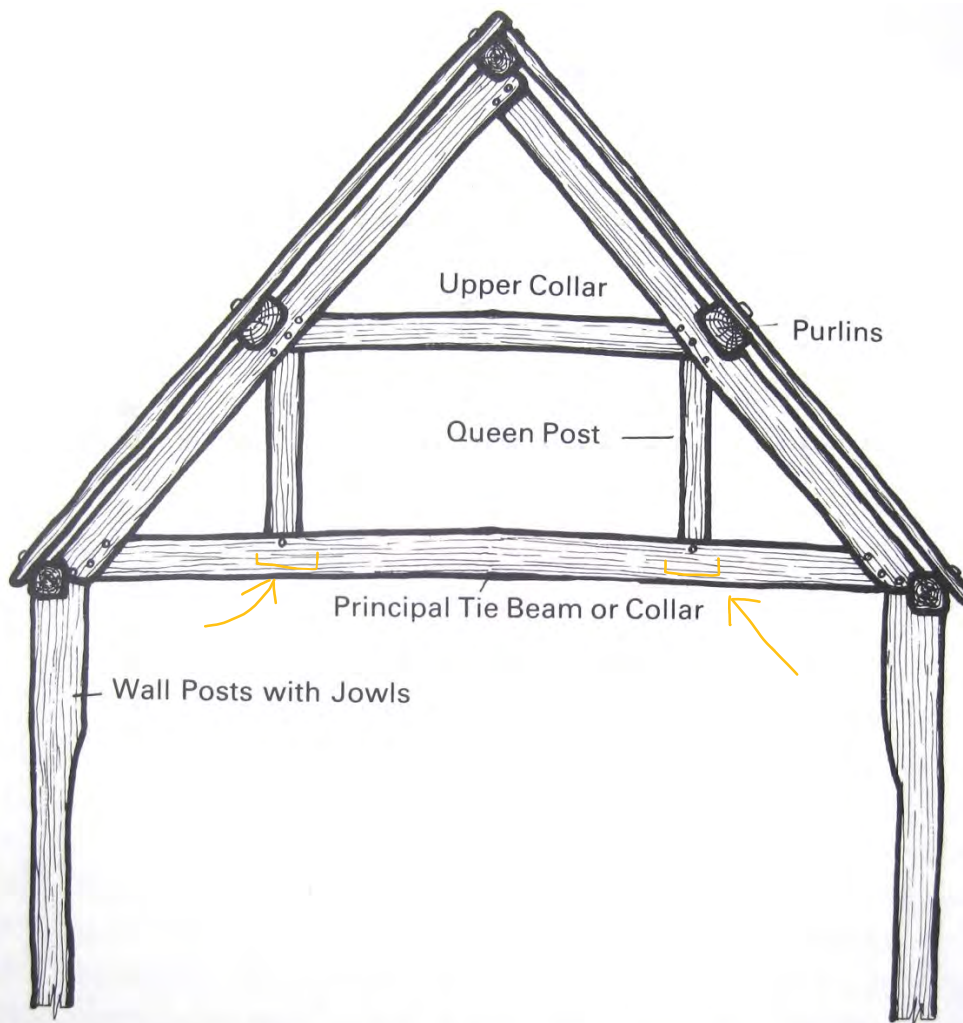
Fig 62 Queen post roof. The queen post developed coincident with the king post.

Above: a diagram of the Queen post roof, which may relate directly to the surviving collar tie beam at 330 Grove Street. [Credit: "*Restoring Timber Framed Houses*" pg.93, David J. Swindells, 1987; Butler & Tanner, Frome; for David & Charles.]

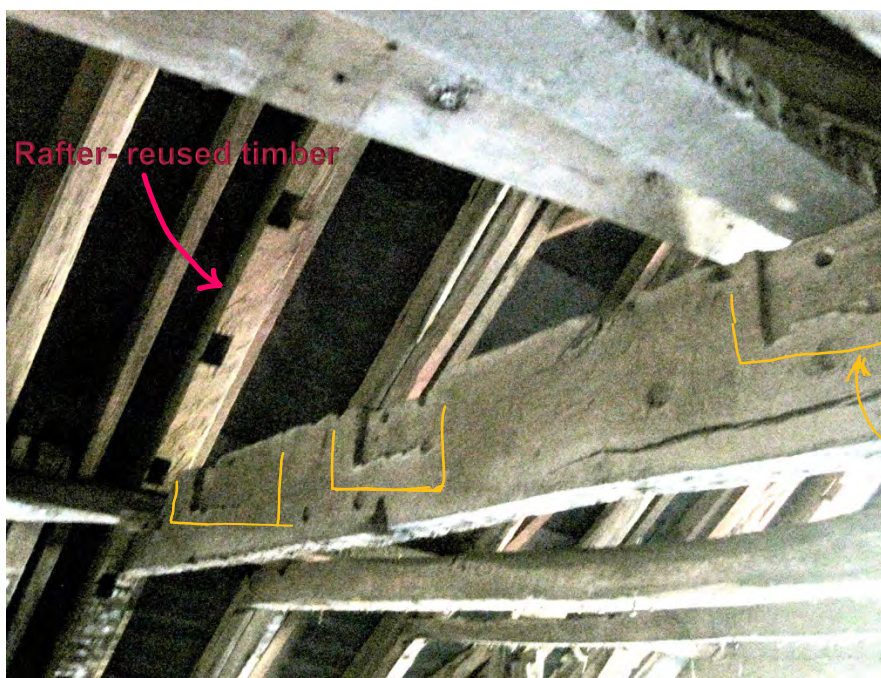
Left: there are obvious 'ghost' markings where the upright members of a Queen post may have originally been constructed. This may be compared, again, with Stirrups' Queen post roof.

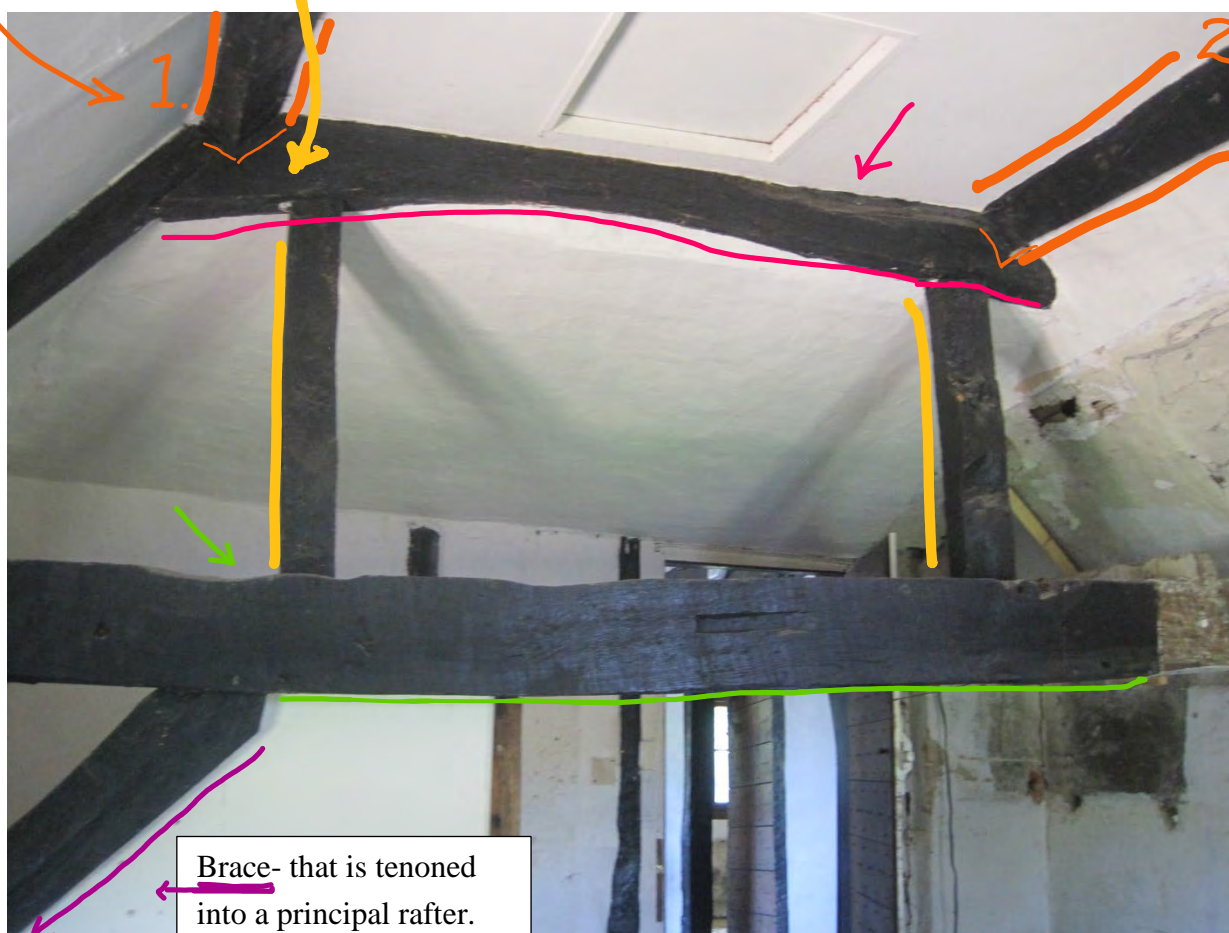
Above: a good example of a Queen post roof, here at the rear wing of Stirrups in Mapledurham, Oxfordshire (as before). It is noticeable that the Queen posts are only tenoned into the principal collar beam on one side. This can also be detected in the principal tie beam at 330 Grove Street, although with a third strut (see next diagram).

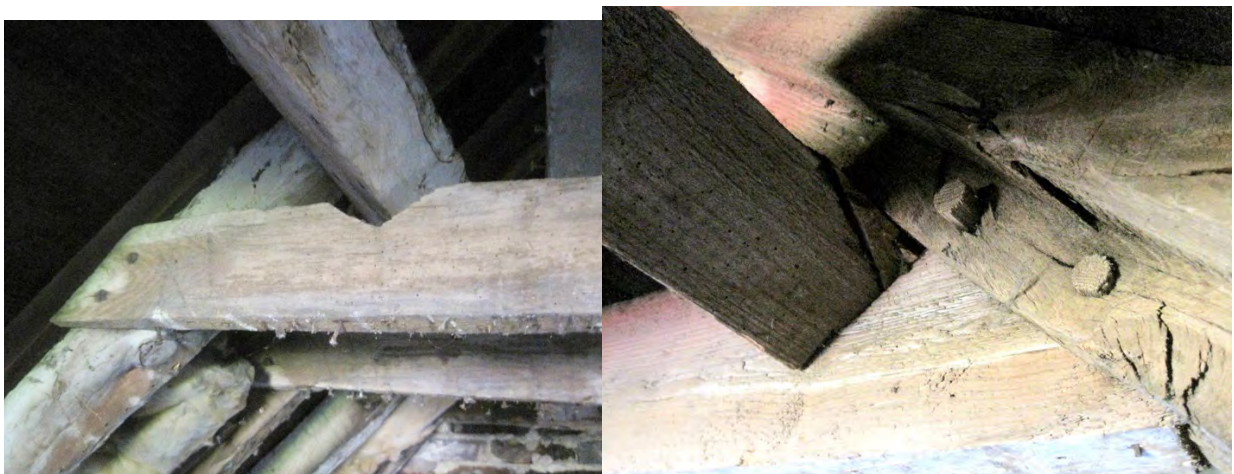
Below: Fig.53, page 85, "*Restoring Period Timber-Framed Houses*," David J. Swindells.

Purlin is clasped  
between principal  
rafter and tie beam  
or collar

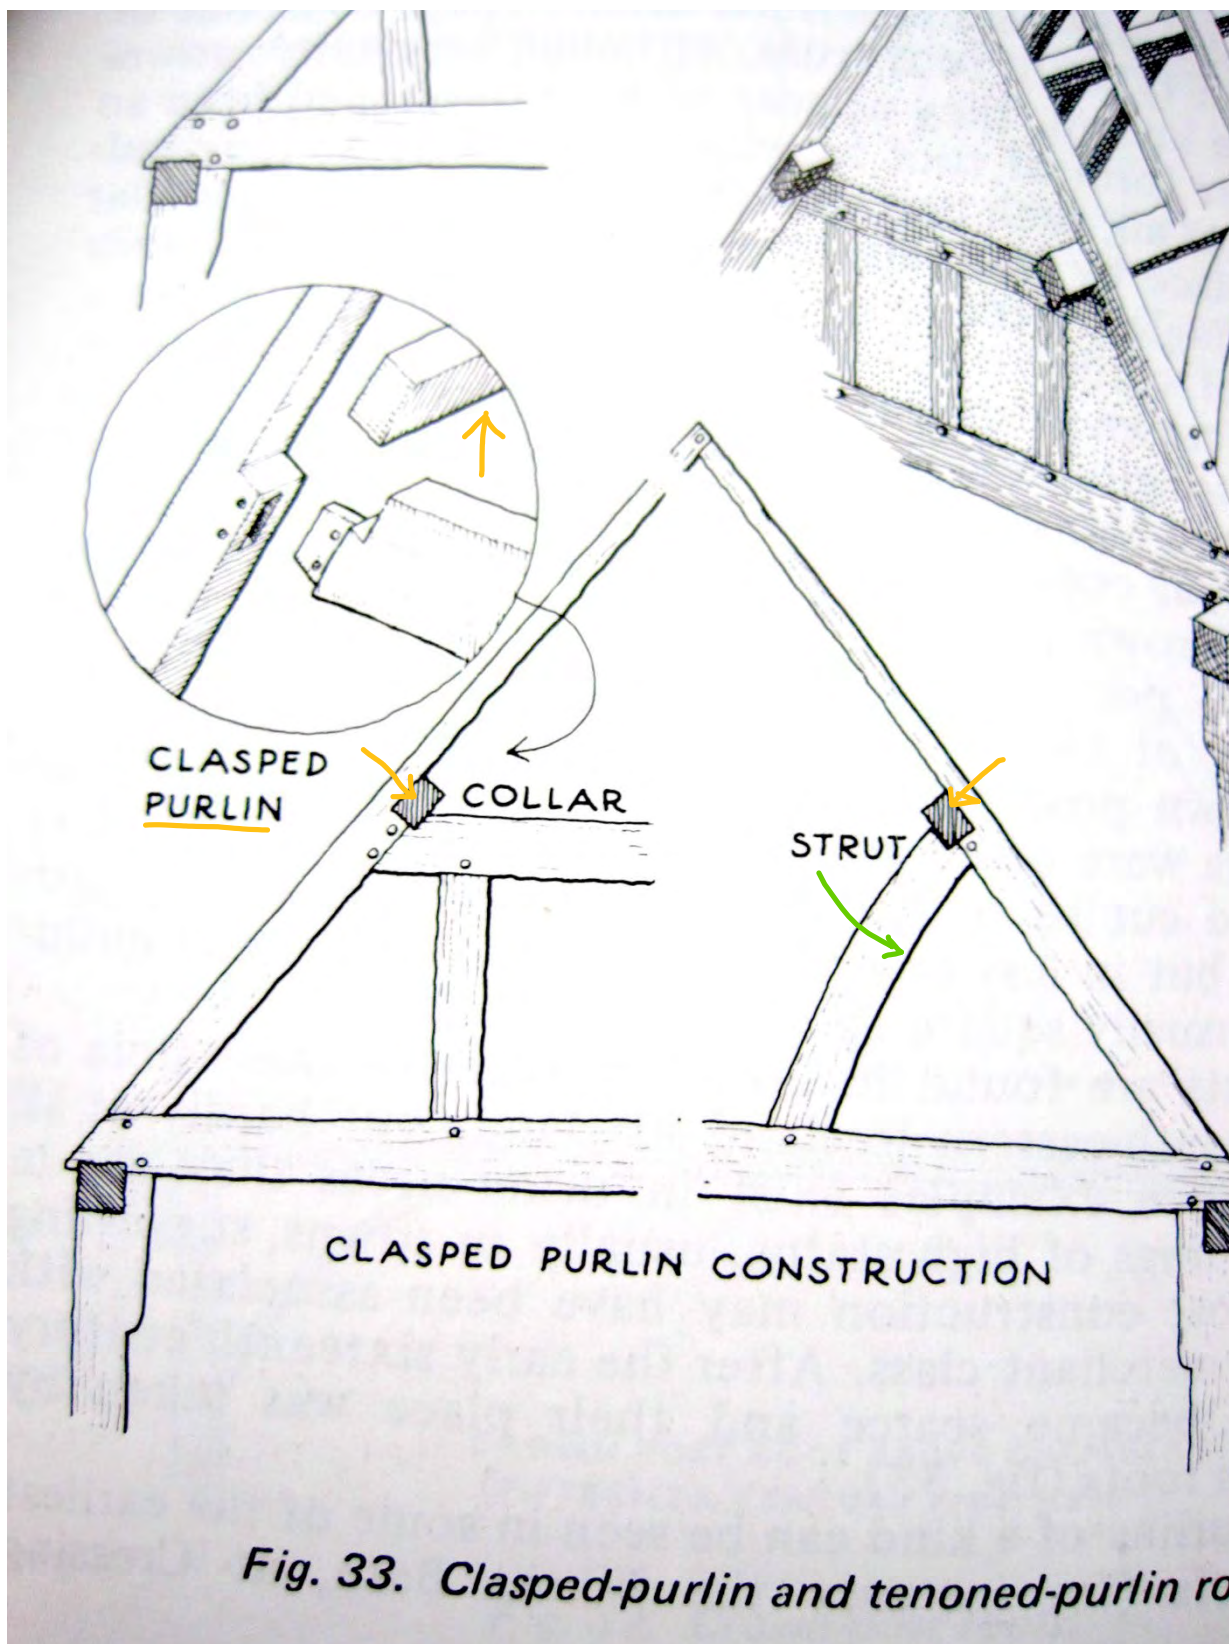
*Fig. 33. Clasped-purlin and tenoned-purlin ro*

Above: diagram explaining the 'clasped-purlin' construction as seen at 330 Grove St.  
 [Credit: "Discovering Timber-Framed Buildings" by Richard Harris, page 64.]

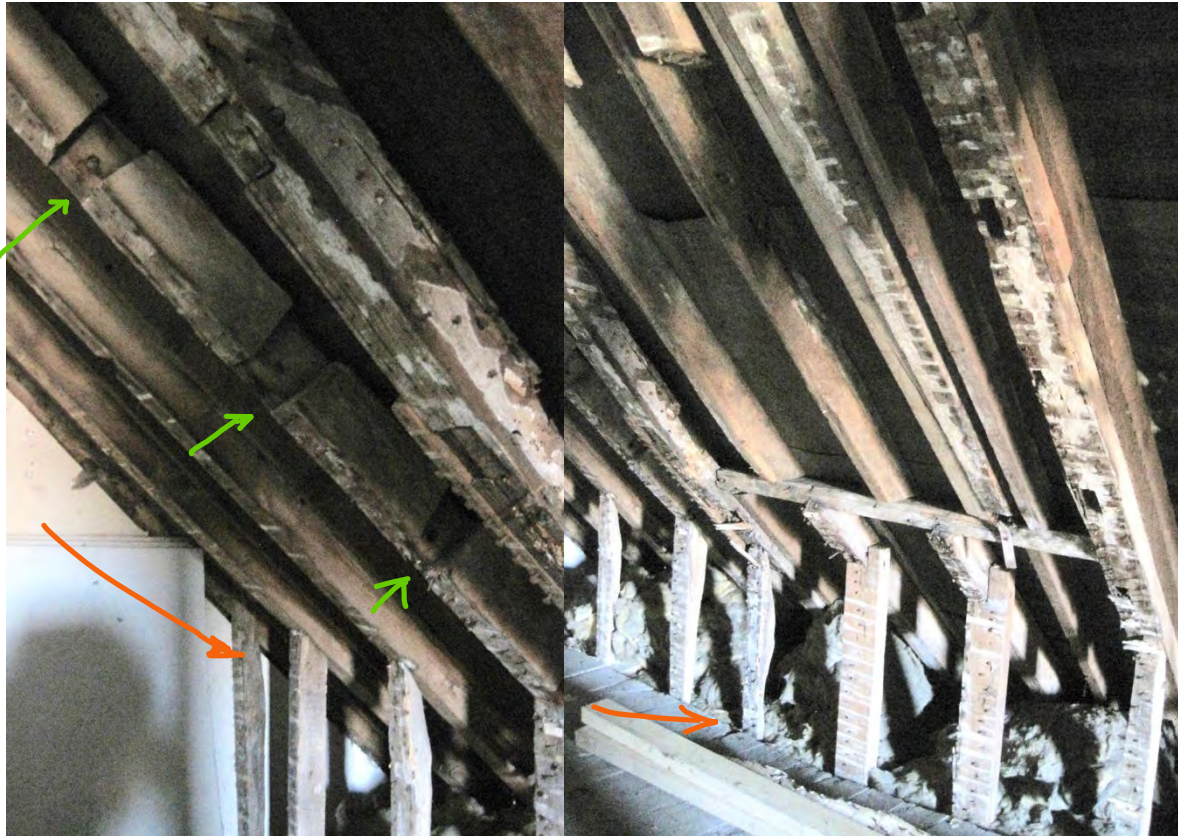
The pictures below on the west side of the roof slope show the rafters, including the “ashlars” or short studs at the bottom of the rafters near the eaves level. The bottom photos show empty mortices, the left one still retains the original peg. Left, does this indicate an area where struts for the original stair (at rear) may have run, for instance?

Below left: An empty pocket or mortice that shows a missing truss, but the peg still survives.  
Below right: An empty mortice on the east slope with 19<sup>th</sup>-C. later truss with machined faces.

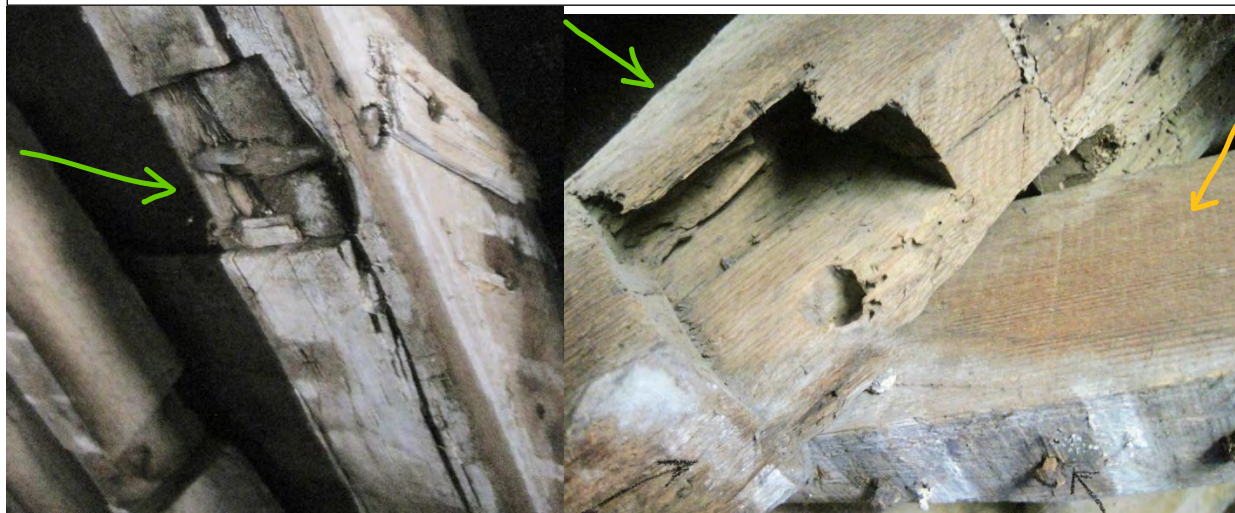
Above: both pictures show ‘ghosts’ of missing lathe & plaster (white marks) + nails. This shows that the attic was altered, so it was likely used as a bedroom at a later date.

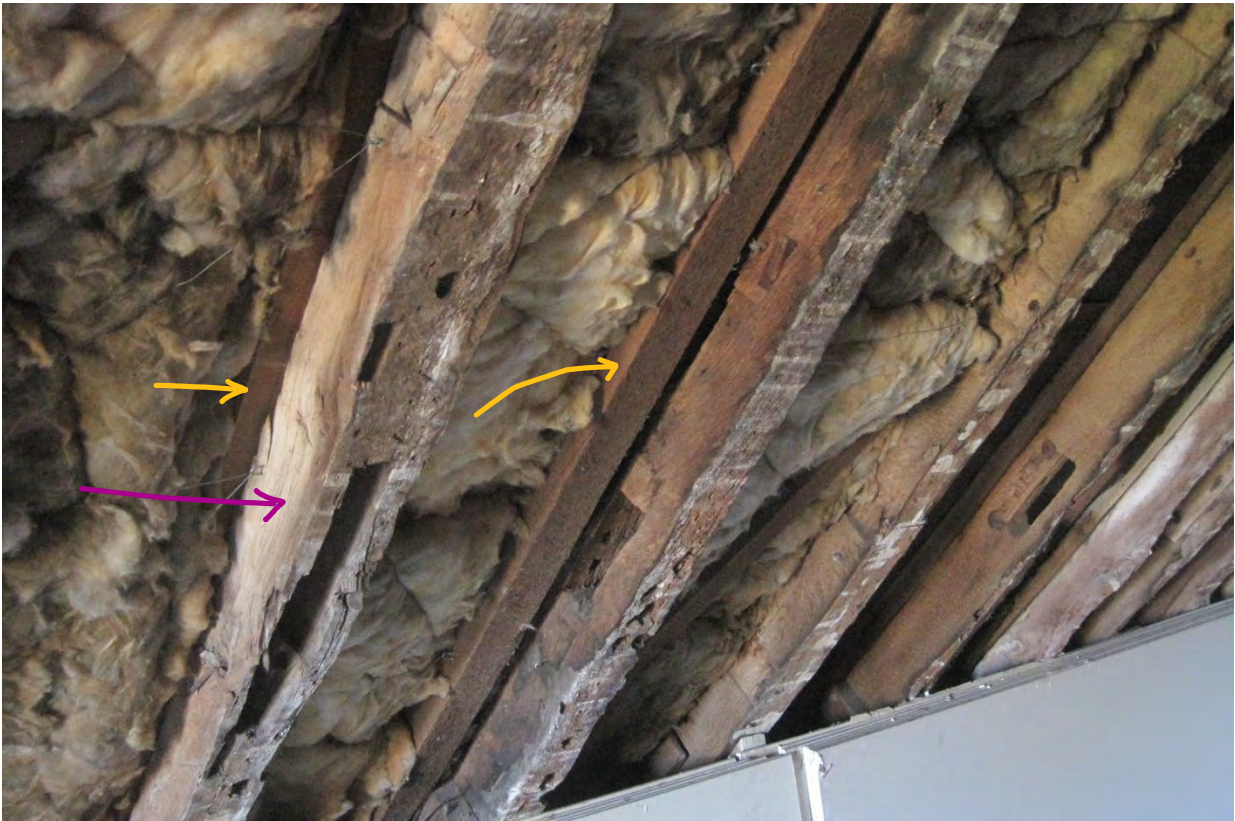
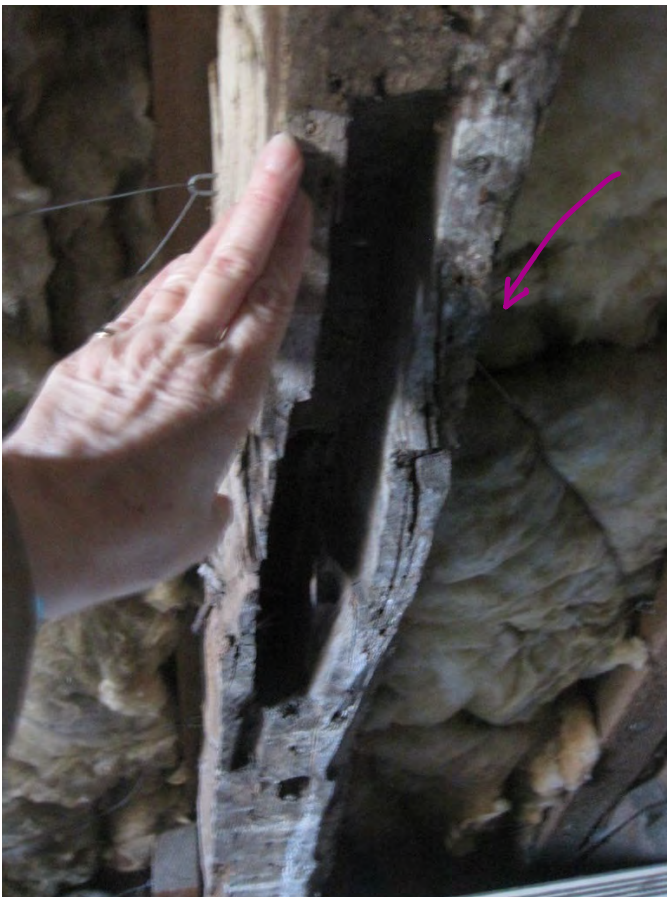
5.4.4. The evidence for a brace. Below we see a principal rafter that has a large mortice. Could this have held the tenon for a brace that is now missing? It seems so.

Bottom Left: This large mortice would appear to be a pocket for a diagonal brace. However, given the apparent re-use of old members, this isn't entirely clear due to missing timbers. It is interesting to notice that the attic would have had lathe-and-plaster at one point and appears 18thC because the nails are hand-made, not 19thC milled ones. [The author's hand is included to give a sense of scale here.]

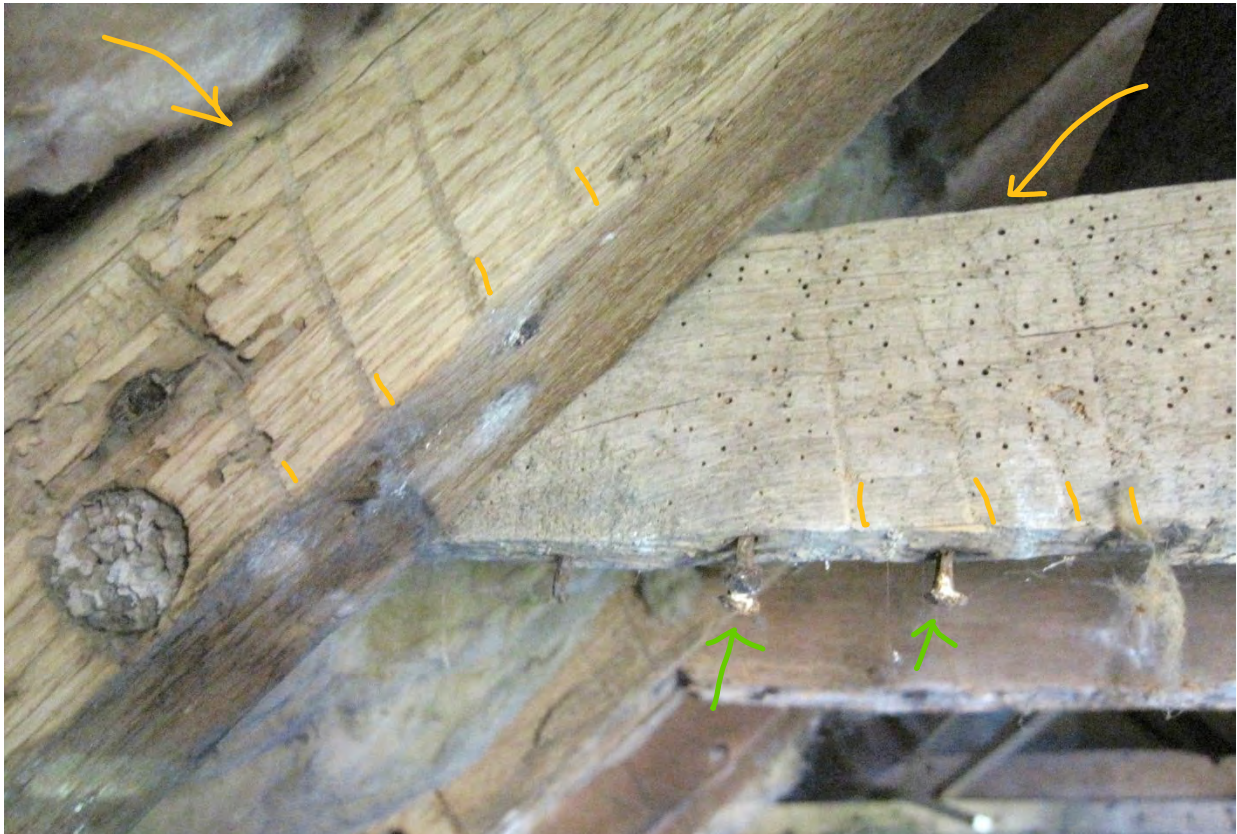
Above: a tie collar and principal rafter show carpenter's marks to guide the roof construction. Notice the original peg, on the left. Below: an original timber shows hand wrought tool or maker's marks and hand-made nails.

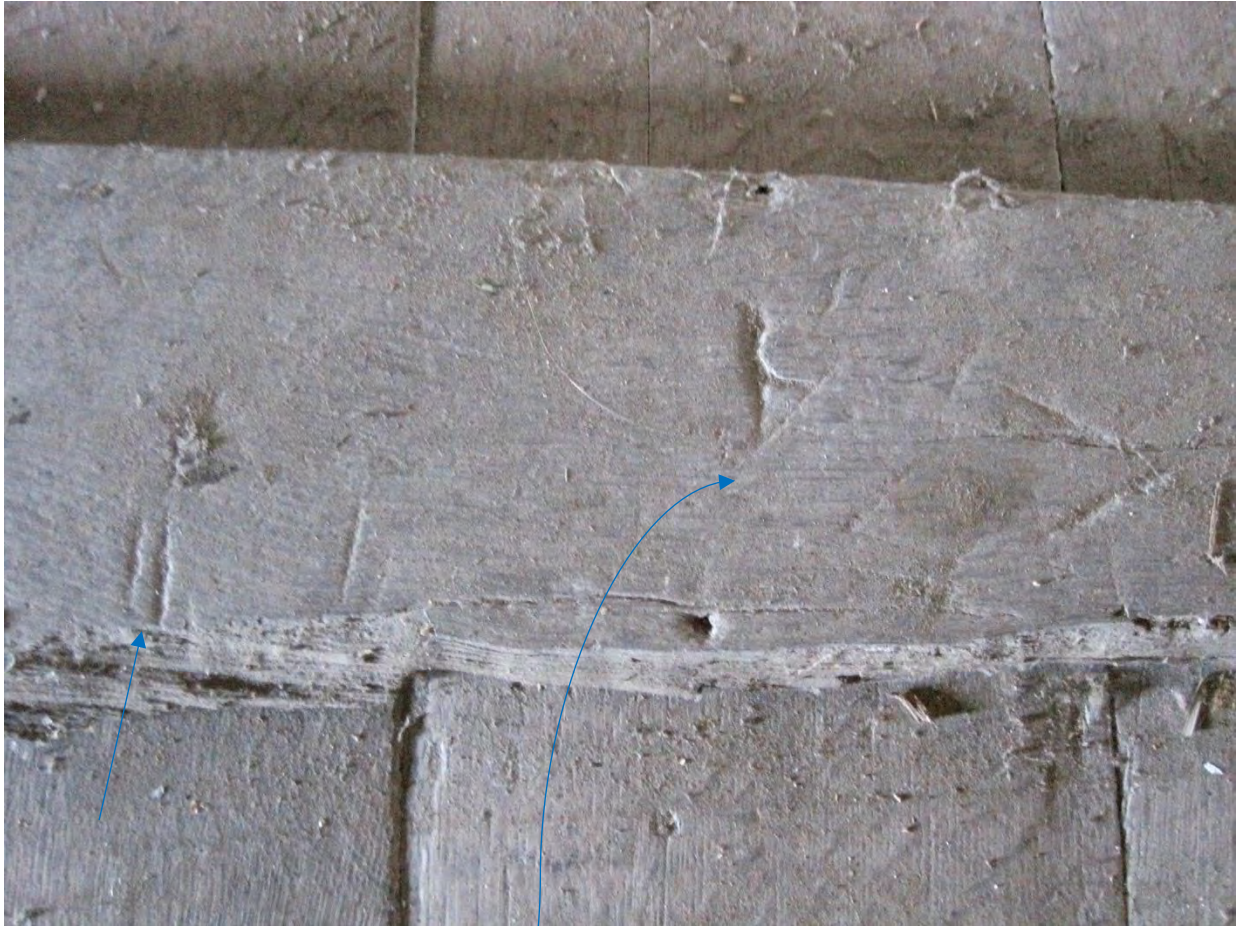
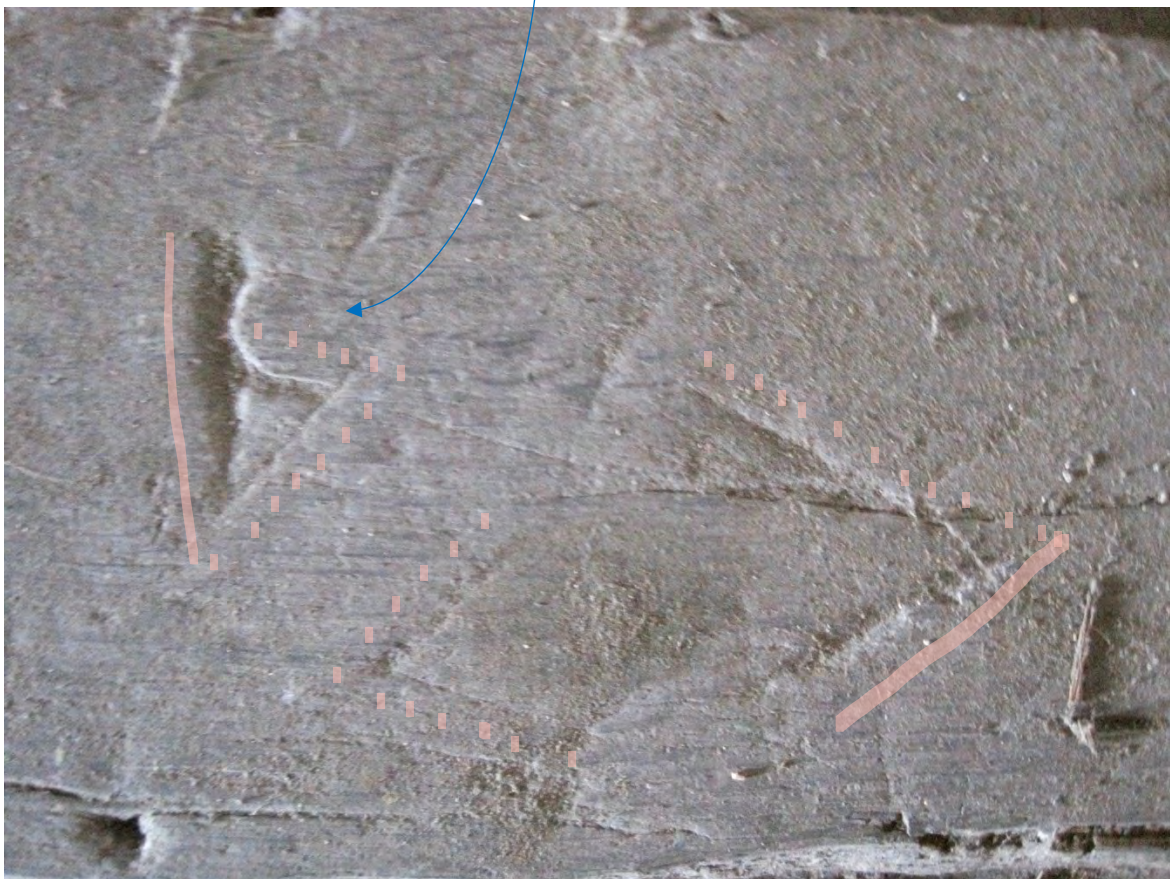
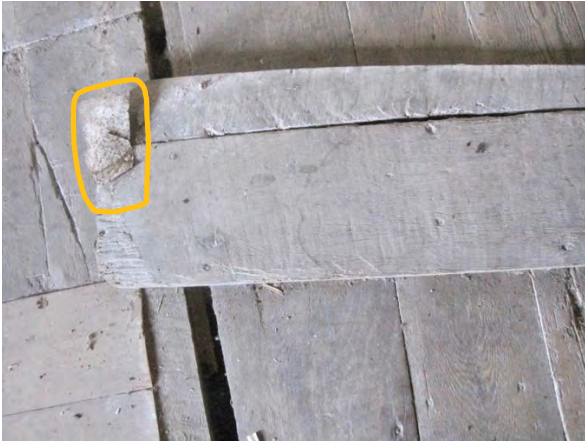
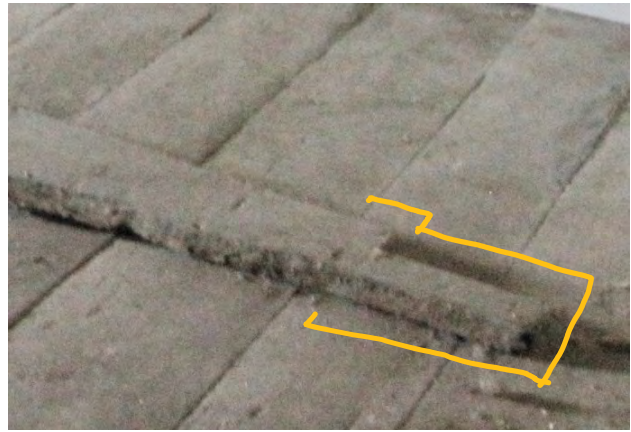
5.4.5. Below: The dislodged board shows original carpenter's marks, on the attic floor.[pg.36]

5.4.5. This same timber does not appear to be a floor-board because of the raised notch at left end and a tenon on the right, which is a fixing- for elsewhere in the roof. While it should be preserved and re-fixed at this level, its exact location must be found.

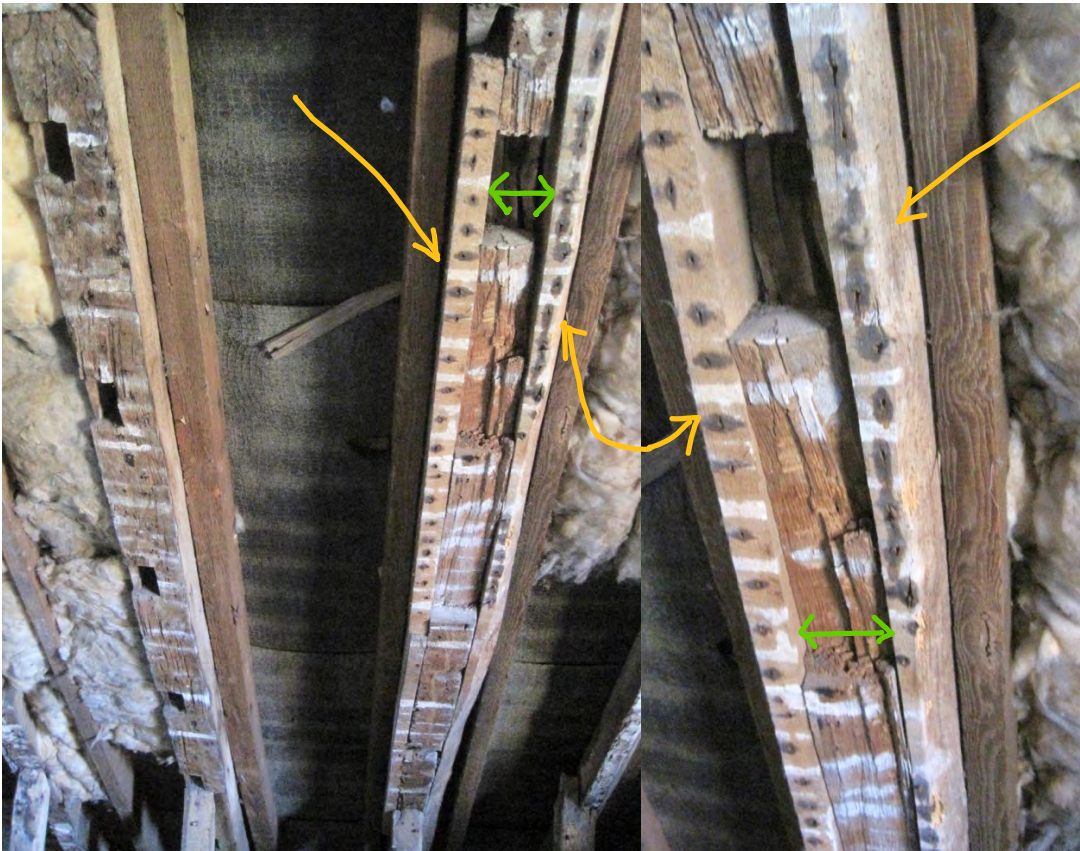
5.6 Repairs and Alterations. Several old rafters have been repaired with “sandwich” planks on either side of the original 16<sup>th</sup>-17<sup>th</sup>-C timbers, as shown below (west slope).

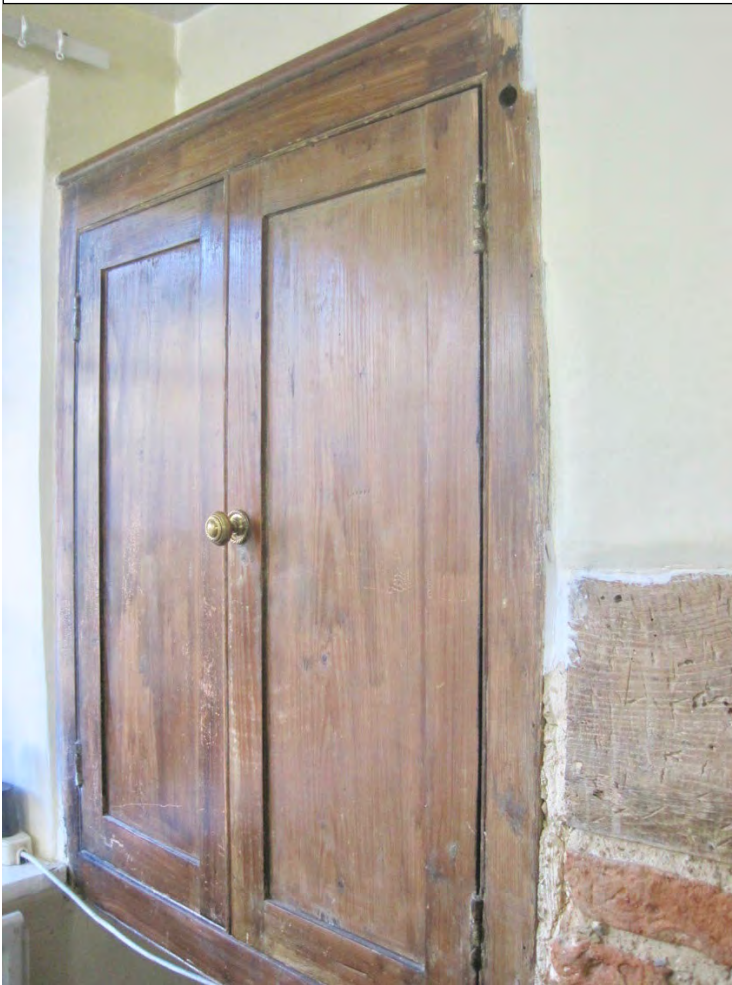
Left: the pine cupboard to the left-hand side of the Living Room hearth appears to be an authentic Georgian feature. Due to its age and aesthetic value, it has 'High Significance.'

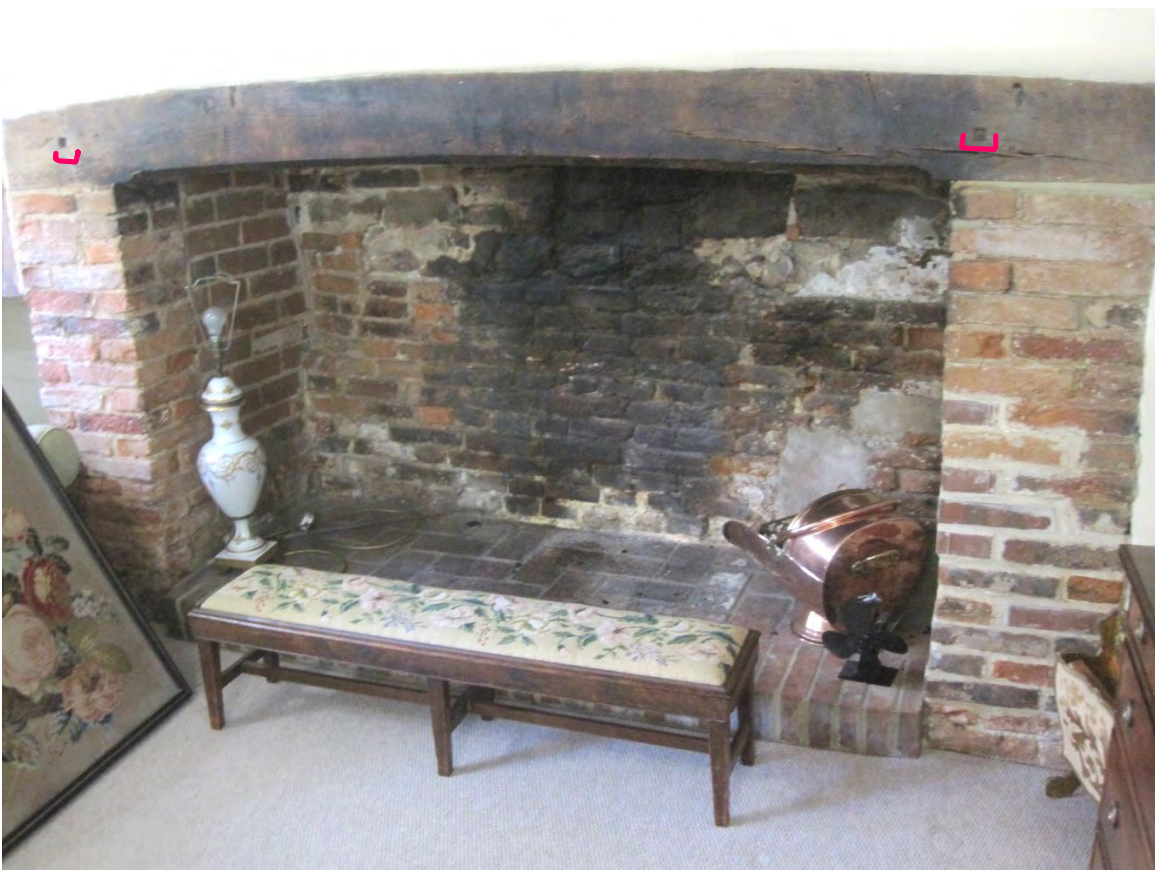
Below: the chimneybreast in the Living Room and front 1stFloor bedroom is also of High Significance. The 2-inch brickwork is original and would appear to date from the 17<sup>th</sup>-C. or mid to late 16<sup>th</sup>-century, dating it from the Elizabethan era, potentially. The timber beam over the fireplace is also original and has hand-wrought nails. The fixings and square open holes may indicate there could have been a timber jamb or side fixings.

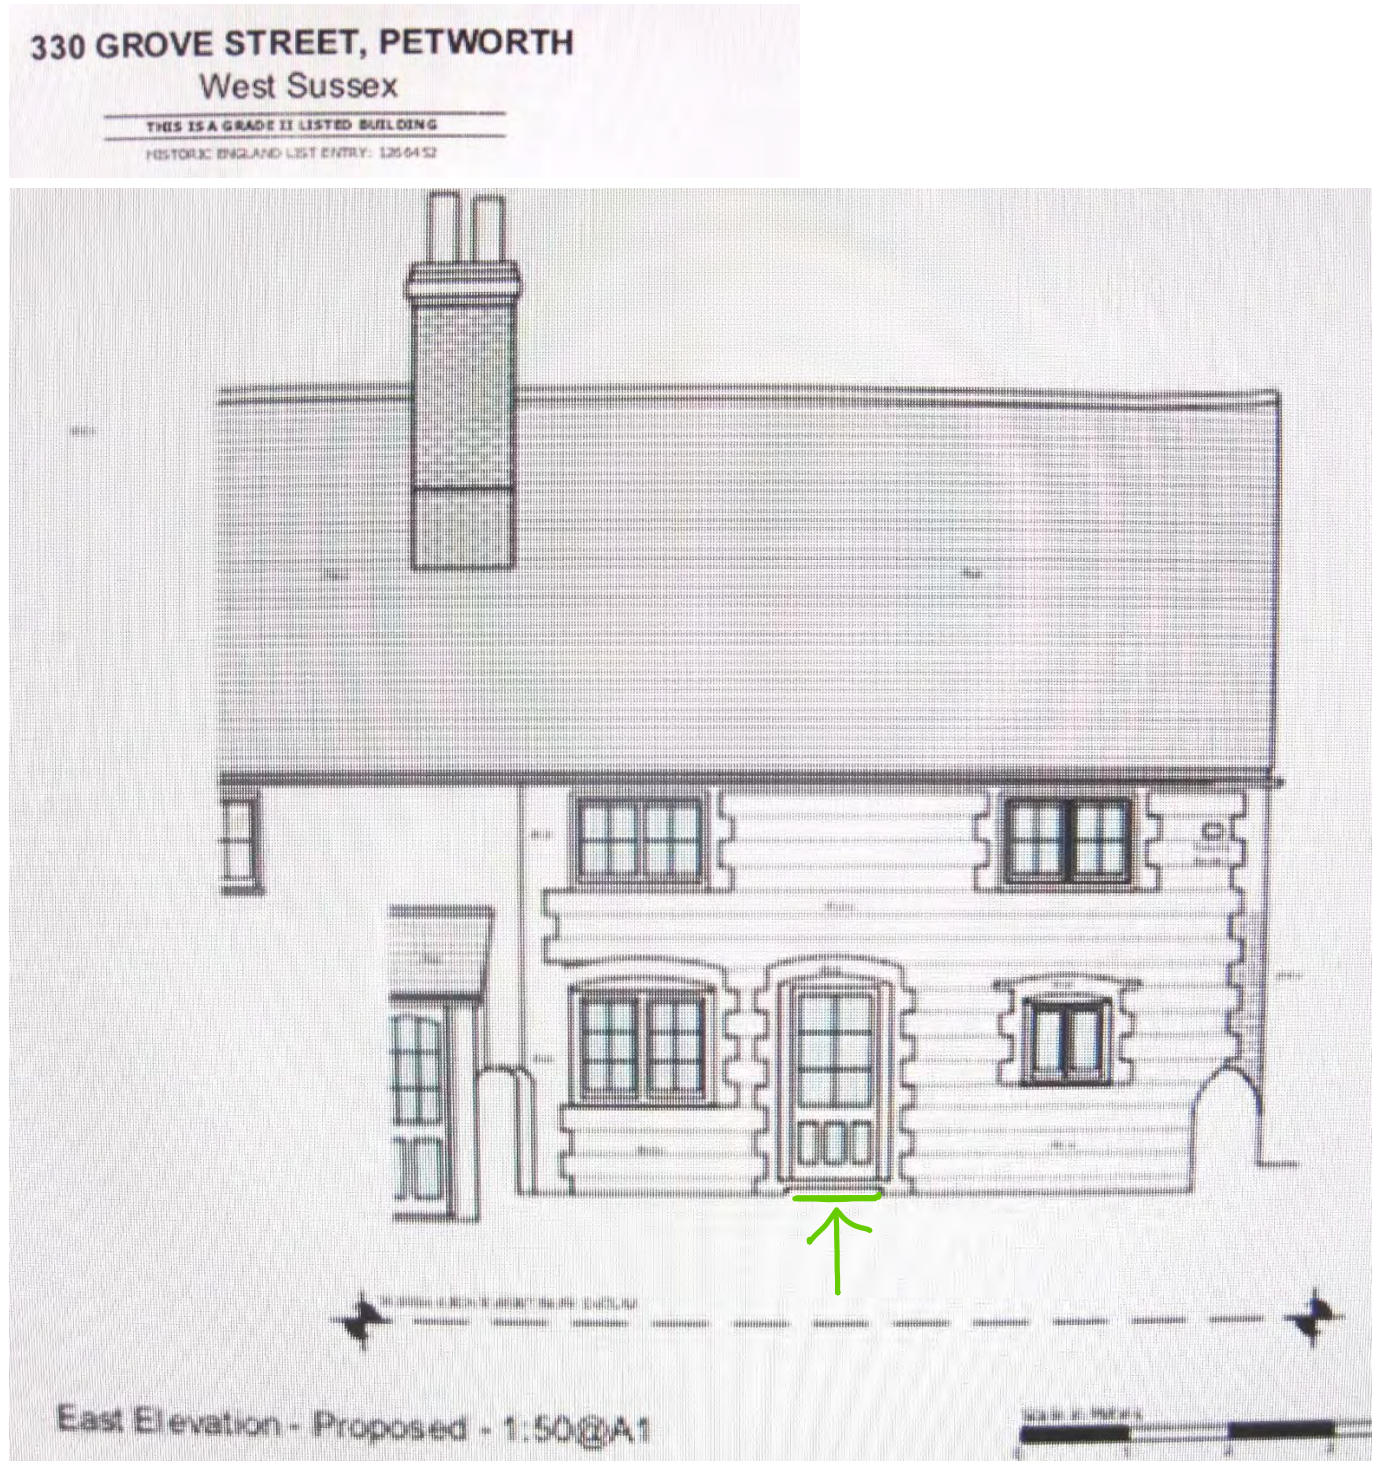
Above: The East elevation of 330 Grove Street will remain unchanged except that the front door will again be used as the main entrance, following the historic function.

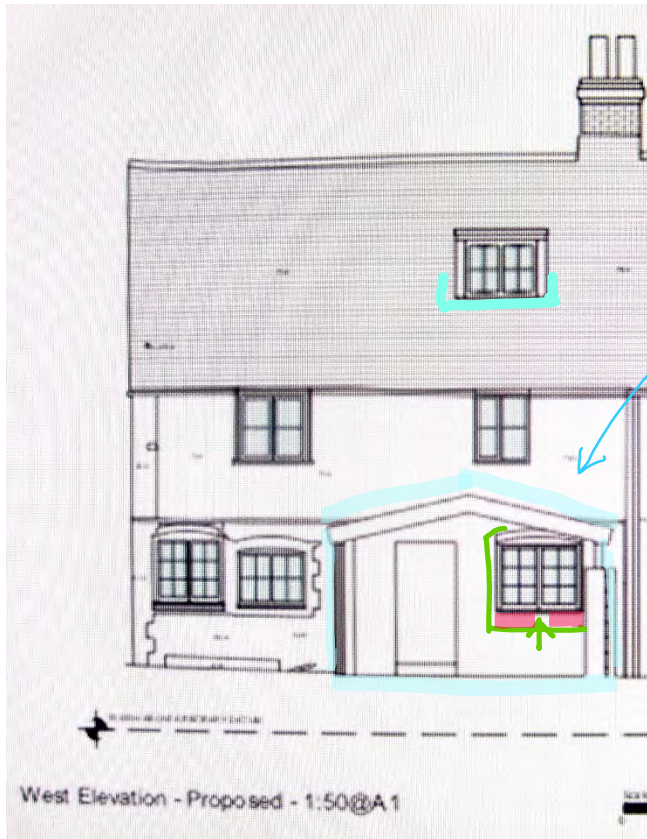
**Left:** The design principle for an improved living space in the Kitchen is, firstly, to retain the authentic casement window and 18thC opening with burnt brick header and red-brick surround to stay as a feature in the new arrangement. Secondly, a new west kitchen wing is proposed with a shallow roof in standing seam metal with the south end standing away from the boundary garden wall for separation and maintenance. The design idea is for a small, light-touch rear extension to accommodate a dining space facing the raised garden. This would allow a U-shaped kitchen in the present rear wing that sits behind the principal Living Room.
