### 5.3 Historic Joinery.

## 5.4. Surviving Timber-Frame Roof in the Attic: Construction Types.

## 5.8 Levels of Significance

### **6.0 Impact of Proposals on Significance.**

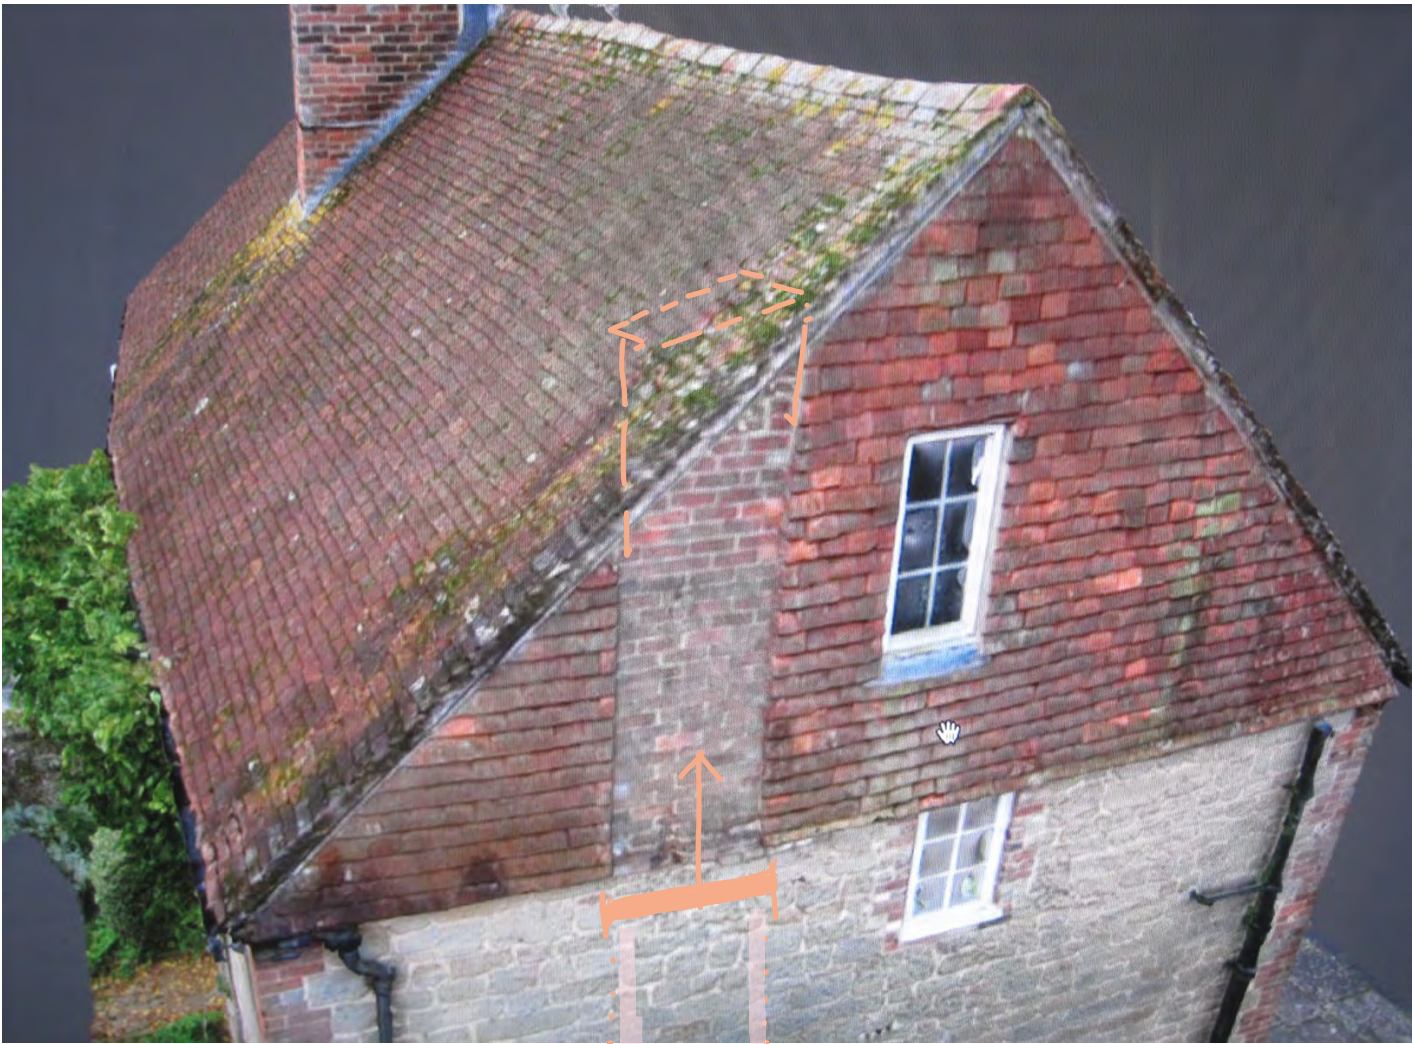
6.2.3. Above: the drone photograph of the north end gable of 330 Grove Street. This clearly shows the ‘ghosting’ where there appears to have been an earlier chimneystack behind what is currently the front entrance door. This also appears in the thicker brickwork of the Ground Floor plan here, and also corresponds to a similar chimneystack for the Kitchen at No.331, although this survives at the rear where one would normally expect it to be located.

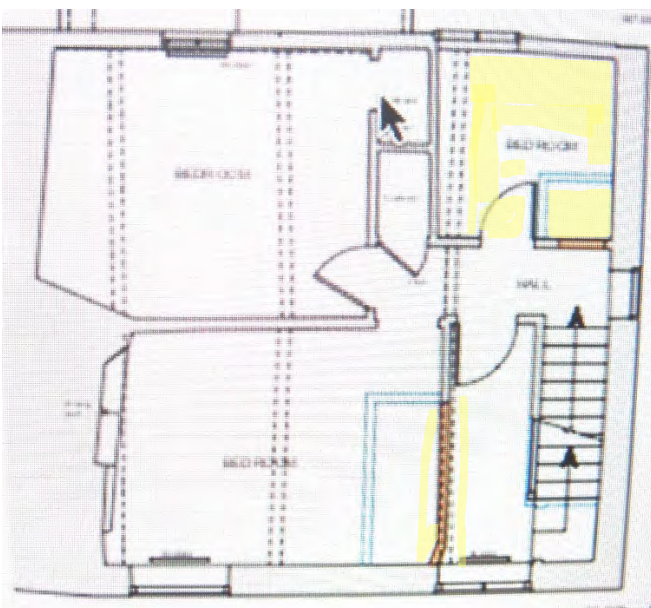
Left: the proposed floorplan which shows the minimal changes needed to reinstall a stair to the attic and amend stud partitions. The small ‘box room’ would be converted into a Hall. The front, or East Bedroom would have more generous proportion and presumably restore its original volume. A boiler cupboard would be removed and incorporated into a refreshed Bathroom in an existing corner of the 1<sup>st</sup> Floor. The brick chimneystack and historic timber structure would be conserved as found.

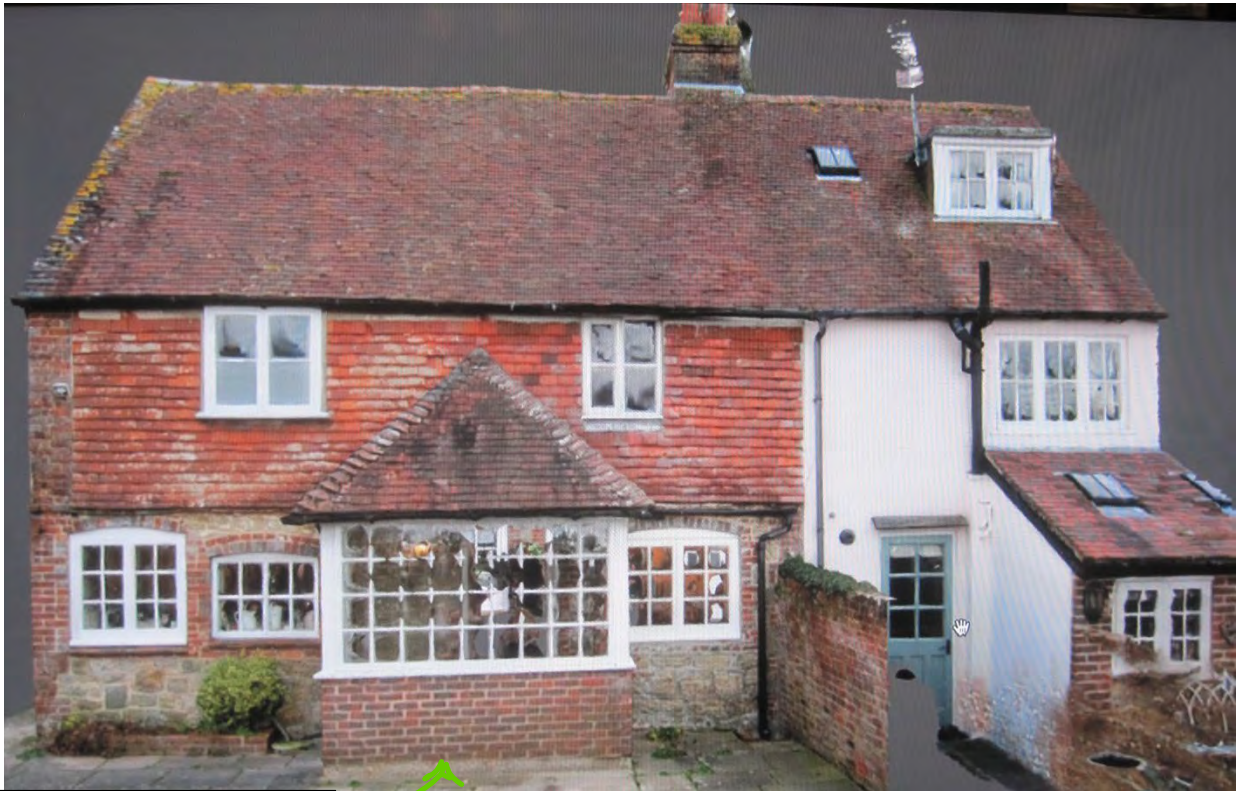
Top: The existing west elevation has a modest Porch with hipped tiled roof. However, the windows appear to be modern replacements and the brick plinth is a cavity wall build with a modern stretcher bond. As a result, it is considered to have a 'Low' significance compared with the historic fabric in principal house.

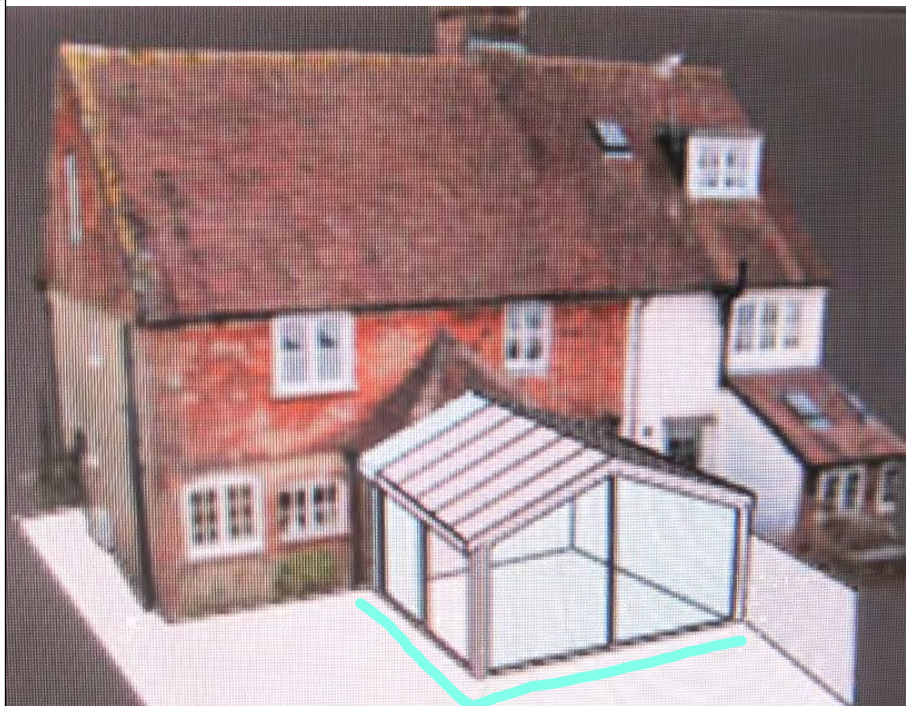
Above: The low-key Dining Room extension to the west such as the suggested one above would simply replace the existing Porch which appears to have had its fenestration replaced in the 20<sup>th</sup>-C. The conservatory would appear lightweight and form a transparent wing that would allow the original rear elevation still to be 'read.'
