# **Heritage Statement**

#### **List of Works**

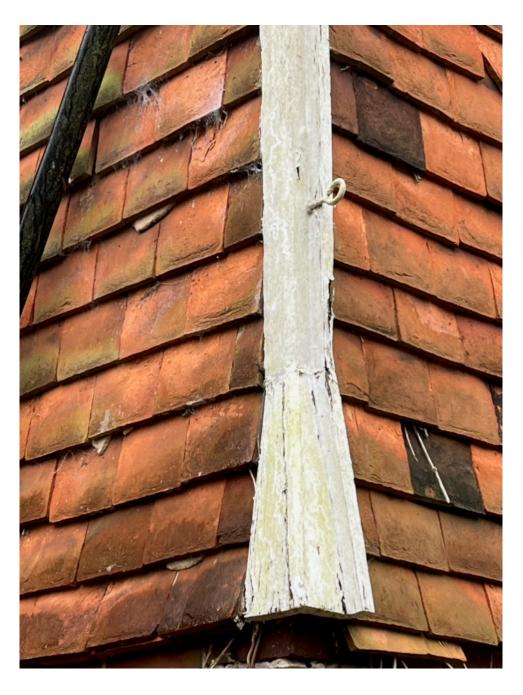
# P1 - Left Corner Post

Repair and/or replace rotten wooden trims (corner posts) to left and right of tile-hung front of house. Additionally, repair or replace three wooden corner posts at rear of property.

- This work is required because the original corner posts have begun to rot away.
- 2. Garage Floor see photo: P11

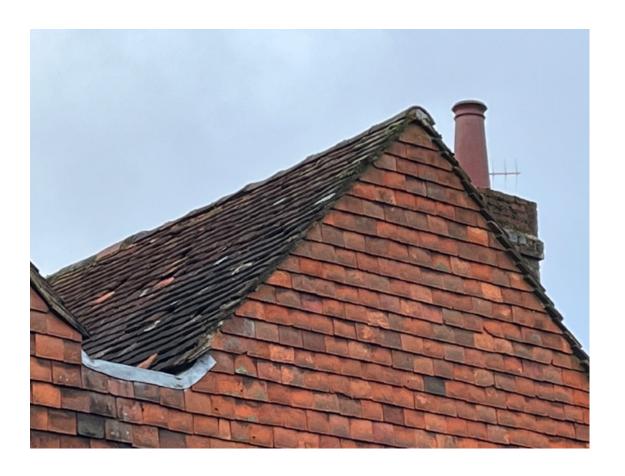
#### P3 - Damaged tiles, rear gulley and chimney

Treat with waterproofing the cracked lead-lined channel running South to North above En Suite bedroom and investigate channel running East to West over bedroom over garage and treat if required. If necessary replace badly-damaged lead sections.

- This work is required in order to prevent water leaking into the property.
- 4. Chimney see photo: P3

Add cap to unused chimney at North over garage.

- This is required to make bird-proof and to provide rain protection.
- 5. Tiles see photos: P3, P4, P5

Replace a small number of missing/cracked tiles on roof and tile-hung elevations. See examples in photographs.

- This is required to maintain the integrity of the tiled surfaces and prevent rain water entering the property.
- 6. Pointing see photo: P10

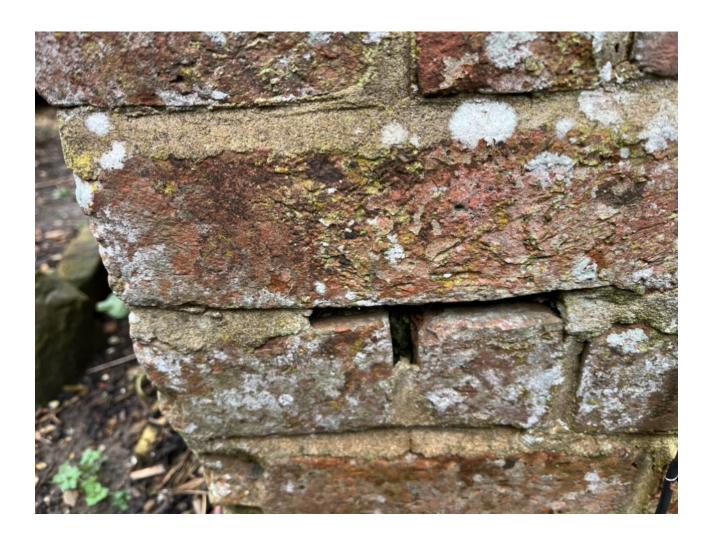
#### P10 - Pointing

Renovate pointing to Southern wall.

- This is required because the existing pointing is missing, cracked or crumbling.

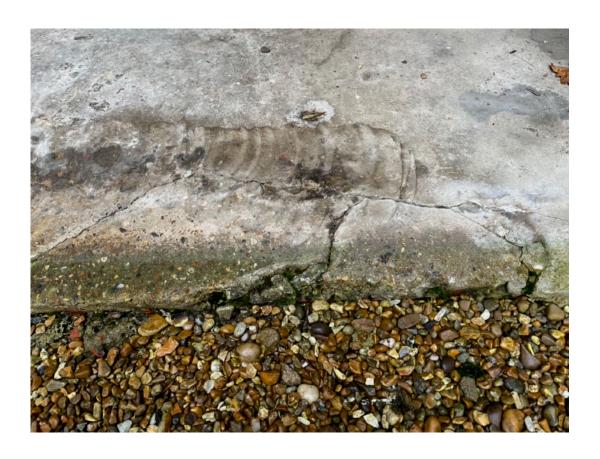
# P11 - Garage Floor

Repair cracking concrete floor at front of garage.

- This work is required because the original floor is cracked and is beginning to crumble.
- 3. Lead Gulleys see photos: P3, P7
