SITE SPECIFIC PHASE 1 CONTAMINATION REPORT (PRELIMINARY RISK ASSESSMENT)

James Stiff Cottages, Alms Houses, Rougham

Havebury Housing

6166 / Rev – P1 / Jan 2021

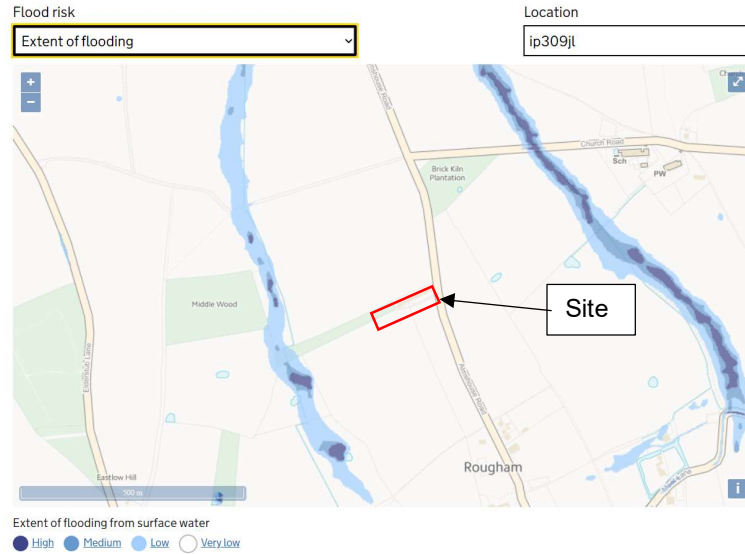
Figure 4: long term flood risk (surface water)

The long-term flood risk map online indicates that the site is at **very low risk** of surface water flooding (see appendix F). The definition of a very low risk area for surface water flooding is *that each year this area has a chance of flooding of less than 0.1%*.
