Madeira Terrace Brighton

Dynamic Appraisal Trial

**Brighton & Hove
City Council**

Project: 11983

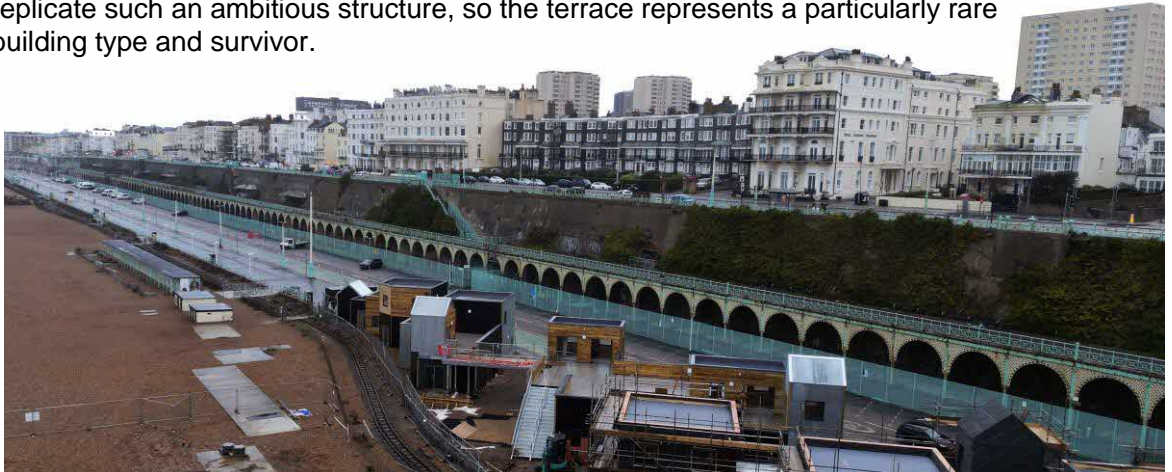
- 2.01 Madeira Terrace, illustrated in the arial view looking west, was designed in the 1880s by the Brighton Borough Surveyor Philip Causton Lockwood as a sheltered walkway with an integral shelter hall and three stage lift which connected Madeira Drive and the beach with the upper walkway and Marine Parade. It was extended in the 1890s by Lockwood's successor, Francis May, and at over 865 metres it is thought to be the longest and oldest continuous cast iron structure in the country. Late Victorian and Edwardian seaside resorts chose not to attempt to replicate such an ambitious structure, so the terrace represents a particularly rare building type and survivor.

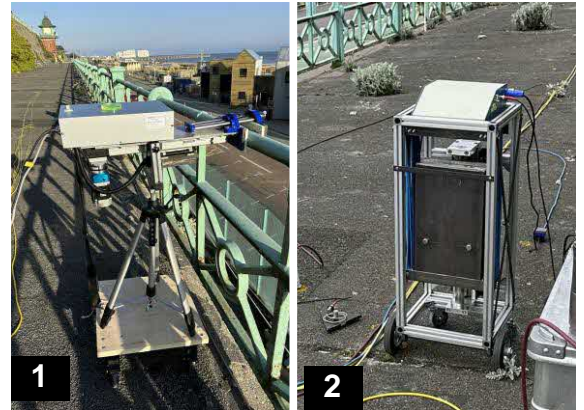
4.02 To overcome these disadvantages Mann Williams and Eatec Dynamics have successfully developed and utilised an innovative non-invasive dynamic assessment method that is faster to carry out and provides additional information about the actual performance of the structure being assessed. The images opposite show the two test rigs utilised on the trial phase of testing at Madeira Terrace. The balustrade rig⁽¹⁾ provides a lateral excitation to the structure and the deck/floor rig⁽²⁾ provides vertical excitation.

4.03 The methodology consists of the application of low magnitude sinusoidal loading into the structure at a known frequency and measuring the response amplitude from the structure at key locations. From the data obtained a finite element model is produced that accurately matches the recorded characteristics of the actual structure. The completed computer model is then able to be used to establish and accurately predict performance and load carrying capacity.

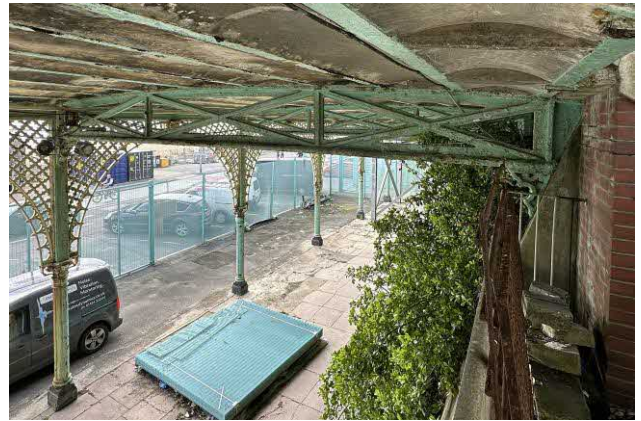
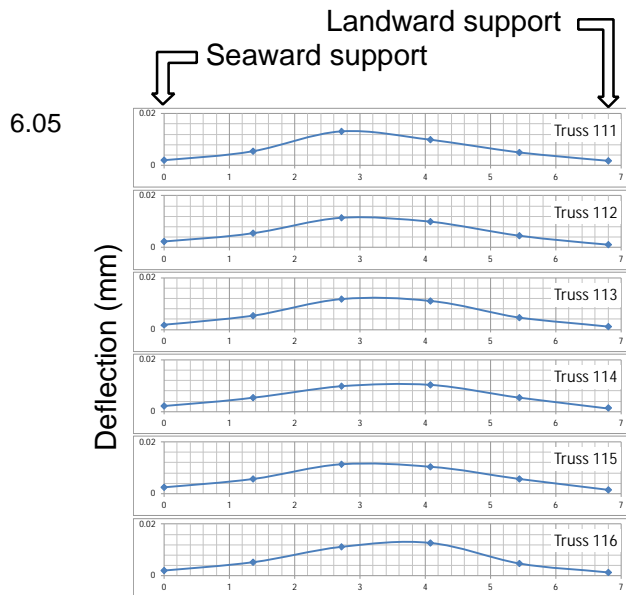
6.04 The image opposite shows the configuration of principal cast iron truss supported on the cliff wall to the right and cast-iron column to the left (seaward) side. The current iron filler joist/concrete slab deck spans over the trusses.

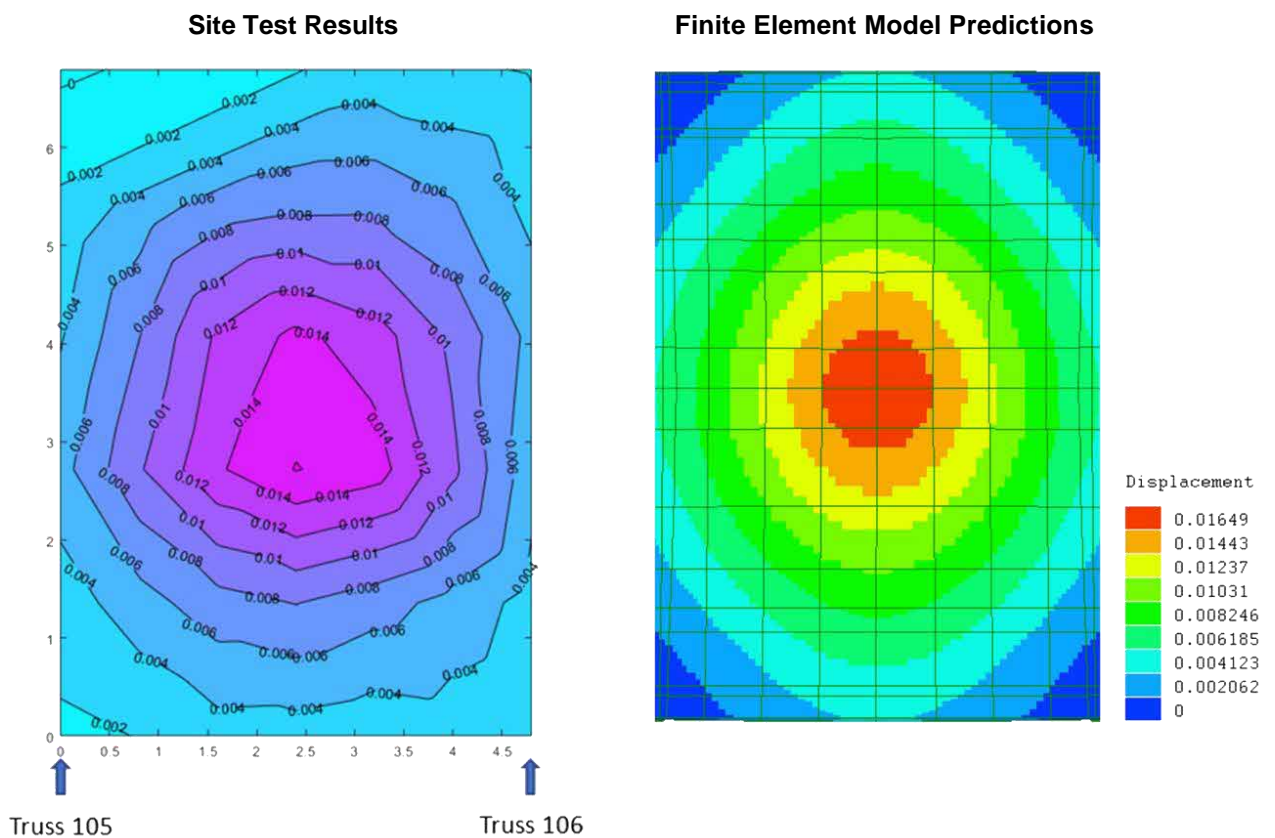
6.10 The results showed excellent correlation between FE Model predictions and the actual performance data obtained from site testing as shown in outputs below.

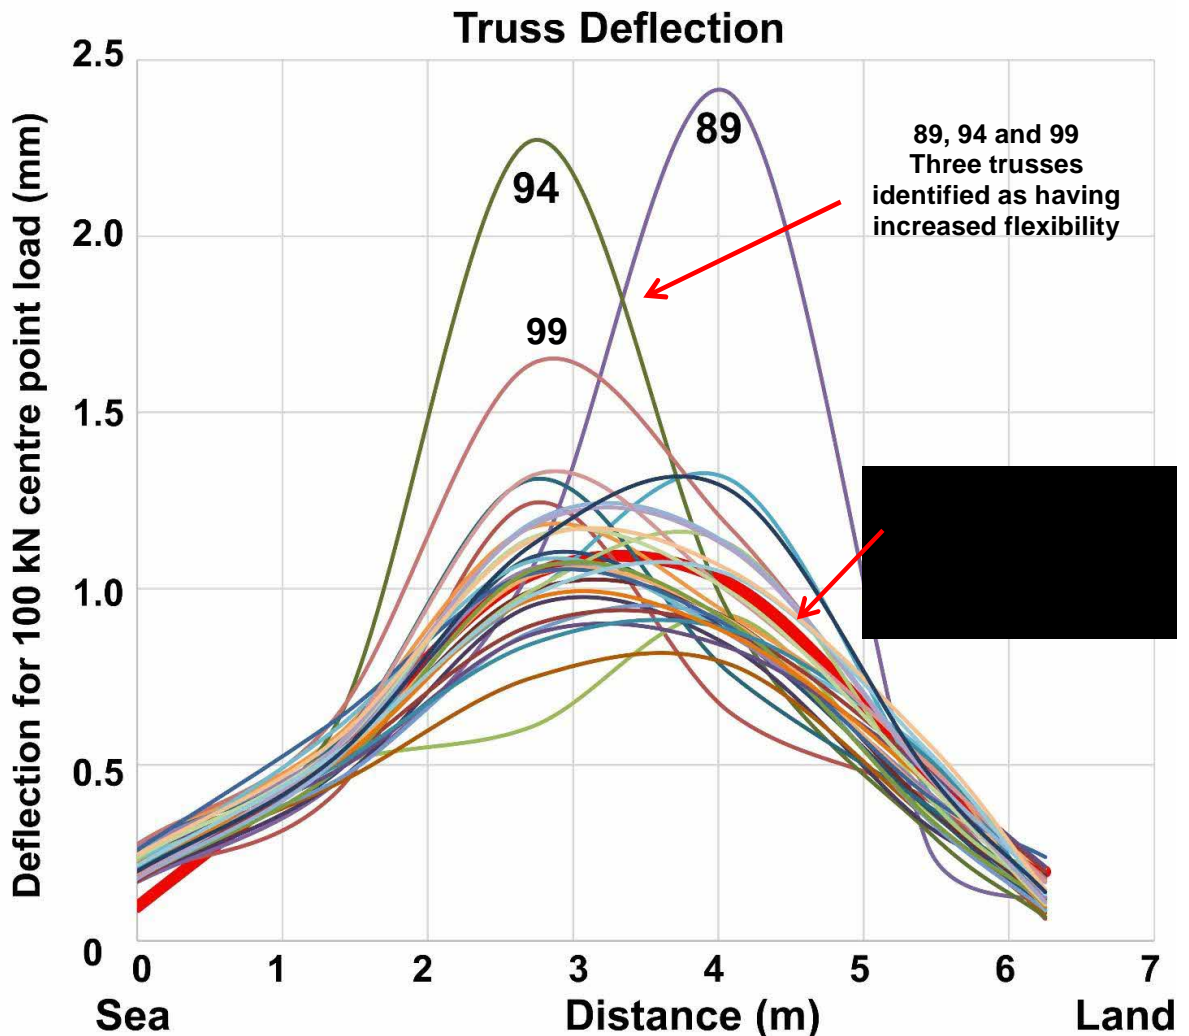
- 6.11 The graph below shows the performance predicted by the Finite Element model with the majority of trusses closely matching. In the trial testing trusses 89, 94 and 99 showed increased flexibility characteristics suggesting a potential weakness or deficiency.

- 6.13 The anomalies revealed in truss positions 89, 94 and 99 may be a result of a number of factors that may include corrosion, element failure in the truss or loss of composite action due to a deficiency in the deck. Further investigation would be required in these areas.

- 10.04 Truss position 89, 94 and 99 require anomalies to be considered. This may simply be a deck deficiency and not a truss deficiency, resulting in reduced composite action, or it may be a truss defect that may require repair.

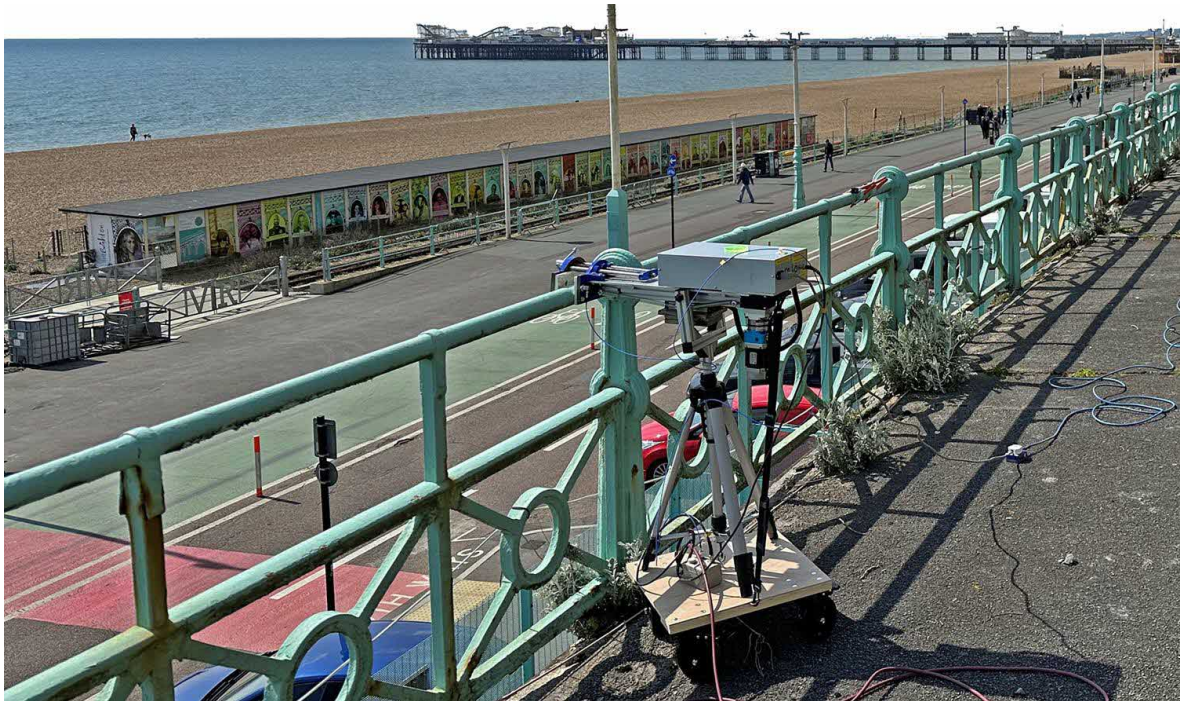
- 7.01 The balustrade to Madeira terrace is shown in the image below. It consists of cast iron, vertically cantilevering, sections located on each main grid line and at mid positions giving a structural spacing of approximately 2.4m. Tests were carried out from grid 88 to 115 at both primary and intermediate locations, with lateral excitation imposed using the rig illustrated below.

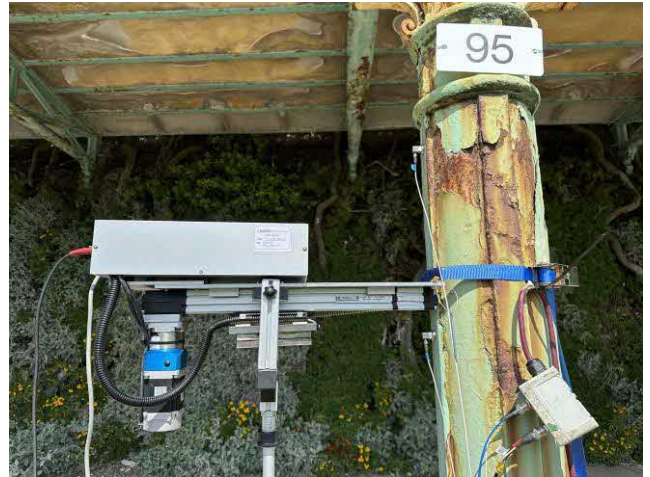
8.01 The trial dynamic assessment of the Madeira Terrace structure was primarily focused on the balustrades and main cast iron trusses, however two columns were briefly assessed during the available time allocated to the trial testing with lateral excitation applied to the column as illustrated in the image opposite.

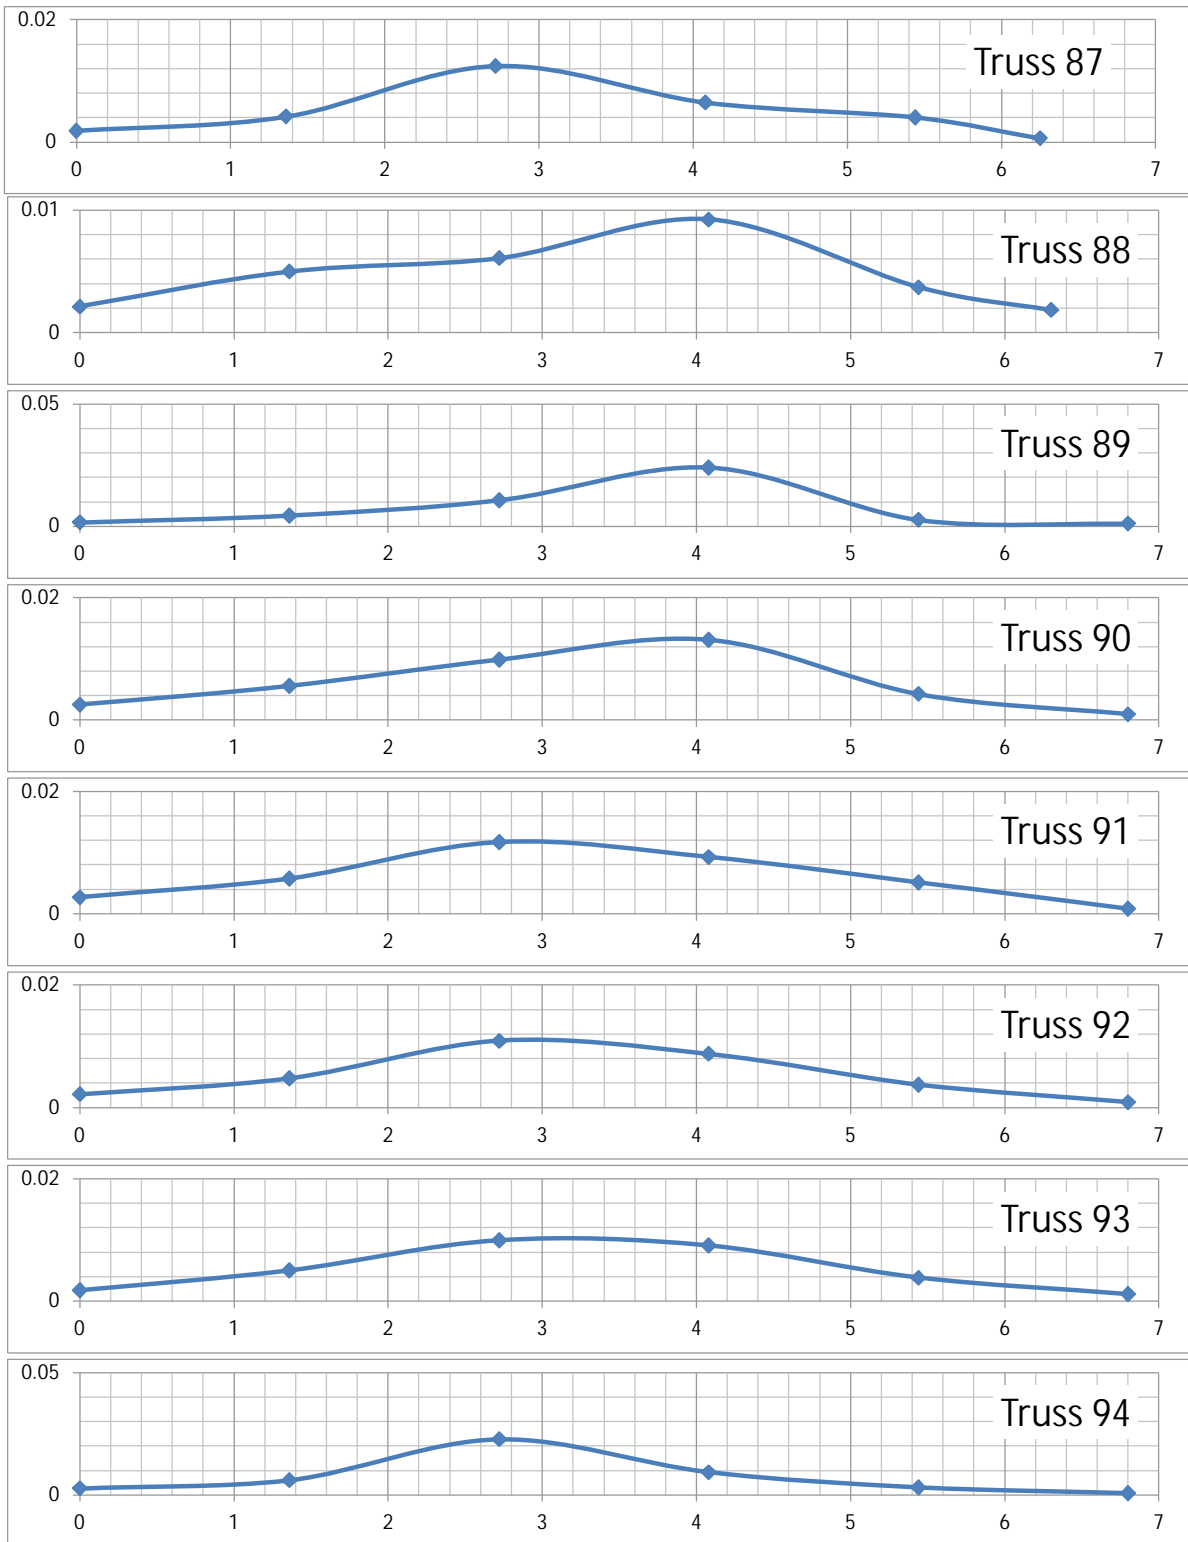
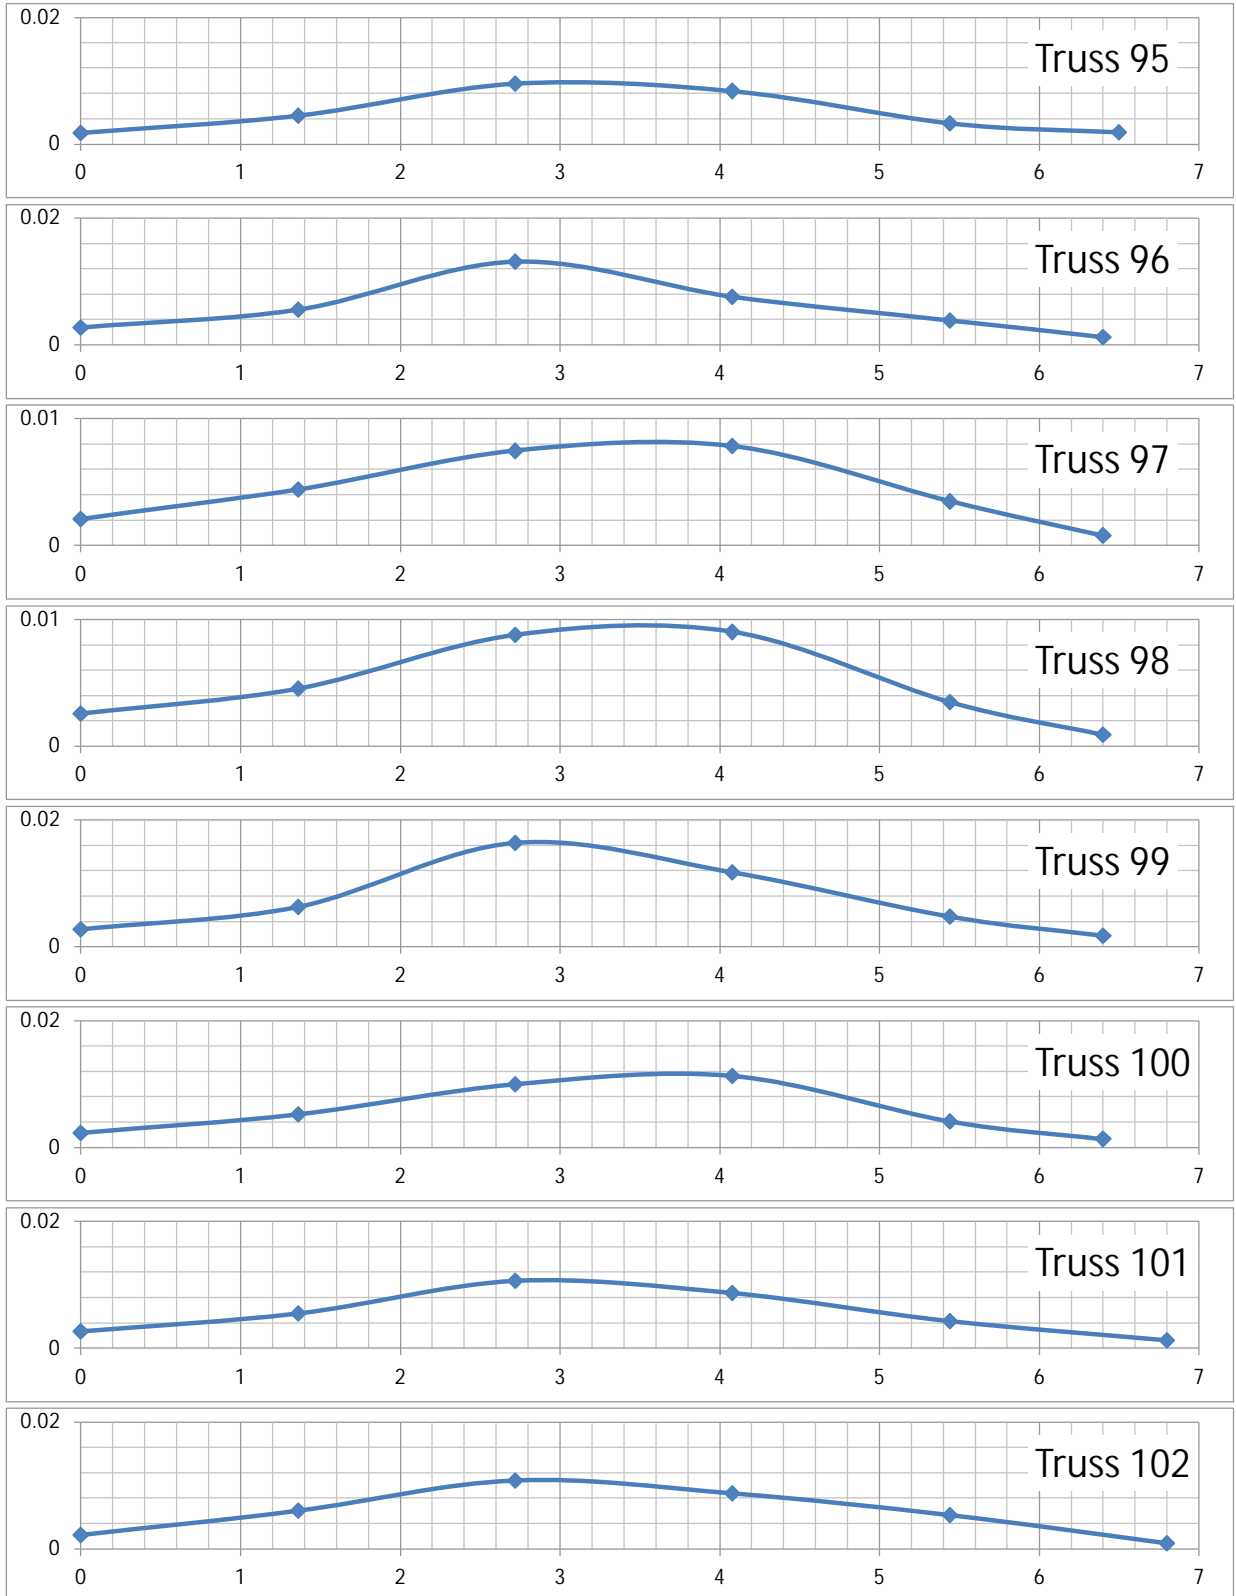
The following plots provide the stiffness characteristics of each truss line with results in mm based on a 1 kN unit central point load on the truss grid line.

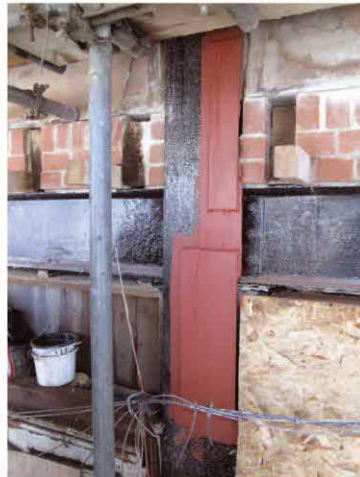
Figure 1
Repair to corroded steel
frame

Figure 1 shows a steel frame from the early 1900s which was exposed when refurbishing a shop front in Glossop, Derbyshire. The area of steelwork was severely reduced due to corrosion in places, particularly where there had been long-term contact with damp, such as where columns pass into the ground, or close to failing flashings. Here the solution was to dress the area back to sound metal and weld on new pieces to compensate for the material lost, before protecting with paintwork.

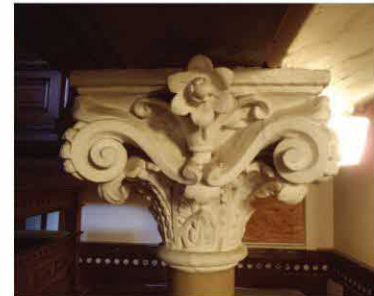
Figure 2
Cast iron column, complete
with cast Corinthian capital

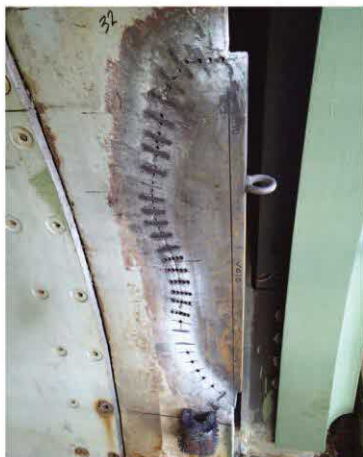
Figure 3 Example of cold stitching

Due to the brittle nature of cast iron, fractures can occur. One possible cause can be impact damage, or localised thermal shock. Cast iron cannot be readily welded; however, a mechanical 'cold stitching' technique can be used. This is where nickel-steel stitches are inserted into tight-fitting drilled slots at regular intervals, running across the fracture line, knitting the two sides together again (Figure 3).

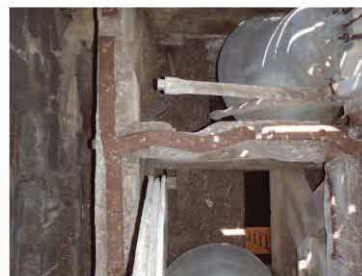
Figure 4 Wrought iron strap within 15th century church tower

Figure 4 shows a wrought iron strap repair to the bell frame within a 15th century Lincolnshire church. This has been carefully crafted to fit the oak frame. Despite hundreds of years of relative exposure, all that is needed is the removal of the surface rust, followed by painting (although it is suspected that it would manage many more years unpainted).
