**UPDATE BAT SURVEYS REPORT**  
**OF**  
**CHURCH FARM BARN, FARM LANE, EASTER COMPTON**

<b>Site Address</b>	Church Farm Barn, Farm Lane, Easter Compton, BS35 5RZ
<b>Report type</b>	Bat Survey Report
<b>Client</b>	Robins Homes Ltd
<b>Project number</b>	003ROHO100

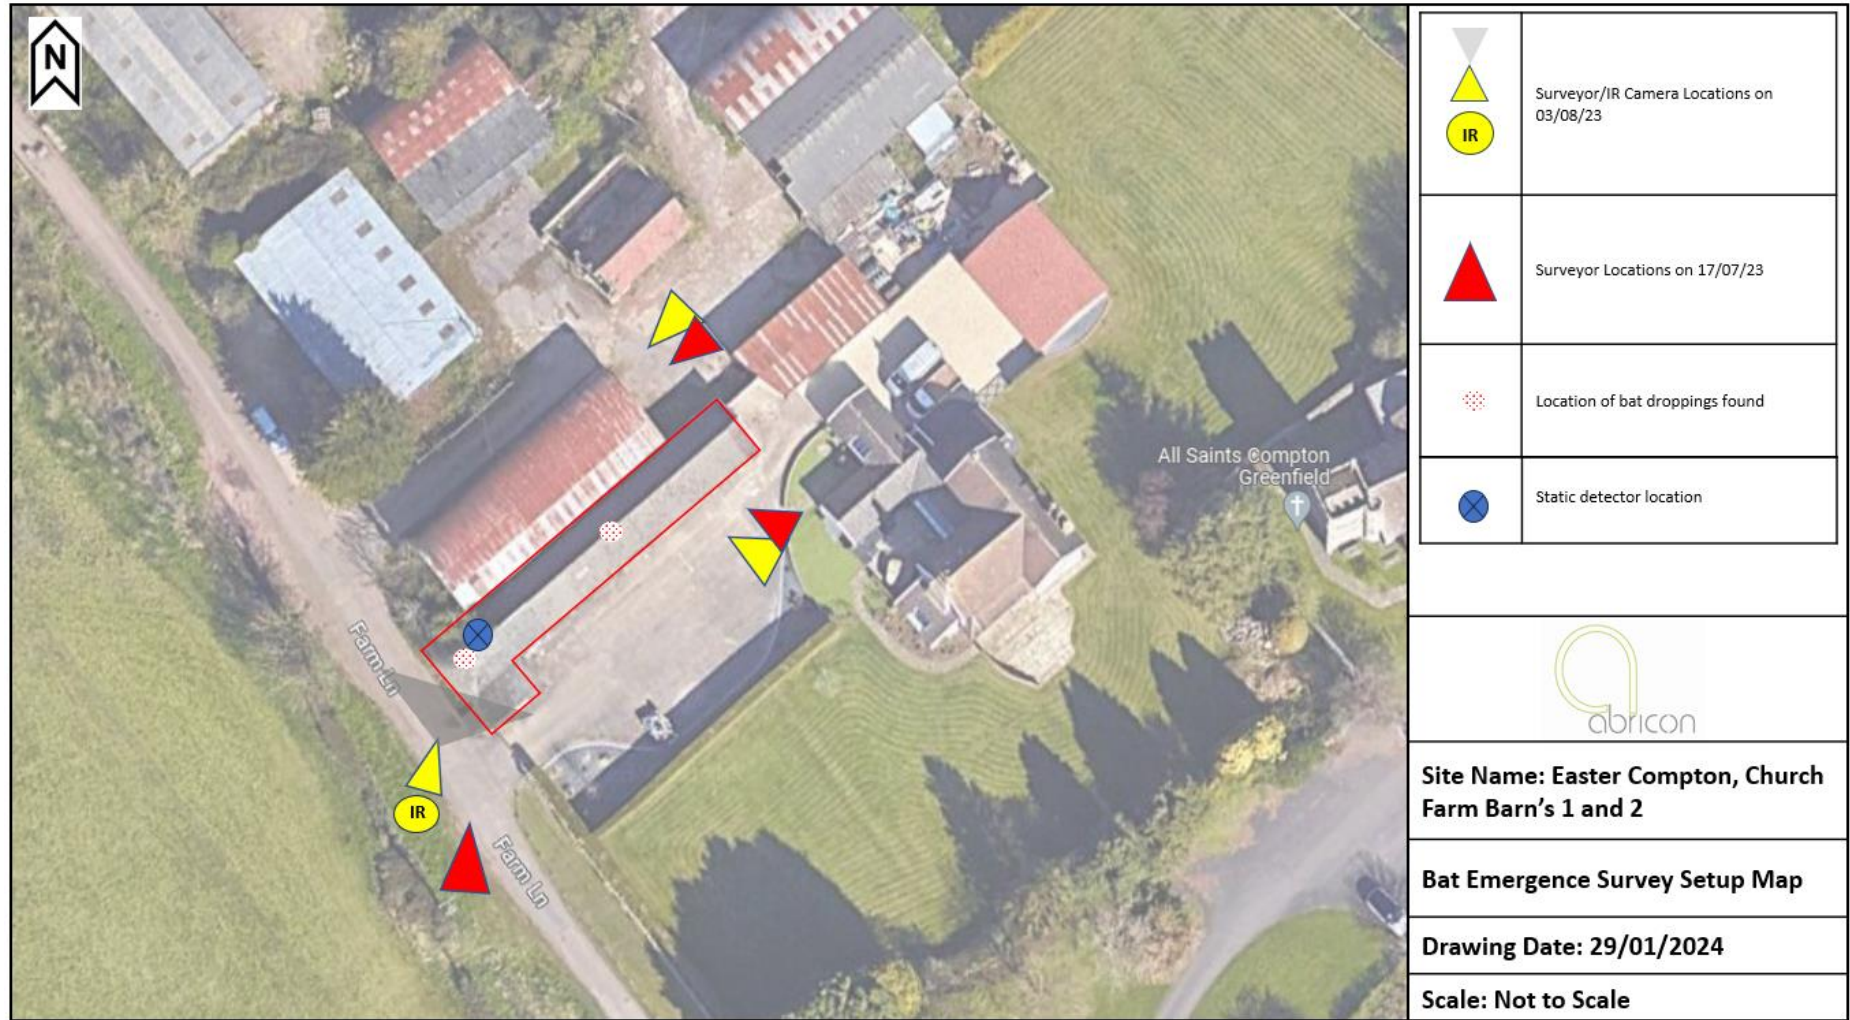
Figure 2 - Bat Emergence Survey Plan

2.2.3 A total of three surveyors were present during the first emergence survey of the building, two surveyors plus an infra-red camera were present during the second emergence survey. During both surveys, the surveyors were situated at key locations to ensure that all aspects of the building to be impacted by the proposed works were observed at all times, particularly those areas that had the highest potential to be used by bats and/or where evidence of bat use was found – see Figure 2 below.

- 2.3.1 A single static detector was deployed to complement the above emergence surveys. Remote monitoring can aid emergence surveys by recording bat echolocation calls throughout the night. This helps to determine the use and importance of a roost as remote monitoring will record calls at time periods that would not be included within an emergence survey.
- 2.3.2 An Anabat Express detector was deployed on 3<sup>rd</sup> August 2023 for 7 consecutive nights. The detector is programmed to begin recording 30 minutes before sunset, and to continue recording until 30 minutes after sunrise. The Anabat Express detectors use omni-directional microphones, with their recordings analysed using Analook software.
- 2.3.3 One static detector location was selected: within the darkest part of Barn 1 (where most bat droppings were found). See Figure 2 for a plan of droppings.

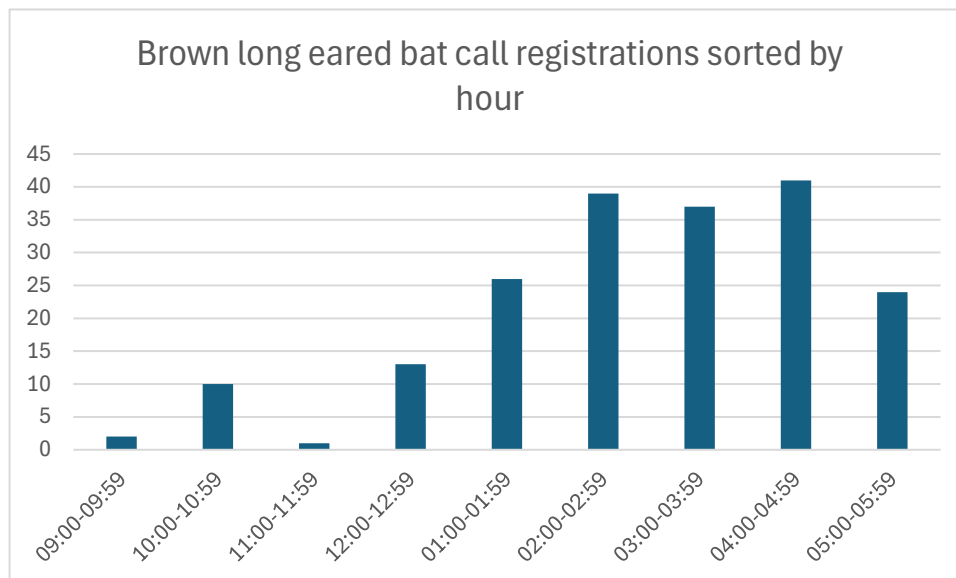
**Figure 3 – Brown long eared call registrations sorted by hour**

- 3.3.1 Table 2 below provides a summary of the bat activity levels recorded at the static detector placed in Barn 1 from 3<sup>rd</sup> August to 8<sup>th</sup> August 2023 during the remote monitoring survey.
- 3.3.2 A total of 193 brown long eared calls were recorded within the interior of Barn 1. Of the total calls for this species, 41% are found within 2 hours of either sunset or sunrise (81 calls).

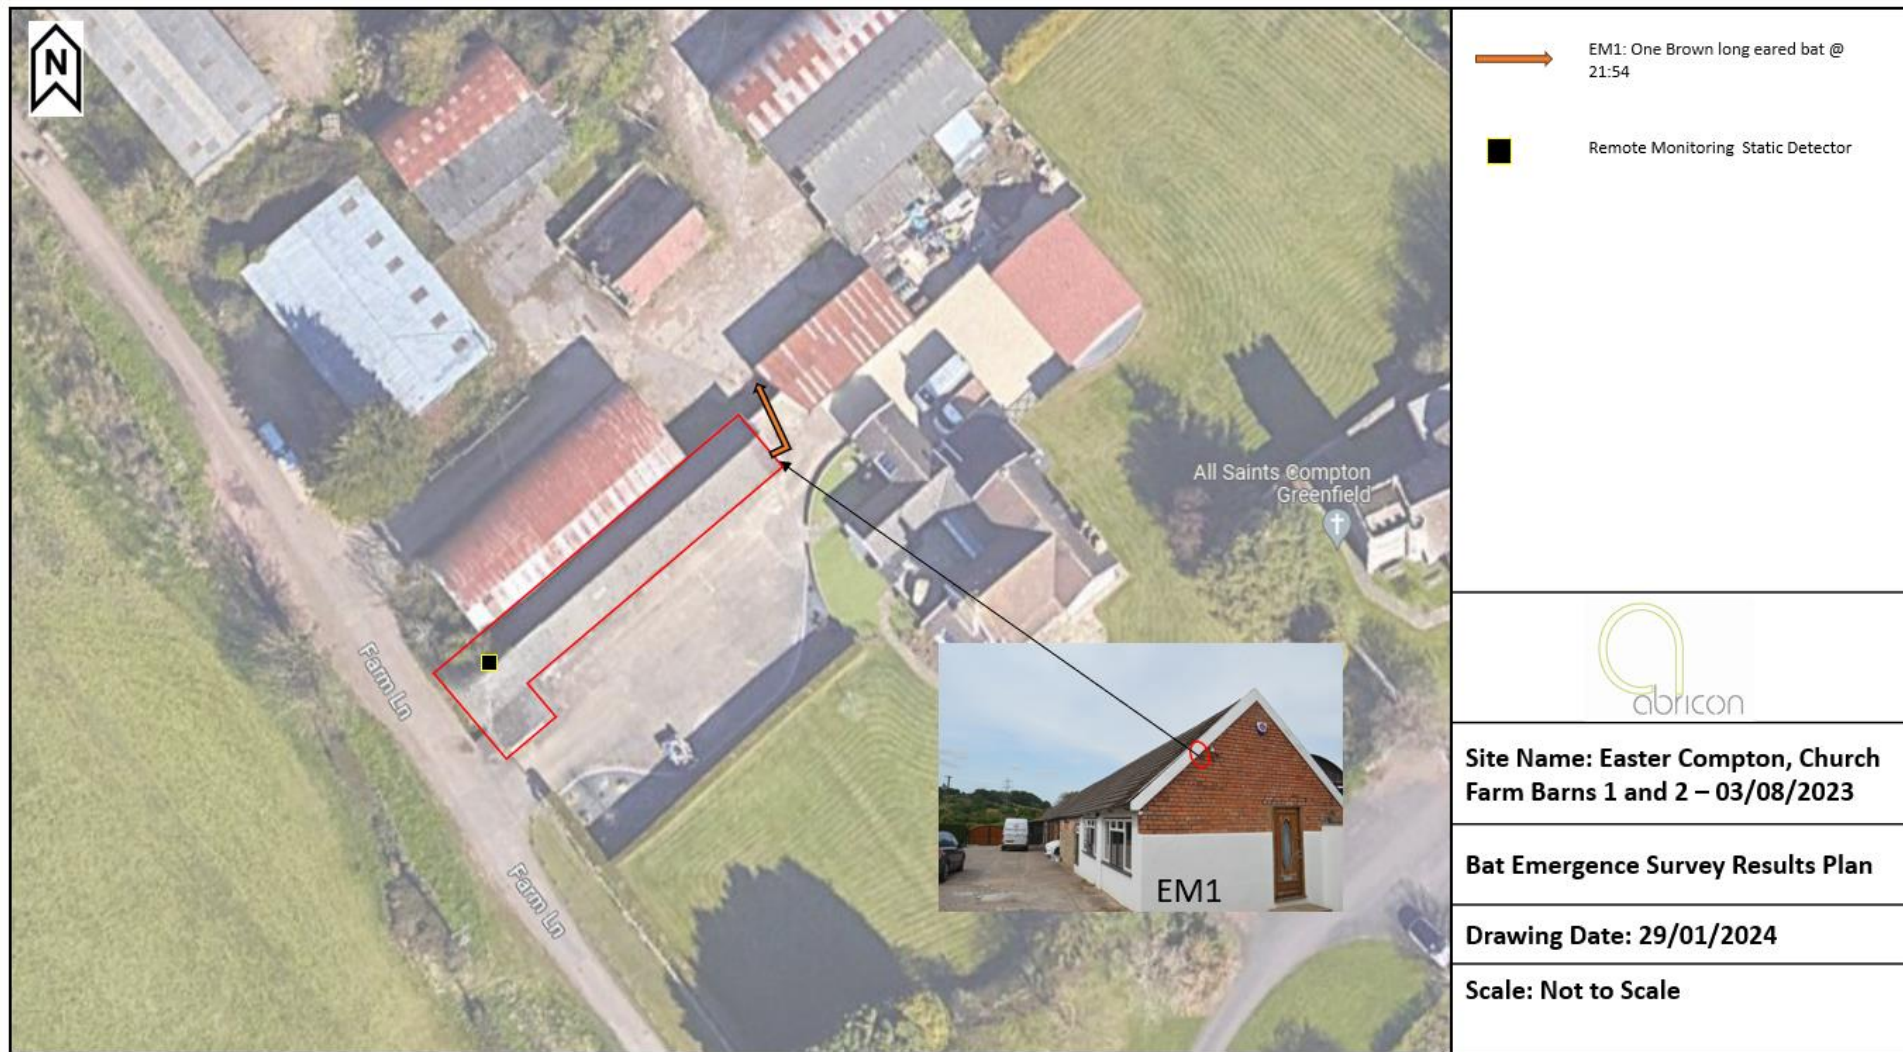
# Appendix B – Bat Emergence Survey Results Plan

3.2.7 At 21:54, one brown long eared bat was observed to emerge from underneath barge boarding from the northern aspect of Barn 2, and then proceeded to commute southeast (EM1, Appendix B).

- 5.2.1 The surveys identified that Barn 2 is a day roost for low numbers of brown long eared bats.
- 5.2.2 As the planned works involve like for like re-roofing which will retain all roosting places present in the loft and the fascia board on the northern gable end and all existing access points, it is considered that the works can proceed without the need for BML if they're carried out outside of bat active season (so between October and March) when bats are likely absent from the structure.

- 5.2.3 Alternatively, as bats might be encountered during the roof strip during active season, a Bat Mitigation Licence (BML) will be required from Natural England (as BMCL registration used on Barn 1, the works affecting Barn 2 are outside of the scope for BMCL until after April 2027) should works be planned to be carried out between April and September, in order to allow works which would otherwise be illegal. The licence must be in place prior to any works being undertaken which could impact bat roosts, and where consents are required (planning, listed building etc), these must be in place prior to applying.
