**BAT SURVEYS REPORT**  
**OF**  
**CHURCH FARM HOUSE, FARM LANE, EASTER COMPTON**

<b>Site Address</b>	Church Farm, Farm Lane, Easter Compton, BS35 5RZ
<b>Report type</b>	Bat Survey Report
<b>Client</b>	Robins Homes Ltd
<b>Project number</b>	003ROHO100

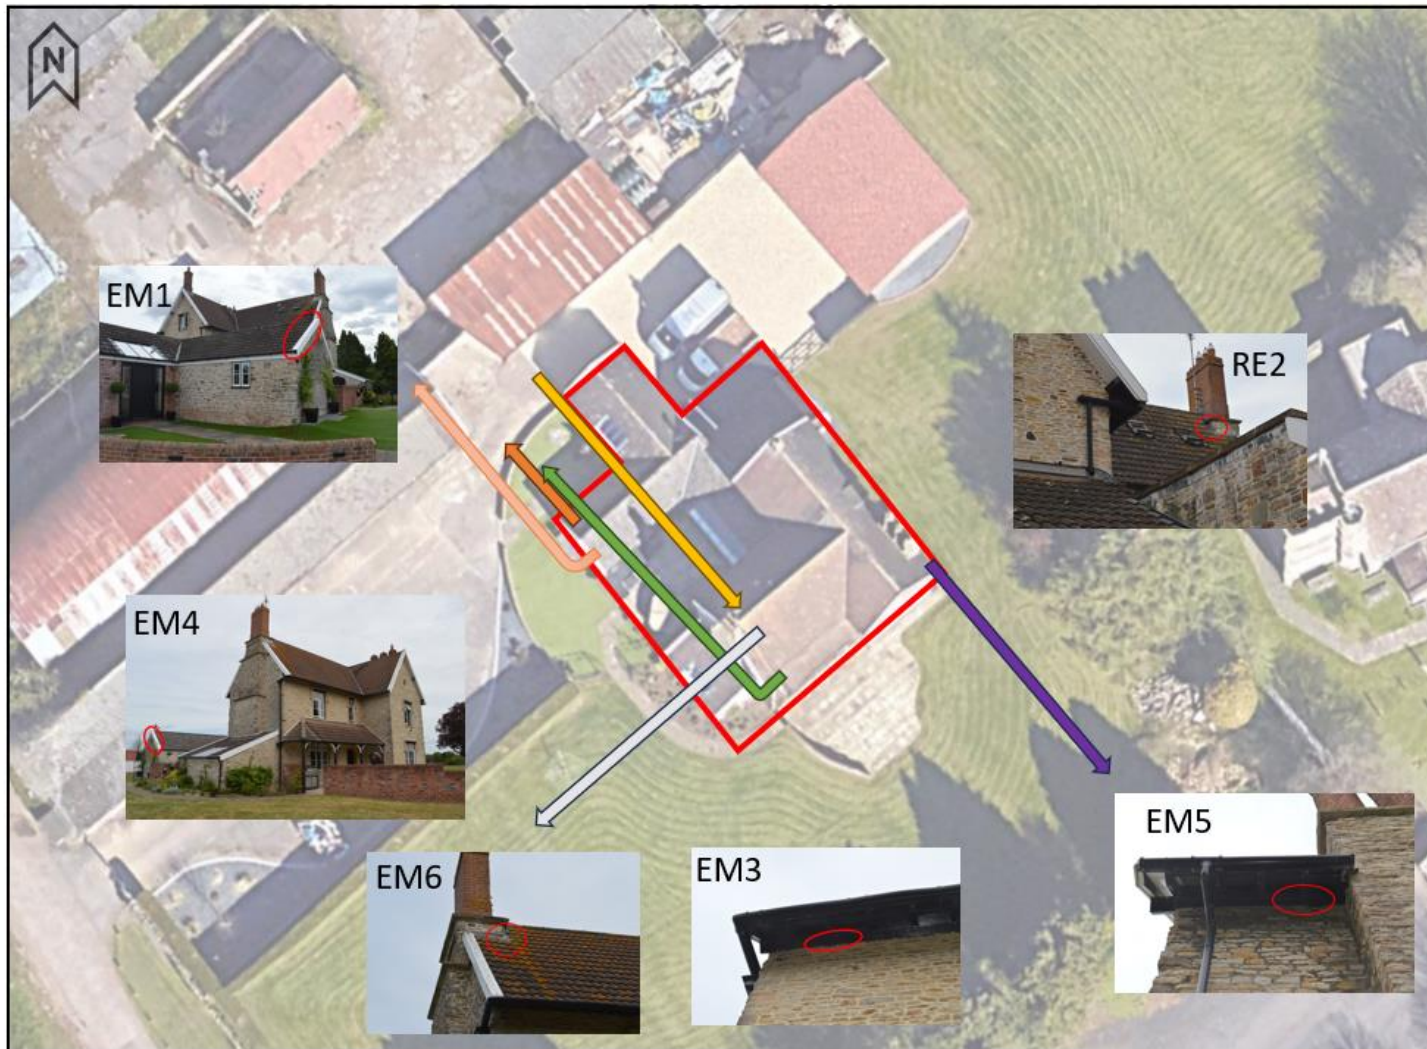
# Appendix B – Bat Emergence Survey Results Plan

- 3.2.5 At 20:42, one common pipistrelle was observed to emerge from underneath a capping board on the northern elevation of the house (EM1, Appendix B).
- 3.2.6 At 21:20, one common pipistrelle was observed to re-enter the house within a lifted section of flashing beneath the chimney to its northwestern aspect (RE2, Appendix B).
- 3.2.7 Noctule, Leisler's, *myotis sp.* and brown long-eared bats were also recorded foraging and commuting within the bounds of the site.

- 3.2.8 At 21:03, one common pipistrelle was observed to emerge from the south-eastern elevation of the main house from underneath open eave and then proceeded to commute south-west (EM3, Appendix B).
- 3.2.9 At 21:07, a single common pipistrelle bat was observed to emerge from the south-western aspect of the house from underneath the wooden capping board (EM4, Appendix B).
- 3.2.10 At 21:09, one non-echolocating bat was observed to emerge from within a hole underneath the open eave to the house's north-eastern aspect (EM5, Appendix B).
- 3.2.11 At 21:00 one noctule was observed to commute high over the site, and at 21:33, one Leisler's bat was observed to commute very low over the site.
- 3.2.12 Long-eared bats were also recorded foraging and commuting within the bounds of the site.

- 3.2.13 At 22:17, one brown long-eared bat was observed emerging from under lifted flashing to the base of the chimney at the south-western gable end (EM6, Appendix B).
- 3.2.14 Noctule and common pipistrelle bats were observed and recorded foraging and commuting within the bounds of the site.
- 3.2.15 A single Leisler's bat was also recorded but not directly observed foraging and commuting within the bounds of the site.

EM1: One common pipistrelle @ 20:42	24/08

Roost access points under eaves to the southeastern and north eastern elevations (EM3+EM5, Appendix B) and capping boards to the northwestern aspect (EM1+EM4, Appendix B) shall be retained and protected as part of development proposals. As permanent mitigation for the loss of the common pipistrelle and brown long-eared access points, replacement bat features will be installed into main roof (see Appendix D for suggested placement and sketches), these include:

- Replacement lifted flashing (i.e lead tile) shall replace the existing lead flashing beneath the chimney to the northwestern aspect of the house (RE2, Appendix B).
- Replacement lifted flashing (i.e lead tile) shall replace the existing lead flashing beneath the chimney to southeastern aspect of the house (EM6, Appendix B).
