Ben's Yard, Frampton Cotterell

Remediation Strategy

Prestige Developments (Bristol) Ltd

P0637/CS-J-1363

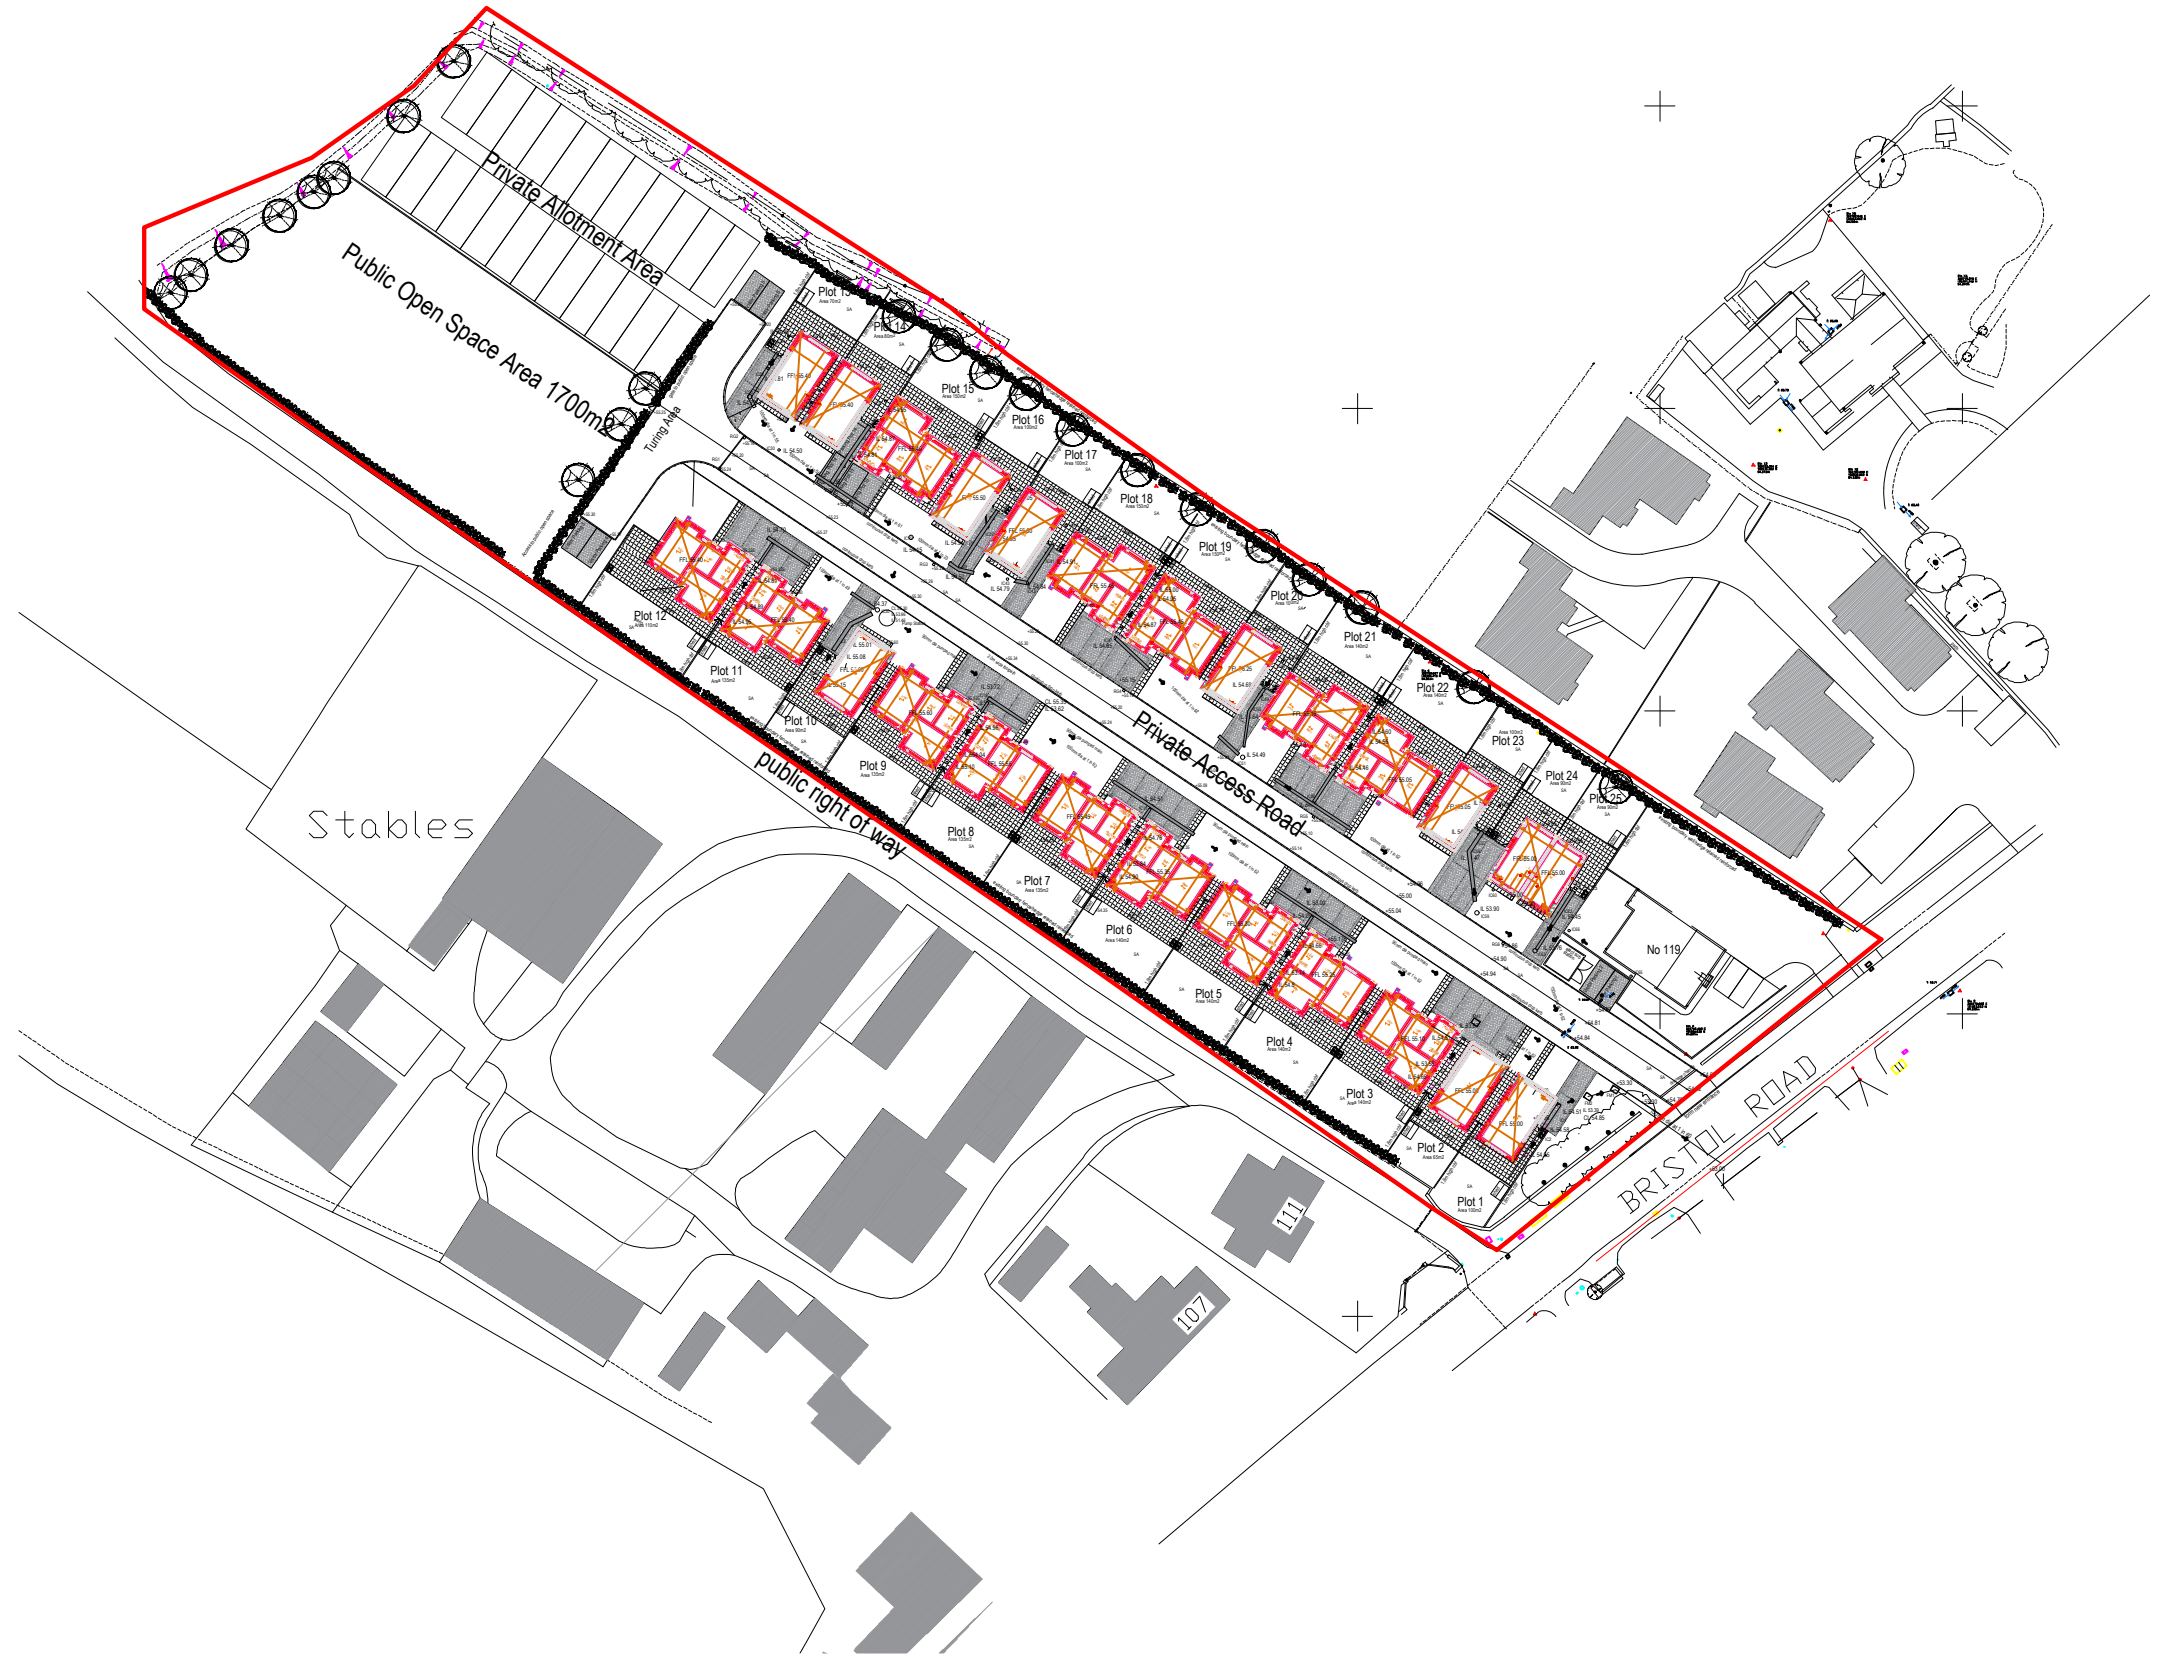
Drawn	Checked	Amendment	Date	Rev.
Client				
Prestige Developments (Bristol) Ltd				
Project				
Bens Yard, Frampton Cotterell				
Title				
Proposed Development Plan

Base Map
 Company: David Cahill Design Consultants Ltd
 DWG Title: Proposed Site Plan: Drainage
 DWG Number: 3188/206
 Date: Dec 2021

Information presented to T&P Regeneration Ltd (T&P) indicates that the proposed development is intended to comprise the construction of 25N^o traditional single and two storey residential dwellings with associated areas of communal and private soft landscaping with hard landscaped access and parking and an area of allotment gardens in the west of the site.

A Proposed Development Plan is included within Appendix A.

- In all areas of proposed private soft landscaping as shown on the plan within Appendix A, a minimum 600mm capping layer of chemically and physically suitable topsoil/sub-soil should be provided. A high visibility geotextile marker should be provided at the base and sides of excavations as a marker layer.

- In all areas of proposed POS soft landscaping as shown on the plan in Appendix A, a minimum 300mm capping layer of chemically and physically suitable topsoil/sub-soil should be provided. A high visibility geotextile marker should be provided at the base and sides of excavations as a marker layer where existing made ground soils are to remain in situ at the base of the capping excavations.

- In all areas of proposed allotments as shown on the plan in Appendix A, a minimum 600mm capping layer of chemically and physically suitable topsoil/sub-soil should be provided. A high visibility geotextile marker should be provided at the base and sides of excavations as
