STAGE 1 TIER 1 PRELIMINARY GEO-ENVIRONMENTAL RISK ASSESSMENT

CITY HOUSE, SUTTON PARK ROAD, SUTTON, LONDON SM1 2AE

Report ref: **10902/SG**

Date: **31st January 2024 (Rev2)**

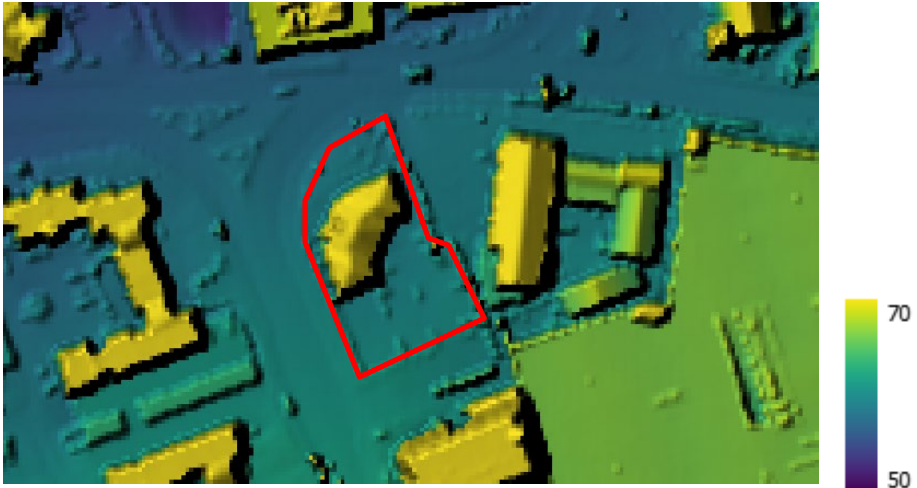
Topography and site levels	<ul style="list-style-type: none"> ✦ A topographical drawing was not supplied ✦ A LiDAR map showing ground level is as follows: <div data-bbox="491 1070 1412 1556" style="text-align: center;">

</div> <ul style="list-style-type: none"> ✦ This map indicates the following: <ul style="list-style-type: none"> ➢ General topography slopes to the north/north-west ➢ Overall fall in elevation of about 2m across the site (SE to NW) from +60.5mOD to +58.8mOD. Sutton Park Road shows similar fall ➢ Cheam Road to the north lies at about +57.5mOD in line with site

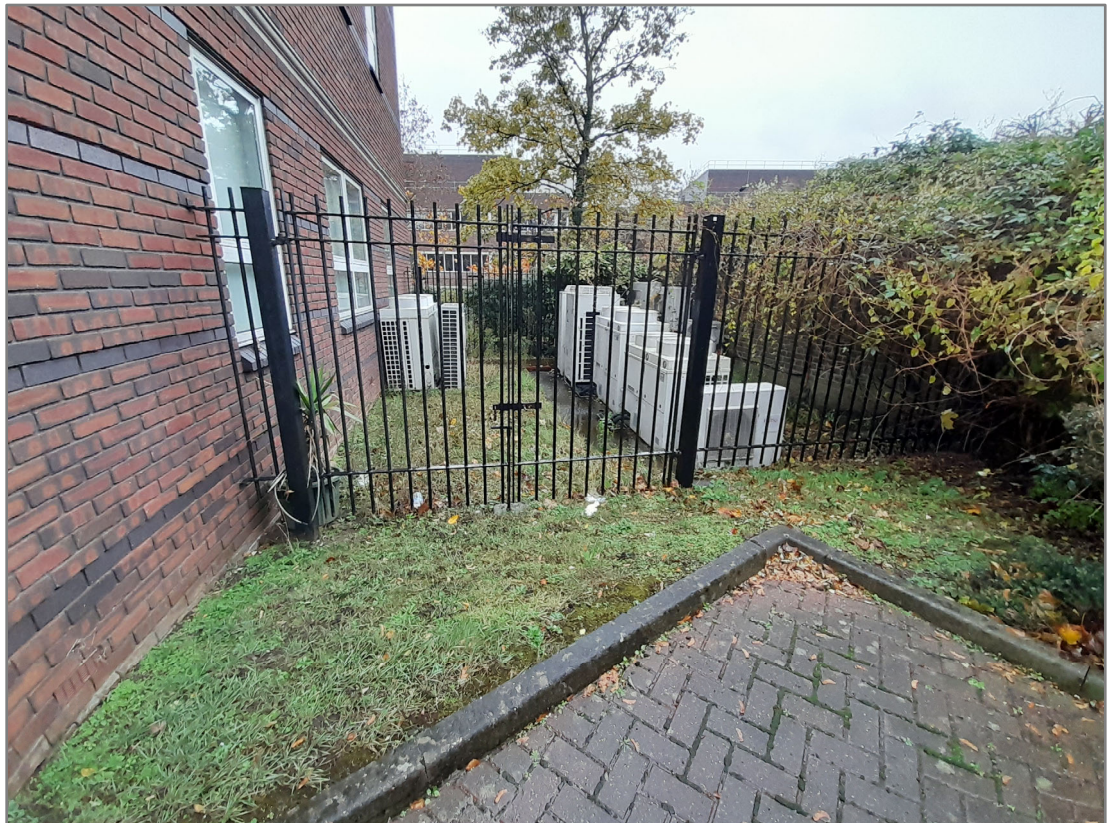
Photo No 14

**Fenced area
containing air
conditioning
units in the
central part of
the eastern
boundary**
