1972 City House, Sutton

Pre-Demolition Audit

Rev 02

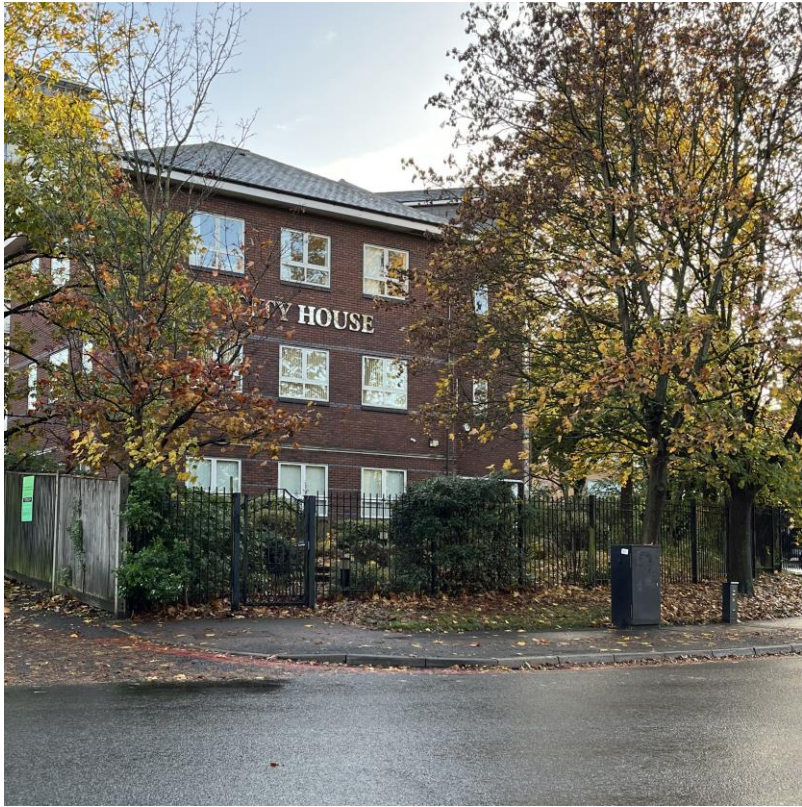
1.1

External façade - view from main road
1.2

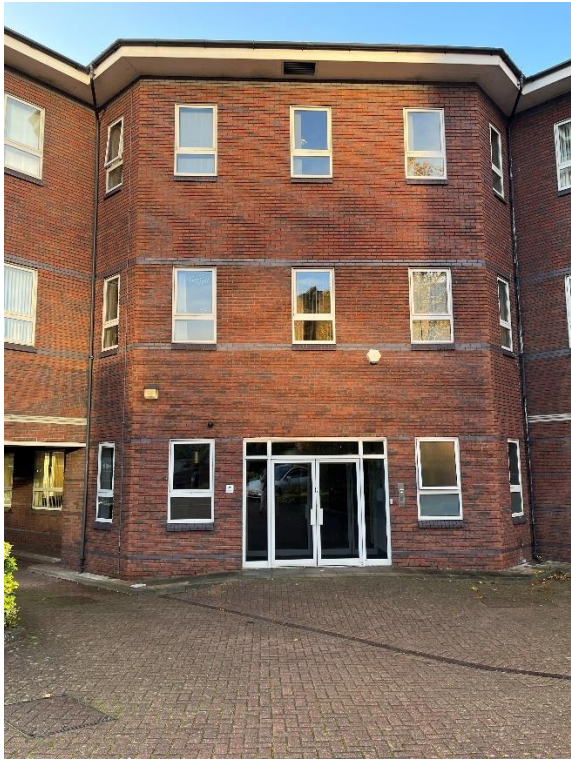
External façade – main entrance

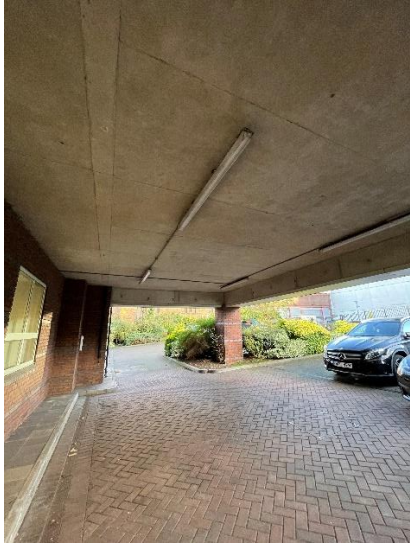
1.3

A photograph showing the interior of a carport. The ceiling is a flat, grey concrete slab supported by a concrete frame. A long, narrow fluorescent light fixture is mounted on the ceiling. The floor is paved with reddish-brown bricks. In the background, a dark-colored car is parked under the carport. To the left, there is a brick wall with a window.	In situ concrete frame and slab to carport

Typically, the floor construction was visible in ceiling voids as precast concrete slab (assumed hollowcore). The exception to this was over the approx. 70m² external carport at ground floor where an in-situ concrete slab was visible with substantial downstanding beams and brick clad concrete (assumed) columns.

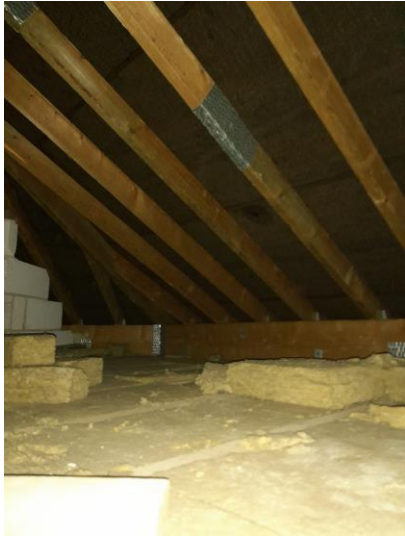
1.4

A photograph of the interior of a pitched roof. The rafters are made of light-colored wood and are spaced evenly. The floor is made of concrete slabs. There are some yellowish deposits on the floor. The roof is pitched upwards towards the right.	Pitched rafter roof timbers

The pitched roof is formed with a number of hips and valleys to suit the winged plan form. The structure is traditional timber raftered construction on loadbearing block walls with a timber post and beam arrangement to support the ridge lines. Over the stairwell and lift core a dormer creates a raised roof line over the lift overrun.

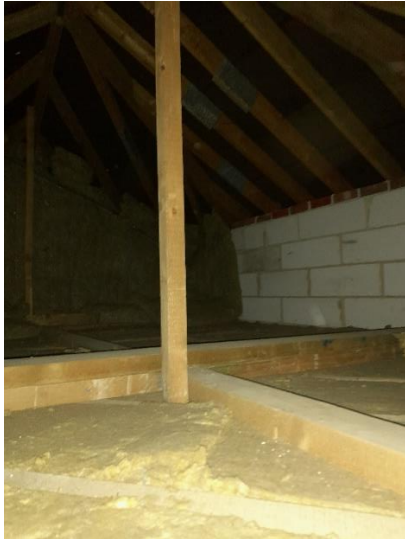
1.5

A photograph of the interior of a pitched roof. A vertical timber post is positioned in the center, supporting the roof structure. The rafters are made of wood and are pitched upwards. The floor is made of concrete slabs. There are some yellowish deposits on the floor. The roof is pitched upwards towards the right.	Timber post to support roof ridgeline

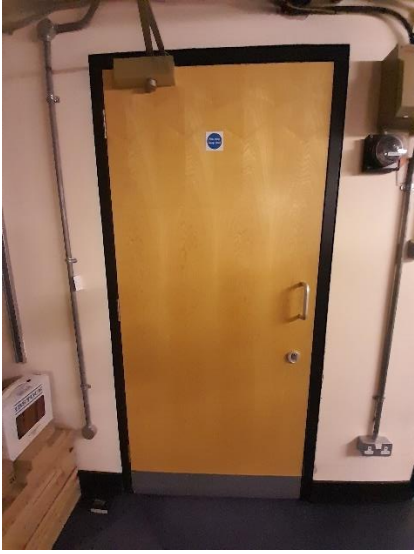
1.6

Fire door and frame 3 rd floor
1.7

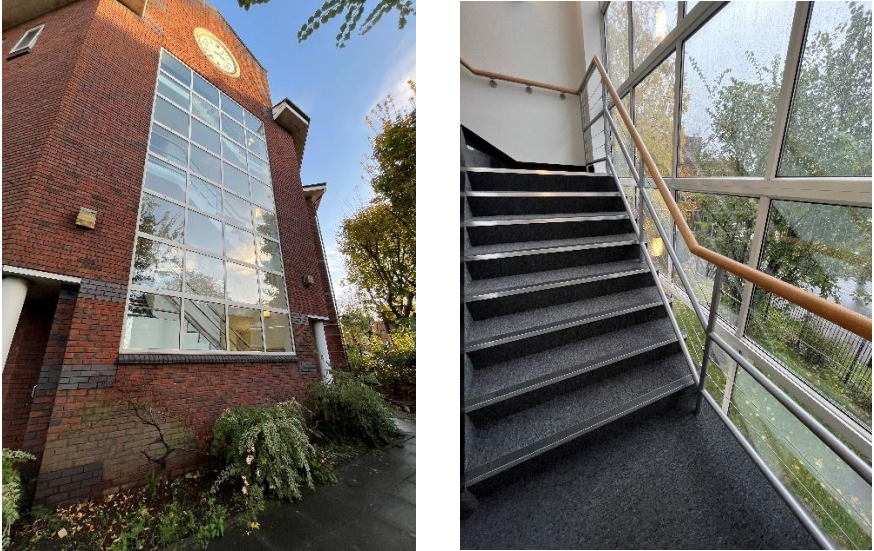
Internal and external view of stairwell
1.8

A full height single glazed curtain wall façade system forms the external wall to the stairwell. The stairs are assumed in-situ cast reinforced concrete.

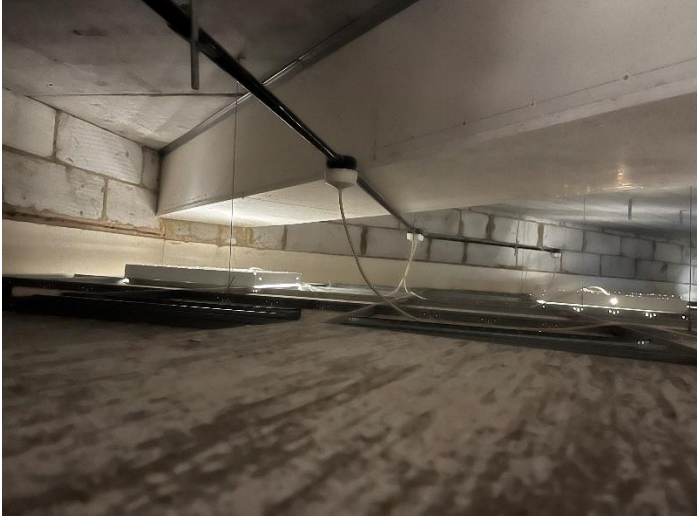
View of fireboard clad downstand beam in ceiling void

Downstanding steel beams span the main office spaces and support the precast concrete floor decks. The beams and decks are set out in a winged plan form. The steel beams do not form part of a frame and instead bear directly onto the blockwork walls and sit within the ceiling void.

Substantial steel beams (12No overall) are visible in the ceiling voids, with high recovery potential following further structural investigation. The condition of the beams has not been assessed but is assumed to be good based on the general condition of the structure. The length of each steel beam (8 to 10 metres) make resale and reuse very favourable but will require special crange methodology for removal and long bed truck for transport from site. Due to the relatively low quantities of steel available, engagement with steel recovery services is required to determine minimum quantities for collection.

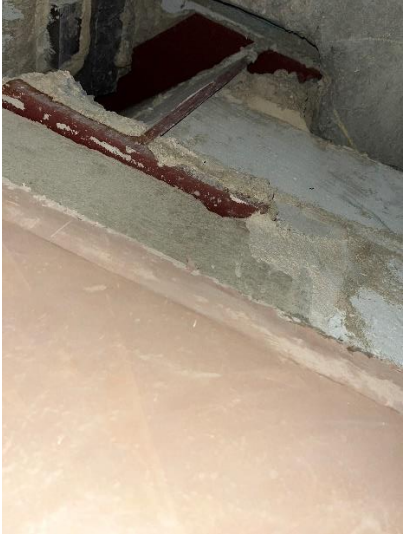
1.9

A photograph showing a close-up of a concrete downstand beam. The beam is supported by a brick wall. The top surface of the beam is covered with a reddish-brown material, possibly a protective coating or a layer of concrete. The wall is made of light-colored bricks. The floor in the foreground is a light-colored, possibly tiled or polished concrete surface.	View of end of downstand beam supported directly on internal block wall (to back of lift lobby)
1.10

demolition for identification of steel sections for recovery and implementation of removal strategies to minimise damage to valuable steel. The beams appear to be simply supported on bearings into the blockwork and potentially will require little preparation or cutting ahead of lifting from position and are therefore favourable for a damage free recovery. Careful removal of the precast concrete slabs sitting on the beams would be required to ensure best outcomes for steel beam recovery.

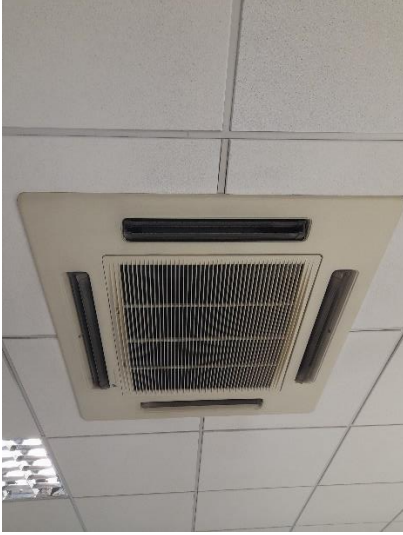
A photograph of a ceiling with a grid pattern. A square fancoil unit is mounted on the ceiling. The unit has a central grille and four side vents. The ceiling is made of white acoustic tiles.	Ceiling at first floor with fancoil unit
