BAT, BARN OWL AND NESTING BIRD SURVEY

**EMERALD COTTAGE, 16 CLAREMONT TERRACE, BEACON ROAD,
BREAGESIDE, PORTHLEVEN, HELSTON, CORNWALL**

August 2023

Report No: 22-316/3HW/Emerald Cottage,Porthleven_BBONB

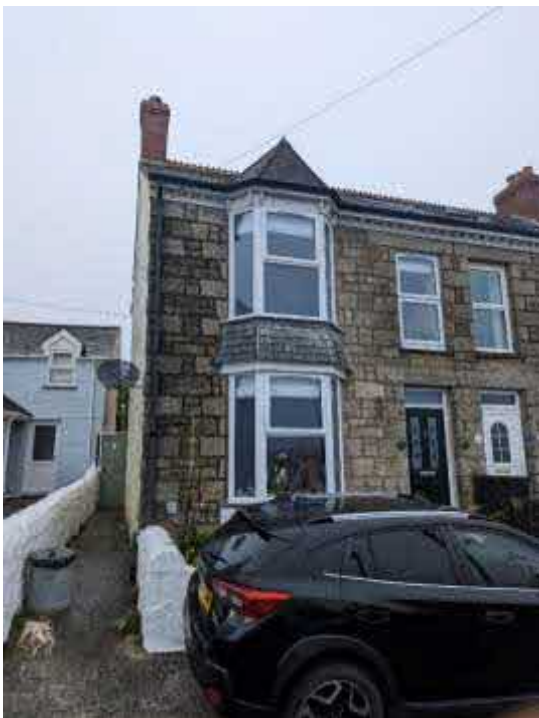
The building subject to this survey is a semi-detached stone two storey Victorian cottage, which looks out to sea to the south, and has a pitched roof covered with natural slate with a bay window to the front. It has a contemporary extension to the rear, which is shared with the attached cottage, and a small single storey lean-to extension to the rear which has a green roof. The western end of the building has a gable end as is the rear extension, see photos 1 and 2.

Photo 1. Showing the cottage from the south

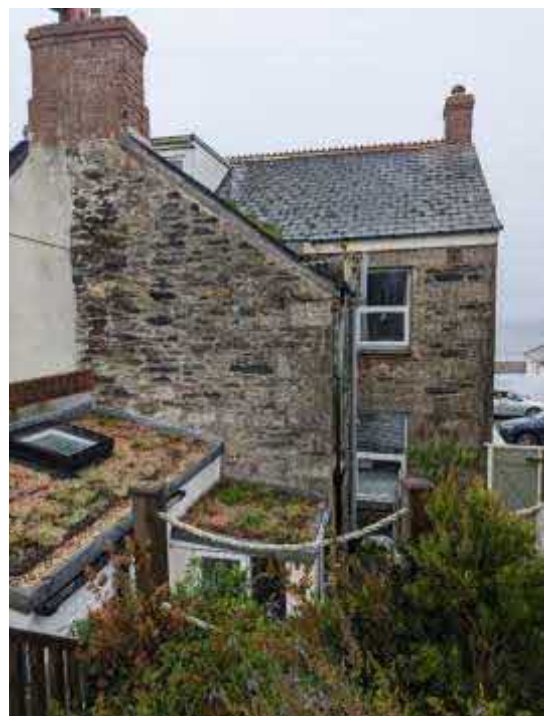
Photo 2. Showing the cottage from the north

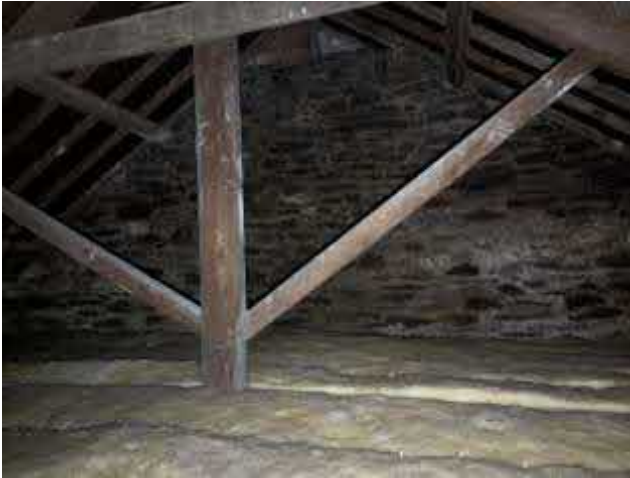
Internally there is a single roof void over the main part of the house which also extends over the rear extension. This is open from the floor of the roof void, which is lined with fibreglass insulation, to the underside of the roof which is lined with bitumen felt. The roof is supported by large wide spaced trusses with the gable ends being bare stone, see photos 3 and 4. The roof space of the attached cottage has already been converted into living accommodation with a plasterboard partition wall and steelwork

have been inserted to divide the roof void and support the roof. There is no roof void over the single storey part of the building.

Photo 3. Showing the roof void over the house

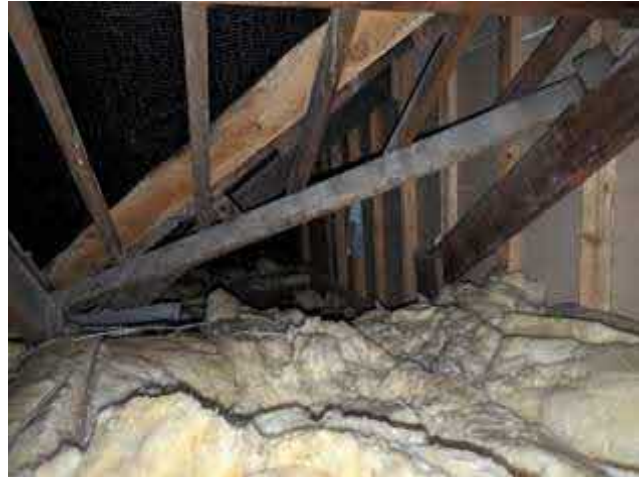
Photo 4. Showing the roof void where it extends over the rear extension
