Ecological Assessment for Bats and Breeding Birds

4 High Street, Bampton, Devon

www.wildlifesurveying.co.uk
Date of issue: 12th February 2024
Report number: KB24/108

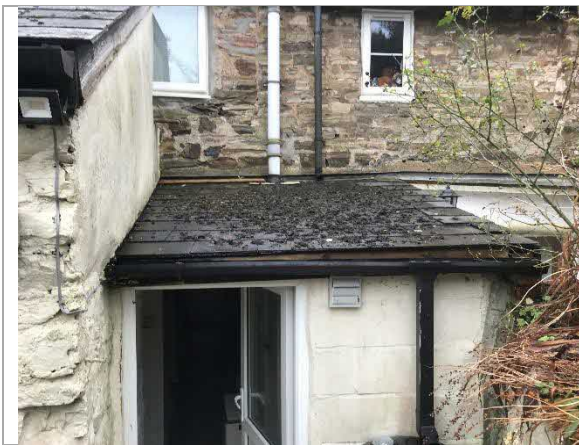
Lobby extension

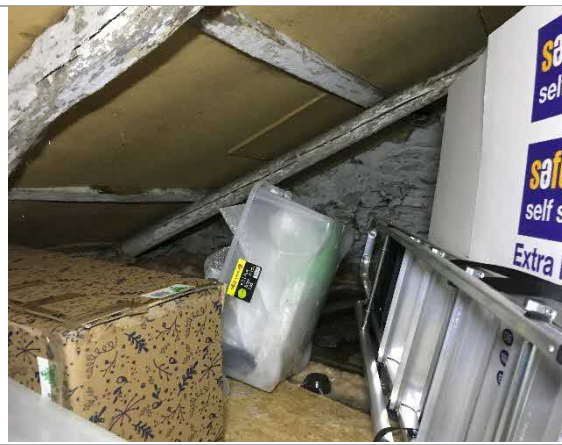
Storage cupboard which forms void over kitchen

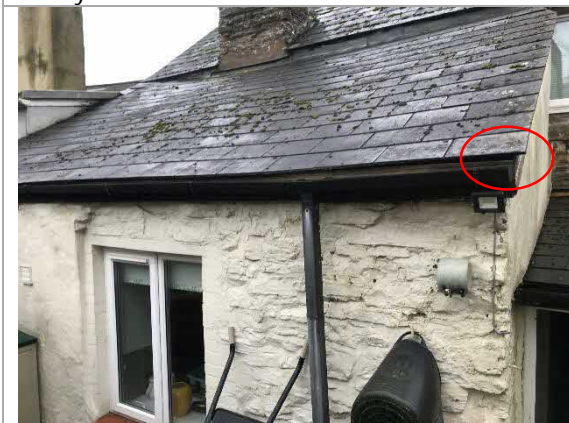
The roof and eaves have closely fitted ridge tiles, slates, and flashing in most areas. The rear kitchen extension features gaps behind soffits and at the corner, but all were full of thick cobwebs and lack

suitable flight paths below, due to the low height and proximity of nearby walls and banks within the garden.

Kitchen extension – showing potential nesting location. Currently full of thick cobwebs.

There is a possibility that birds may move into voids accessed by gaps under the tiles at the gutter line of the kitchen extension at the rear of the structure. No evidence of historic nesting by breeding birds was in any part of the building, although a prospecting blue tit *Cyanistes caeruleus* was seen showing interest in the area. House sparrows *Passer domesticus* also favour these kinds of nests sites and may move into this crevice in future.

To prevent inadvertent damage to breeding birds, their nests and young, a breeding bird check should be completed a minimum of 48 hours before works commences to ensure there are no nesting birds. In the unlikely event that birds are found to be using the buildings, works must be postponed until the chicks have fledged, which may be for a period of several weeks. All species of birds are protected when nesting, brooding eggs, or rearing chicks right up to fledging.

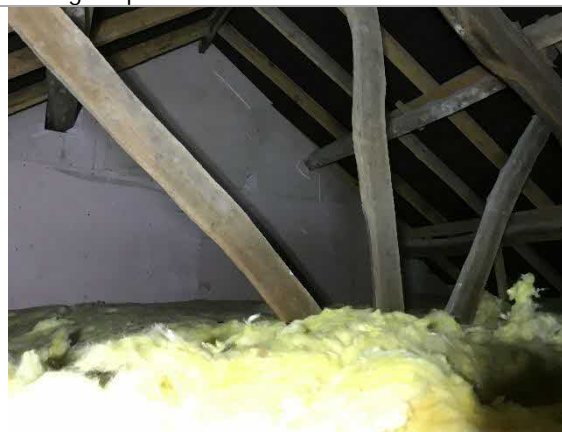
No field signs of bats, and no access points suitable for use by roosting bats were identified within the loft void. No evidence of roosting bats was found within the building on any floors, walls, ledges or stored items within the loft and storage cupboard that forms the kitchen loft. No feeding remains, droppings, staining or other field signs were observed within the interior or exterior of any of the buildings.

No droppings were seen on insulation or boarding within the loft and no evidence of droppings on walls, although cobwebs were present on the gable end walls.

Interior of main loft

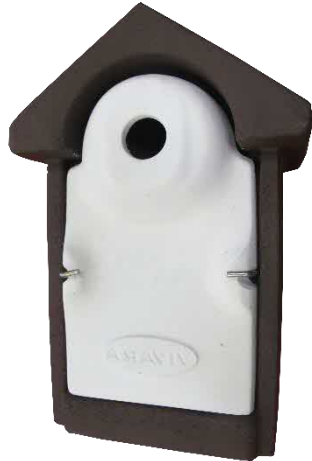
Tit/robin/wren box

Manufacturer: Vivara

Model: Pro Seville WoodStone® Nest Box

Material: Woodcrete

No mitigation is required. It is recommended that at least one bird box suitable for blue tits is erected within the garden at a minimum height of 2 metres (see Appendix 2 for details).

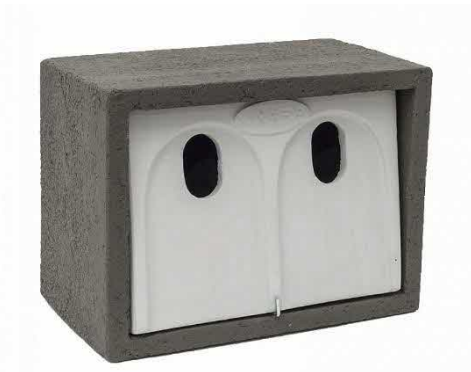
Sparrow terrace

Manufacturer: Vivara
