STRUCTURAL REPORT

THE OLD THRESHING BARN

LOWER DORWEEKE FARM, SILVERTON

PLANNING REPORT

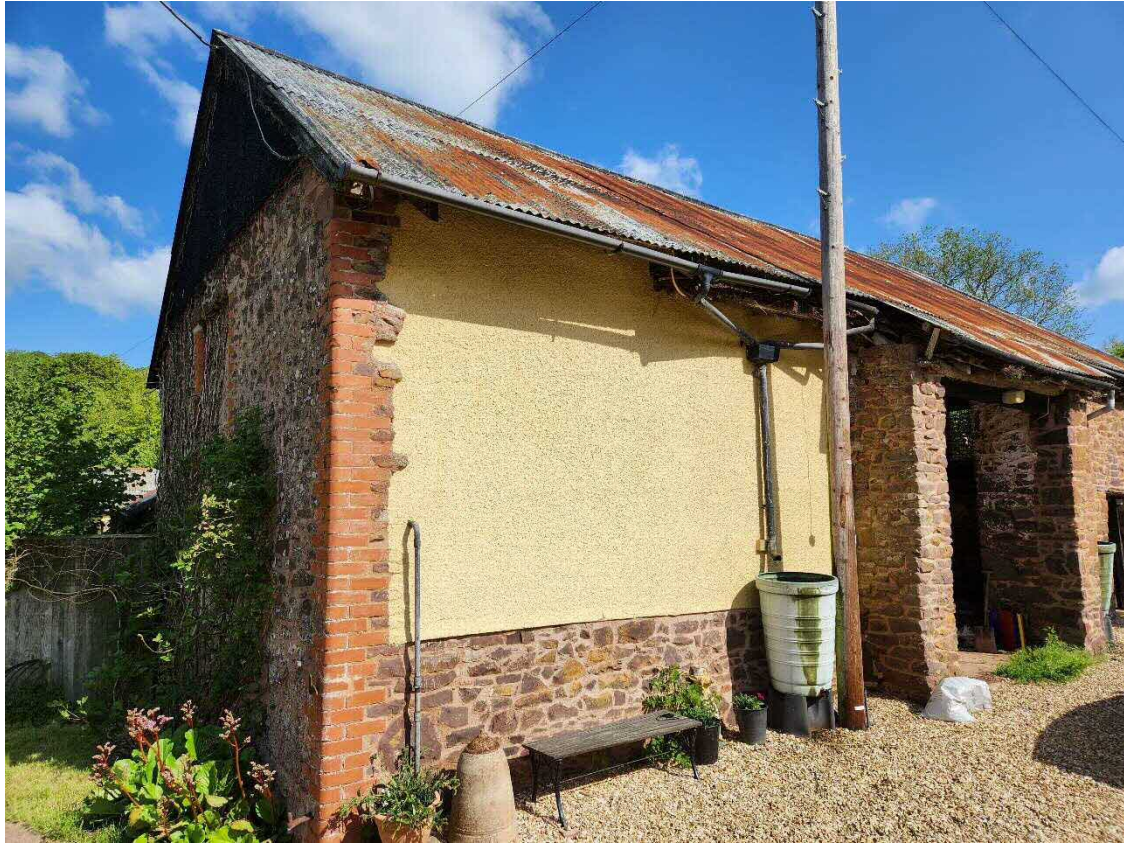
Above: South West Gable/South East elevation of barn

The barn is rectangular; measuring approximately 13m x 5.5m on plan. The primary structure of stone walls, with a series of timber trusses supporting purlins, cut rafters and a corrugated metal covered thatch roof. The North Eastern end of the barn retains the land behind it and to the North Western side there is an adjacent structure in different ownership. The Northern end of the barn has a mezzanine floor installed with diving wall at ground floor level creating separate room below.

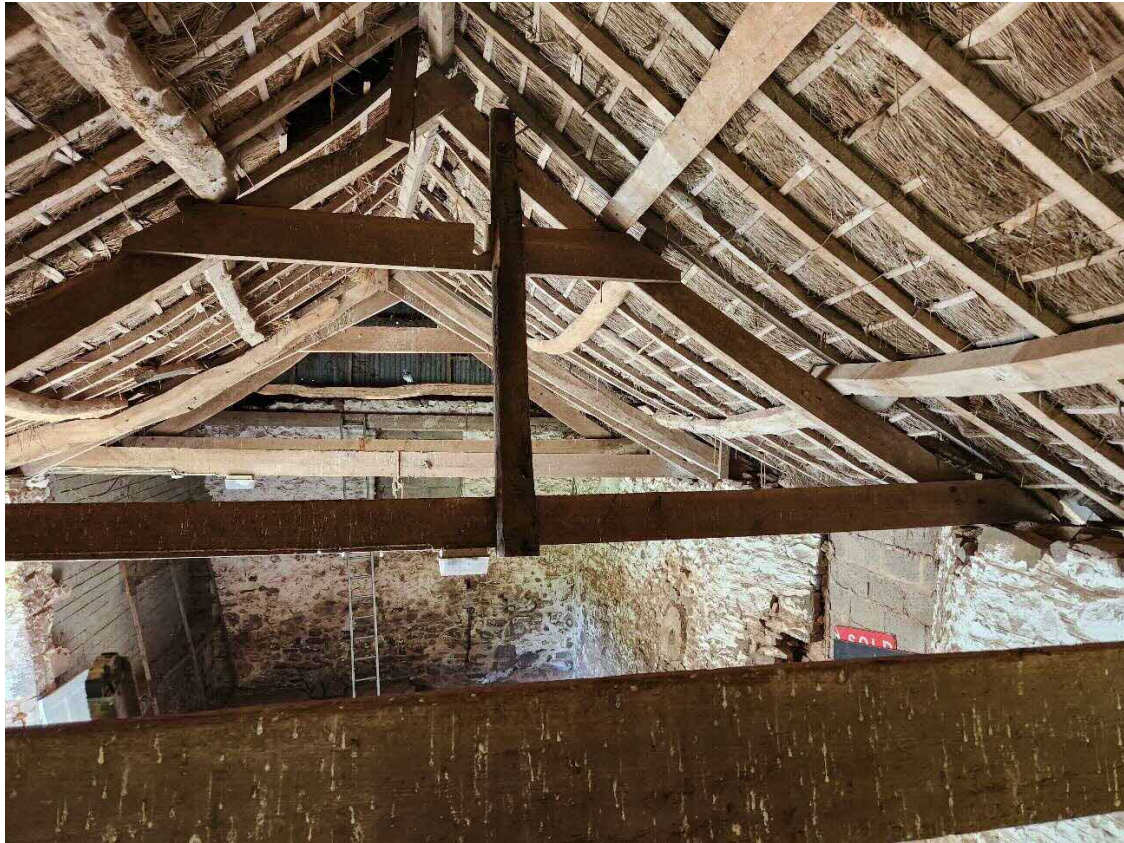
The current roof is covered in thatch with a corrugated metal sheet overcladding. This is supported on natural, un-regularised timber purlins, onto more modern sawn softwood timber trusses. The North Eastern end of the barn has a clipped gable profile.

Above: Over clad thatch roof supported on cut rafters, purlins and trusses.

- The cut rafters, purlins and trusses would not withstand scrutiny of a modern design standards and will need replacing.
- The external walls of the barn will require remedial work in places to make good, but appear suitable for proposed conversion.
- The ground floor concrete slab will need further investigation to see if levels and make-up will be suitable for proposed conversion.

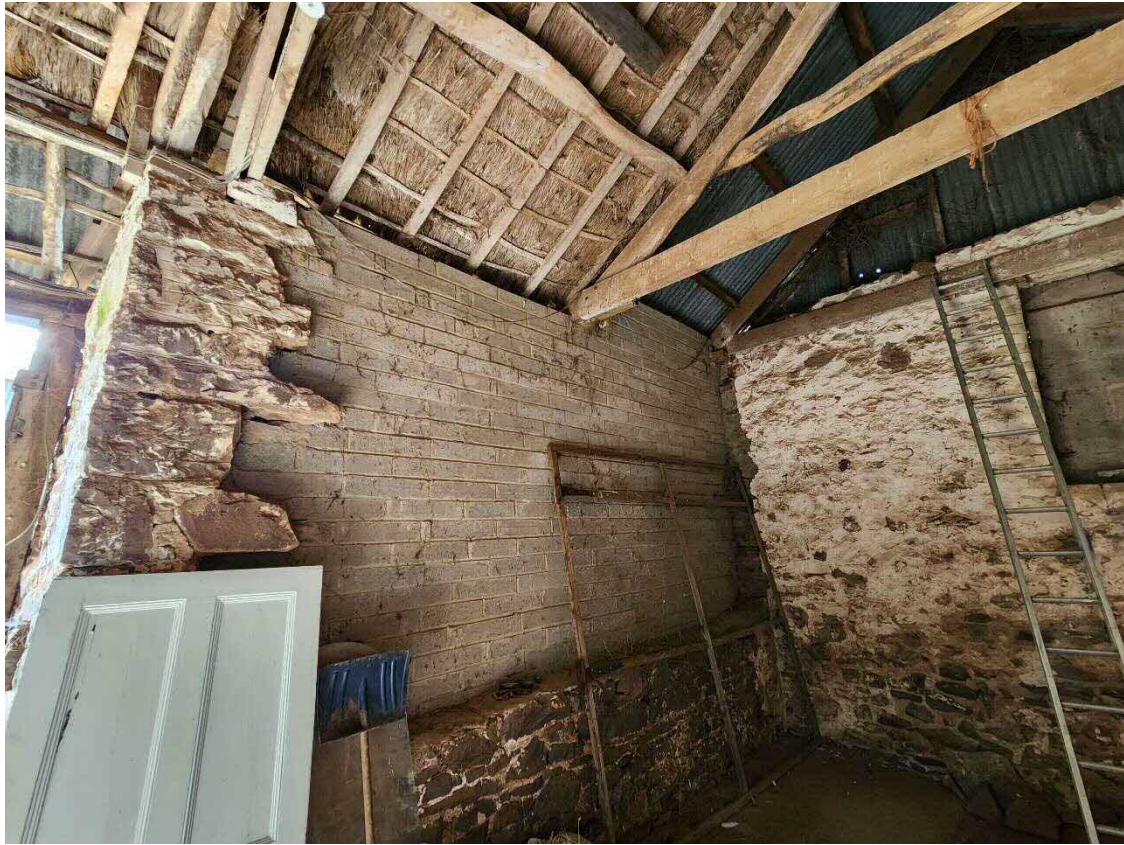
The principal elevations are ~450mm thick throughout, built from local rubble stone with a pink-hued lime mortar. A section of the South Western elevation, nearest the North Western gable appears to have collapsed previously and been rebuilt in block on flat with a brick quoin detail tying the two constructions.

Above: Block on flat infill and stone wall construction internally.

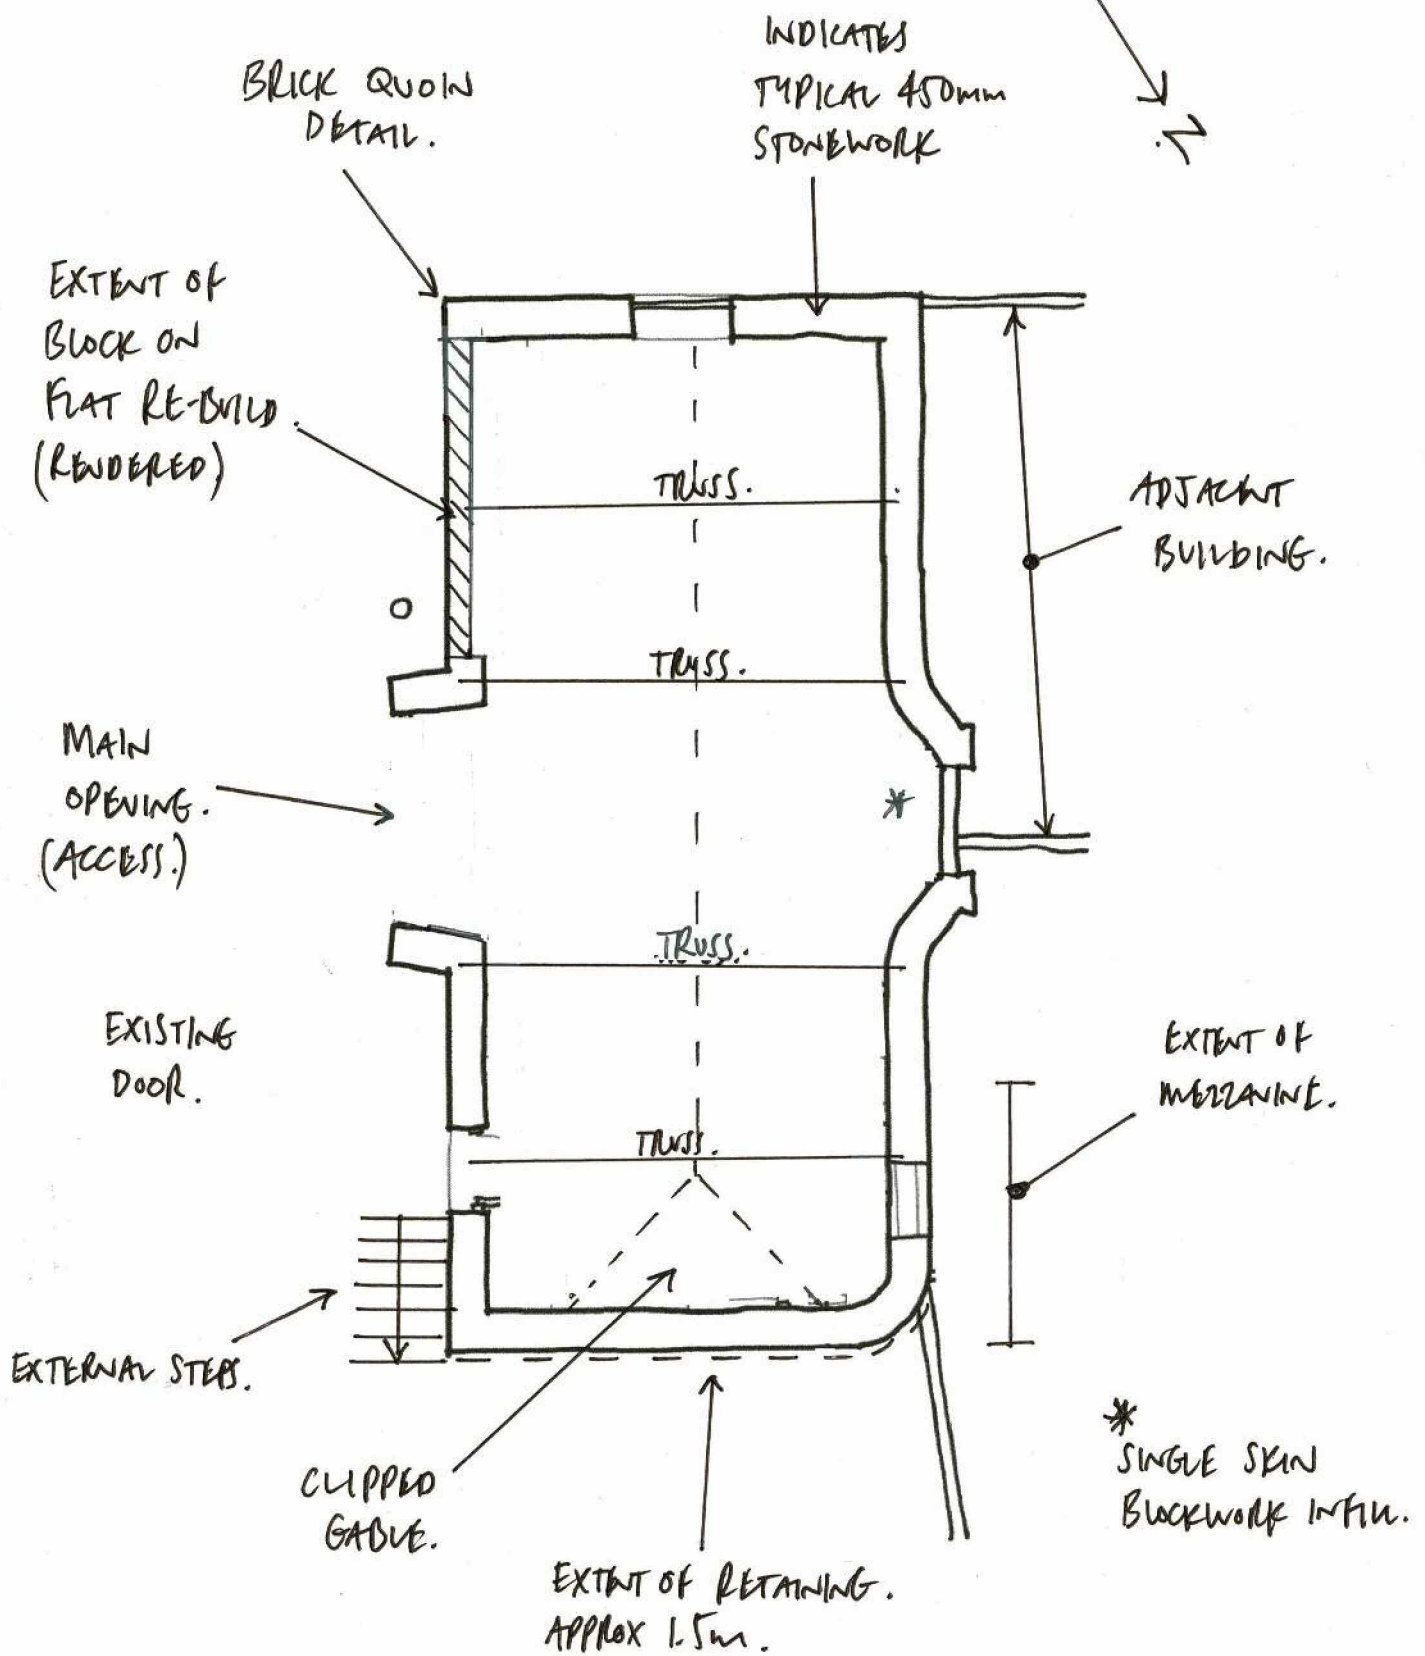
K0133/SK01.

EXISTING STRUCTURE - OLD THRESHING BARN.
