A
LISTED BUILDING ASSESSMENT
for
SOUTH MUNDHAM HOUSE

MAY 2019
AMENDED JANUARY 2024

This Listed Building Assessment has been prepared on behalf of Mr and Mrs David Evans and their advisers, the Douglas Briggs Partnership, in order to inform and advise discussions with the Local Planning Authority and for submission in support of applications for Planning Permission and Listed Building Consent, to alter and extend the property known as South Mundham House. Its purpose is primarily to establish the form and dates of construction and alteration of the building, which is Listed at Grade II*, and to assess the current proposals against the significance of the house as a Listed building and as a heritage asset.

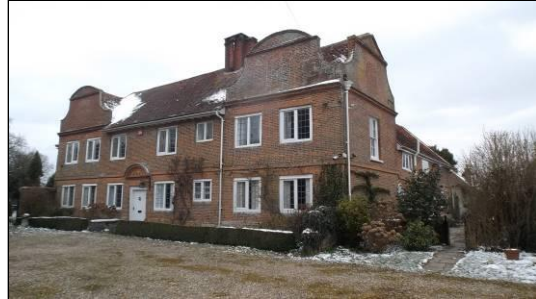
This is a mostly two-storey dwelling, with some single-storey elements under catside roofs, and with one, now abandoned, room in the attic. It is constructed of brick and stone, with one elevation now part tile-hung and part rendered. The roofs are mostly pitched and tiled, with both gabled and half-hipped ends, supporting three chimney stacks and a fourth externally at the south end.

South Mundham House, from the north-east.

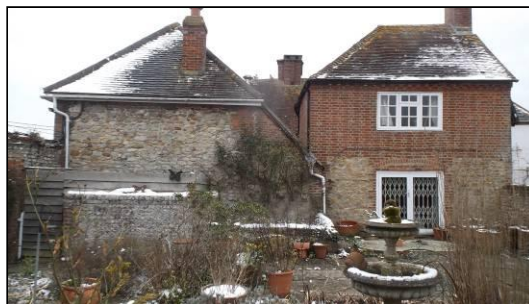
South Mundham House, from west.

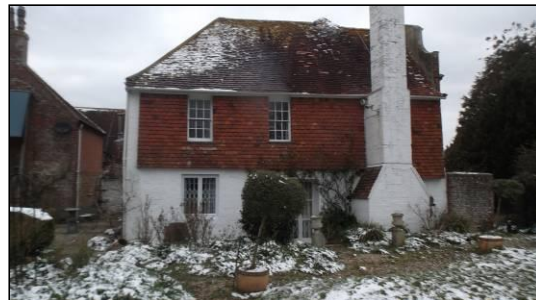
South Mundham House, from south.

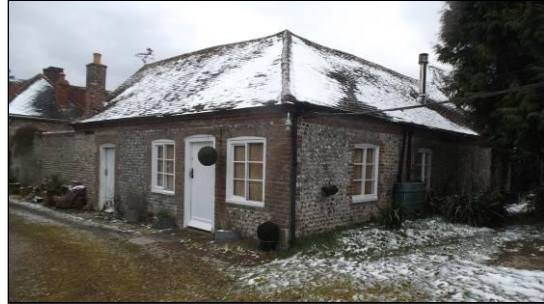
The former dairy, from the north-west.

The former dairy was depicted on the 1847 Tithe Map and on all editions of the of the Ordnance Survey plans and probably dates to the late eighteenth or early nineteenth century.

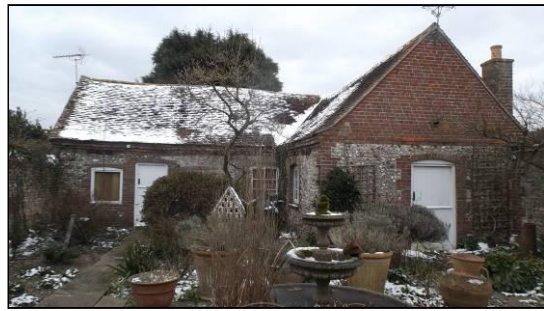
The former dairy, from the east

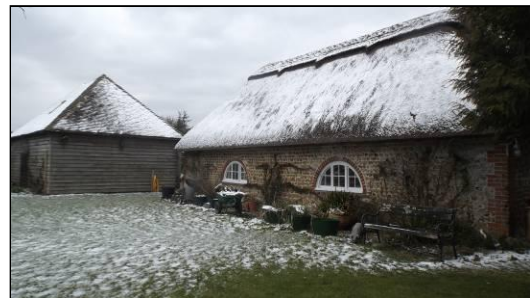
The is a rectangular building of stone with brick dressings, under a thatched roof that is hipped at either end.

The barn, from the south-east.

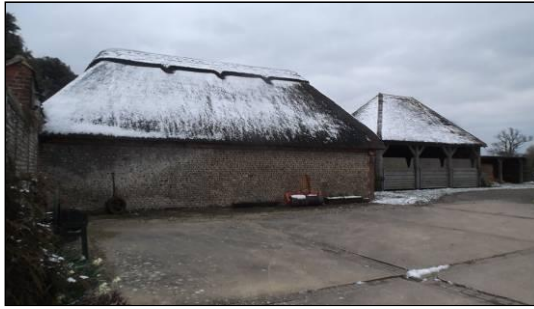
The barn, from the north-east.

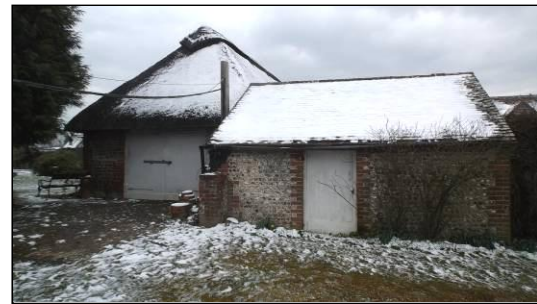
This is a small shed built up against the external face of the farmyard wall, through which it can be accessed via a door (see p-q below). It is built of flint with brick dressings under a single-slope roof of tiles.

The shed, from the east.

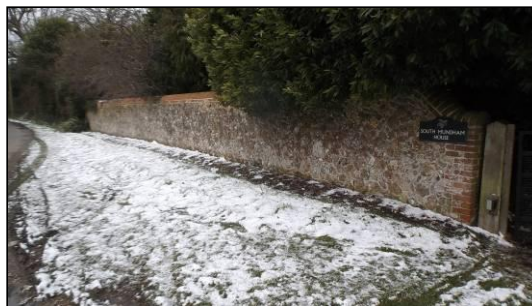
A length of stone wall with brick dressings and copings, about one metre in height, forming the boundary of the property on the road frontage. It probably dates to the nineteenth century.

The boundary wall (a-b), from the north-east.

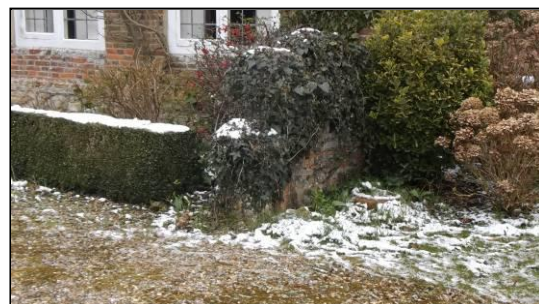
A short length of stone and brick wall, less than one metre in height, abutting the north-east corner of the house. Possibly a remnant of a longer nineteenth century wall shown on the 1847 Tithe Map and the Ordnance Survey plan of 1875.

The garden wall (c), from the north-east.

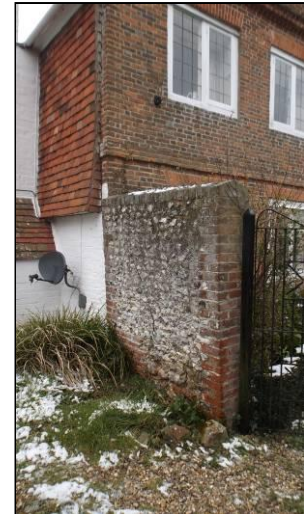
A short length of stone and brick wall, a little less than two metres in height, abutting the south-east corner of the house. Possibly a remnant of a longer nineteenth century wall shown on the 1847 Tithe Map and the Ordnance Survey plan of 1875.

*The garden wall (d),
from the south-east.*

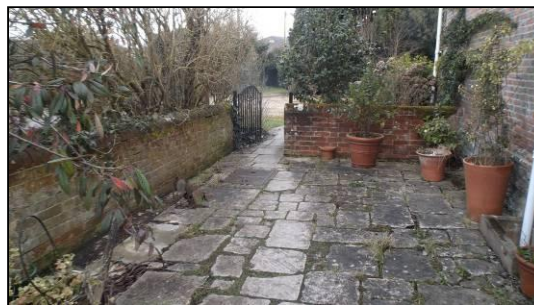
A length of brick wall and coping, a little under one metre in height, extending near parallel to and about 3.6 metres from the north side of the house, enclosing a paved area. It seems to have been depicted on the 1847 Tithe Map and on the Ordnance Survey plan of 1875 and probably dates to the first half of the nineteenth century.

*The garden wall (e-f),
from the west.*

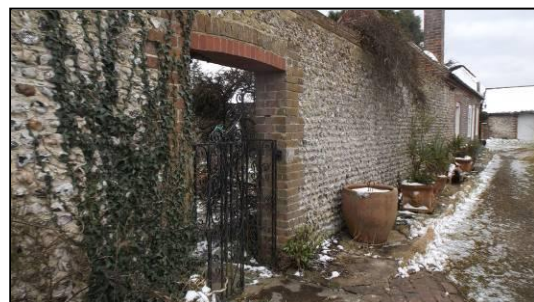
A length of flint wall with brick dressings and coping, about two metres in height, extending from the north-west corner of the house to the dairy (B), and containing an arched opening and gate near its east end. It provided access to a small walled garden.

*The garden wall (g-h),
looking west.*

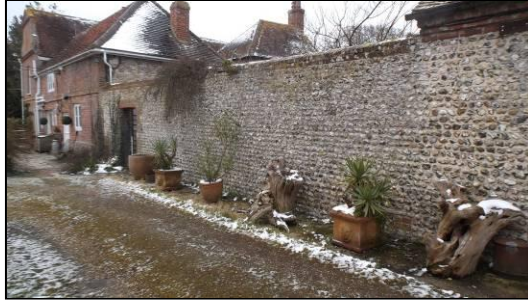
*The garden wall (g-h),
looking east.*

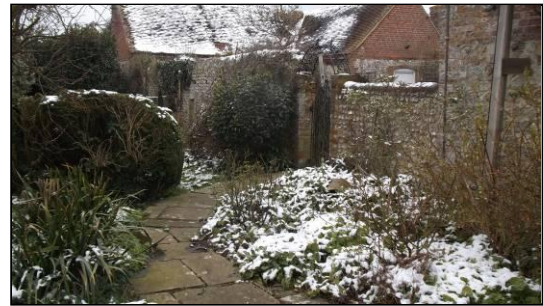
A length of flint wall with brick dressings and coping, up to a little under two metres in height, extending from the south-west corner of the house to the dairy (B), and containing an opening and gate towards its east end. It provided access to a small walled garden. It was depicted on the 1847 Tithe Map and the Ordnance Survey plan of 1875 and probably dates to the first part of the nineteenth century.

*The garden wall (j-k),
looking west.*

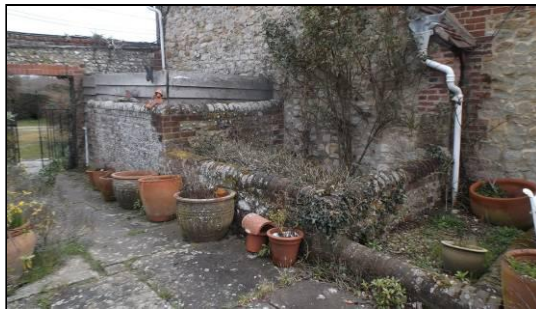
A group of low walls of flint with brick dressings and copings, of varying heights, attached to the west end of the house, being perhaps the remains of three raised beds and/or compost yards.

*The garden walls (l),
from the south-west.*

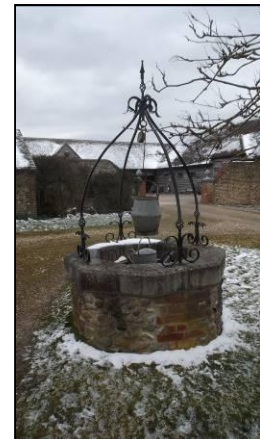
An octagonal well head of brick, flint and stone, with an ornamental iron support for a rope and bucket. This was shown as a P[ump] on the Ordnance Survey plans of 1875 and 1896.

The well head, from the east.

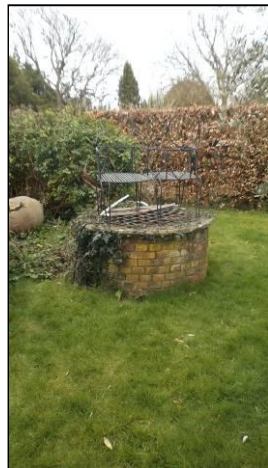
A circular well head of yellow bricks, with an iron grate over the top. It was not depicted on any of the old plans examined.

The well head, from the east.

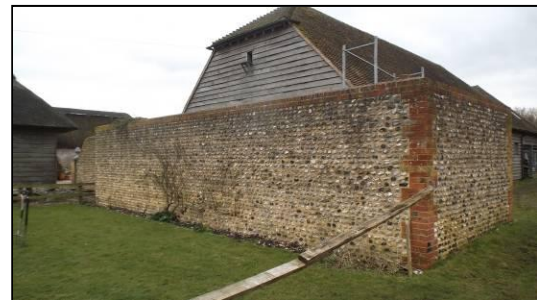
Two sections of farmyard wall, up to about two metres in height, built of flint with brick dressings and copings, with a pair of brick pillars forming the entrance into the former farmyard. It was not depicted on the 1847 Tithe Map but was included on the Ordnance Survey plan of 1875 and probably dates to about 1860. It contains the blocked door to the shed (D) at its south end where it abuts the barn (C).

The north end of the farmyard wall, from the north-east.

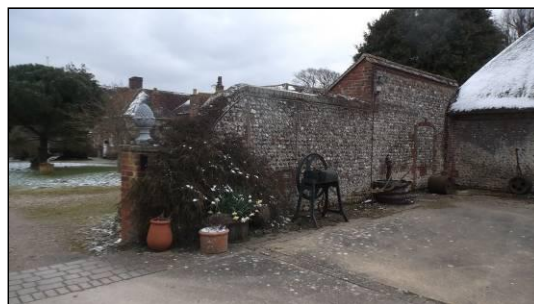
The south end of the farmyard wall, from the north-west.

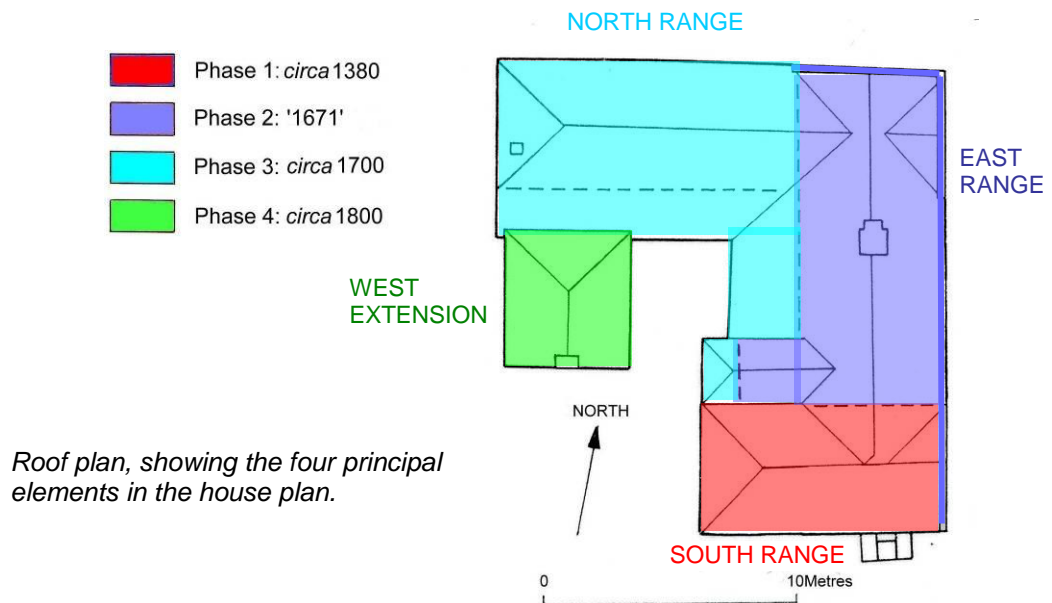
For the purposes of the assessment the four principal elements in the plan of the house are described as a *south range* (Phase 1); an *east range* (Phase 2); a *north range* (Phase 3); and a *west extension* (Phase 4) – each phase being colour-coded on the floor plans.

Roof plan, showing the four principal elements in the house plan.

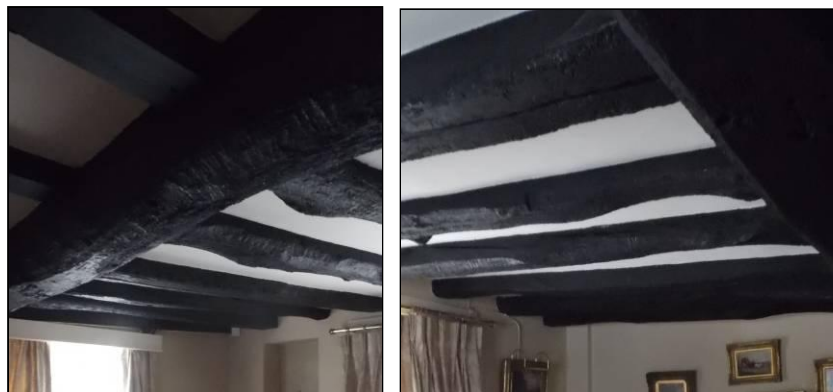
On its west side the beam supports nine floor joists, laid flat (ie not on edge) and these are secured by round pegs in square holes visible on the underside of the beam.

The floor beam and joists, looking south-west (above left) and looking north-west (above right).

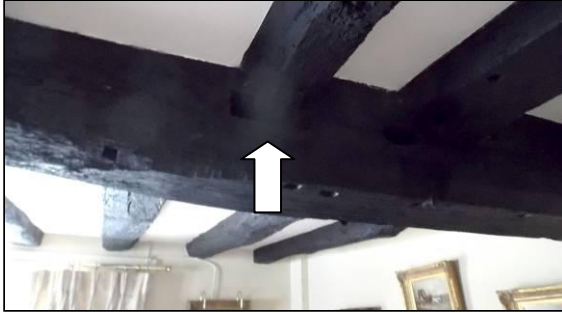
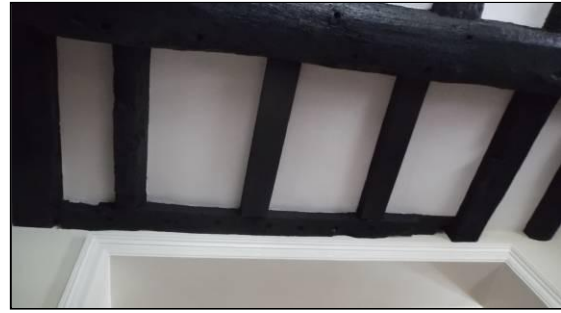
The opening was later in-filled, presumably when the later (Phase 2) partition wall was built, by the insertion of a three smaller timbers, one inserted in a re-used mortice and the other two not morticed into the beam. They were supported at their eastern end by a re-cycled timber, with a row of drilled holes in its underside, set in the later (Phase 2) wall.

The re-used mortice (arrowed - above left) and the inserted timbers, looking east (above right).

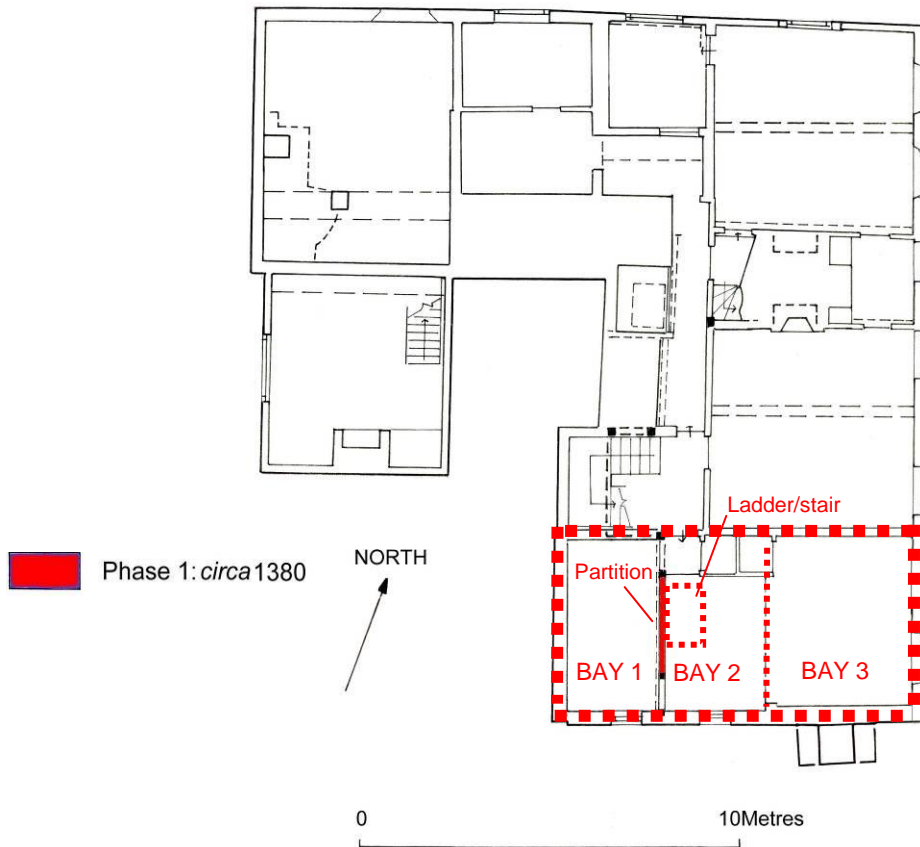
There are the remains of a partition, above the floor beam below, comprising a pair of end posts, both with expanded, or *jowled* heads, and two intermediate posts which may originally have formed door openings at either end, that at the north end still in use. They support a partially exposed tie beam in the ceiling.

First floor plan, showing the arrangement of the original (Phase 1) dwelling (red). Scale 1:200.

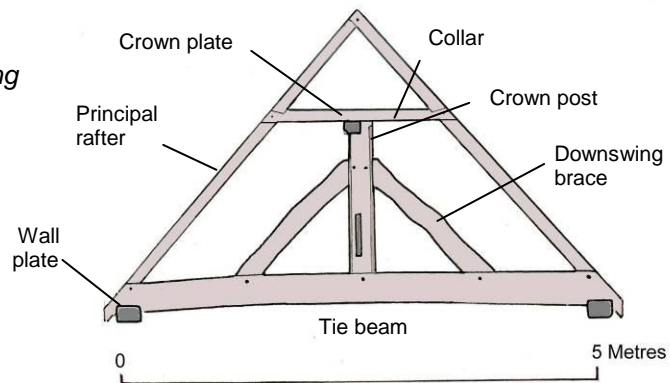
Truss 1, from the east, showing the component parts.

The *crown posts* are 1.48 metres tall, to the underside of a *crown plate*, and each measures 19 centimetres by 23 centimetres – the larger dimension being north-south on the line of the truss. They are chamfered on all four corners – on the south side these terminate at the top in a return to the chamfer on the *crown plate* (see below) and on the north side they terminate near the top in a *step stop*.

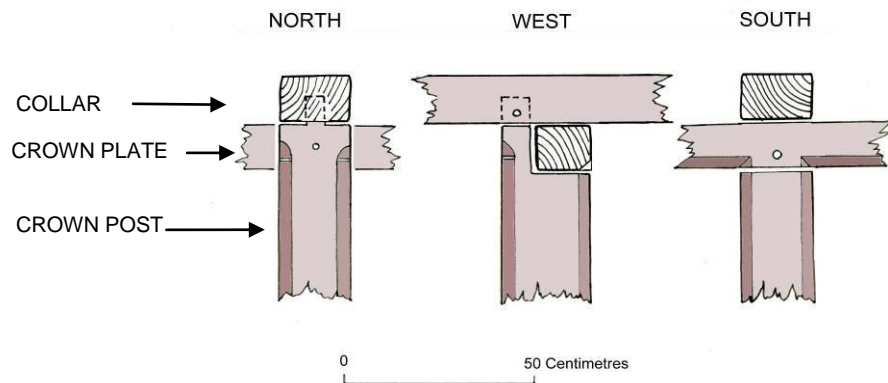
The posts are cut away at the top on the south side to provide a seating for a longitudinal timber, which extended the full length of the roof, and this is usually referred to as a *crown plate*, but sometimes as a *collar plate* or a *collar purlin*, and this is pegged into place from the north side.

The crown post/crown plate/collar assembly on Truss 2.

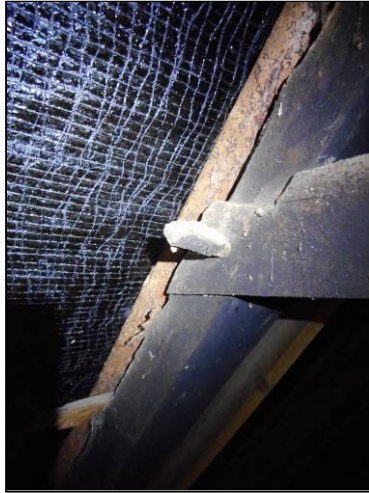
The *crown plate*, measuring about 13 centimetres by 16 centimetres and chamfered on its lower edges, supports the horizontal *collars*, each measuring on average about 13 centimetres by 18 centimetres, one on each truss, secured by a pegged tenon on the top of the post, and by pegged *dovetail halving joints*, also known as *bare-faced dovetail joints*, to *principal rafters* at each end, and others between them (see Bays 1 and 2).

The dovetail halving joint at the south end of Truss 2 (left) and a typical joint of this type (above).

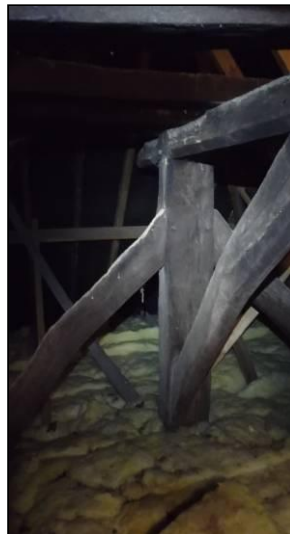
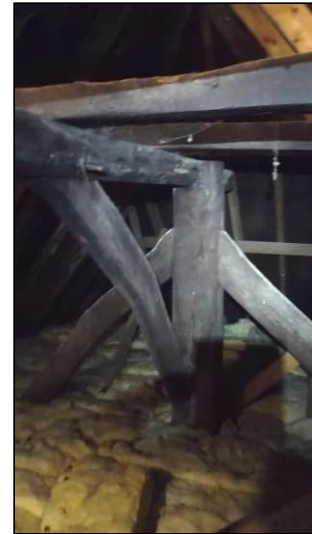
Truss 1, from the south-east (right) and from the north-east (far right).

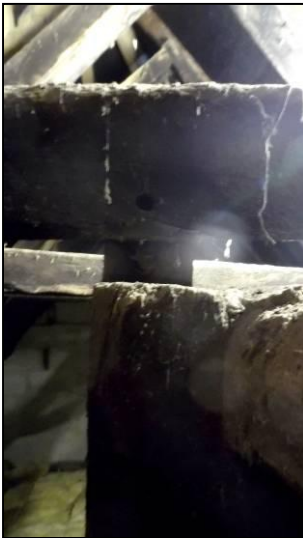
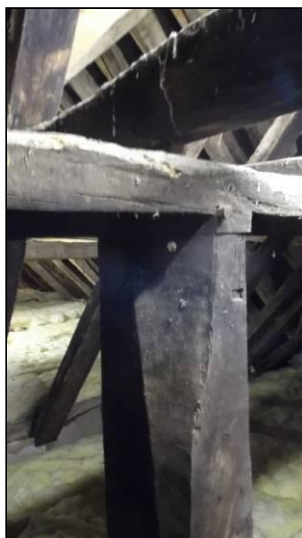
The top of the post on Truss 2, from the north-west - showing the seating for the crown plate and the pegged and tenoned collar (far left) and from the south-west, showing the seated crown plate (left).

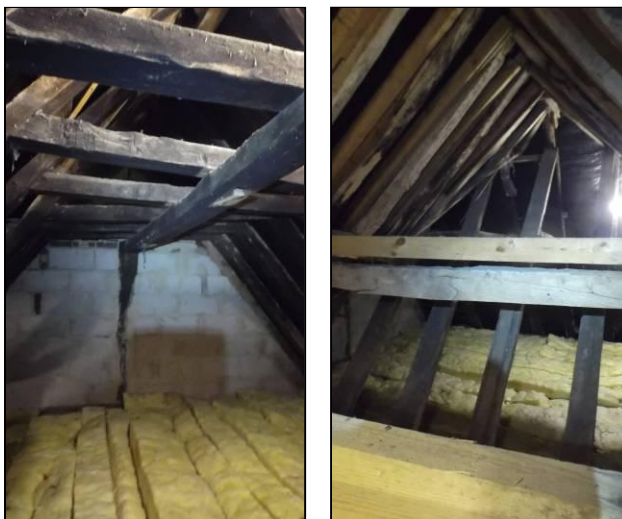
The post embedded in the east wall of the attic and the crown plate - both with redundant mortices (right) and the north face of Bay 3 from the adjoining attic space (far right).

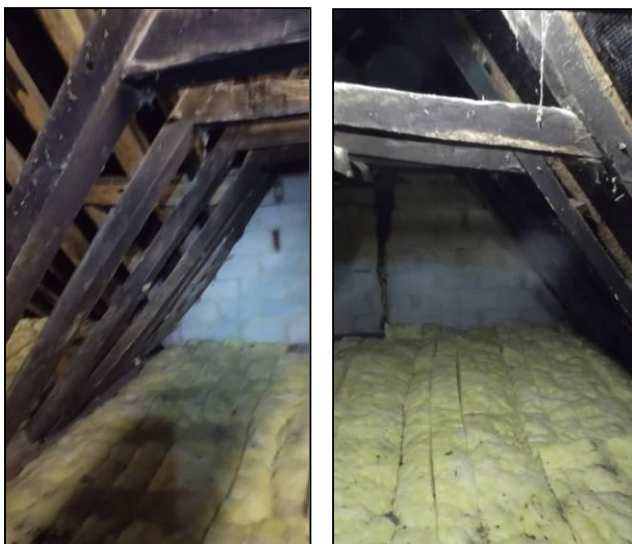
It is noted that all of the twelve pairs of original rafters on Trusses 1 and 2 and in Bays 2 and 3, which all descend to what may have been the original *wall plates*, survive and have been supplemented by additional members at later dates.

Looking east in Bay 3, showing some of the collars and rafters (far left and left).

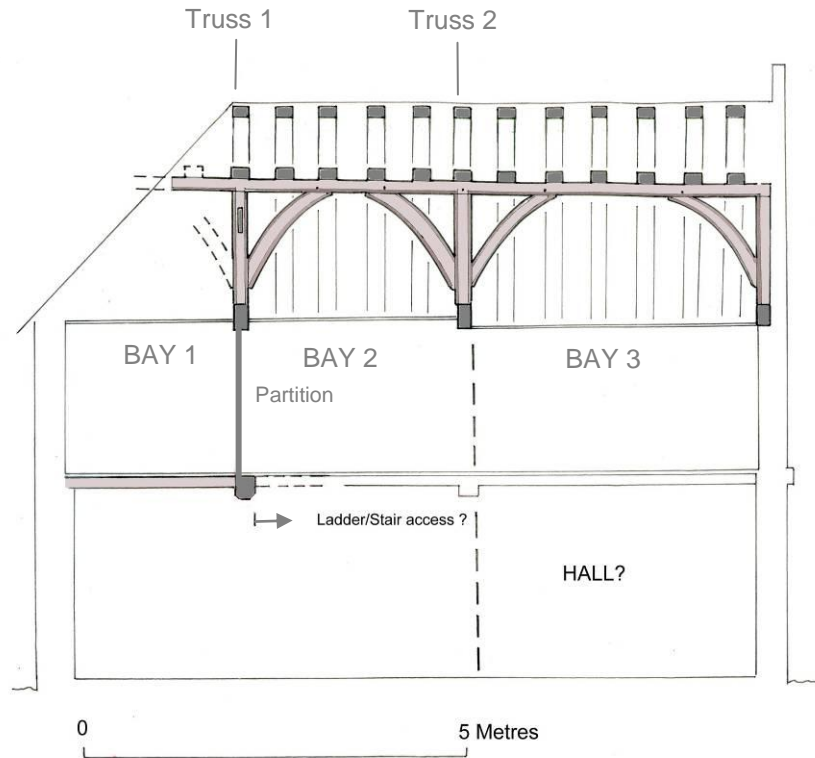
Most of the timbers in the attic show signs of soot-blackening or charring, but not excessively so, and may indicate the presence of an open hall in their vicinity.

*A partially reconstructed long section through the building, looking north, showing the surviving elements and those for which there is evidence.
Scale 1:100*

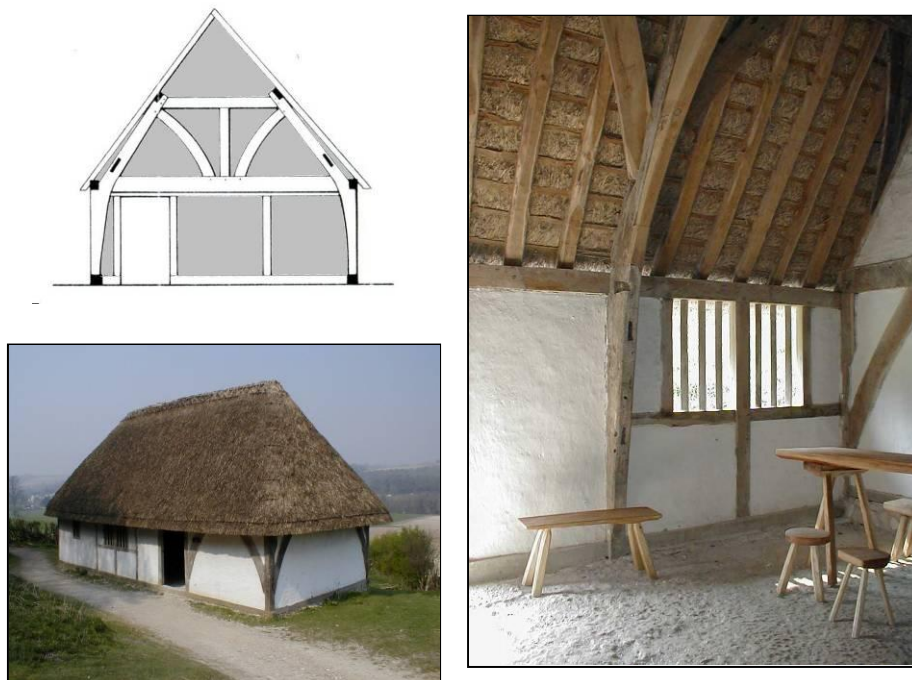
The first of these involved the employment of trusses formed of pairs of curved timbers known as 'crucks', which were seated on sill beams or stone foundations and joined or linked at the top to form a series of A-frames. The form is known from the beginning of the fourteenth century and continued to be employed through to the middle of the sixteenth century in central and southern England down into Hampshire, but it has not been recognised as far south-east as Sussex.

A section through a cruck building, with wattle-and-daub panels infill panels coloured grey (top left) and the house from Boarhunt (above left and right).

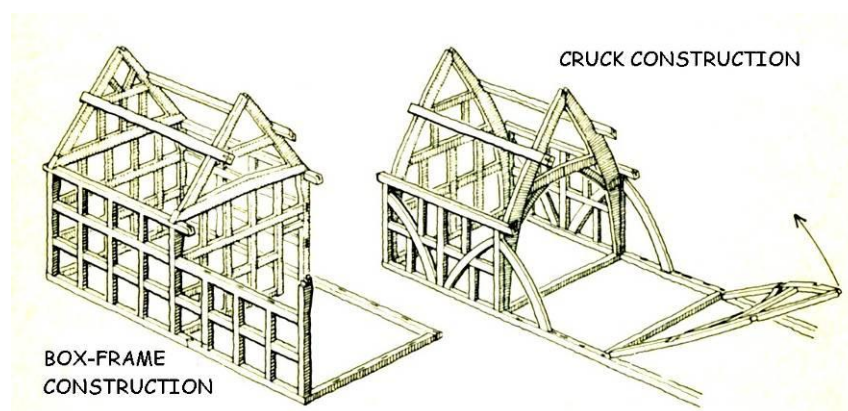
Box-frame and cruck construction.

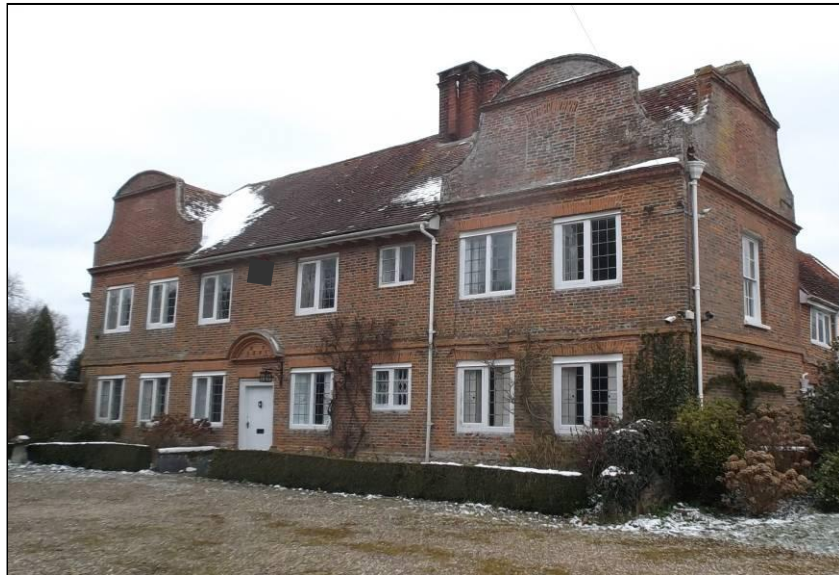
The new extension was aligned north-south and measured about 18.3 metres in length by 5.7 metres, in width, partially encasing the east end of the original (Phase 1) dwelling at its south end. It was about 5 metres in height to the eaves.

The east range from the north-east.

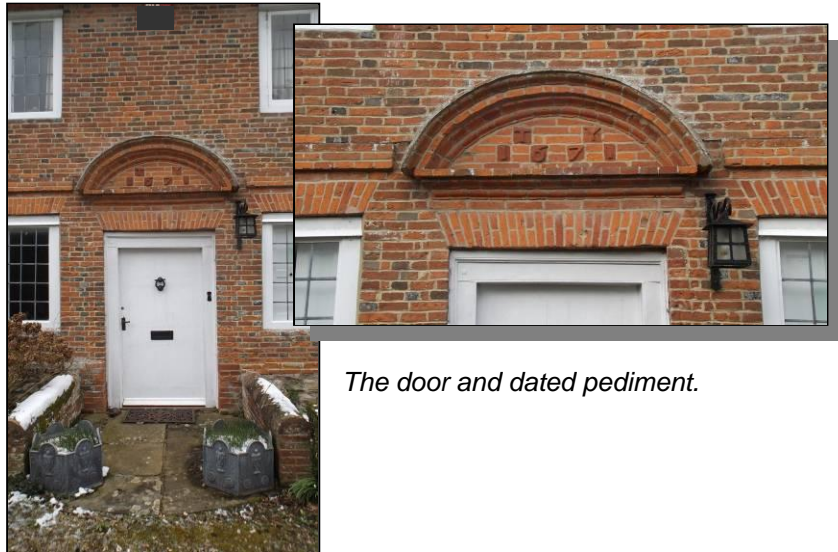
At ground floor level there is doorway located a little south of centre and this has a flat head formed of bricks on end. Above this is a projecting segmental brick pediment, formed of moulded or cut bricks, containing a brick panel and the carved letters 'T Y' for Thomas Young and the date '1671'.

The door and dated pediment.

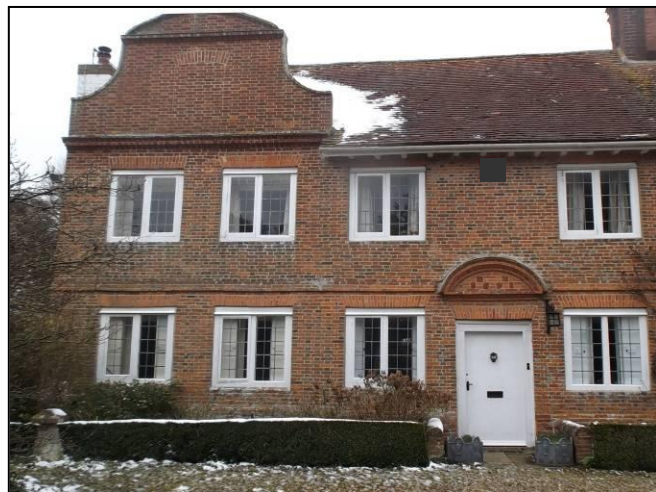
The southern part of the east elevation.

Above the two southernmost windows there is a projecting three-course string of moulded bricks supporting a Dutch gable of bricks with a curved brick pediment. It is understood that this was damaged during a gale in 1980 and was subsequently re-built and, seemingly, backed by blockwork internally. It contains a false window opening formed by a segmental head of bricks with the jambs apparently only marked on the surface. It is noted that this cannot have contained an original window as the original (Phase 1) crown post survives internally.

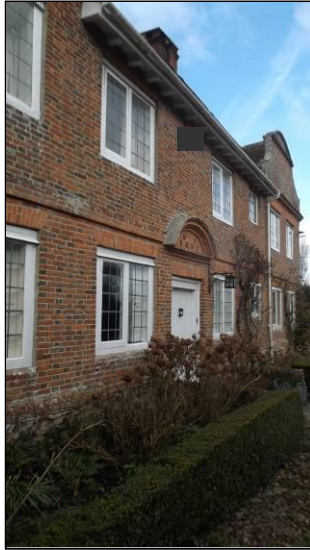
Between this Dutch gable and that at the north end, there is a projecting eaves supported on wooden brackets.

The projecting eaves on the east elevation.

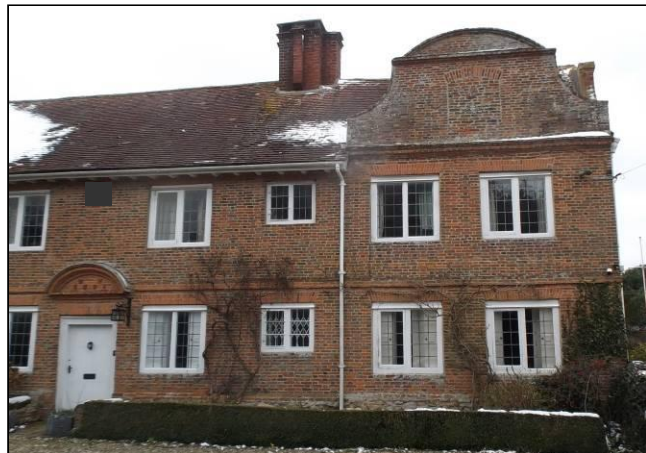
Above the two northernmost windows there is a projecting three-course string of moulded bricks supporting a Dutch gable of bricks with a curved brick pediment, like that at the south end. This contains an original window opening, presumably designed to serve an attic room, but this is now blocked.

The northern part of the east elevation.

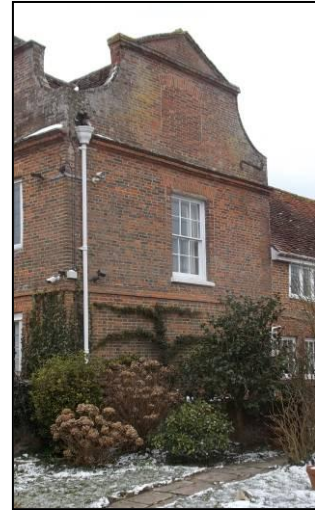
There is a window opening at first floor level which, in its original form, was identical in size to the larger ones on the east elevation, but the sill has subsequently been lowered and the opening reduced in width to provide a taller and slender opening.

The Dutch gable contains an original window opening, similar to that at the north end of the east elevation and presumably designed to serve the same attic room, but this is now also blocked.

The north elevation of the east range, from the north-east.

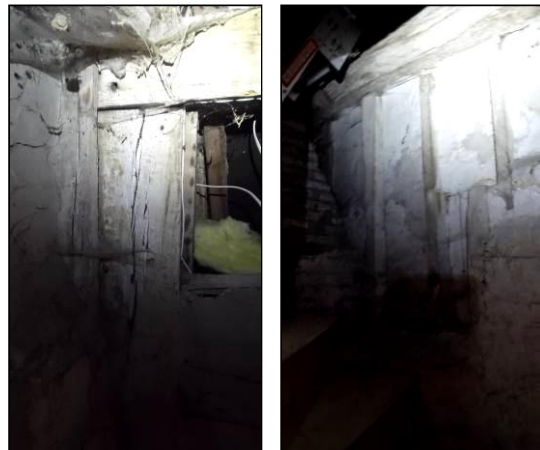
It is conceivable that whilst, the east range was mostly built of brick, the west wall and partitions adjacent to it may have been, like the stair turret, timber-framed, and there are surviving posts and elements of framing with lath-and-plaster infill at both ground and first floor levels which may support this suggestion.

Timber-framed elements in and adjacent to the west wall (right and far right).

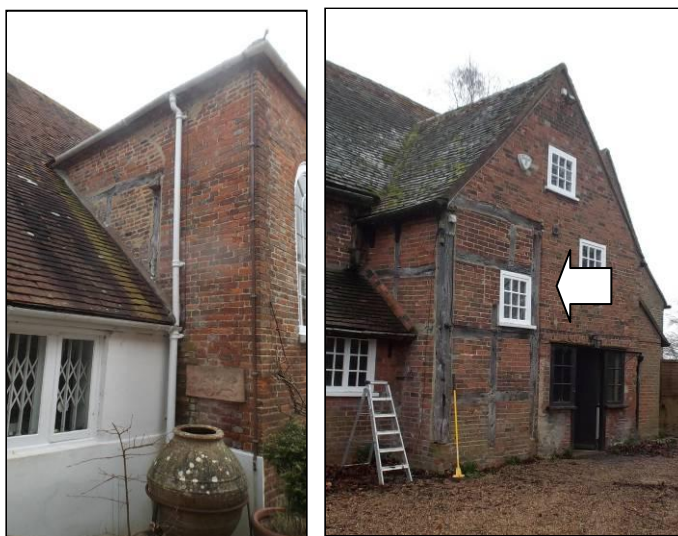
It was probably similar in form to the remains of a more-complete stair turret recently recorded at Pyrford, Surrey, and probably supported a pitched roof with a gable at its west end.

The remains of the stair turret at South Mundham (right) and the example at Pyrford (far right- arrowed).

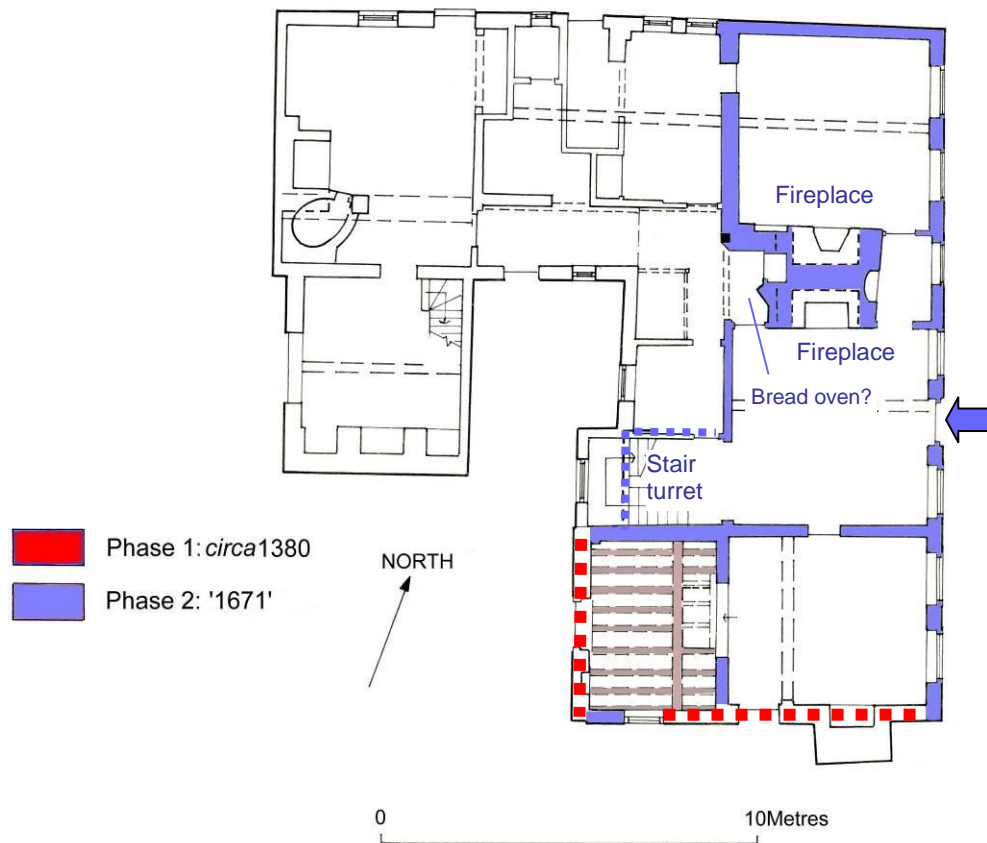
Ground floor plan, showing the arrangement of the extended (Phase 2) dwelling (dark blue). Scale 1:200.

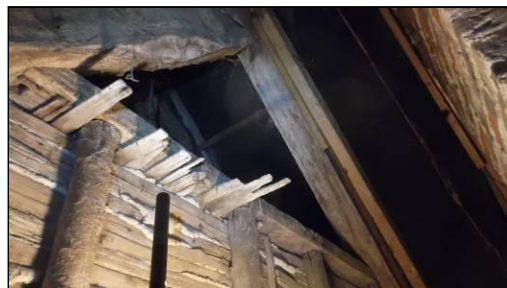
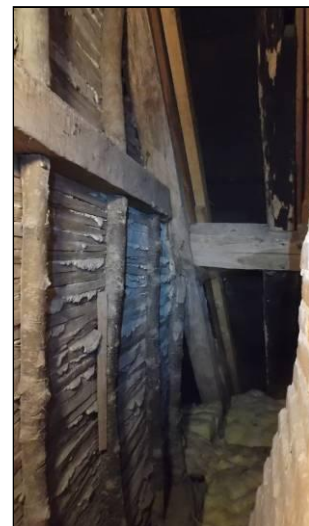
The single room at the north end, which has an old wooden plank door in its south west corner, measures about 5.2 metres by 3 metres internally and is formed by the north end wall of the house and by timber-framed partitions with a lath-and-plaster ceiling and similar partitions on the other three sides.

The south end of the lath-and-plaster ceiling (above) and the external face of the partition at the south end (right).

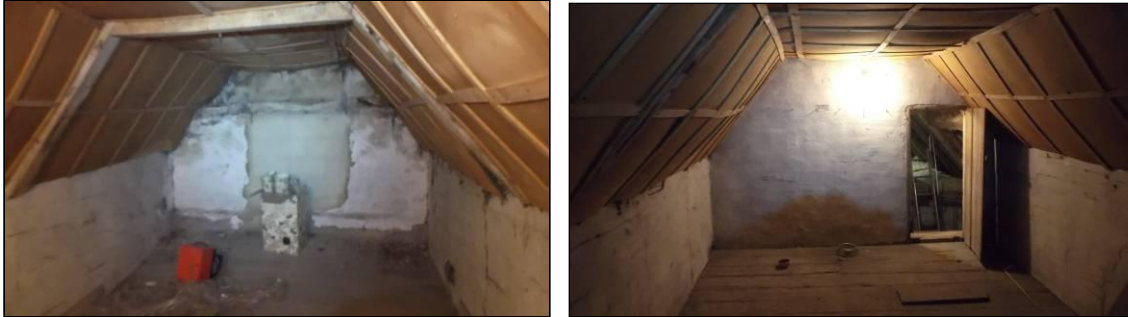
The windows in the Dutch gables on the north and east sides indicate that the room probably formed part of the original proposal and may have been intended only for storage, but both window openings have been blocked, and the ceiling has been boarded over and obscures the dormer for the window on the east side. The floor of the room is relatively wide wooden boards.

The second floor room, looking north (above left) and looking south (above right).

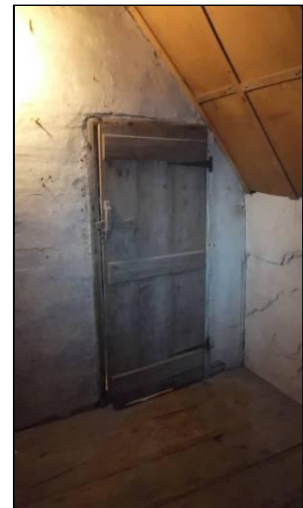
The plank door in the second floor room, from the north-east.

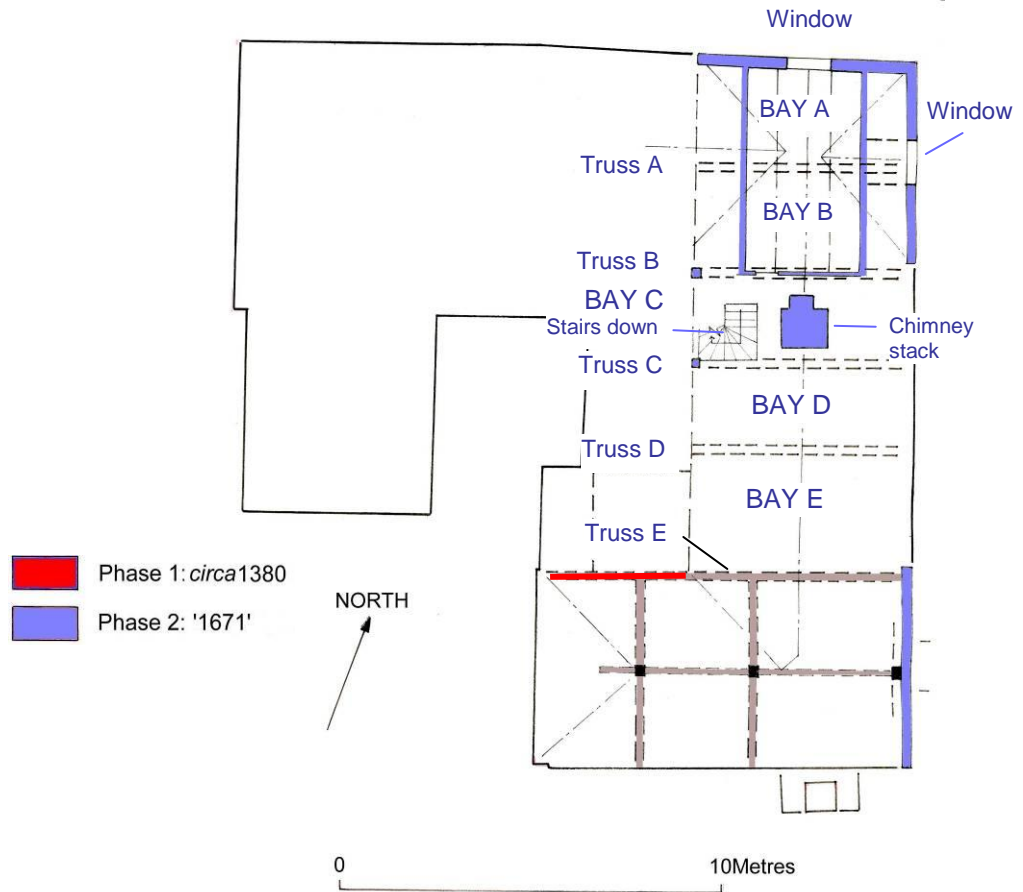
The collar in the northernmost truss (Truss A) , which is located within the room, has been removed from the principal rafters leaving redundant mortices exposed in the underside of the principal rafters. This would seem to indicate that the use of the space as a room was, perhaps to some extent, an afterthought with a replacement collar being nailed in place at a higher level to support the lath-and-plaster ceiling.

Second floor and attic plan, showing the arrangement of the extended (Phase 2) dwelling (dark blue). Scale 1:200.

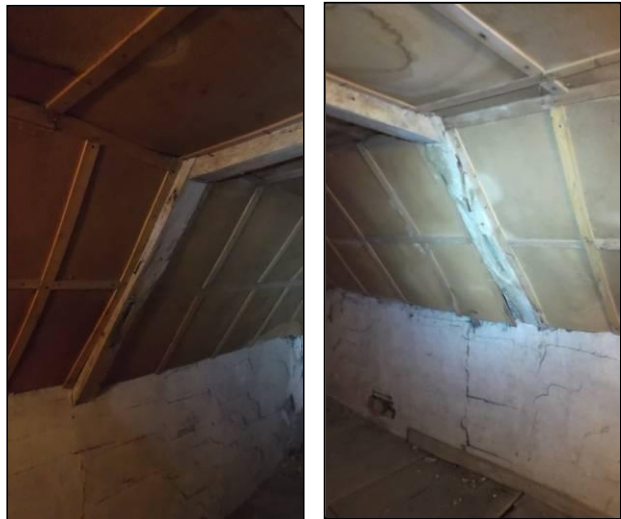
The principal rafters of Truss A, from the south, showing the redundant mortices in their undersides, and the replacement collar.

Truss B, which supports the lath-and-plaster partition forming the south wall of the room, has both its original collar, cut away on the underside for the head of the door opening, and a second collar nailed on at a higher level to support the ceiling.

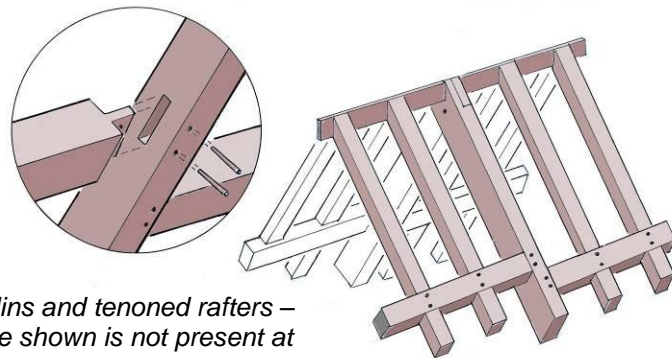
Staggered butt purlins and tenoned rafters – Note the ridge piece shown is not present at South Mundham.

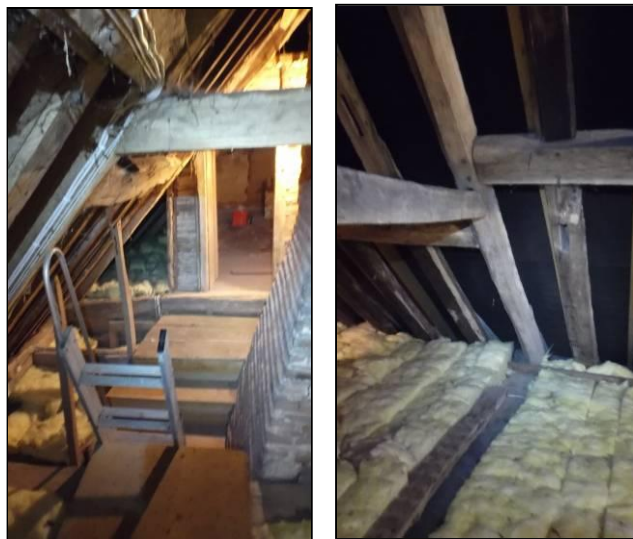
Some of the common rafters employed at South Mundham are recycled timbers, which are sooted and contain redundant mortices, and these may have been derived from an earlier east wing, perhaps with an open hall (see Phase 1) and there are some later replacements and insertions.

The two end assemblies on Truss C, looking north (right) and north-east (far right). Note the redundant mortice on the re-used timber employed as a rafter on the far right.

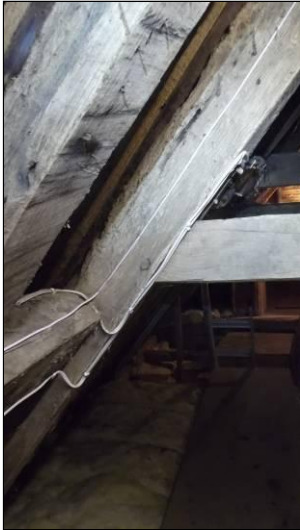
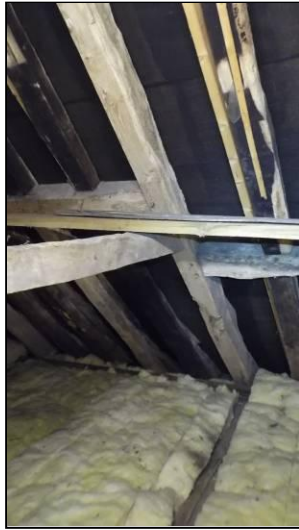
The two end assemblies on Truss D, looking north (far left) and north-east (left).

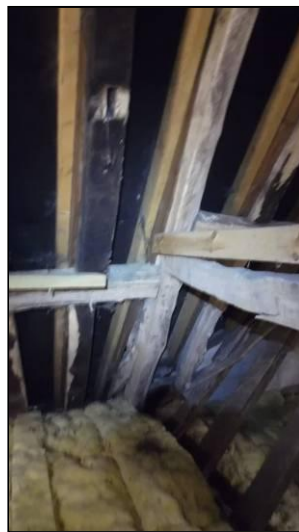
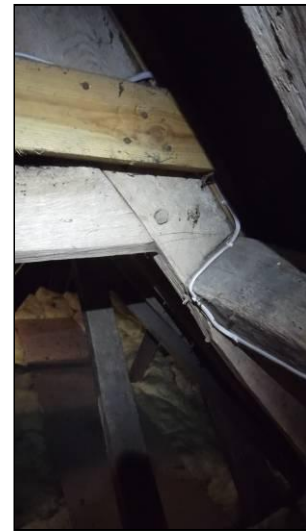
The two end assemblies on Truss E, looking south-east (right) and south (far right).

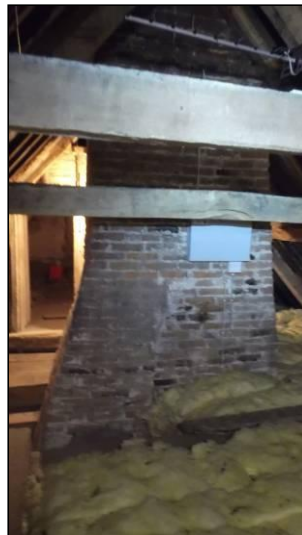
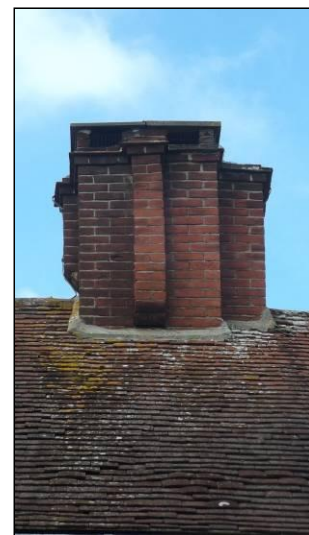
Within the roof space this can be seen to be constructed of relatively thin red bricks set in a lime-based mortar with some later repairs – each ten courses of brickwork giving a height of about 62 centimetres.

Externally it appears to have been either re-built or substantially repaired and re-pointed.

The chimney stack, internally from the south (right) and externally from the east (far right).

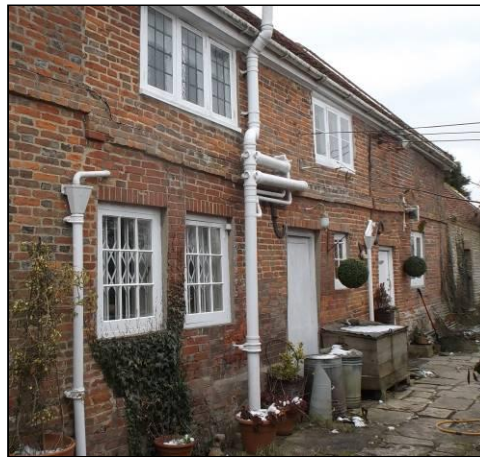
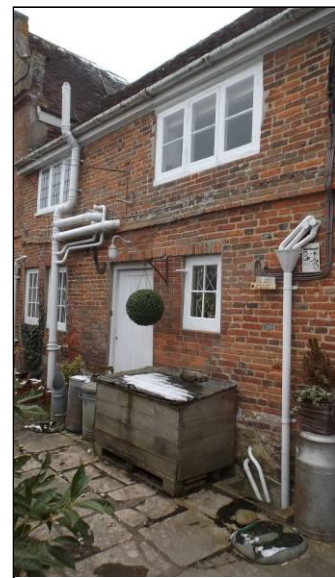
In its original form it had an offset plinth of brick and stone rising to between 63 and 75 centimetres above ground level. Above this the brickwork is similar to that in the earlier (Phase 2) structure, but not to the same standard or quality. The relatively thin red bricks and some blue/grey headers are laid in courses mostly of alternate headers and stretchers, but with no real attempt at Flemish bond and with ten courses of brickwork giving a wall height of about 60 centimetres.

The north elevation, from the north-east (above) and from the north-west (right).

It has a projecting string of three courses of bricks at first floor level, set three courses below that on the east range.

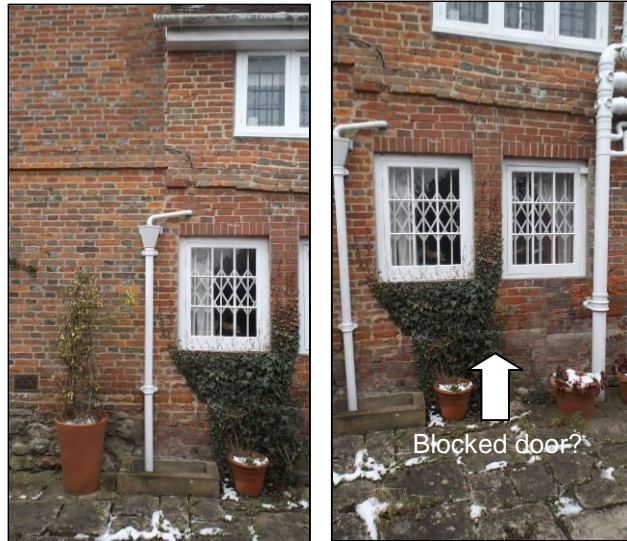
Where it abuts the existing (Phase 2) structure there is just the hint that the north wall of the east range may have extended a little to the west at ground floor level, but there is much re-pointing here and there was an attempt to course the new brickwork in with what was already existing.

The first two ground floor windows are later (perhaps Phase 5) insertions but they seem to have replaced an original opening, later blocked, which may have been a door.

The junction of the extension with the existing house (right) and the two inserted ground floor windows, showing the possible blocked door (far right).

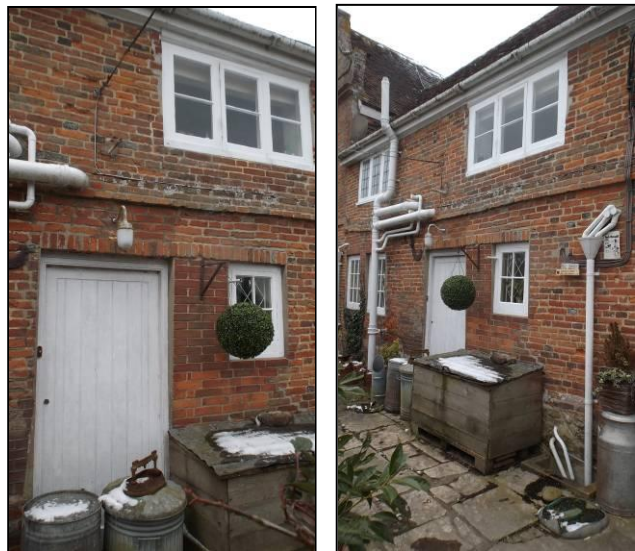
The first ground floor door opening and the small window to the west of it are both later insertions, perhaps of the nineteenth century, but above them there is a course of header bricks on edge, about 1.9 metres in length, which may have been the head of a larger opening, now blocked.

The first two window openings at first floor level are also later, perhaps nineteenth century insertions, their jambs having been cut through the original brickwork.

The inserted window and door openings at ground level and the two first floor windows above them (right and far right).

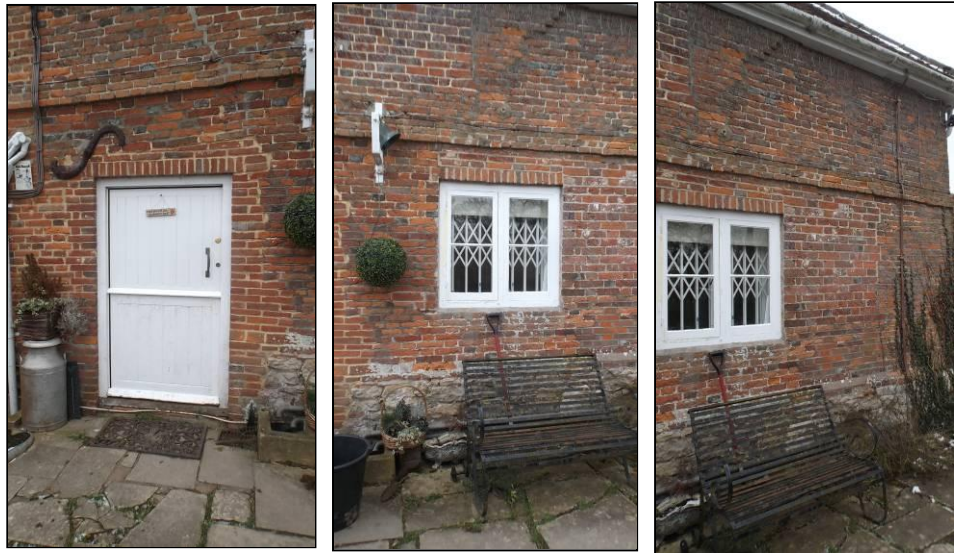
The second door opening, which currently contains a two-part stable door, is also a later (perhaps Phase 6) insertion and the brickwork indicates that it may have been inserted in the early part of the twentieth century. However, the ground floor window opening beyond it seems to have been an original feature, with queen closer bricks in its east jamb and with a flat head of header bricks on edge.

Beyond the window the original brickwork has been replaced for a distance of about one metre, employing larger bricks than the originals, and this included the reconstruction of the west jamb of the window to include queen closer bricks. Beyond this the wall survives in its original form to the north-west corner of the extension, with a plinth of stone and brick to a height of 75 centimetres and the string course at first floor level.

The inserted door opening with stable door (above left); the original window opening (above centre); and the partially re-built wall to the north-west corner (above right).
