A
LISTED BUILDING ASSESSMENT
for
SOUTH MUNDHAM HOUSE

MAY 2019
AMENDED JANUARY 2024

This Listed Building Assessment has been prepared on behalf of Mr and Mrs David Evans and their advisers, the Douglas Briggs Partnership, in order to inform and advise discussions with the Local Planning Authority and for submission in support of applications for Planning Permission and Listed Building Consent, to alter and extend the property known as South Mundham House. Its purpose is primarily to establish the form and dates of construction and alteration of the building, which is Listed at Grade II*, and to assess the current proposals against the significance of the house as a Listed building and as a heritage asset.

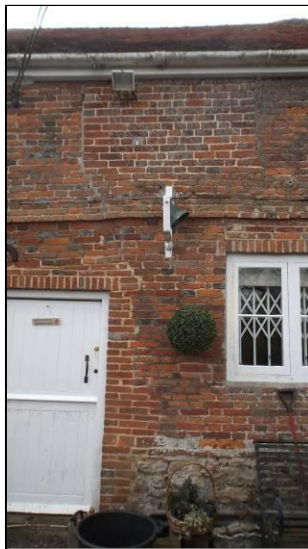
At first floor level above the stable door and window, is an original window opening which has been blocked, perhaps at a later (Phase 5) date. It has queen closer bricks in its east jamb and the opening was probably about 1.4 metres long in its original form. The blocked opening is visible internally and seems to have extended over a distance of 2.2 metres, which suggests that the jambs were splayed internally.

The blocked window opening over the stable door.

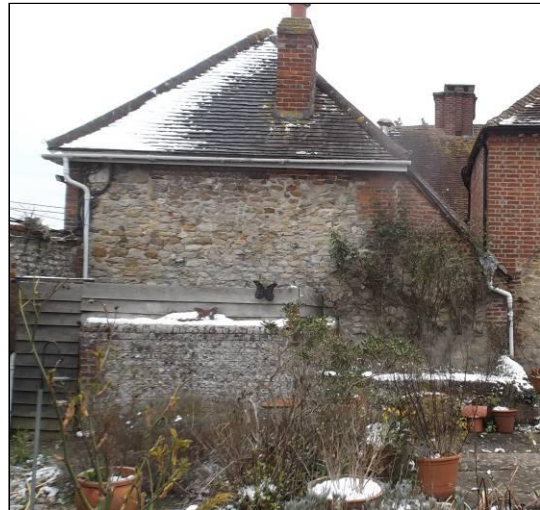
The north wall returns at its west end in a brick quoin. The west wall, which includes that forming the end of the single-storey element under a catslide roof, is constructed of lumps of local sandstone, not laid in courses, but with several courses of brickwork at the top and also forming the south-west quoin and part of the part-gable end above it.

There is no evidence to suggest that, in its original form, the wall extended up as a gable end or contained an integral chimney stack – the internal stack behind it being a later (Phase 5) insertion.

The west wall of the north range.

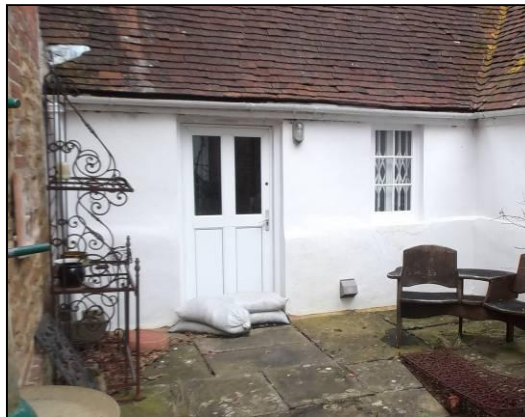
This formed the external wall of the single-storey element under a catslide roof and is partially obscured from view by the later (Phase 4) west extension.

It is now rendered and painted and contains one door opening and one window opening, and has an offset a little under one metre above ground level.

The south wall of the north range.

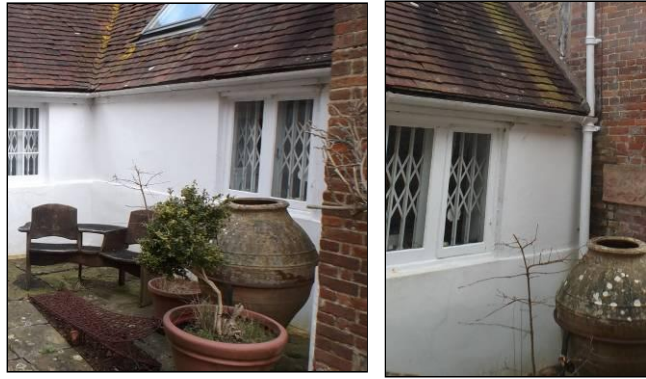
The external west wall of the passage extension is identical to that on the north range. It is also rendered and painted and contains one window opening, above an offset a little under one metre above ground level.

The west wall of the passage extension, looking north-east (right) and looking south-east (far right).

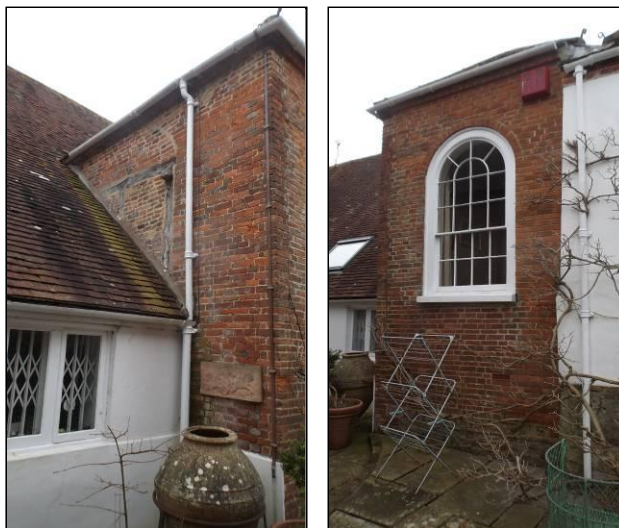
The roof was probably raised and converted to a hip at this time.

The stair turret extension, from the north-west (right) and from the south-west (far right).

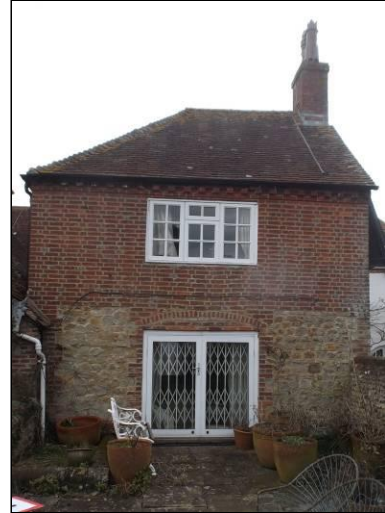
This has been partially re-built and heavily pointed with cement, to incorporate French doors at ground level and a large window above, neither of which are likely to be original features. It is difficult to be sure about its original form.

The ground floor elevation is of, mostly un-coursed, lumps of sandstone, with red brick quoins and surround to the door opening. The upper level is of red bricks laid in courses each comprising two stretchers and then one header, with the header bricks aligned vertically in alternate courses, and with ten courses of brickwork giving a wall height of 72 centimetres. It has a dentilled eaves course of projecting header bricks.

The west elevation of the west extension.

The new opening in the west side of the *west extension* would be created in a wall where there has been much alteration and repair/reconstruction in the recent past.

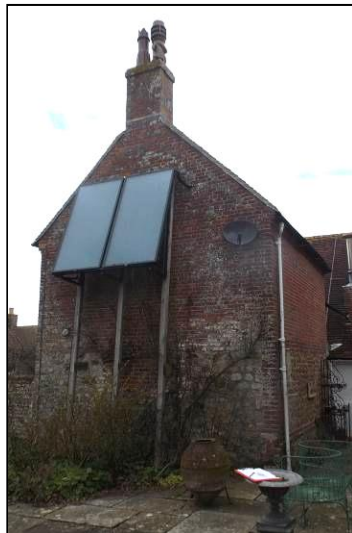
The ground floor level is, again, mostly of un-coursed lumps of sandstone but it has red brick quoins and the back of an integral chimney stack that is also of red bricks, in both cases with ten courses of brickwork giving a wall height of 72 centimetres.

The upper level, gable end and chimney stack are all of red bricks, partially laid in a similar style to those in the west wall. The east slope of the gable has been re-built at some stage.

The south elevation of the west extension.

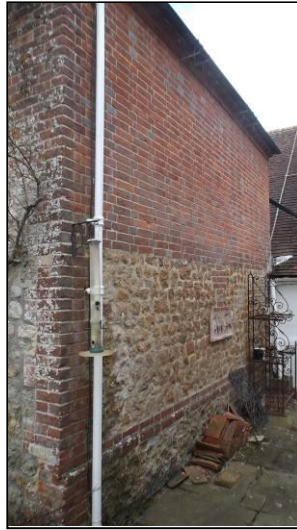
This has an offset plinth of stone, capped with a course of brickwork, rising to a height of about 60 centimetres above ground level. Above this the ground floor level has one course of bricks and then is constructed of very roughly coursed lumps of sandstone to a height of a little under two metres.

The upper level is of red bricks laid in courses each comprising two stretchers and then one header, with the header bricks aligned vertically in alternate courses, and with ten courses of brickwork giving a wall height of 72 centimetres. It has a dentilled eaves course of projecting header bricks.

The east elevation of the west extension, from the south-east.

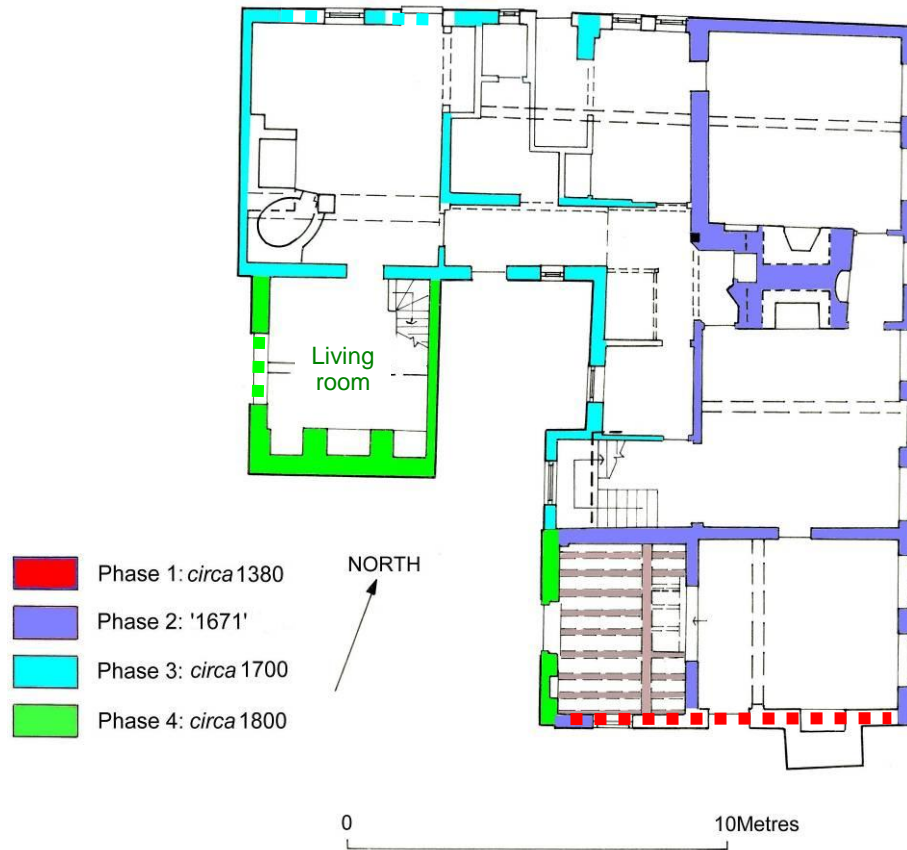
Ground floor plan, showing the arrangement of the extended (Phase 4) dwelling (green). Scale 1:200.

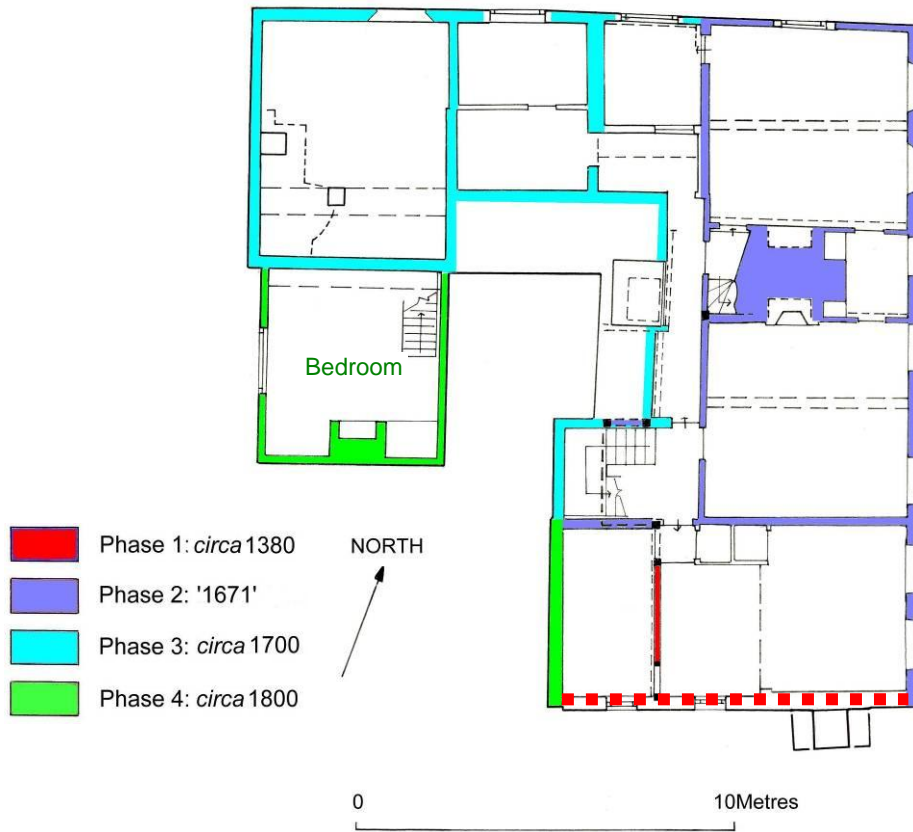
First floor plan, showing the arrangement of the extended (Phase 4) dwelling (green). Scale 1:200.

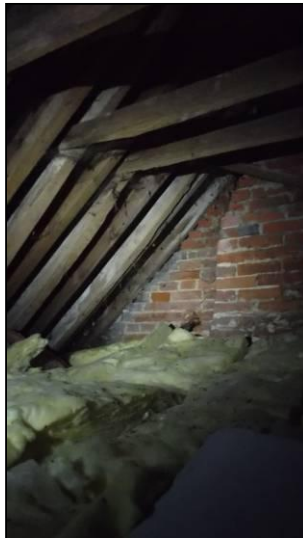
This is formed of pairs of softwood common rafters rising to a ridge piece with some collars nailed in place.

The roof of the west extension, looking south.

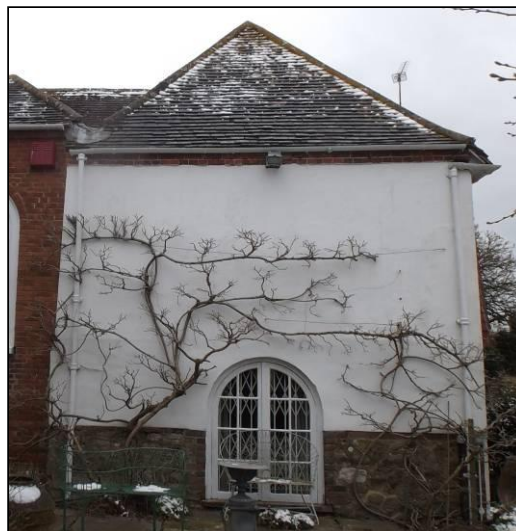
The lower part is of un-coursed lumps of sandstone topped by a single course of bricks and with brick quoins to a height of about 97 centimetres above ground level. Above this the wall is rendered and painted, with two courses of brickwork exposed and forming the top of the wall. It contains a round-headed opening with glazed French doors.

The bricks are indicative of a date in the first part of the nineteenth century.

The west wall of the south range.

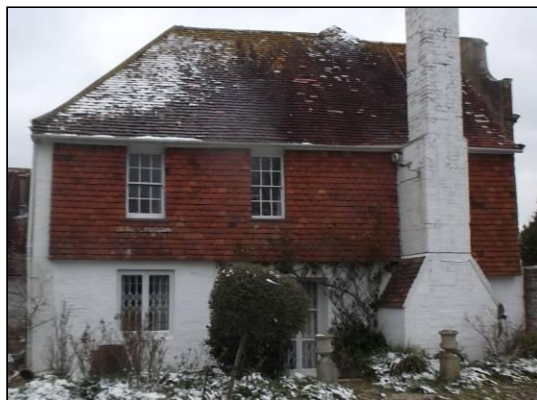
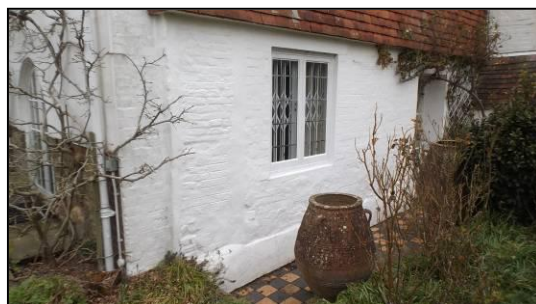
The substantial alterations to the south wall of the south range, which are partially obscured by paint at ground level, commenced about 50 centimetres from the south-west corner, where courses of earlier (Phase 2) brickwork, with ten courses of brick giving a wall height of 62 centimetres, were retained. The remainder of the wall was replaced; the French doors were inserted; and the external chimney stack was added, using larger bricks with ten courses giving a wall height of 75 centimetres, extending as far as the return of the east wall of the east range, which was retained. At first floor level the wall is tile-hung suggesting that it may obscure timber framing.

The south wall of the south range, from the south-west (above) where it abuts the end of the east wall (right).

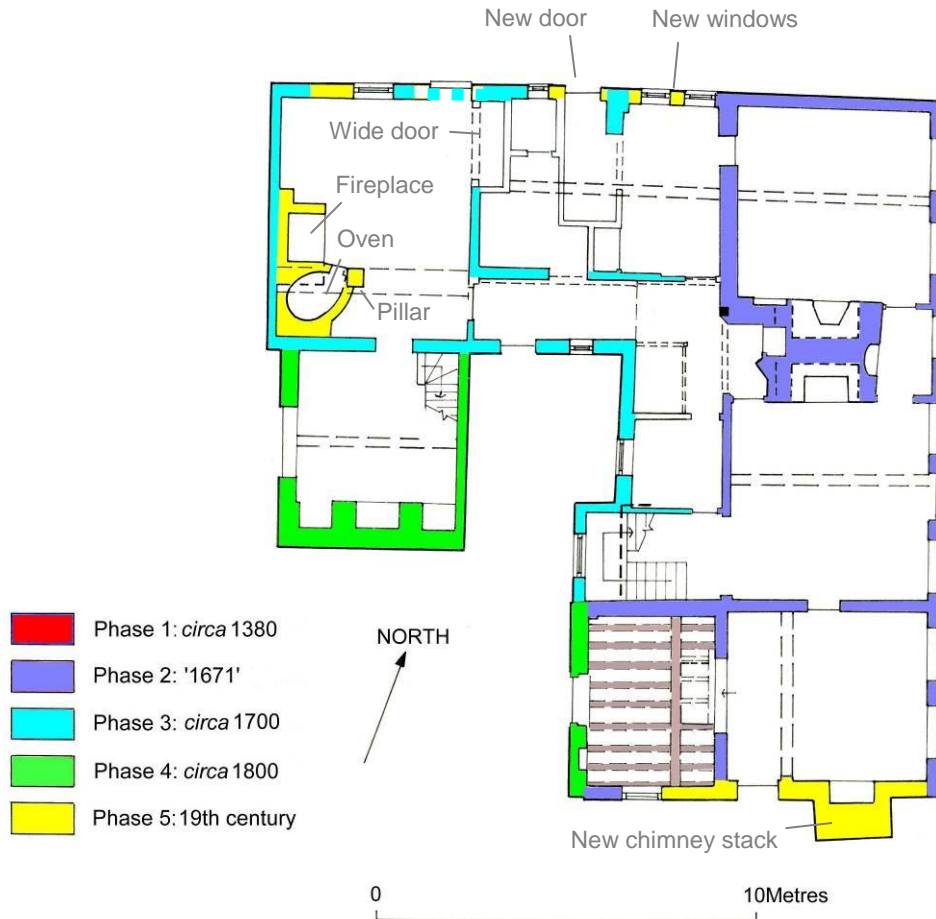
Ground floor plan, showing the Phase 5 alterations and additions (yellow).
Scale 1:200.

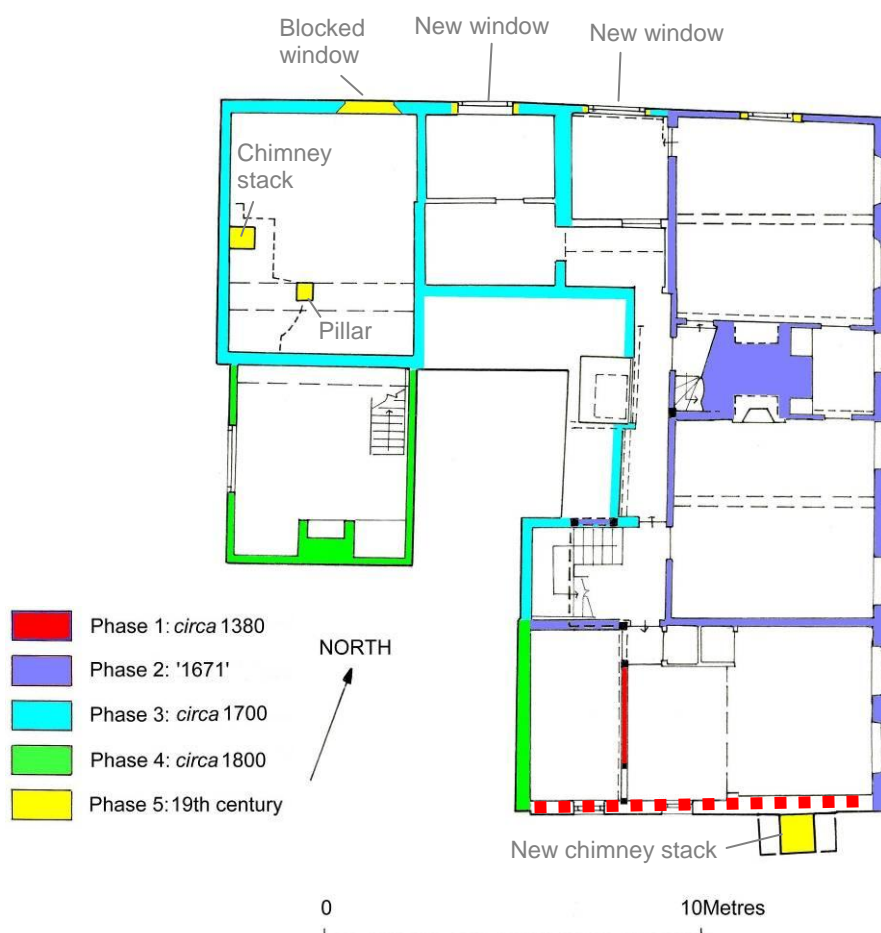
*First floor plan, showing the Phase 5 alterations and additions (yellow).
Scale 1:200.*

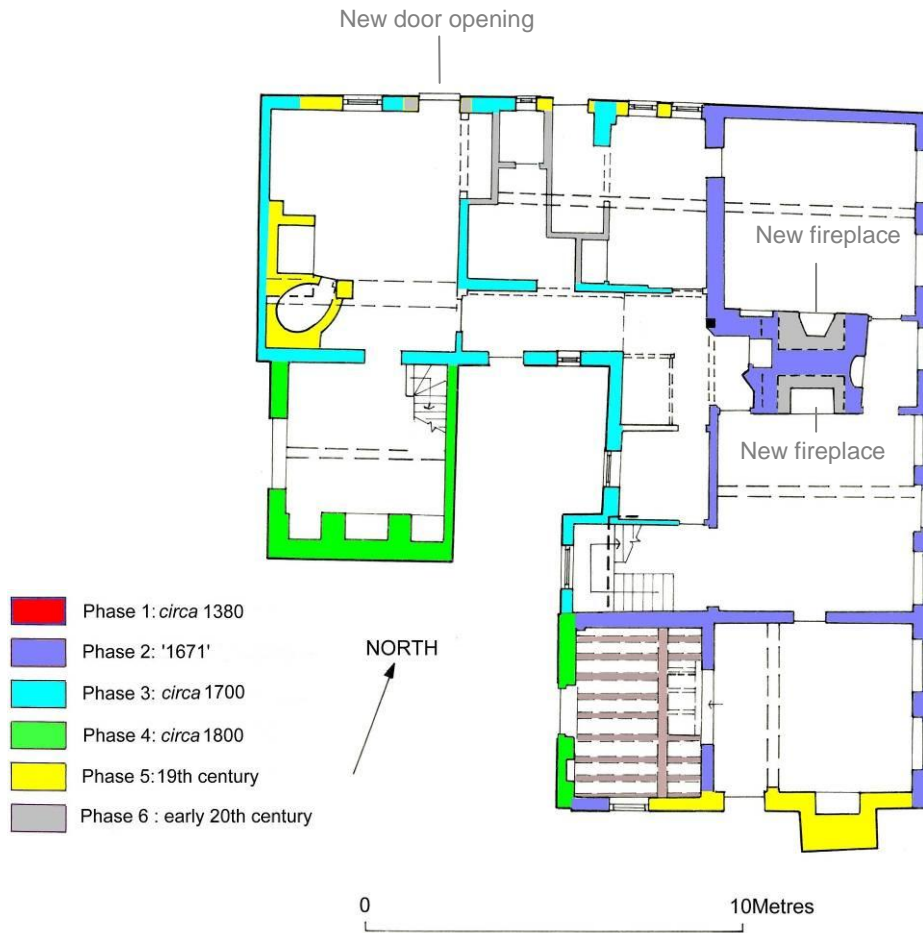
The new fireplaces at *ground floor level*, both presumably inserted into original (Phase 2) inglenooks, are both constructed of very small bricks or tiles. That on the south side of the chimneystack contains an old iron fireback behind the modern wood-burning stove.

*Ground floor plan, showing the Phase 6 alterations and additions (grey).
Scale 1:200.*
