Report on established trees at Worth Farm.

Trees to be protected

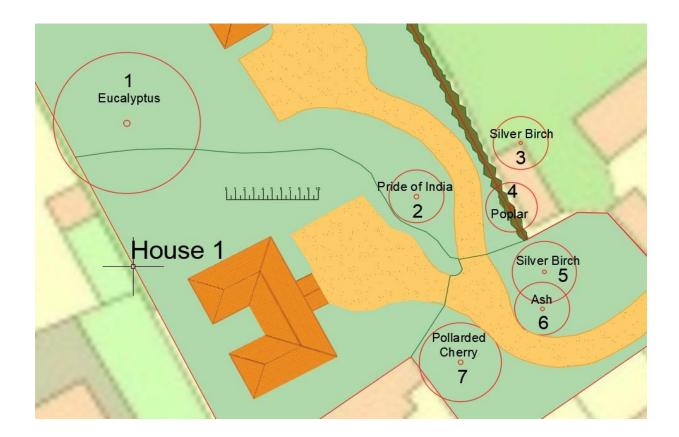
Tree map

This report details the specie and location of all mature trees that are within the proposed development at Worth Farm all of which are to be protected and retained. Protection fencing will be installed around the trees shown in red, to run in line vertically with the reach of the canopy thus ensuring root protection.

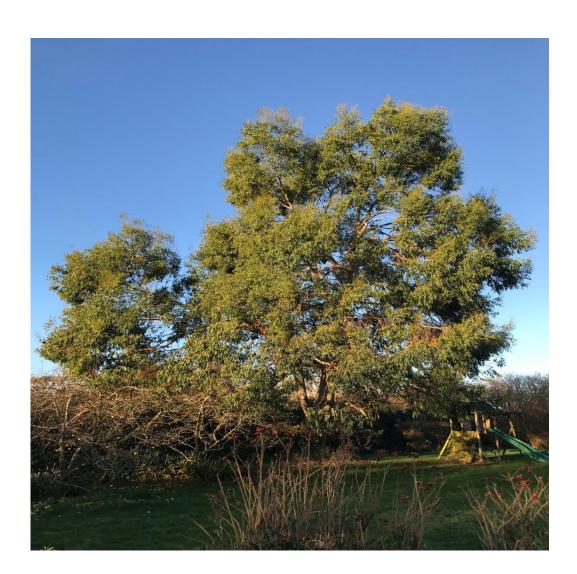
(1) Eucalyptus.

Large mature tree generally in good condition, would benefit from a slight balancing trim around the lower limbs, this is the largest tree on the site, if the application is successful it would result in creating a striking feature tree within the garden of house 2.

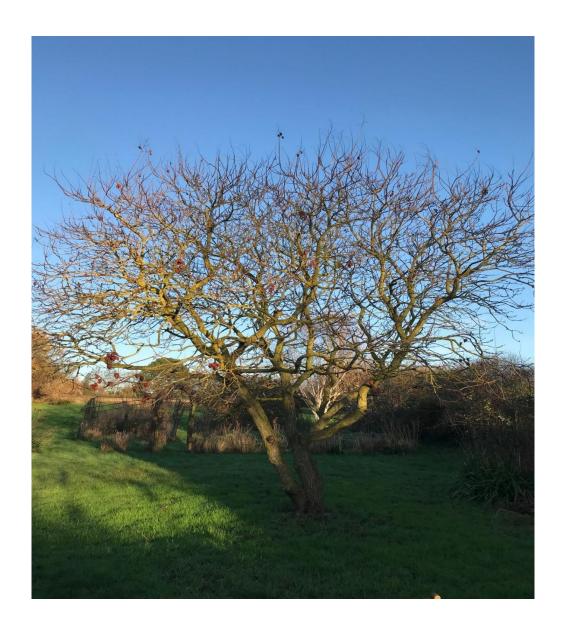
(2) Pride of India.

The tree looks to be in good condition, having not come across this specie before, on investigation it is said to be a very "showy tree" and looking at pictures of similar sized specimens it should make a very interesting sight, the proposed design sits this tree within the front garden of house 2.

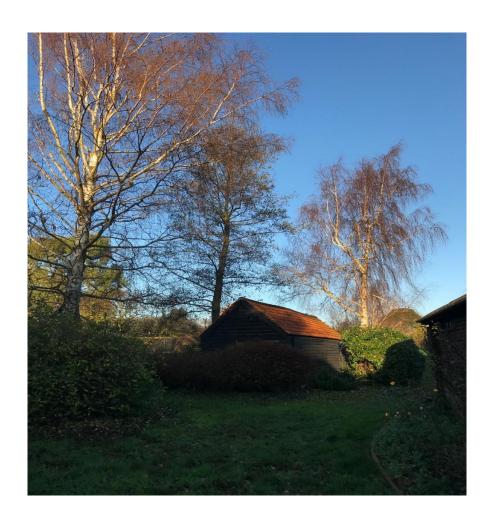
(3) Silver Birch.

Tree 3 sits to the right in this photo beside the garden shed, the shed is to be removed to allow for the driveway. The tree looks to be in good order with healthy well balanced growth.

(4) Poplar.

Tree 4 sits in the center of the photo beside the garden shed that will be removed it is a nice specimen in good condition. The proposed driveway is to run between the Silver Birch to the right and the poplar in the center as indicated in the site plan on page 1.

(5) Silver Birch.

Tree 5 sits to the left of the photo it is a very healthy specimen.

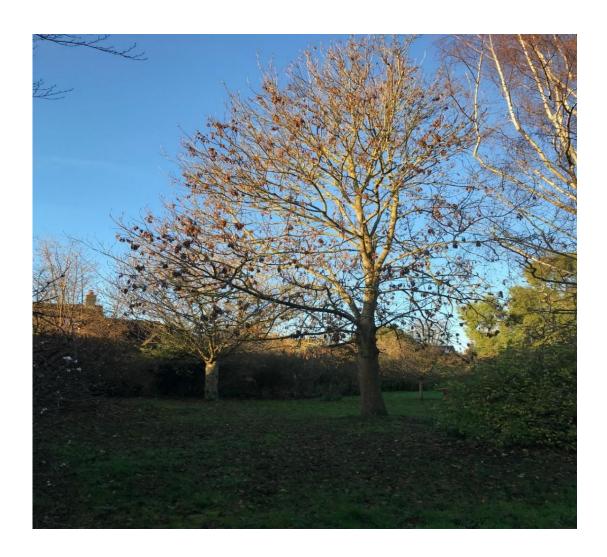
(6) Ash.

In the fore ground. A looked after specimen, shows signs of having been high pruned at some time in the past and is in good health. The lower limb to the left would be cut back to allow for unobstructed access for the proposed driveway between it and the Cherry as show on the proposed site plan on page 1.

(7) Cherry.

Looking at the girth of the trunk this tree has been extensively pollarded over many years, It looks to be healthy and will, in the spring/summer, be a very attractive specimen.
