**GEO-ENVIRONMENTAL AND GEOTECHNICAL
SITE INVESTIGATION
REPORT**

**TOWN FARM
HARRISONS LANE
HALESWORTH
SUFFOLK
IP19 8PZ**

**Reference Number 2954/Rpt 1v2
January 2024**

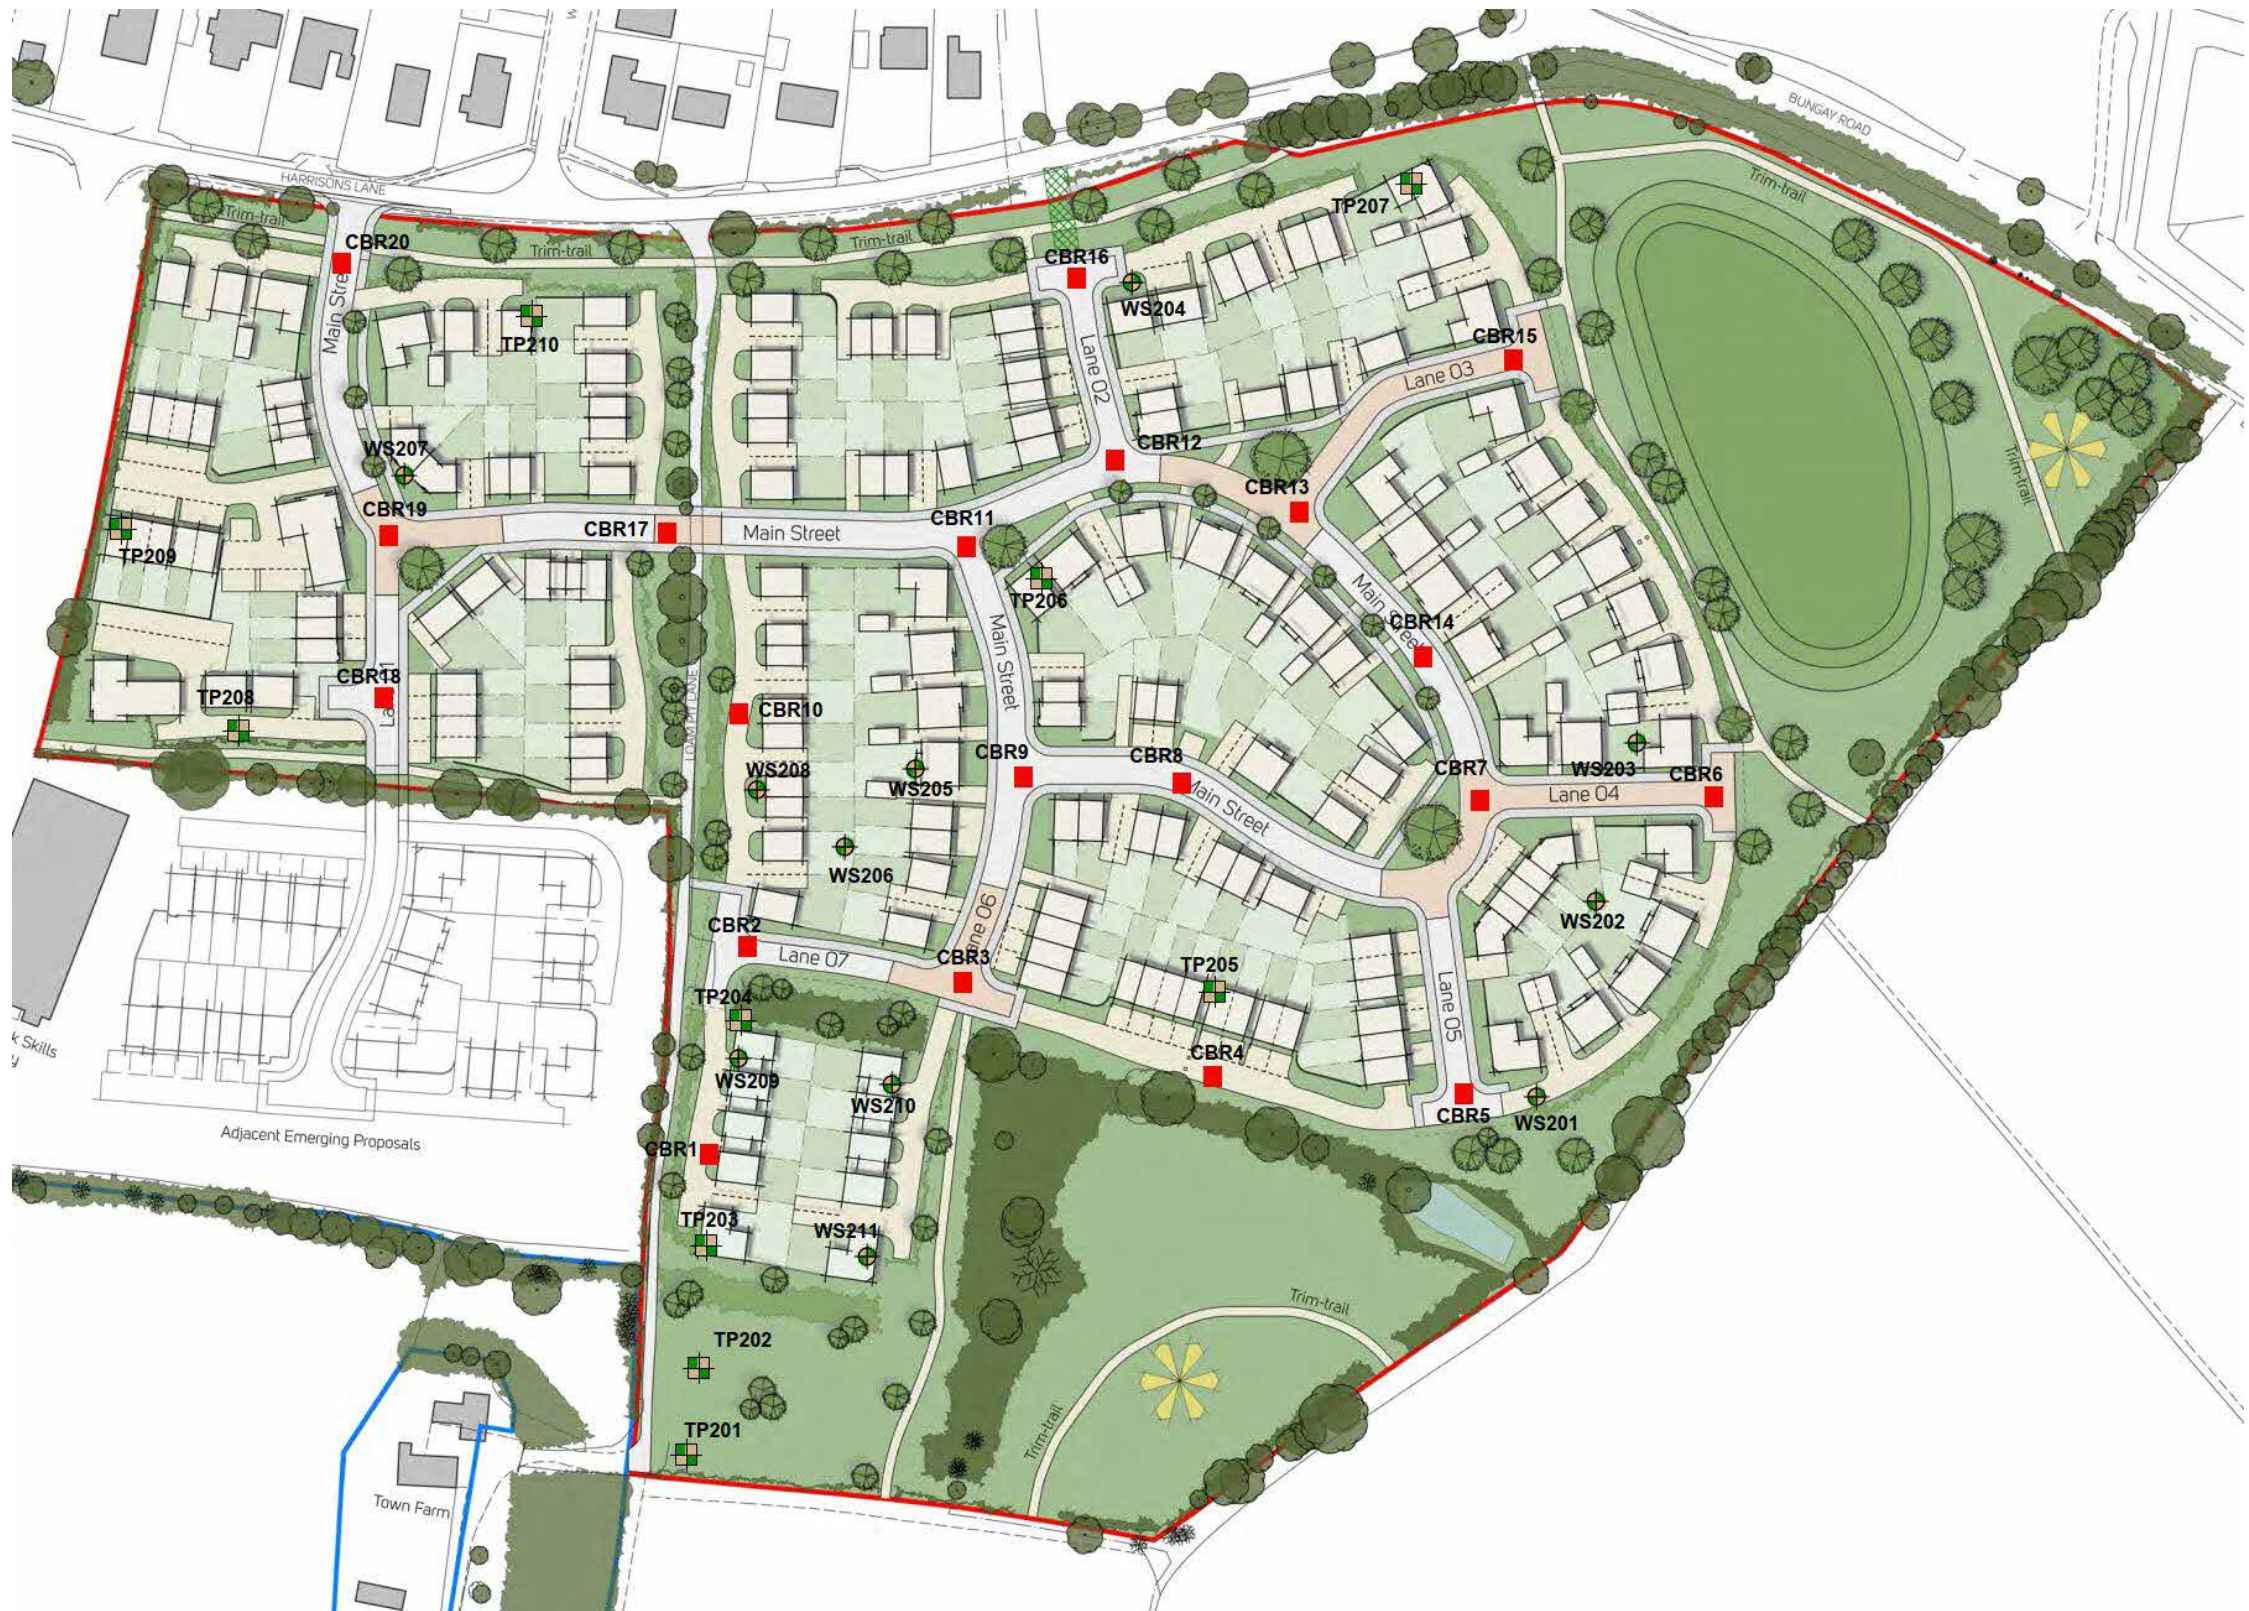
Project Number: 2954	Project: Harrisons Lane, Halesworth	Scale: NTS
Figure 2	Exploratory Hole Locations Plan

Sample Location	Rational/Potential Source Area
WS201, WS202, WS203	Assessment of soft spot located in BH104. WS201 installed as a gas monitoring well.
WS204	Installed as a gas monitoring well
WS205, WS206, WS208	Assessment of soft spot located in BH102. WS205 installed as a gas monitoring well.
WS207, WS209, WS211	Installed as a monitoring well
TP204	Potential asbestos and burning area
TP202	Assess potential hydrocarbons noted in geological log prepared by ASL for WS111.

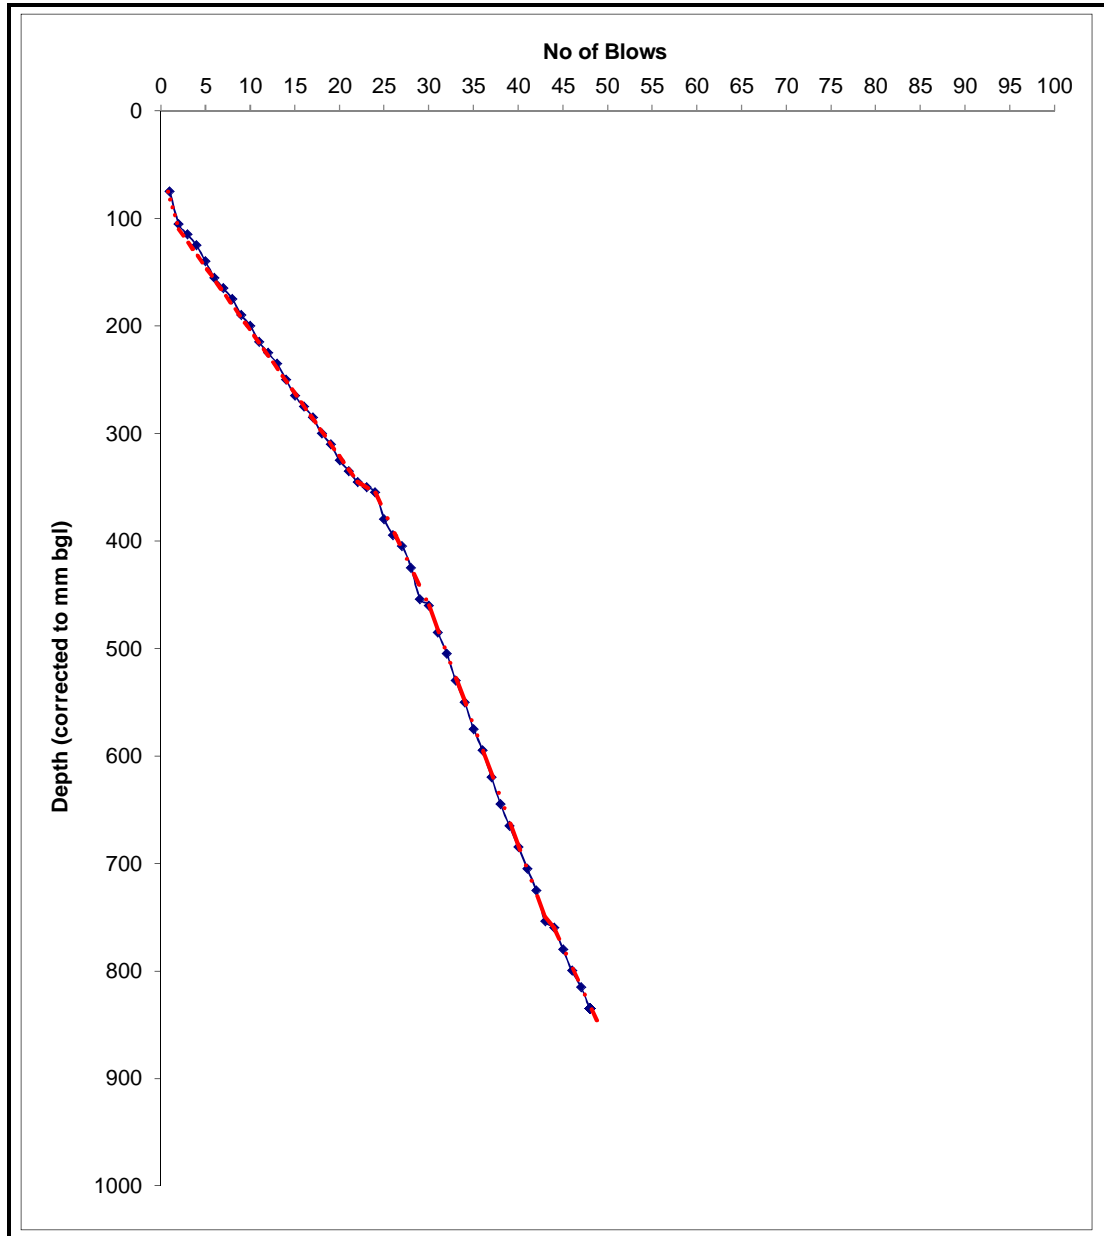
Assessment	mm/blow	depth (m bgf)		Log10(CBR)	CBR (%)
		from	to		
1	29.17	0.08	0.11	0.756944898	5.71
2	11.75	0.11	0.35	1.262351531	18.30
3	5.00	0.35	0.36	1.737318394	54.62
4	17.50	0.36	0.46	1.040911298	10.99
5	22.31	0.46	0.75	0.905978054	8.05
6	10.00	0.75	0.76	1.352	22.49
7	18.00	0.76	0.85	1.025251193	10.60

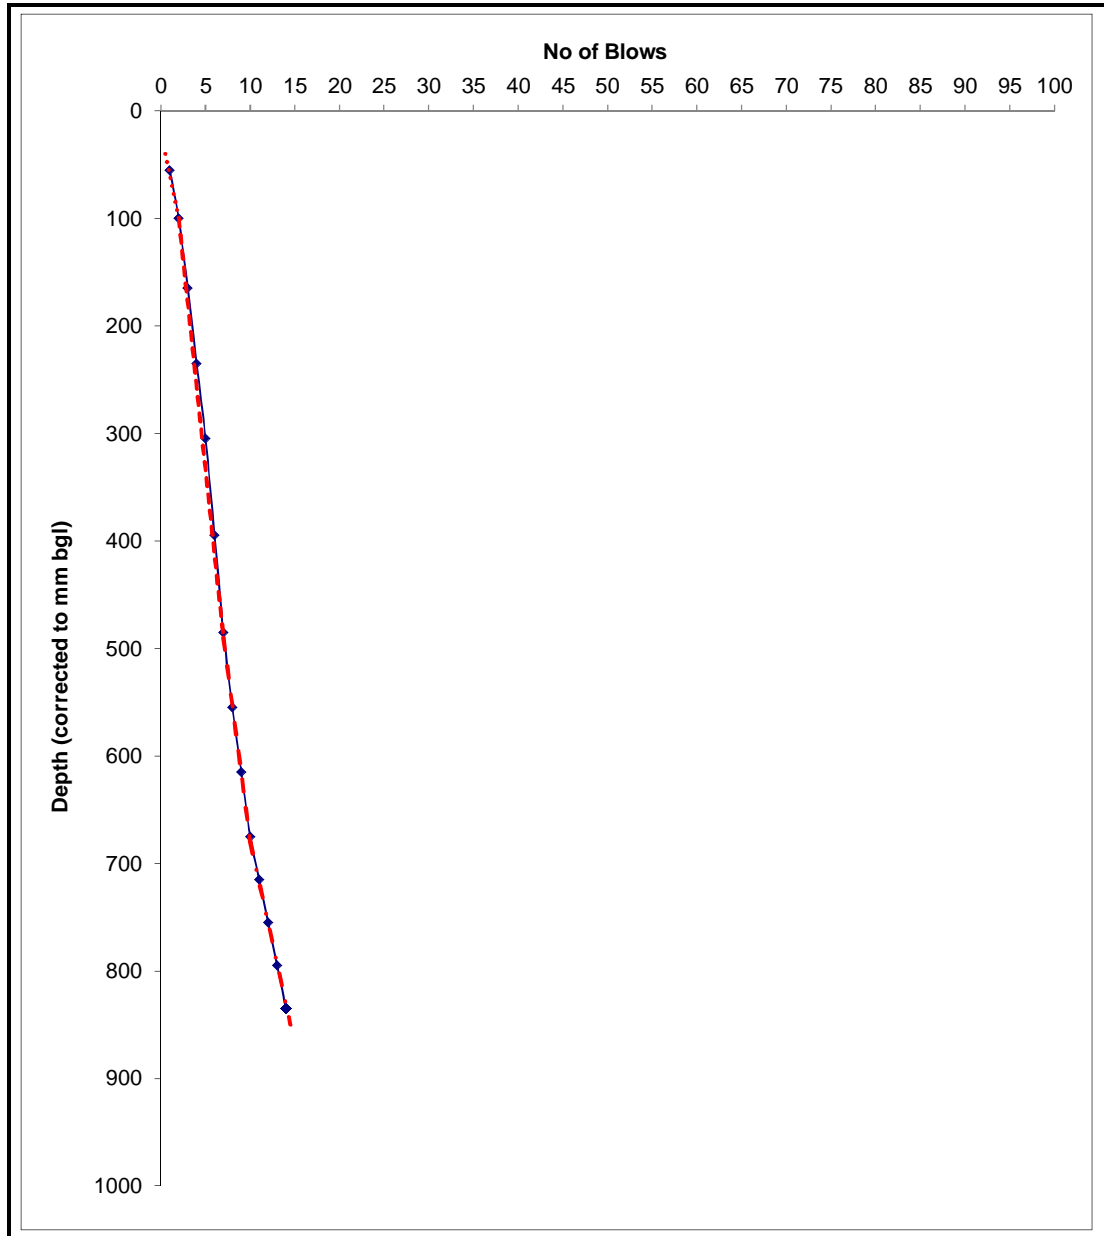
Assessment	mm/blow	depth (m bgl)		Log10(CBR)	CBR (%)
		from	to		
1	40.00	0.04	0.10	0.581363211	3.81
2	78.00	0.10	0.49	0.210118909	1.62
3	63.33	0.49	0.68	0.325910597	2.12
4	37.78	0.68	0.85	0.613137398	4.10

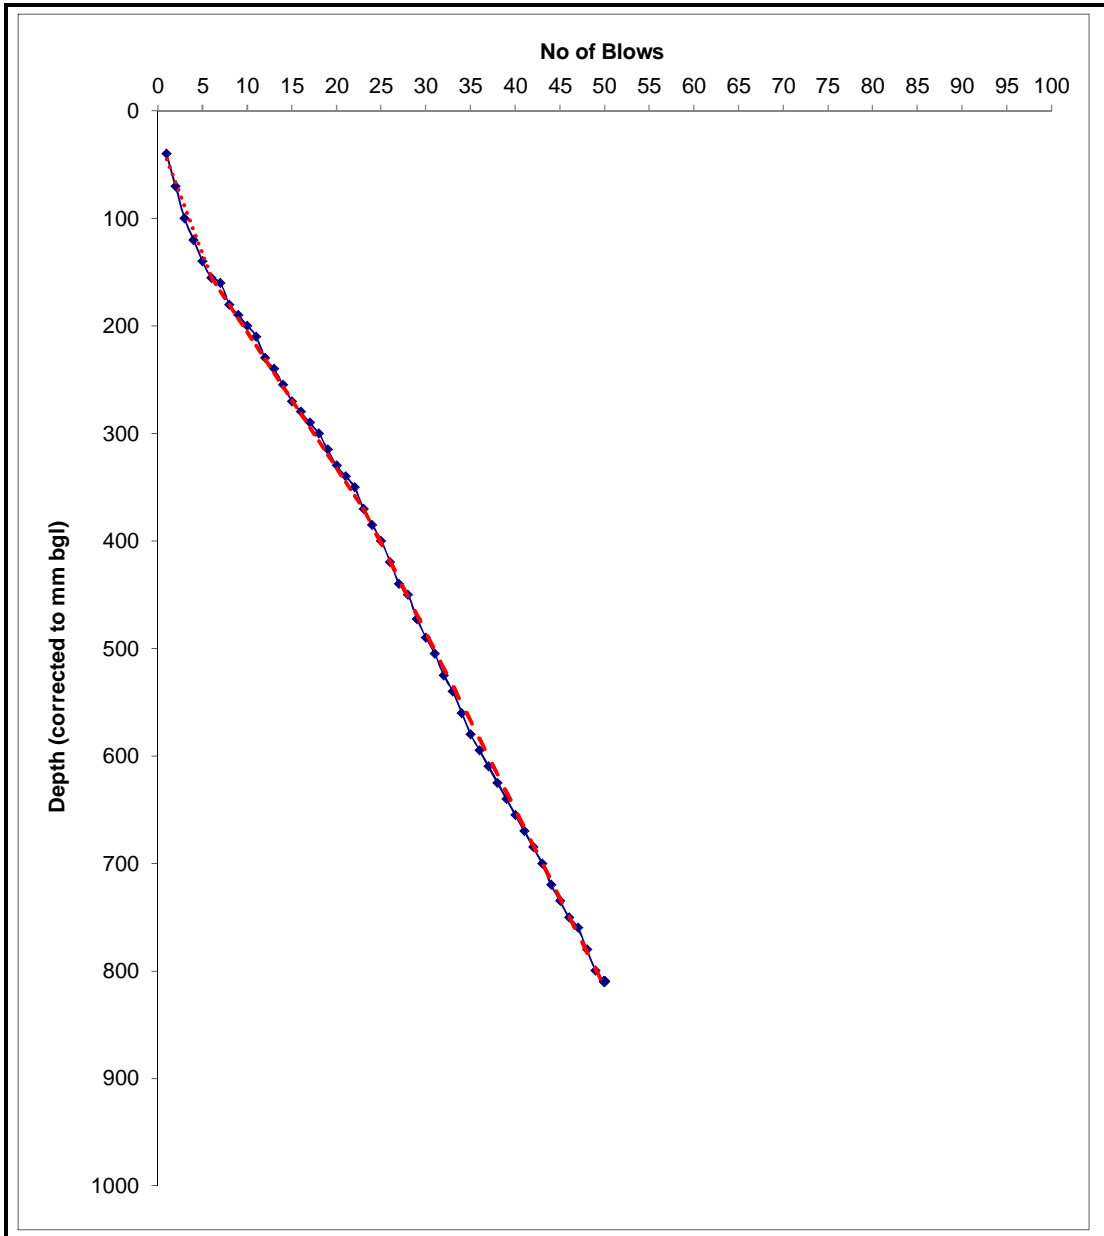
Assessment	mm/blow	depth (m bgl)		Log10(CBR)	CBR (%)
		from	to		
1	22.00	0.05	0.16	0.913698969	8.20
2	12.65	0.16	0.37	1.221453391	16.65
3	16.48	0.37	0.82	1.074244804	11.86

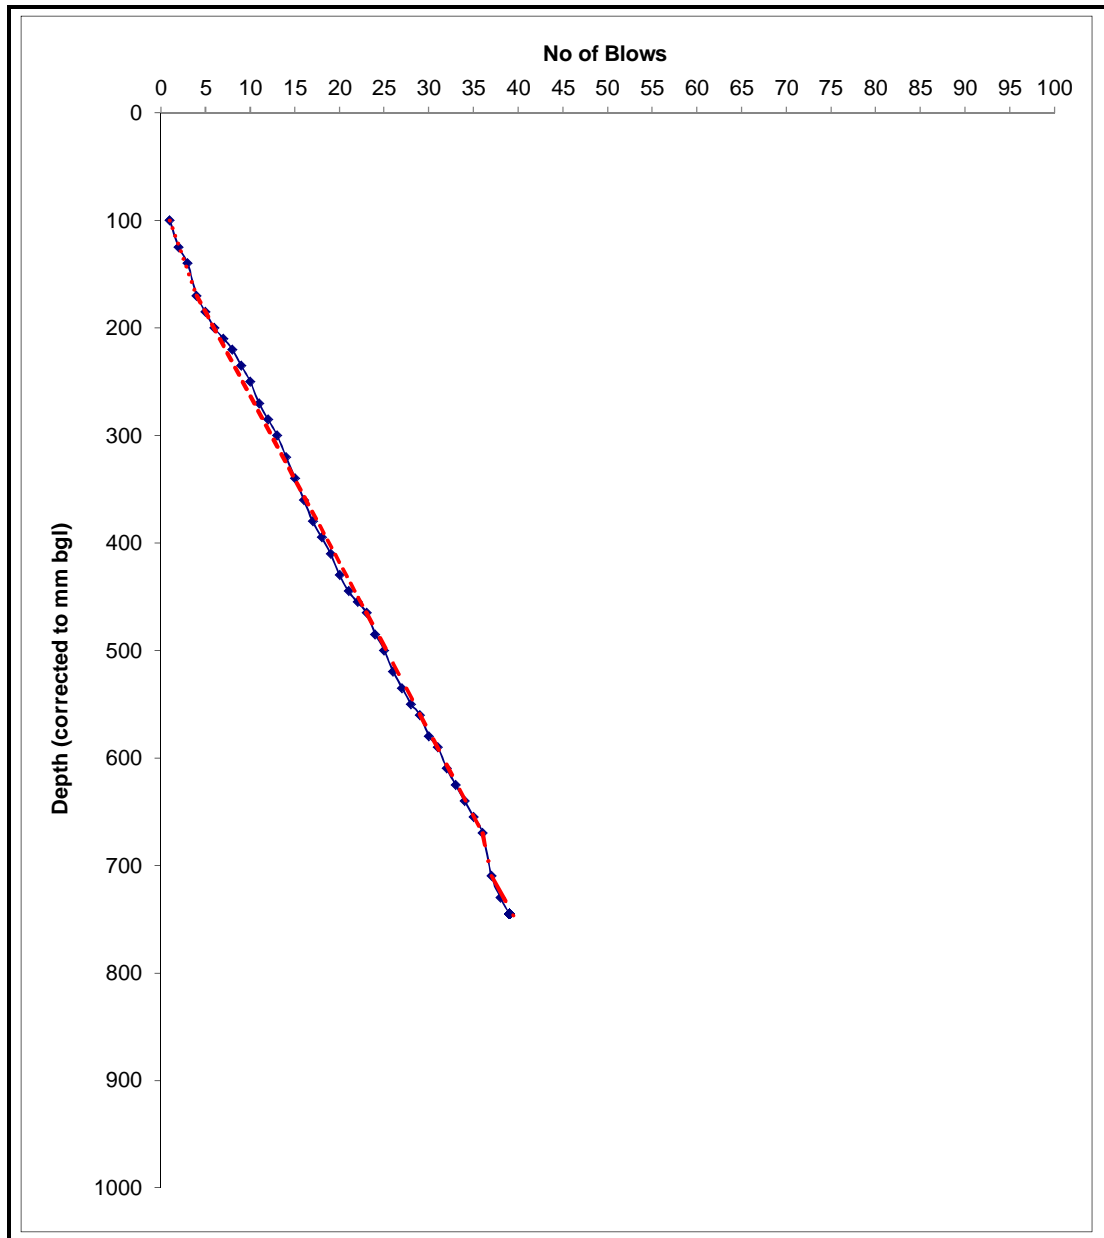
Assessment	mm/blow	depth (m bgl)		Log10(CBR)	CBR (%)
		from	to		
1	23.33	0.10	0.17	0.880989715	7.60
2	15.53	0.17	0.47	1.107432429	12.81
3	15.77	0.47	0.67	1.098802549	12.55
4	40.00	0.67	0.71	0.581363211	3.81
5	15.00	0.71	0.76	1.126603188	13.38

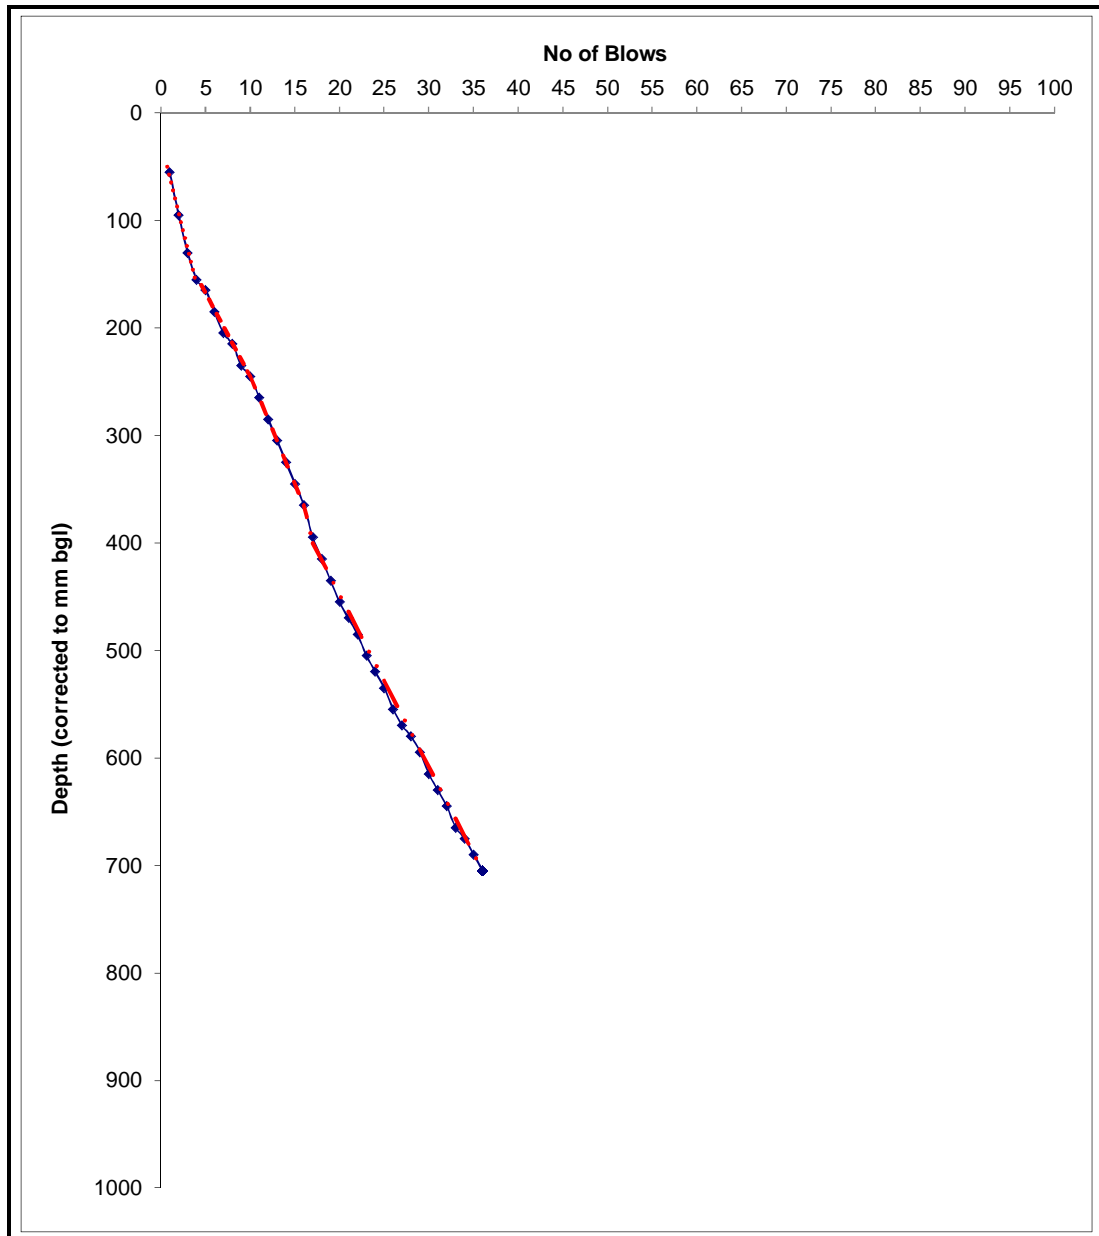
Assessment	mm/blow	depth (m bgl)		Log10(CBR)	CBR (%)
		from	to		
1	33.33	0.05	0.16	0.682715206	4.82
2	15.45	0.16	0.25	1.110008018	12.88
3	20.00	0.25	0.37	0.966681606	9.26
4	35.00	0.37	0.40	0.655592903	4.52
5	16.05	0.40	0.71	1.088900815	12.27

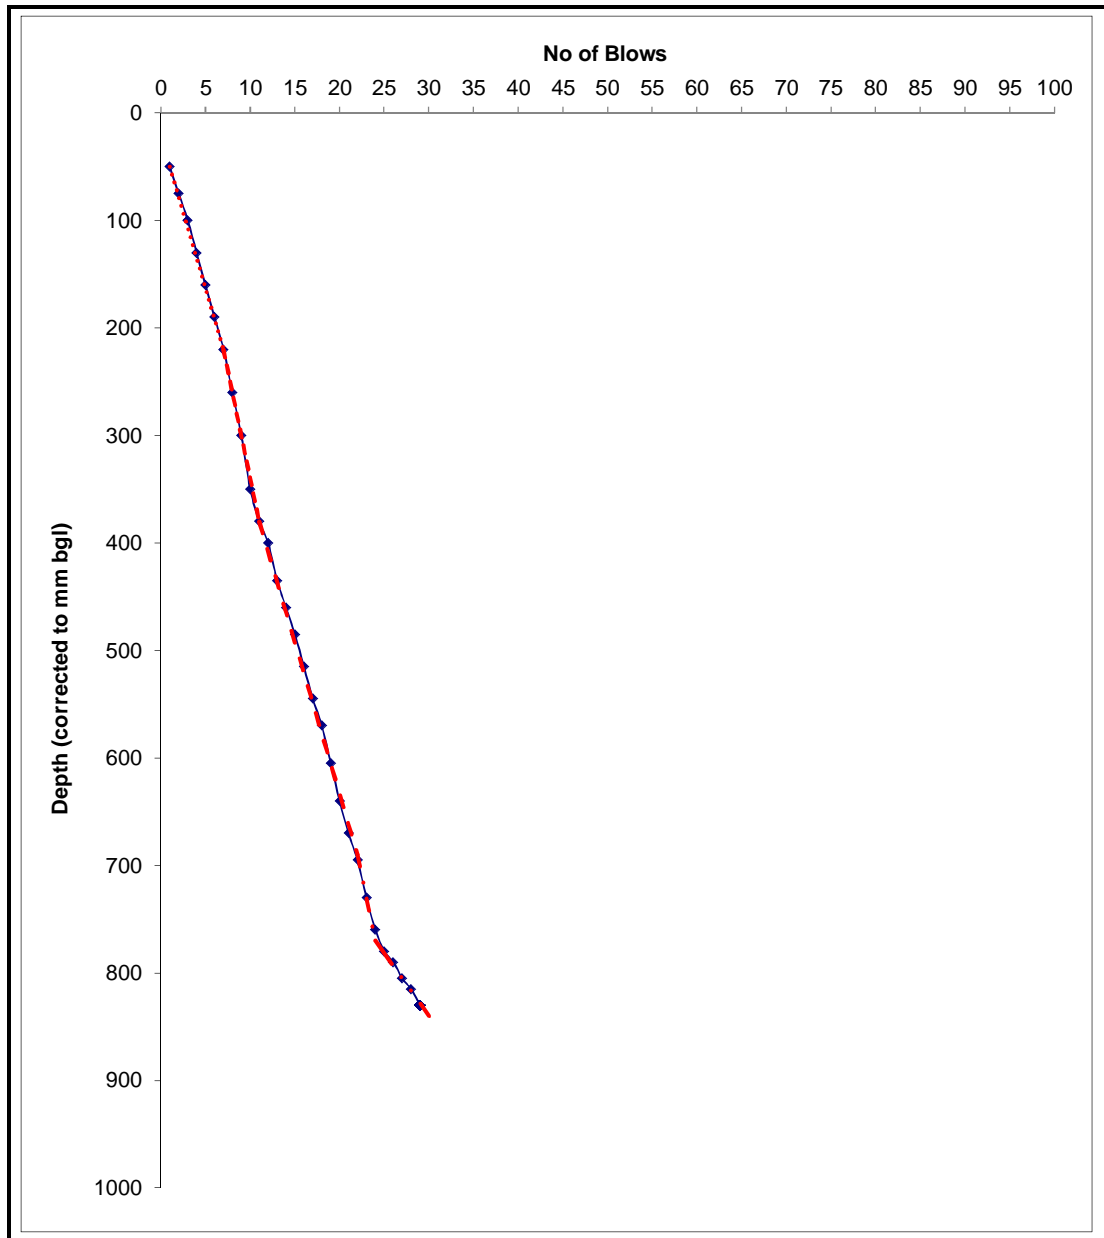
Assessment	mm/blow	depth (m bgf)		Log10(CBR)	CBR (%)
		from	to		
1	28.33	0.05	0.22	0.773058981	5.93
2	40.00	0.22	0.38	0.581363211	3.81
3	28.18	0.38	0.69	0.776039669	5.97
4	40.00	0.69	0.77	0.581363211	3.81
5	11.67	0.77	0.84	1.266308109	18.46

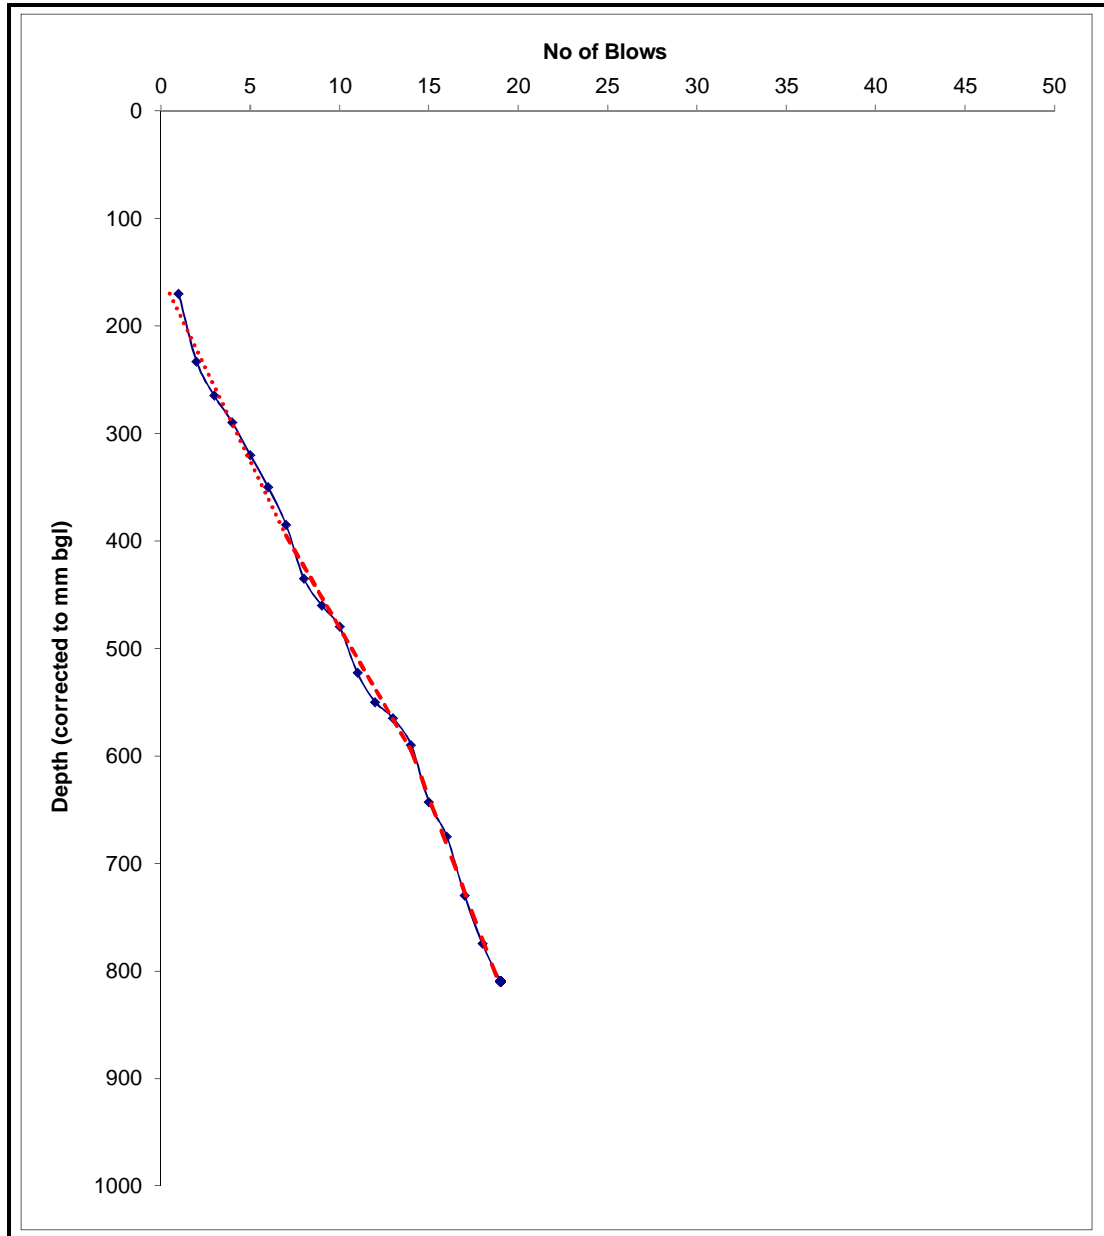
Assessment	mm/blow	depth (m bgl)		Log10(CBR)	CBR (%)
		from	to		
1	34.62	0.17	0.40	0.661735473	4.59
2	28.57	0.40	0.60	0.768407097	5.87
3	44.00	0.60	0.82	0.528380574	3.38
