Newbold Farm Barn, Duntisbourne Abbots, Gloucestershire

Bat Survey Report

A report for Blake Architects Limited

August 2022

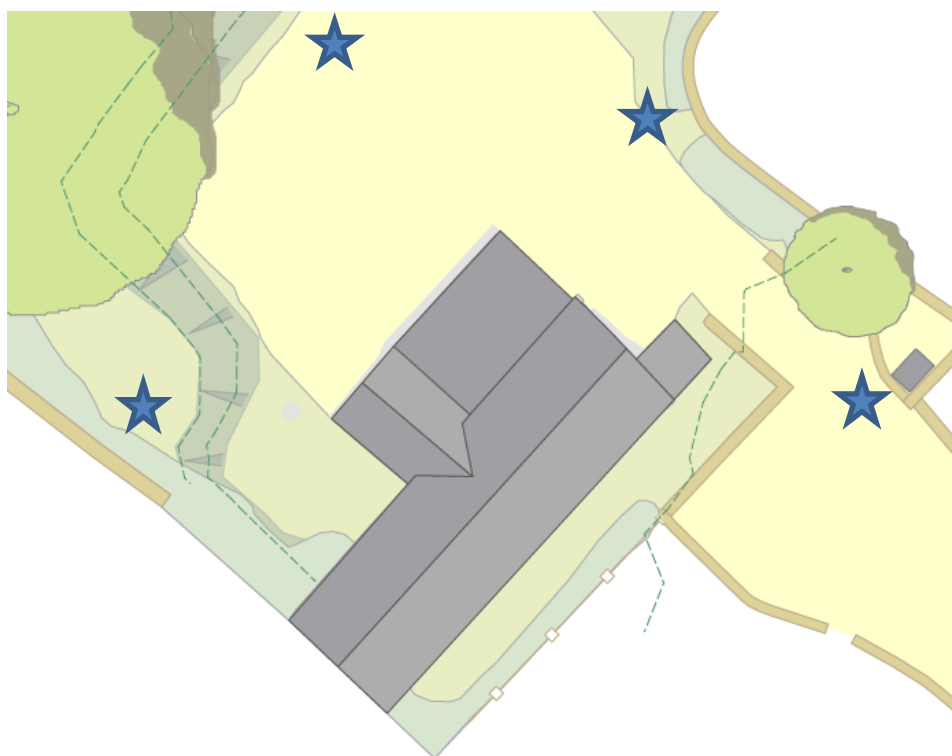
**Plate 1: Surveyor/thermal camera locations**

3.9 Surveyors/thermal imagery cameras were positioned around the buildings in suitable weather conditions, to look for bats emerging from their roosts (see Table 2). Dusk surveys commenced 15mins prior to sunset and continued for 1hr30mins thereafter. EMT2 Touch Pro bat detectors to record the bat echolocation calls to analyse following the survey

3.12 The western gable end was not fully visible as is overlooking the neighbouring property. However the thermal camera was well positioned to see the apex of the roof line.

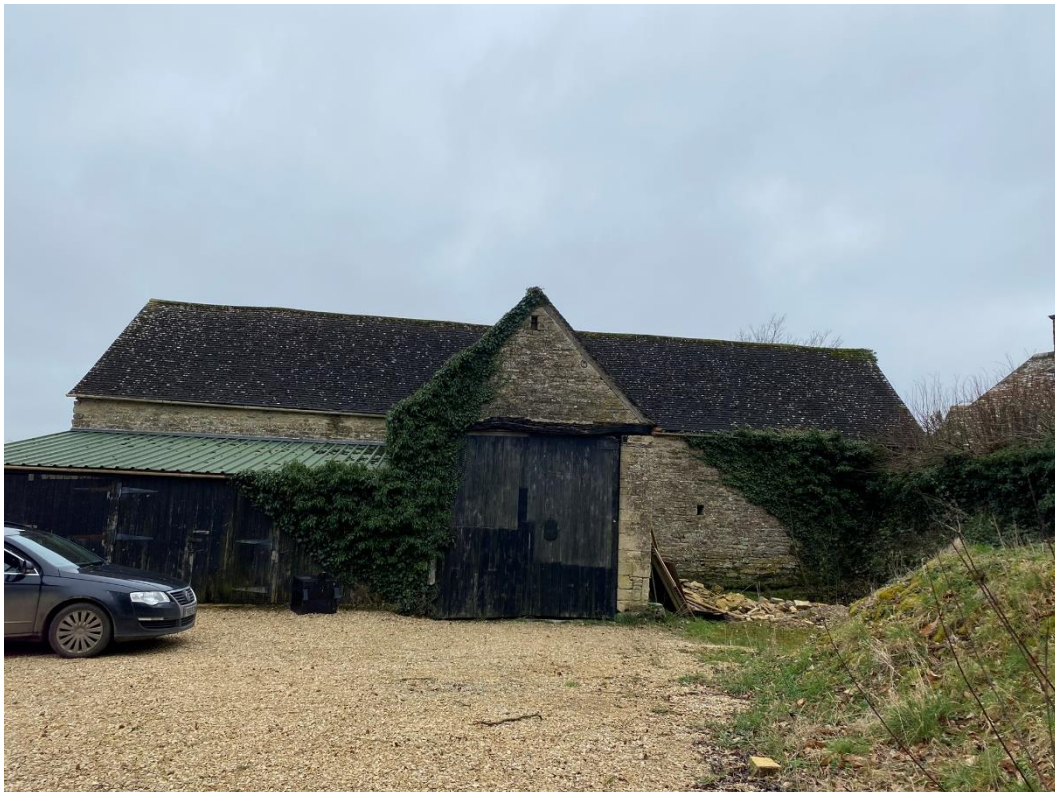
- 3.5 The Tithe Barn is large stone 'T'- shaped building with a pitched clay tile roof. There is a single storey timber framed lean-to to the rear (northern) elevation, which has a sloping corrugated metal roof. In addition, there is an original small lean to on the side (NE) elevation, which has a sloping stone tiled roof.
- 3.6 There are large traditional timber barn doors to the side elevations with timber lintels. The eaves and gable ends sit flush to the wall and no soffits are present. An open 'arrow slit' is present on the rear elevation and there are a number of other gaps and crevices within the stonework and around the door lintels that allow direct access into the barn. There is some ivy growth across the building and up onto the roof. The roof tiles are generally in a good condition, with only a few slipped tiles noted that could provide access for bats beneath.

Plate 2: Side (NW elevation) of the barn showing more recent single storey lean-to

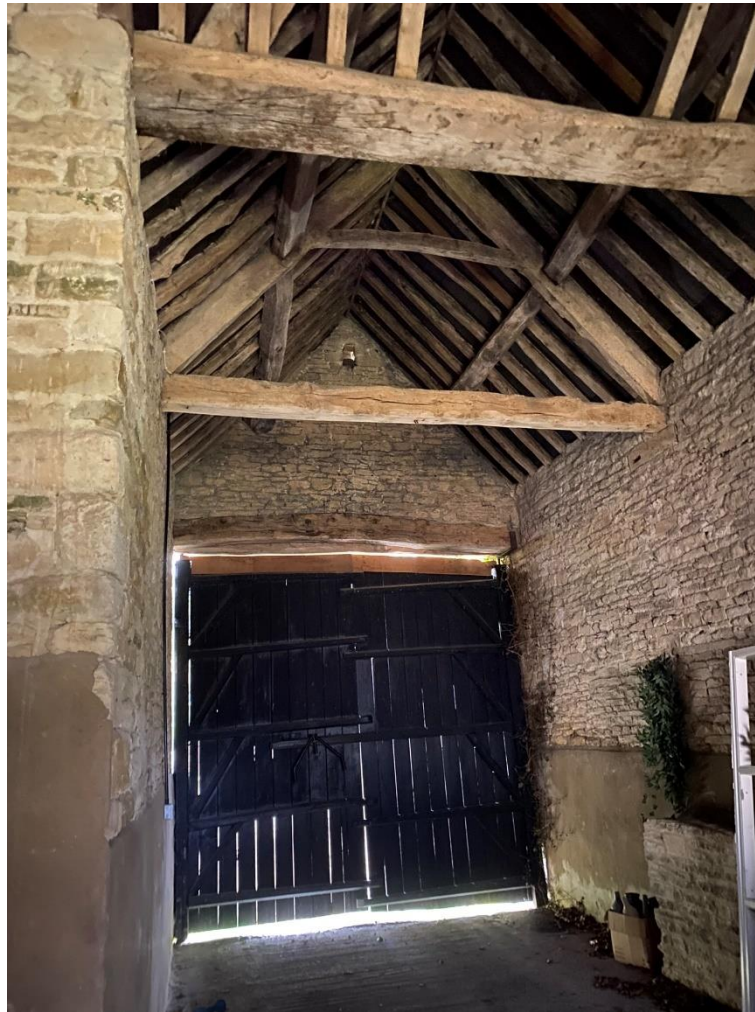
- 3.7 Internally, the building open with the exposed timber beams, and there is no separate roof void. The roof is lined with bitumastic felt, which appears to be in a good condition. Light ingress is visible around the barn doors and through some of the gaps within the stone work. There are numerous crevices through the internal stonework that go far back into rubble filled cavities or behind the stones. There are also crevices within the mortise and tenon joints and where the timber frame joins the stone walls. The southern gable appears to have received some repair work and is partially constructed of breeze block.

- 3.8 Whilst no bats were seen during the inspection, a number of bat droppings were identified throughout the barn, and were considered to be from at least two different species of bats. There was a general scattering of droppings but also an accumulation of around 100+ below the ridge beam towards the eastern side of the barn. These were considered to be from a serotine bat. A small accumulation was also found within a crevice in the northern wall. The droppings were characteristic of a pipistrelle species.

Plate 3: Internal view of barn showing doors.

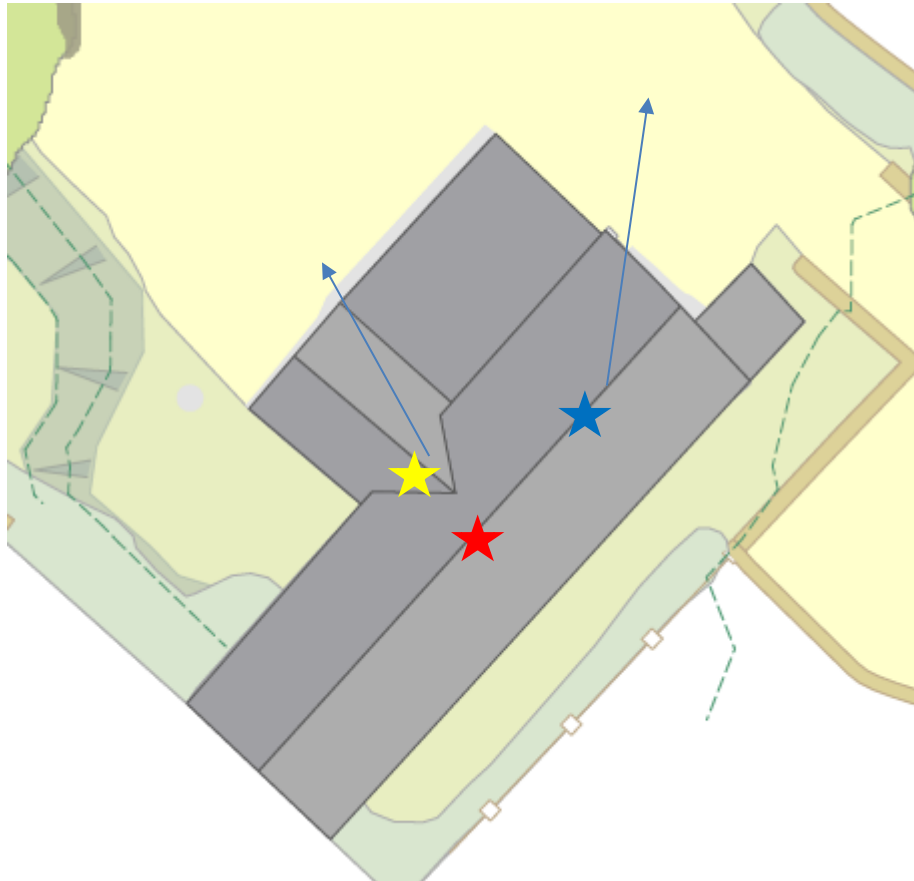
- 3.13 The survey identified three serotine bats along the ridge line as shown in Plate 4 below. In addition, two common pipistrelles emerged from close to the ridge of the lower section

Plate 4: Emergence points during the surveys (Two common pipistrelles emerged at yellow star, two serotine bats from the red star and one from the blue star)

- 3.14 The survey identified a single serotine bat emerging from the red star in Plate 4. A single common pipistrelle emerged from the same location, as illustrated in Plate 4.

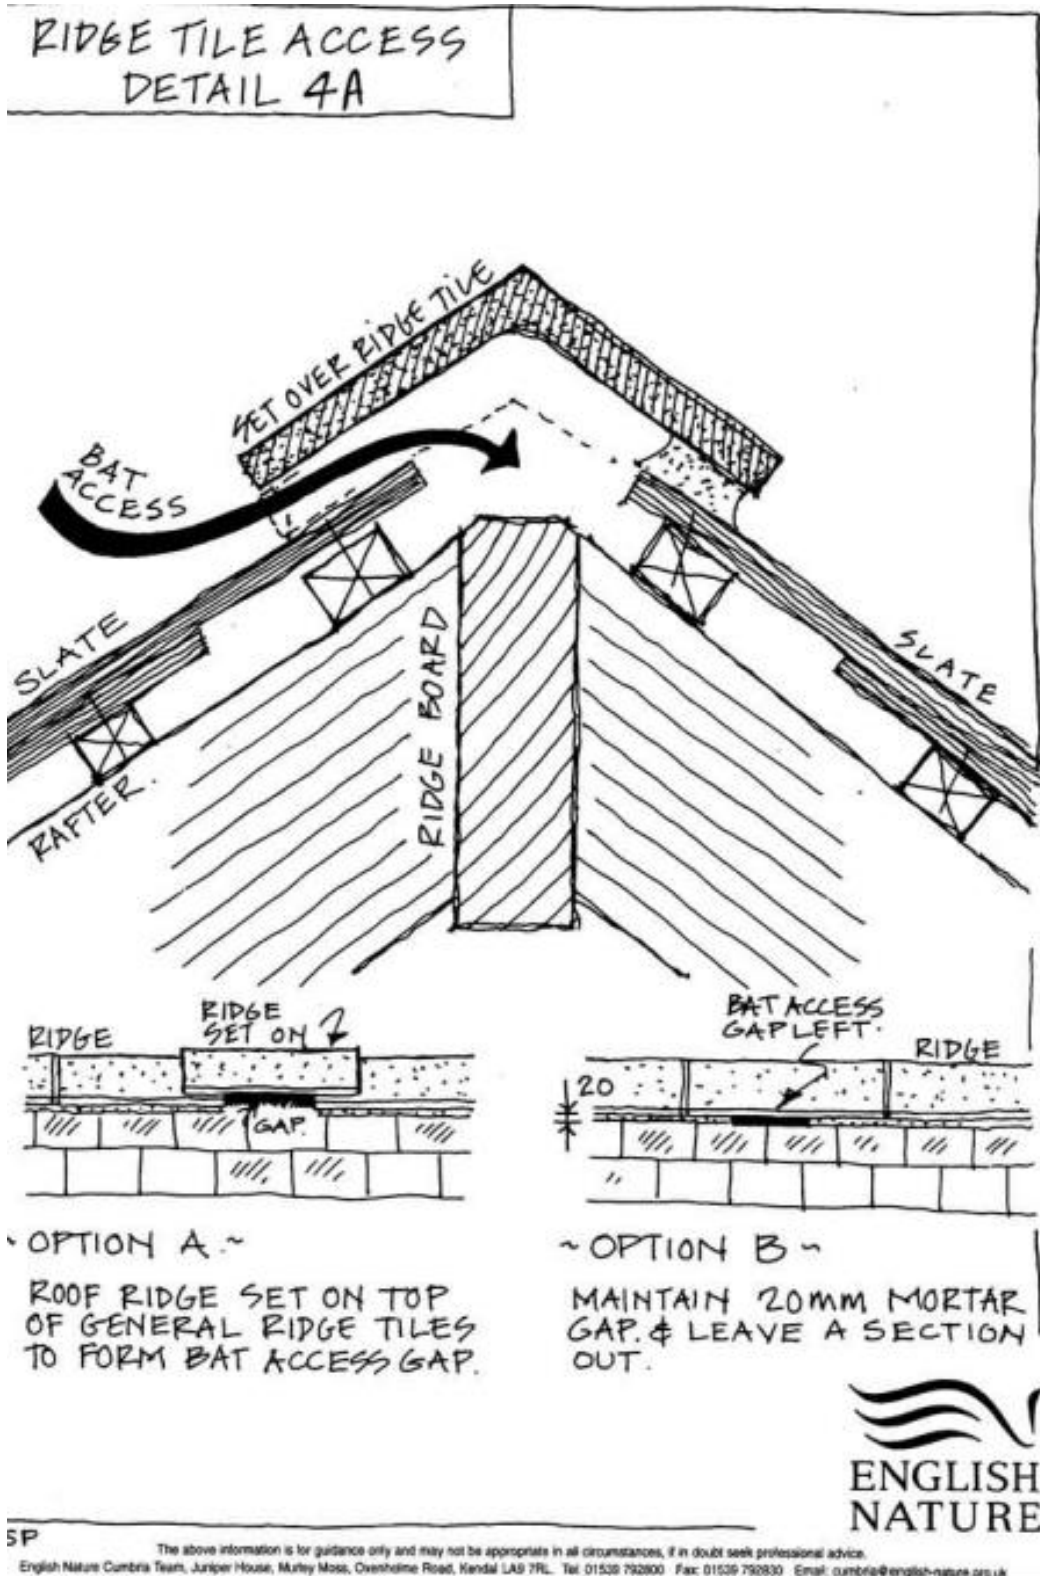
Ridge Access
