WHITBY OLD TOWN HALL AND MARKET SQUARE HERITAGE STATEMENT

BURRELL | FOLEY | FISCHER
ARCHITECTS AND URBAN DESIGNERS

MARCH 2023
ISSUED: 17.03.23

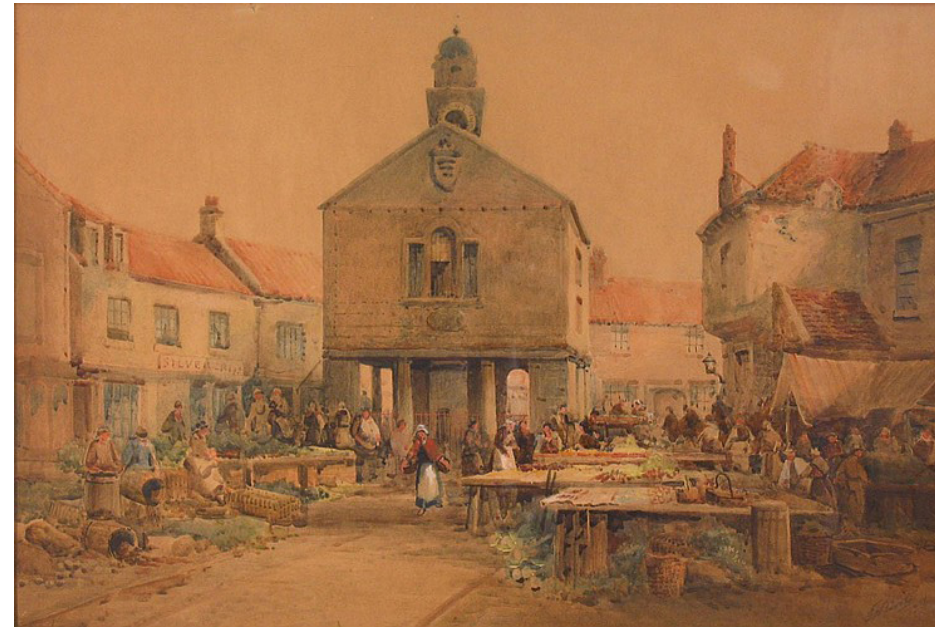
Painting by Frederick William Booty (1840-1924) depicting Whitby Market Place

Note: By the 1800's Railings had been installed to the undercroft of the Town Hall. The Market was a vibrant place and the heart of the town. The stalls were set out either side of the town hall with a central 'walkway' left clear.

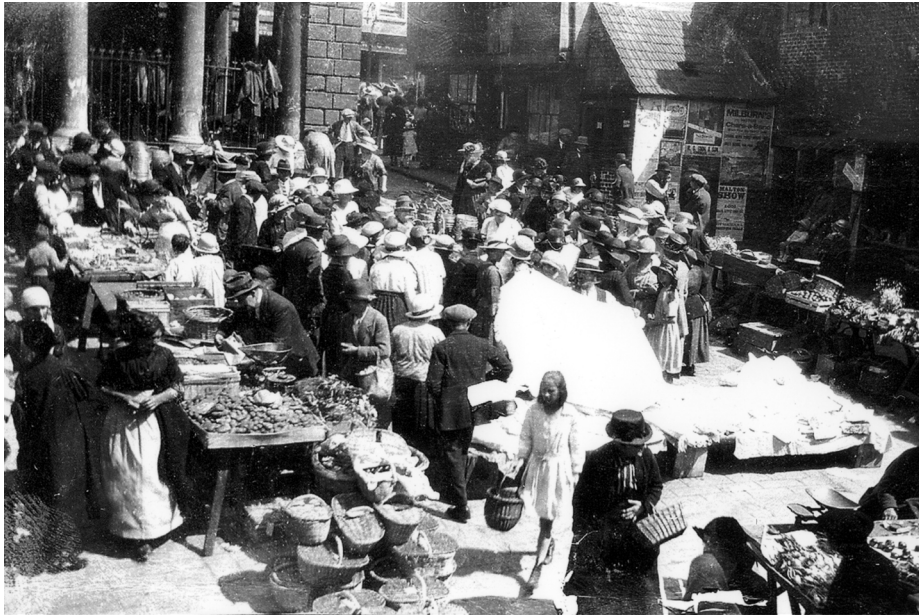
Whitby Market in 1920. Note: At this point, the Town Hall had metal railings surrounding the Ground Floor. The market stalls were simple trestle tables.

While there is no confirmation of when the railings were removed, we know that "Iron gates and railings were cut down to help the war effort" in the 1940's. The Town Hall railings, like others across the country were cut off at the sides leaving the stubs to be seen in situ.

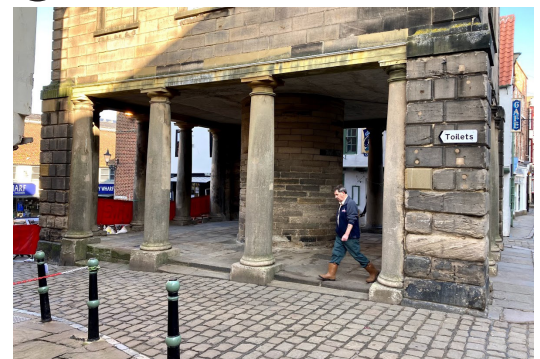
9 South Elevation Ground Floor

The sandstone columns are original with subsequent repairs circa 1960s. The sandstone columns were rendered with cement and most of the lintels above the columns replaced with reinforced concrete. There is extensive cracking to the cement render exposing the sandstone behind. In 2022, a large section of stone fell from the building.

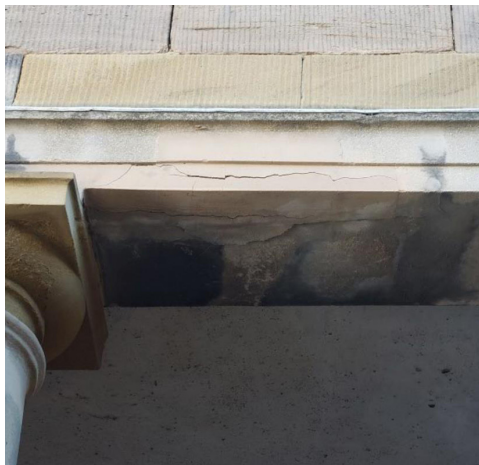
17 Broken stonework to lintels

Undercroft								
No	Proposal	Drawing no ref -	Fabric Affected	Significance of fabric	Impact on Building	Reversibility	Reason	Notes
10	Existing paving slabs, lifted, and reinstated level like-for-like.	0402	Ground floor paving slabs/ surround stone steps	High	Neutral	It would not be appropriate to reverse this change	To replace damaged paving slabs, insulate to upgrade thermal performance and make undercroft habitable.	A stone survey has been conducted as part of RIBA Stage 3 to ensure any new paving slabs best match the existing.
11	Removing detrimental cement render to columns and re-rendering in lime render.	0500	Existing concrete rendered stone columns	Detrimental	Low	It would not be appropriate to reverse this change	Existing poor historic indent repairs and decaying fabric are reducing the lifespan of the building.	Current concrete render has blown and is causing damage to existing columns

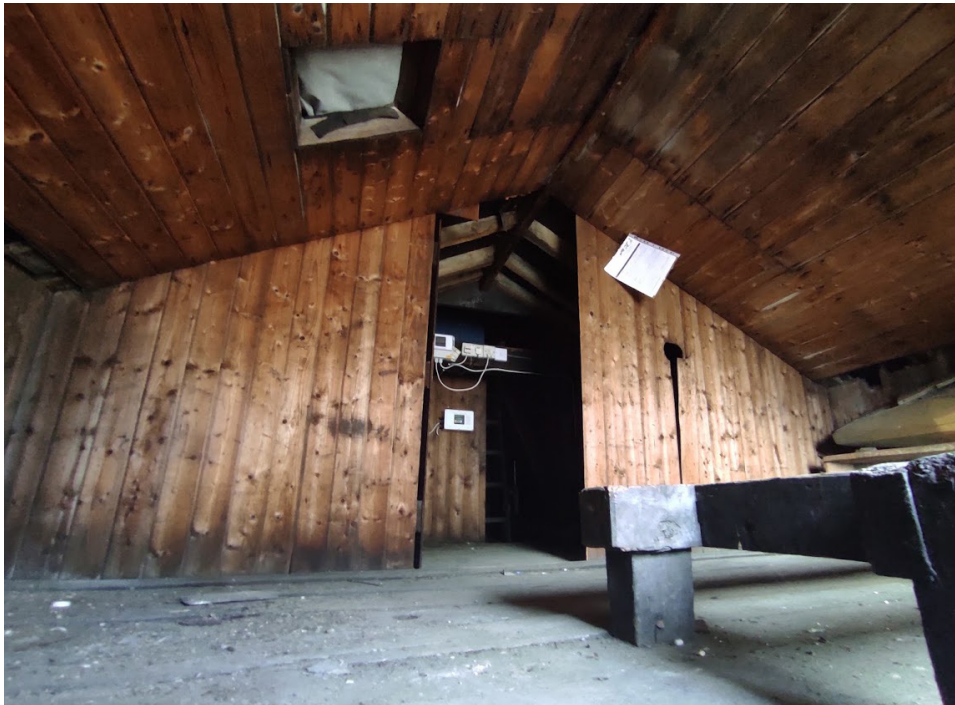
26 Timber panels in the roof void. Photograph taken from the top of the ladder staircase.

Internal: The ceiling of the first floor has been damaged by water penetration through leaks in the roof. Sections of the Roof Void: The pitched ceiling has been lined with timber T&G boards.

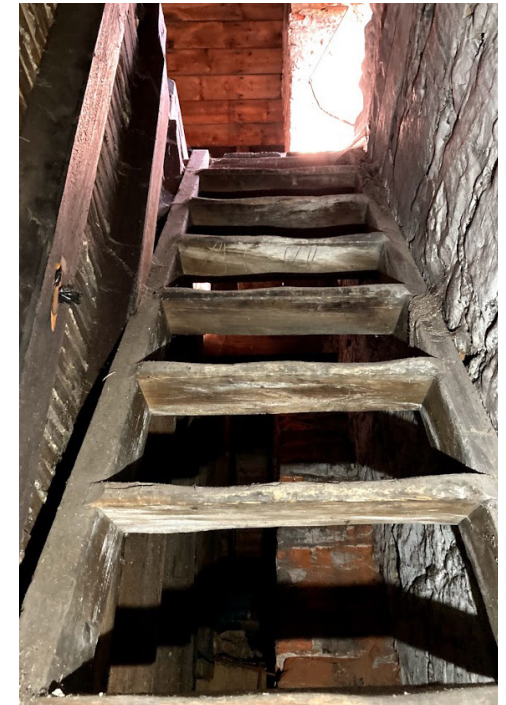
28 Ladder staircase leading to roof void

Many of the stone treads to the spiral staircase have cracks. The lower treads of the spiral staircase have been damaged. The iron balustrade is set with the stone and as a result the corner of the treads have blown/cracked. The narrow timber staircase leading to the roof void is presumed to be original and has worn treads.
