AN ARCHAEOLOGICAL EVALUATION
EXCAVATION AT THE SITE OF THE
FORMER 23 QUAY STREET,
SCARBOROUGH

Christopher Hall

NATIONAL GRID REF TA 04935 88835
SITE CODE PL05
MUSEUM ACCESSION No. SCAR.2006.51

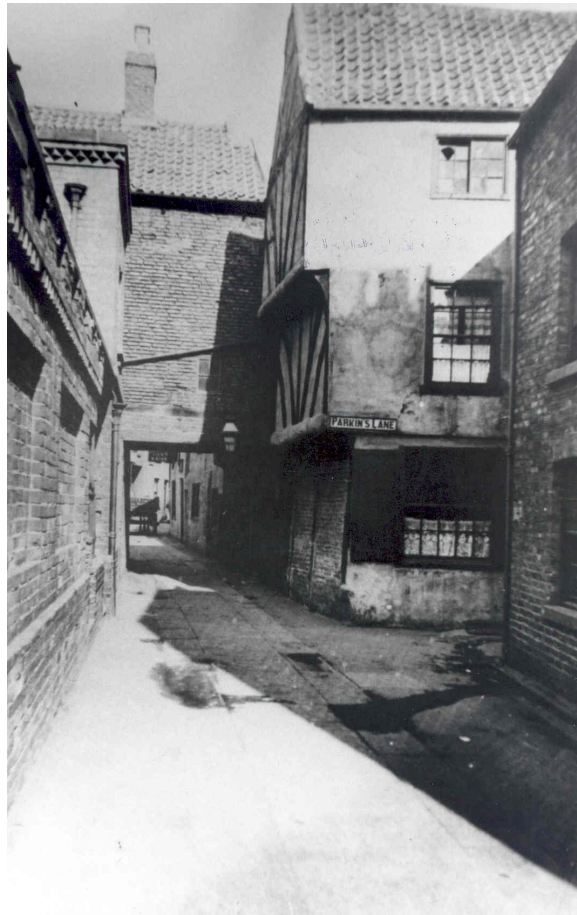
Frontispiece – a 19th century photograph of the timber framed house which occupied the site

- 3.10 Quite a lot of information is available about the house which stood on the site before the building of the garage in the 1920s. For example it is illustrated in 'Old and New Scarborough'⁷ and also in 19th century photographs. This building is almost certainly the one referred to in an article of 1888,⁸ which claims it may be 13th or 14th century and which contains the illustration of the gable end reproduced in Figure 2. The building was of three storeys with a two-bay gable end-on to Quay Street. The gable was of jettied construction, down braced, and cross braced at gable level. Stevenson's sketch implies that the infilling was plastered brick and that the building was set on a two-course stone plinth - these features are not apparent in the photograph. Clearly to be seen in both sketch and photograph however is that the ground floor

- 3.11 The gable end of this building when photographed had no windows and indeed the disposition of the framing was such that windows could never have existed here. Recent recording work has shown that there are similarities in timber-frame construction between buildings in Scarborough and York, particularly in Goodramgate, York.⁹ The former 23 Quay Street has affinities with 41-45 Goodramgate, although the latter do not have windowless gable ends. It is suggested that the same carpenters were operating in both York and Scarborough, and that they may have been Flemish. Given the trade links between Scarborough and northern Europe and the Low Countries, this would not be surprising.

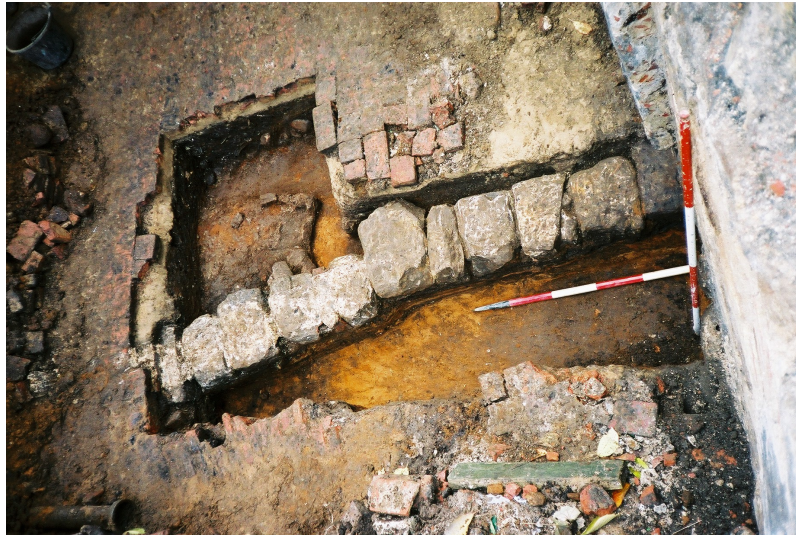
Figure 6 Looking South showing F1007.8 – scales 2metre & 500mm

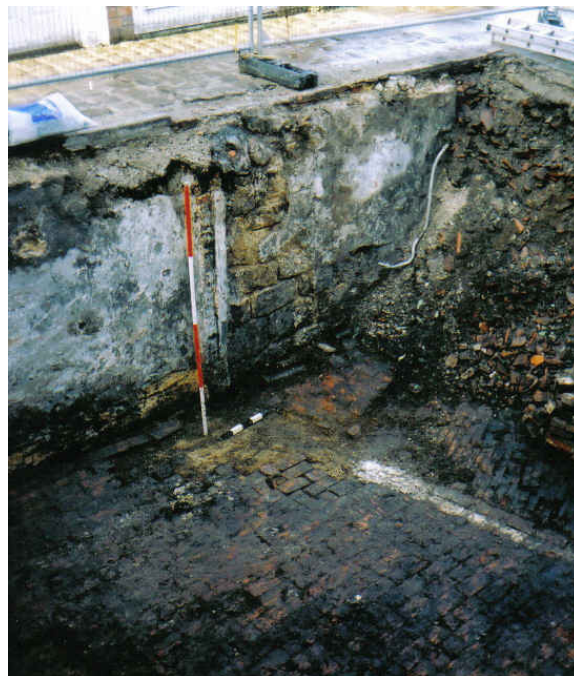
**Figure 7 Looking West showing wall F1002 and Cellar Floor F1005
Scales 2metre & 500mm**

F1002 (Figure 7) is a substantial stone wall of large squared courses forming the western boundary of the cellar and retaining Parkins Lane and is thought to be the cellar wall to the house. Its relationship with

1007.2 would be consistent with the 14th or 15th date for the building given on stylistic grounds. No evidence of the timber frame was found. The northern cellar wall lies under the present road and in any event some cellar fill had to be kept in place to support the road so it was not possible to examine this and thus to ascertain whether it is an old quay alignment as was postulated at The Three Mariners. At the south only three courses of the stone wall remained (F1006.10) underneath a later brick wall and later alterations had taken place at the east also.

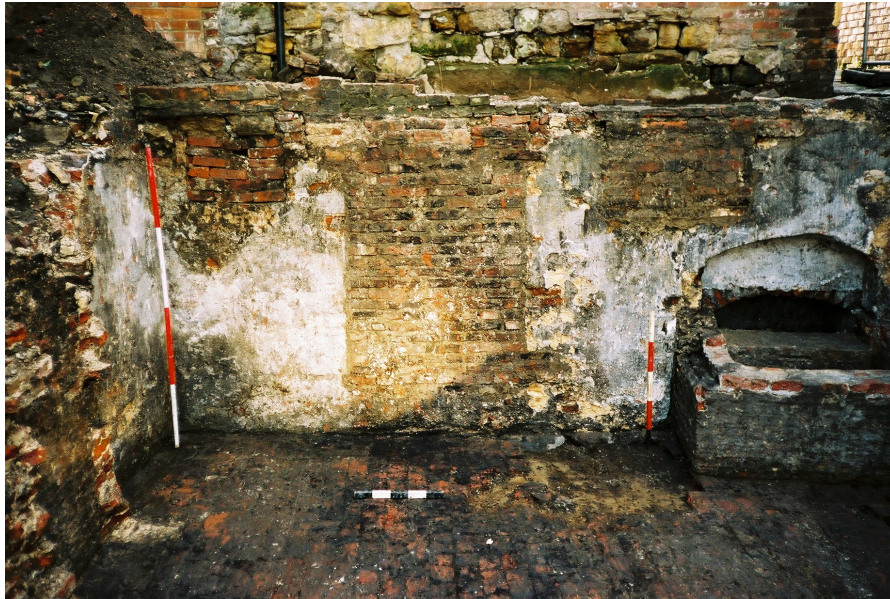
Figure 8 Looking South showing feature F1004 (to the right) brick cellar floor F1005, the brick wall with blocked openings - Scales 2m, 1m & 500mm

The cellar was re-floored using bricks (F1005, Figure 8) and judging by their size and form this was done in the 18th century. At this period the

There were three openings in the wall (subsequently blocked in possibly when the cellar was filled) consisting of a door opening above where trench 1006 was positioned, a small opening to its east probably for a coal chute and a larger opening to the west probably a window. At this time therefore the passage to the south must have been much lower than at present with steps up to Parkins Lane. Trench 2 – had it been proceeded with - may have revealed these steps or a void. Contemporaneously, a cross wall running on the approximate alignment of F1007.8 was built representing the phase at which the house was subdivided into two (as shown on the maps) This represents a change in status of the building from a single house to two much smaller lower class houses.

F1004 is a rectangular brick feature built against the south wall – Figure 8 and with a low arch penetrating the wall. It is of 18th or 19th date. Various theories have been put forward as to its use the most plausible being a small furnace for a blacksmith's shop (which would accord with the name Smithy Lane on Cossin's map of 1725) or a boiler containing a vessels for boiling crabs. More research is needed into this.
