# Bentley Cottage, Painswick

## Preliminary Ecological Appraisal (PEA) & Bat Survey Report

February 2024  
Version 1 - Final

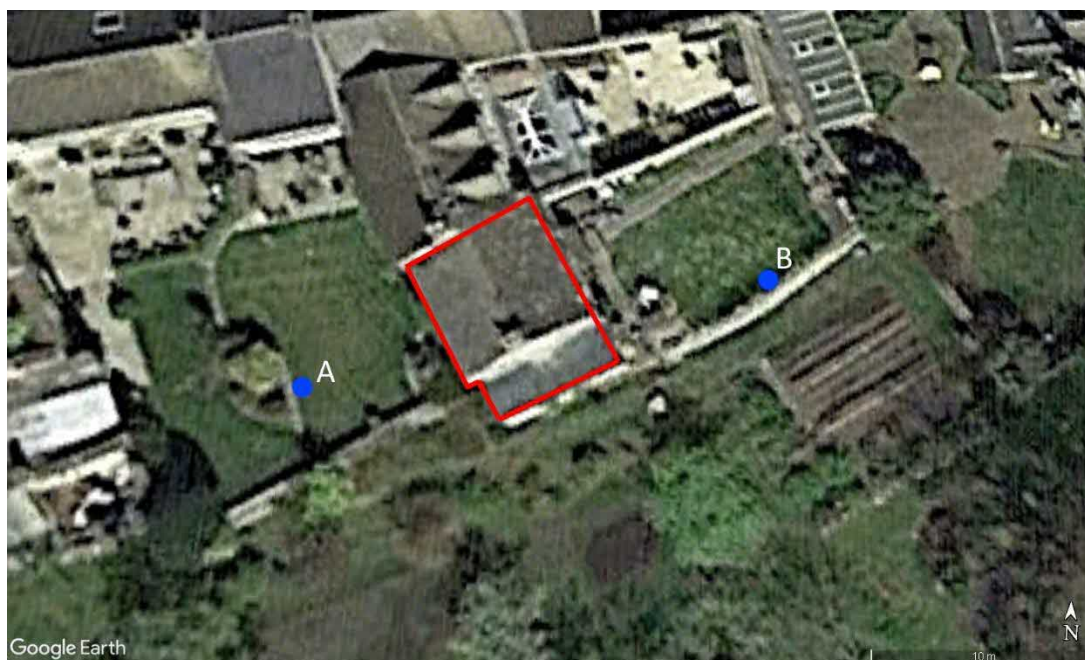
Figure 3 – Plan showing the locations of Surveyor A and B in relation to Bentley Cottage (Google Earth, 2023)

The dusk emergence surveys commenced 15 minutes before sunset and continued for 1.5 hours after sunset. Both surveyors were strategically positioned either side of the building so as to be able to observe any bats leaving their roosts, if roosts were present. Surveyor locations are shown in blue in Figure 3 below, with the outline of Bentley Cottage highlighted in red.

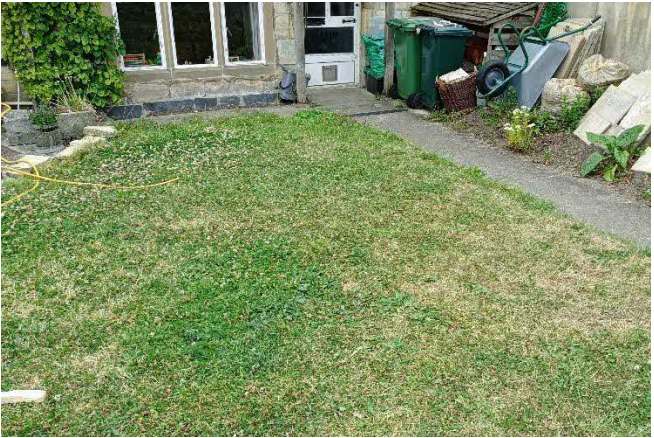
<p>Modified Grassland - Frequently Mown (g4 108)</p> <p>Area of amenity lawn approximately 10m x 5m which occupies the majority of the garden to Bentley Cottage (the central part of the site).</p> <p>The lawn is regularly mown and is comprised of perennial rye-grass (<i>Lolium perenne</i>) and annual meadow grass (<i>Poa annua</i>). Broad-leaved herbs are relatively frequent but limited in diversity, comprising: white clover (<i>Trifolium repens</i>), yarrow (<i>Achillea millefolium</i>), dandelion (<i>Taraxacum</i> agg.), broadleaf plantain (<i>Plantago major</i>) and bristly ox-tongue (<i>Helminthotheca echioides</i>).</p>

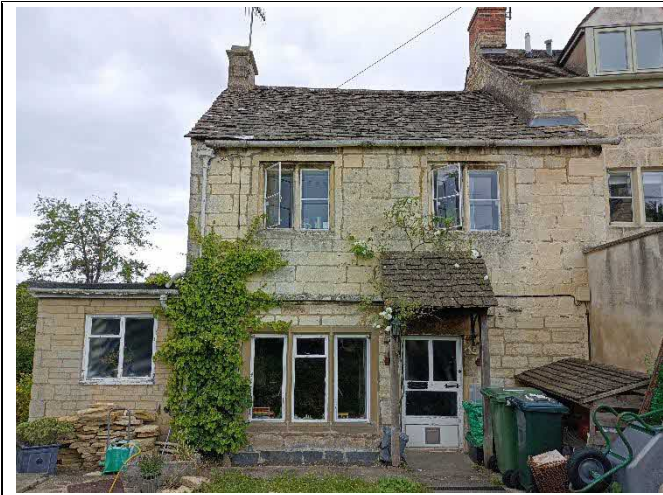
**Building – Residential Building (u1b5 818)**

Bentley Cottage is the only building present within the site boundary and is a two storey Cotswold stone cottage. The building occupies the western part of the site. A more detailed description of the building is provided in the PRA survey results (Appendix 03).

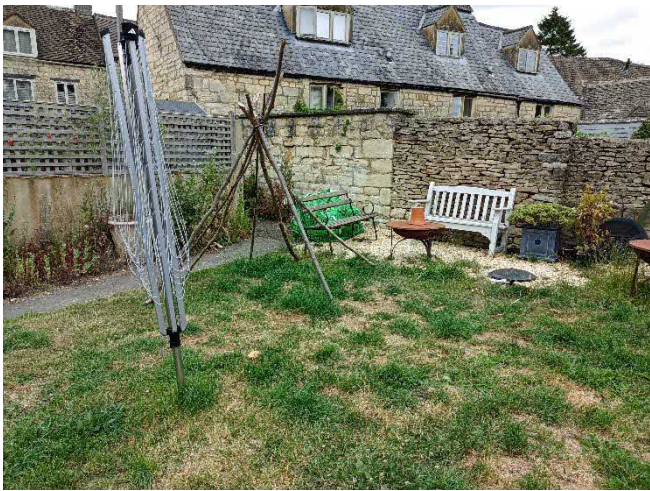
**Suburban Mosaic of Developed & Natural Surface - Garden (u1d 827)**

Habitat comprises concrete path from Vicarage Road leading to the door of Bentley Cottage with an adjacent ornamental flower bed. There also several small patio areas including a gravel seating area at the eastern end of the garden and a smaller concrete area adjacent to the single storey extension of Bentley Cottage. The northern and eastern site boundaries are marked by the high walls of neighbouring gardens. These habitats make up the remaining areas within the site boundary in addition to the amenity lawn and building described above.

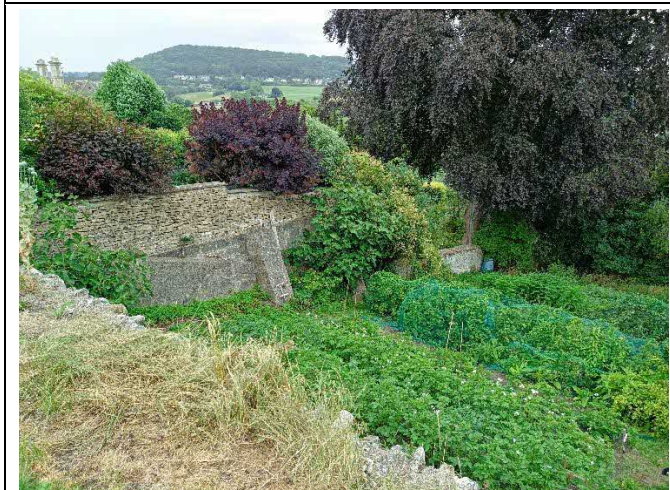
Suburban Mosaic of Developed & Natural Surface –  
Garden (u1d 827) (OFF SITE)

Garden of the neighbouring property (to the west of the site) which comprises a frequently mown amenity lawn, ornamental flower beds and shrubs, several patio areas and a stone retaining wall. This garden is outside of the site boundary, but within the survey area. The lower part of the building that can be seen in the photograph is the rear (western) elevation of Bentley Cottage.

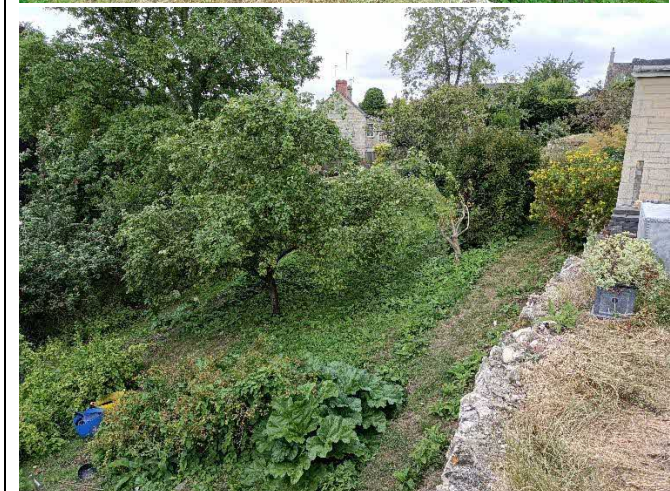
Suburban Mosaic of Developed & Natural Surface –  
Garden (u1d 827) (OFF SITE)

Neighbouring garden to the south of the site and below the 2-3m high retaining wall (which forms the site's southern boundary). The garden in this location is regularly managed and is primarily used for fruit and vegetable production. There are occasional ornamental shrubs at the boundaries of the garden. This garden is outside of the site boundary, but within the survey area. The garden could not be accessed but good views were available from within the site.

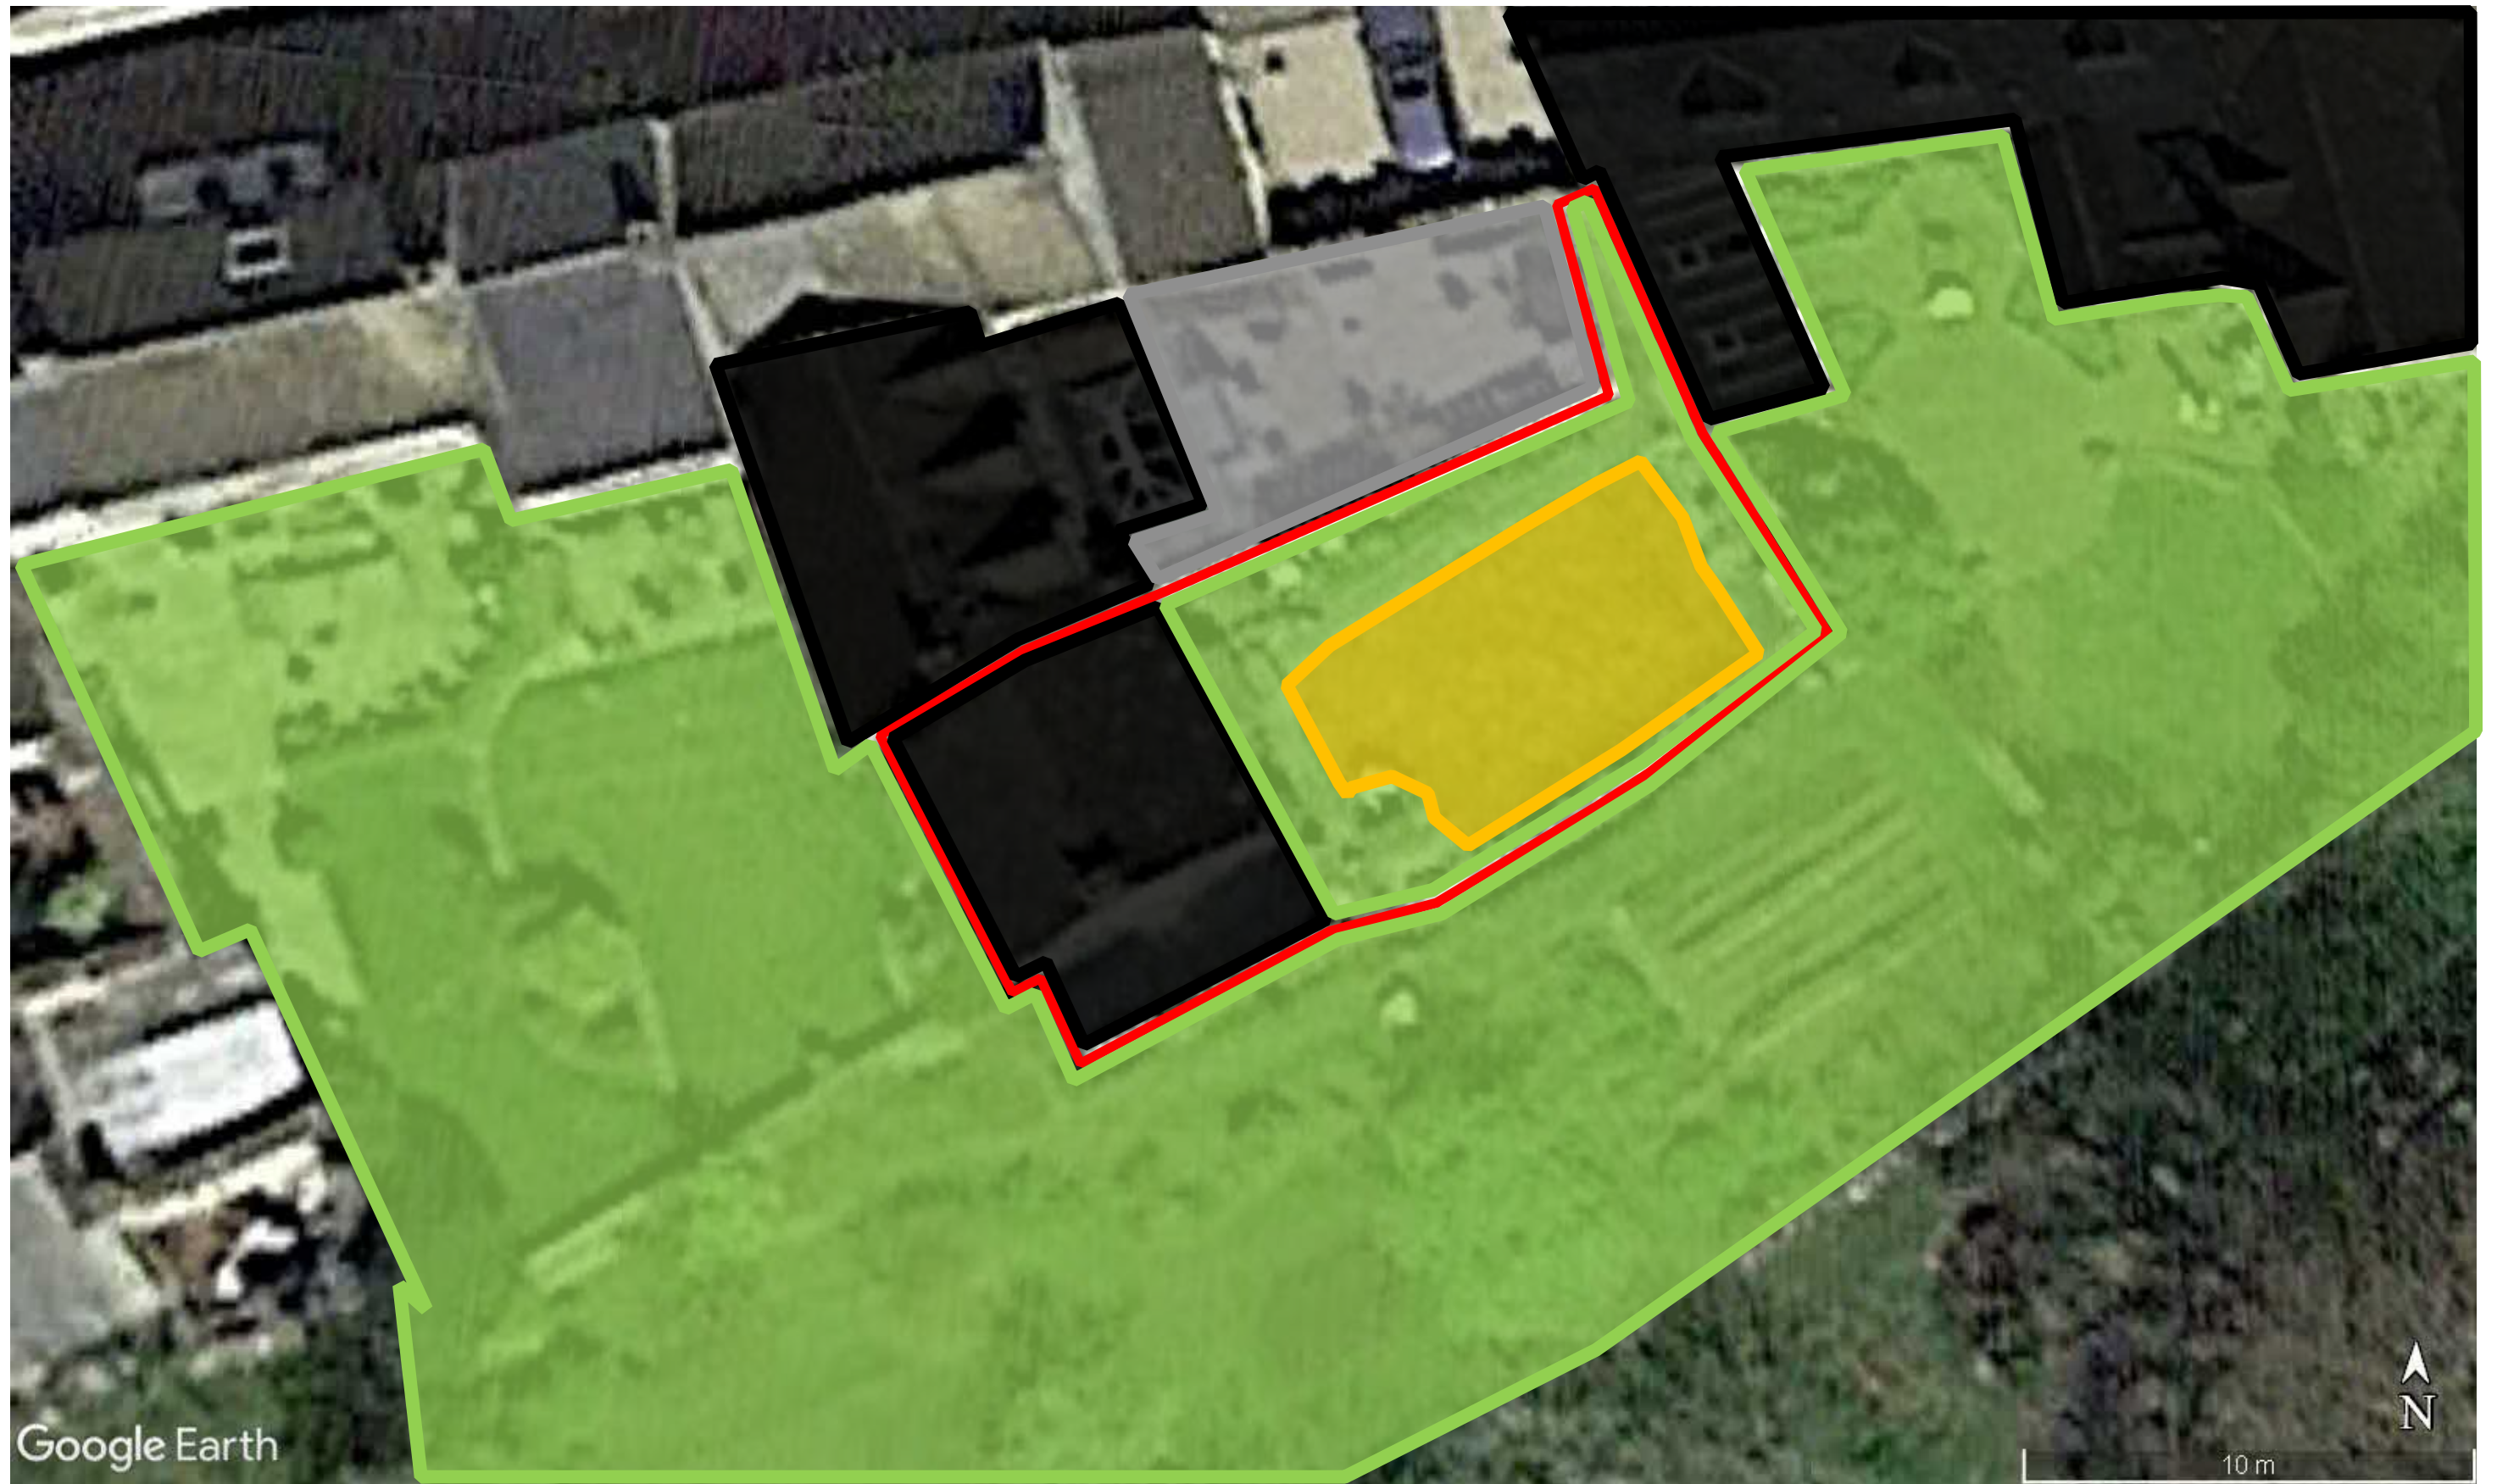
Drawing 01 – UK Hab Classification Plan

# UK Hab Classification Plan of Survey Area

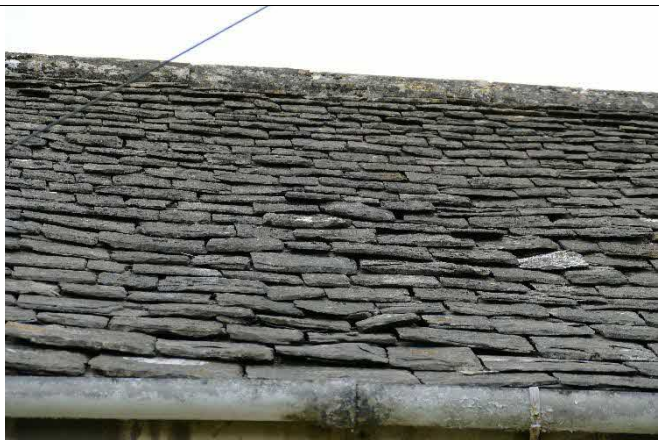
Building Elevation:	Feature No:	Notes:	Photograph:
Northern Elevation	-	No features – Building joined to neighbouring property along this elevation.	N/A
Eastern Elevation	1	Gaps beneath roof tiles – Multiple gaps of varying sizes beneath the irregular Cotswold stone roof tiles. Gaps are present throughout the main roof on the eastern elevation of the building. Such gaps may represent potential roost features for bats, as well as providing access to potential roosting areas between the tiles and roof lining.

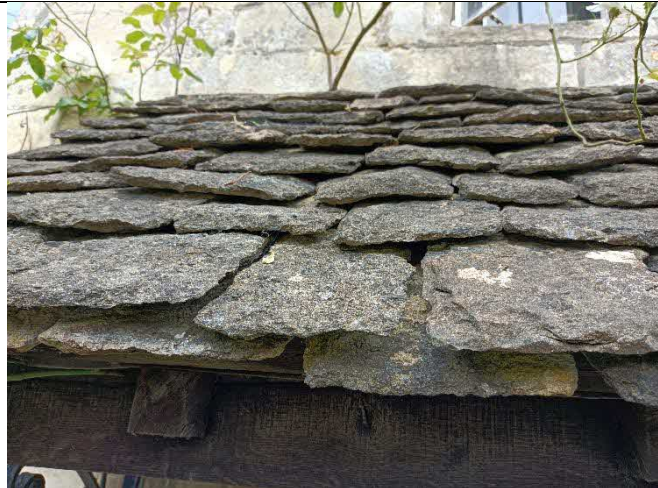
2	<p>Gaps beneath porch roof tiles – Multiple gaps of varying sizes beneath the irregular Cotswold stone tiles on the porch. Gaps are present throughout the small porch roof above the main door to Bentley Cottage. Such gaps may represent potential roost features for bats, as well as providing access to potential roosting areas between the tiles and the bitumen felt roof lining.</p>

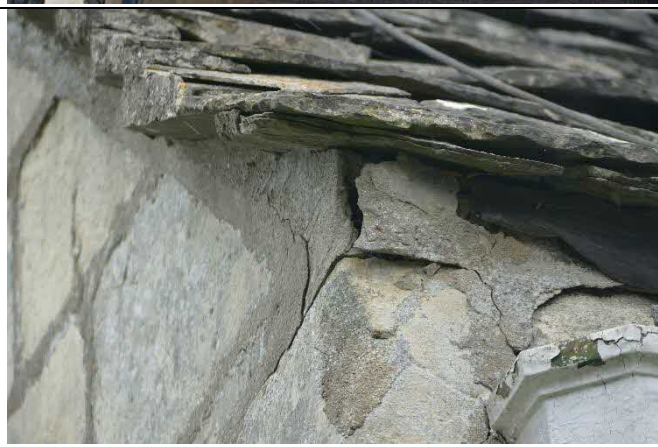
3	<p>Gap in cracked mortar – This gap is located at the wall top beneath the first row of roof tiles. The gap may form a suitable roost feature, or provide bat access to the roof void or areas between the roof tiles and roof lining.</p>

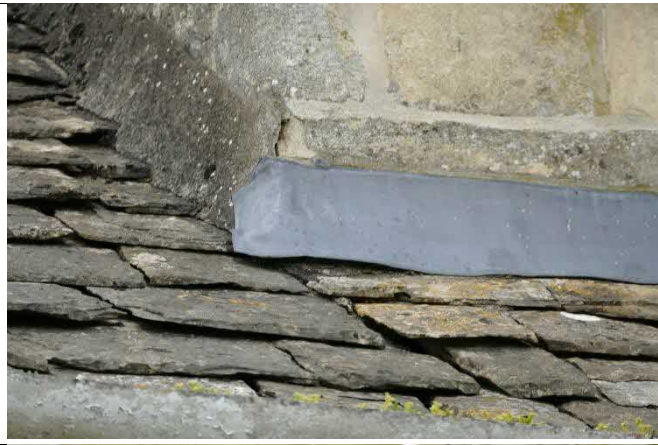
4	<p>Gap beneath lead flashing – small gap beneath lifted flashing that may provide a suitable roost feature for individual bats.</p>

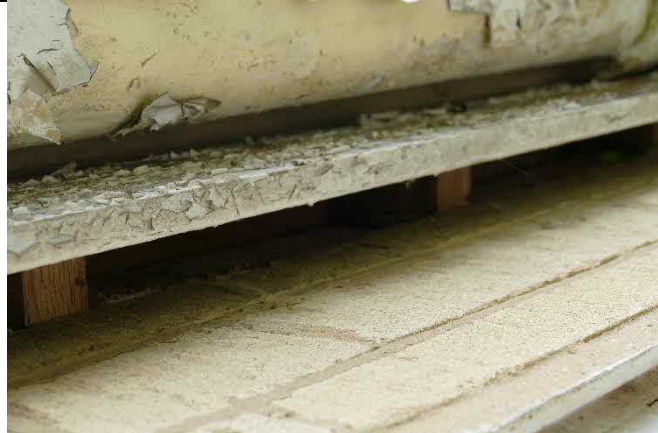
5	<p>Gaps between fascia board and wall – These gaps are on the single storey extension and are too wide to be used as a roost feature. However, the gaps may provide bat access to potential roost locations within the flat roof of the extension.</p>

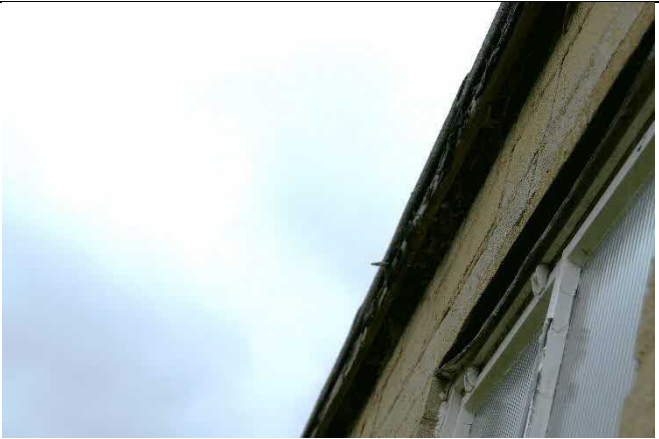
Southern Elevation	6	Gaps between fascia board and wall – These gaps are on the single storey extension and are too wide to be used as a roost feature. However, the gaps may provide bat access to potential roost locations within the flat roof of the extension.

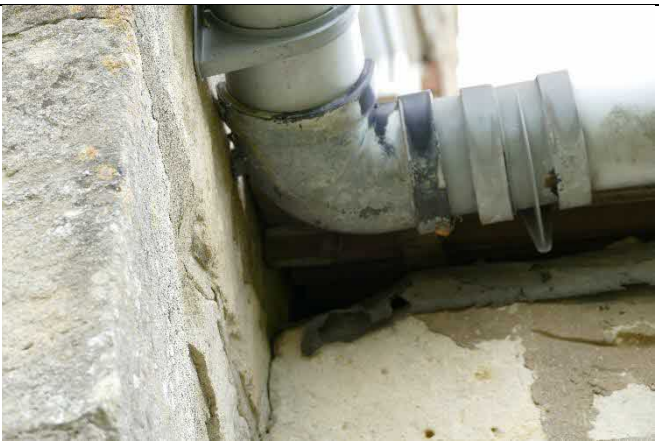
Western Elevation	7	Gap between wall top and roof – Gap / crevice that extends inwards and may provide bat access to the roof void or areas between the roof tiles and roof lining.

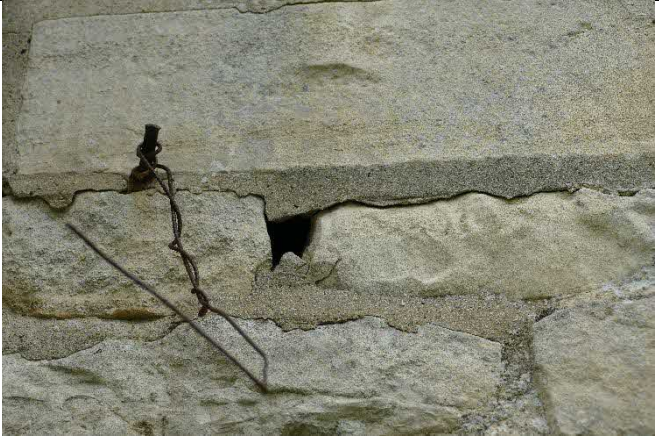
8	Gap in mortar – Small cavity in masonry wall due to missing mortar. The cavity extends inwards a short way, but does not have any evidence of bat roosting.

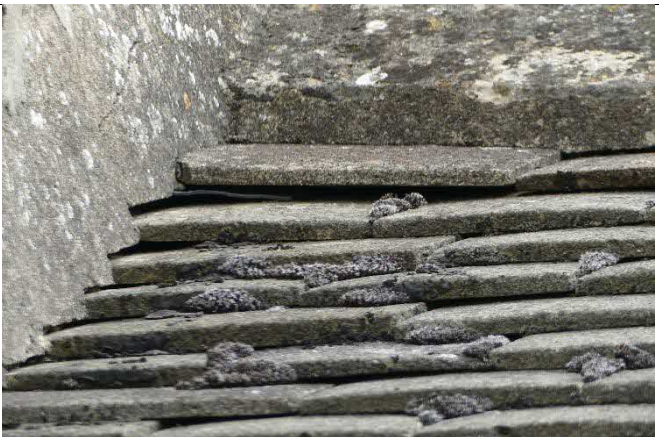
9	Gap beneath roof tile – Small gap between one of the concrete roof tiles that may be wide enough for a bat to roost.

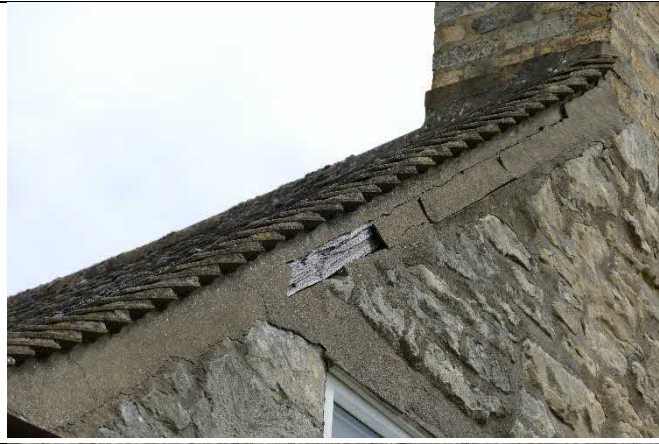
10	<p>Gaps behind loose mortar – This feature is located on the gable end of the neighbouring property but would potentially be affected / disturbed by any development works to Bentley Cottage (and thus has been included here). The feature may provide sufficient space for a single bat to roost.</p>

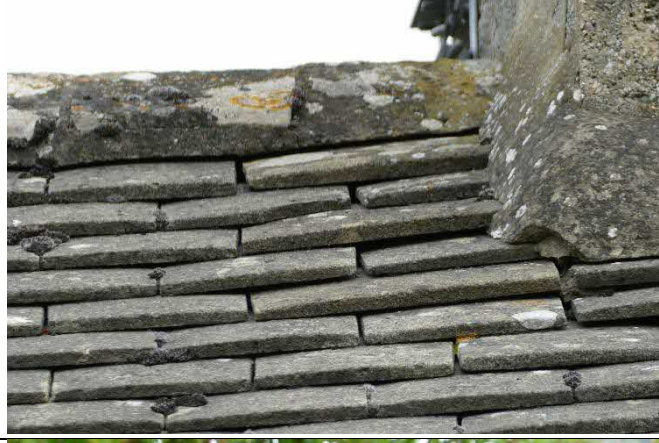
12	<p>Gaps beneath roof tiles – A series of small gaps between concrete roof tiles around the chimney area. The gaps may however not be wide enough for bats to access.</p>

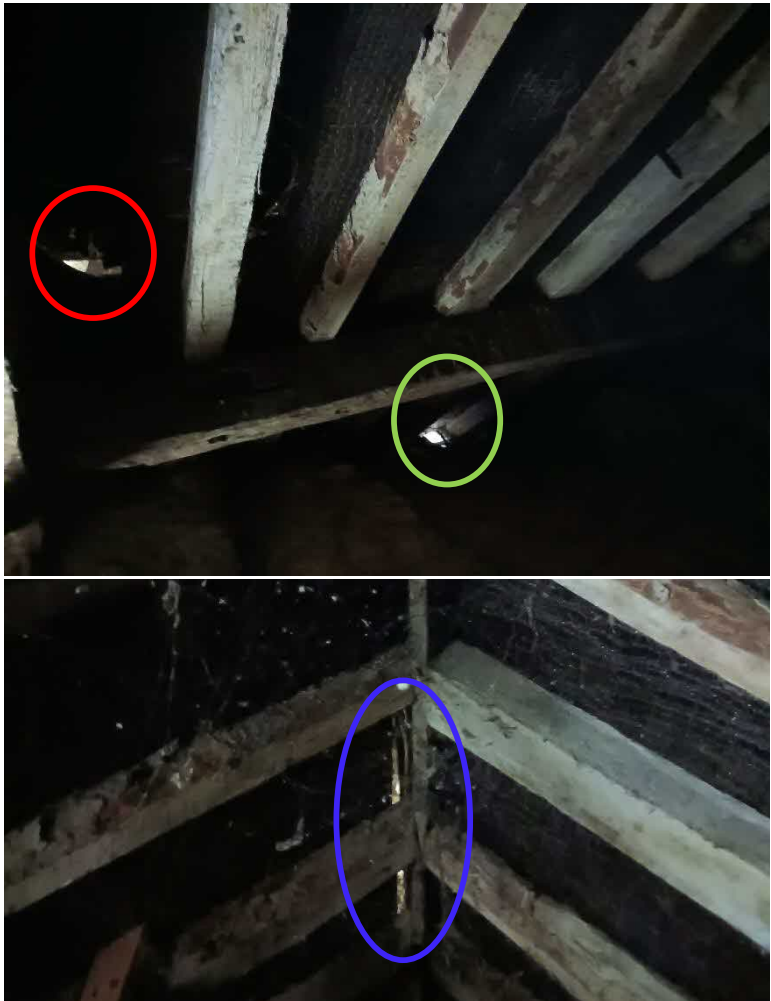
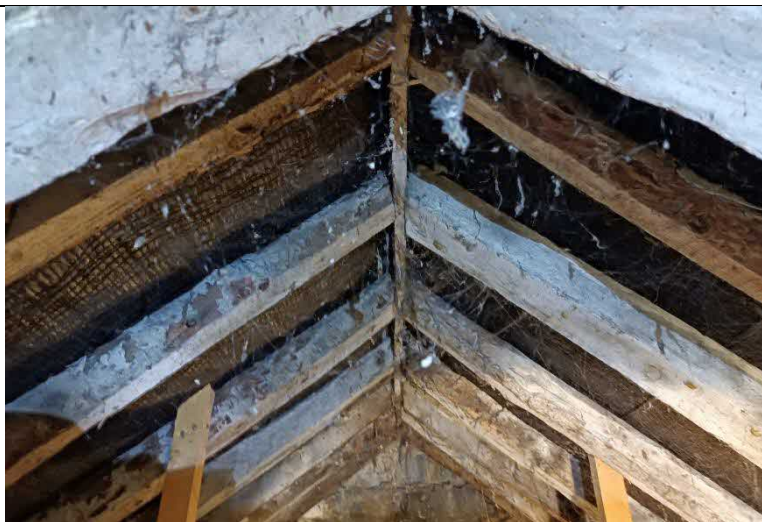
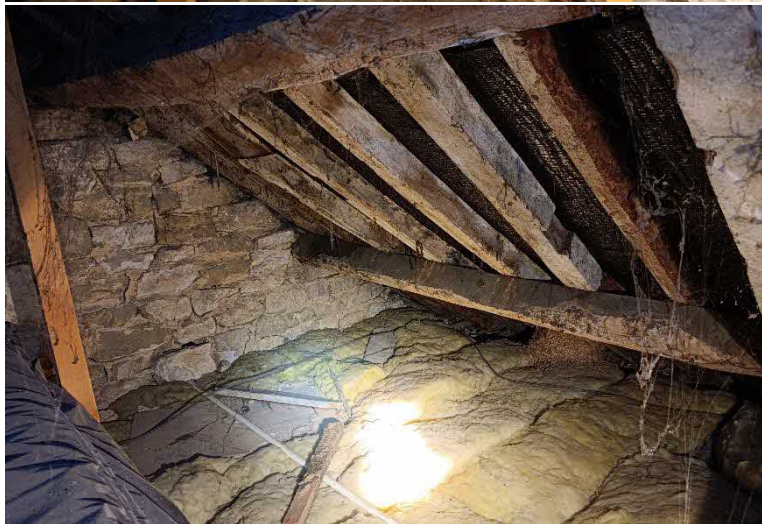
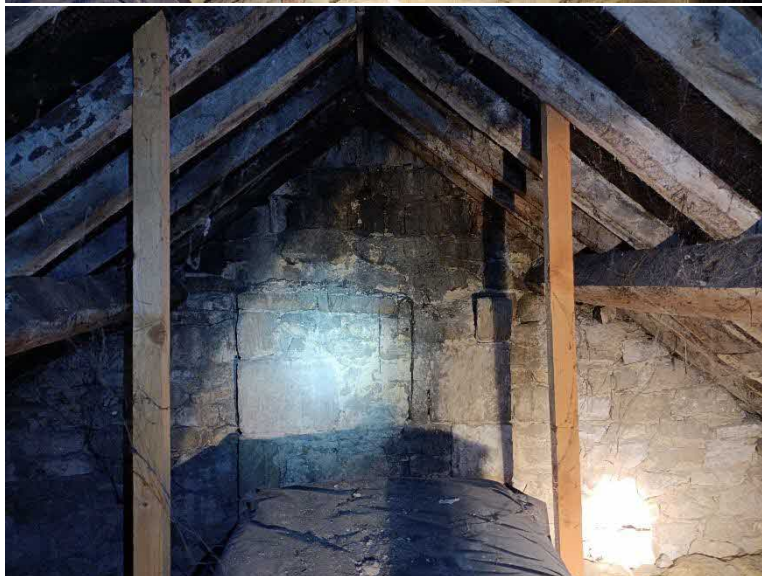
The roof is a traditional timber framed roof with a degraded bitumen-felt roof lining. The roof void is relatively small and is dominated by the water tank which is located in the centre of the roof void. The roof void is not used for storage and was covered in cobwebs throughout (including along the ridge beam). Many of the roof timbers are subject to extensive wood worm activity, and the resulting frass means that the roof void is also particularly dusty. There was extensive evidence (i.e. droppings and gnawed items) of both brown rat (*Rattus norvegicus*) and house mouse (*Mus musculus*) throughout the roof void, as well as several old wasp nests. Light from outside was visible in a number of places within the roof void, indicating that there are potential access routes into the roof void from the exterior of the building. The roof void was 19.9°C and 55% relative humidity at the time of survey on 3<sup>rd</sup> July 2023.

Building Section:	Notes:	Photograph:
Roof Void	<p><u>Potential Bat Access Locations:</u></p> <ul style="list-style-type: none"> <li>Tears in the bitumen felt roof lining (circled in red)</li> <li>Gap between the wall top and roof (Feature 7 in Table A3-1 above) which allows light into the roof void interior (circled in green)</li> <li>Gaps in bitumen felt along the ridge beam with light visible (circled in blue).</li> </ul> <p><u>Potential Bat Roost Features:</u></p> <ul style="list-style-type: none"> <li>Along the ridge beam (although the presence of extensive cobwebs throughout the roof void would suggest that there has been little or no bat activity).</li> <li>Between the roof tiles and bitumen felt roof lining.</li> </ul>

Evidence of Bat Activity:  
There was no evidence of bat activity in the roof void. Brown rat and mouse droppings were both present.

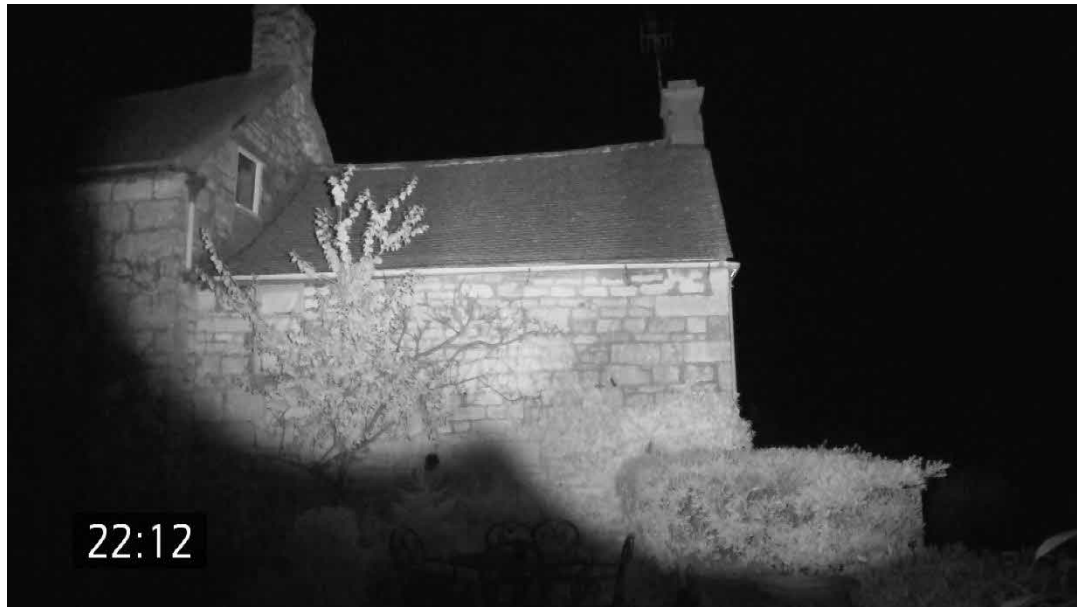
21:53	Noctule – Single distant pass, bat was heard but not seen.
Summary:	No bat emergence recorded. Overall, relatively low levels of bat activity, with mostly common pipistrelle passes recorded. Occasional passes of Leisler’s, serotine, noctule and soprano pipistrelle.	
Infra-red Camera View (taken at end of survey):

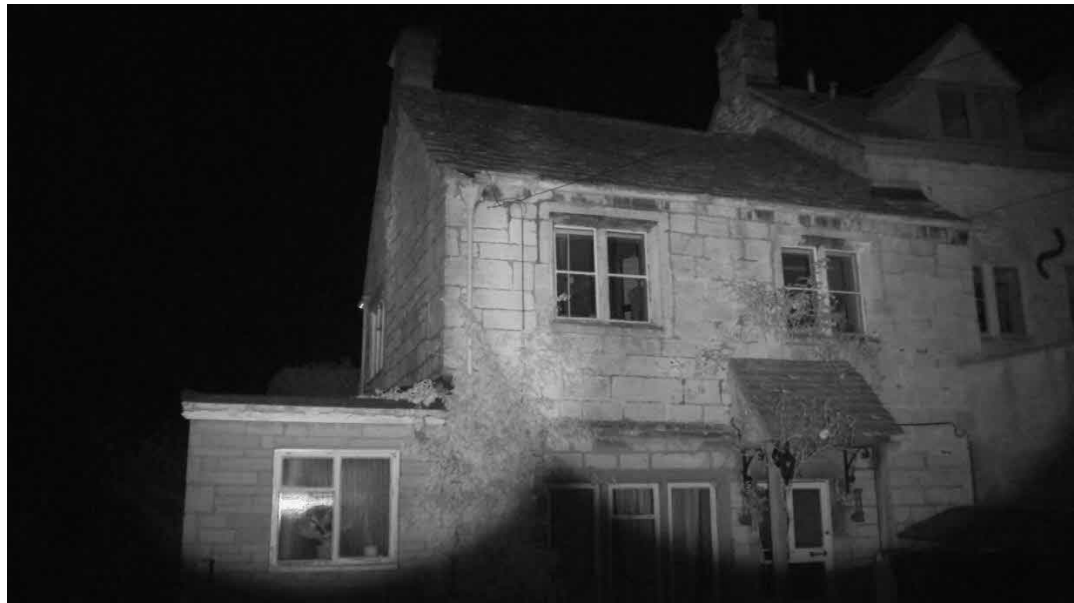
22:04	Common pipistrelle – Seen foraging southwards over site and survey area.
	Summary:	No bat emergence recorded and no obvious flight lines or commuting routes identified. Relatively low levels of bat activity recorded, mostly comprising common pipistrelle commuting / foraging passes. Occasional passes of Leisler’s and noctule.
Infra-red Camera View (taken at end of survey):

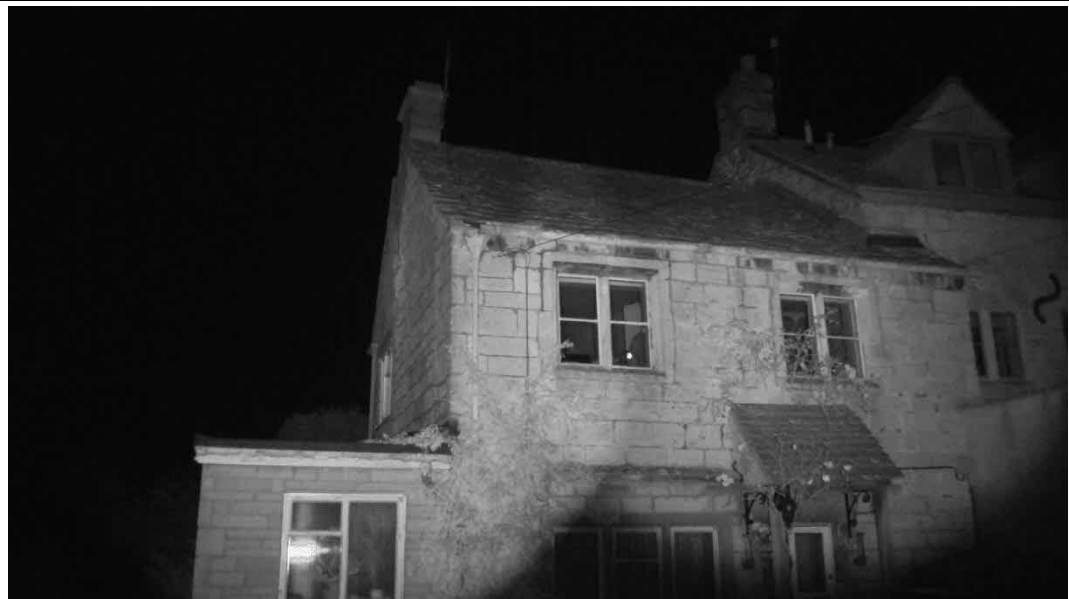
<p>Summary:</p>	<p>No bat emergence recorded and no obvious flight lines or commuting routes identified. Relatively low levels of bat activity recorded, mostly comprising common pipistrelle commuting / foraging passes. Occasional passes of noctule, with single passes of serotine, lesser horseshoe and brown long-eared bat.</p>	
<p>Infra-red Camera View (taken at end of survey):</p>

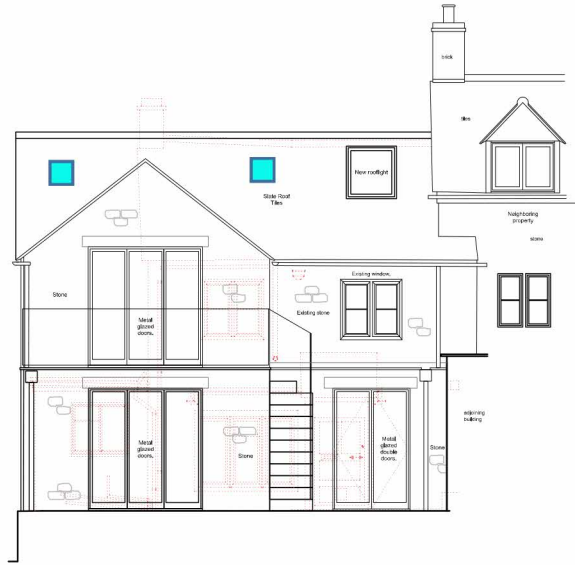
EAST ELEVATION

# Biodiversity Enhancement Plan

Bat Box – There are a number of different designs available that can be retro-fitted to the walls of new buildings post-construction to give a discrete but long-lasting enhancement. The installation of a single ‘woodstone’ bat box (Beaumaris Woodstone Maxi Bat Box or similar-sized equivalent) suitable for crevice dwelling bat species is recommended to replicate the nature of potential roost features lost as part of the

development. It is recommended that one box is installed immediately below the soffit box on the wood clad section of western elevation to ensure the box is located away from windows;

Sparrow Boxes - Sparrow terraces are considered an appropriate ecological enhancement due to the sub-urban location of the site and the species being listed as a Bird of Conservation Concern due to a recent significant decline in numbers. The installation of two 'woodstone' sparrow terraces is therefore recommended (Vivara Pro WoodStone House Sparrow Nest Box or equivalent) to the western end of the building's southern elevation; and

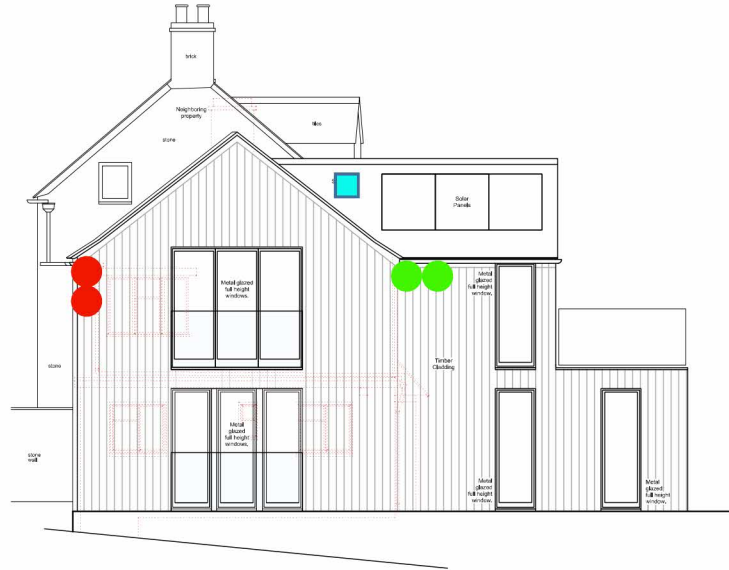
SOUTH ELEVATION

Swift Boxes - The installation of two 'woodstone' swift boxes is also recommended (Vivara Pro Madrid Swift Box or equivalent) in the central section of the building's southern elevation. Swifts are listed as a Bird of Conservation Concern with the decline of the species partly linked to a lack of suitable nesting sites.
