ROSEBANK

BAT SURVEY & MITIGATION

FEBRUARY 2024

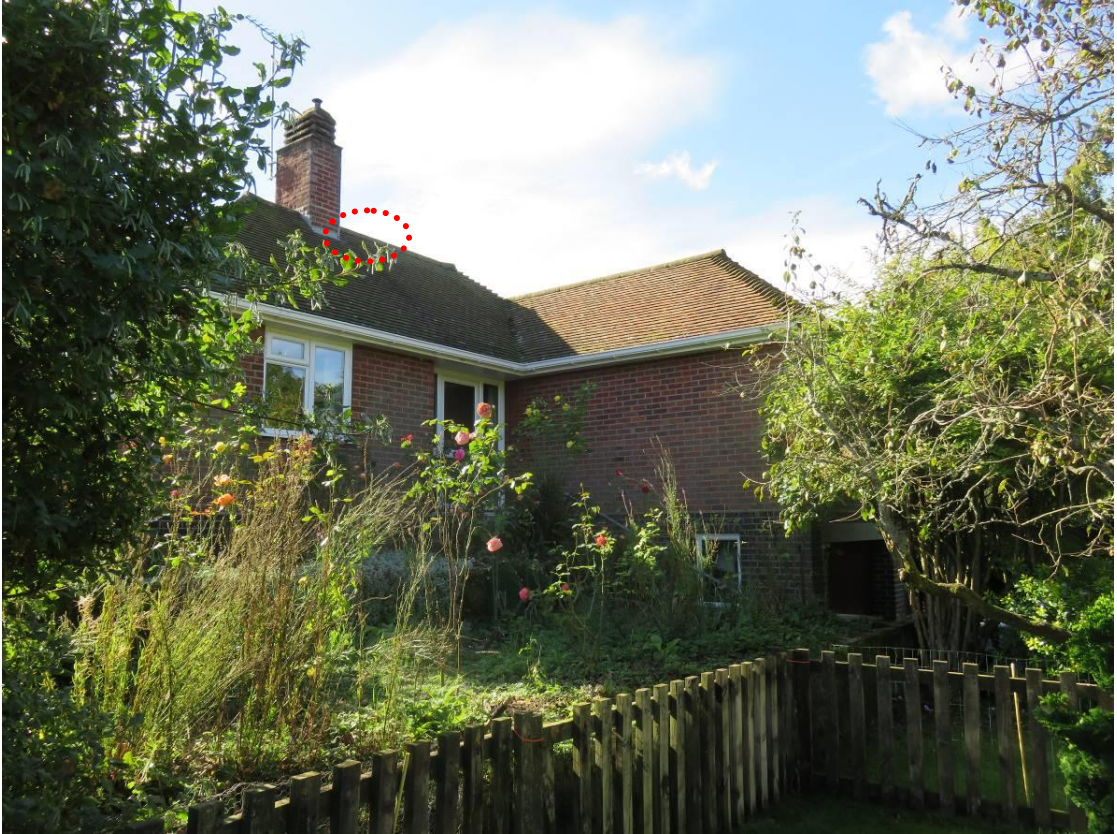
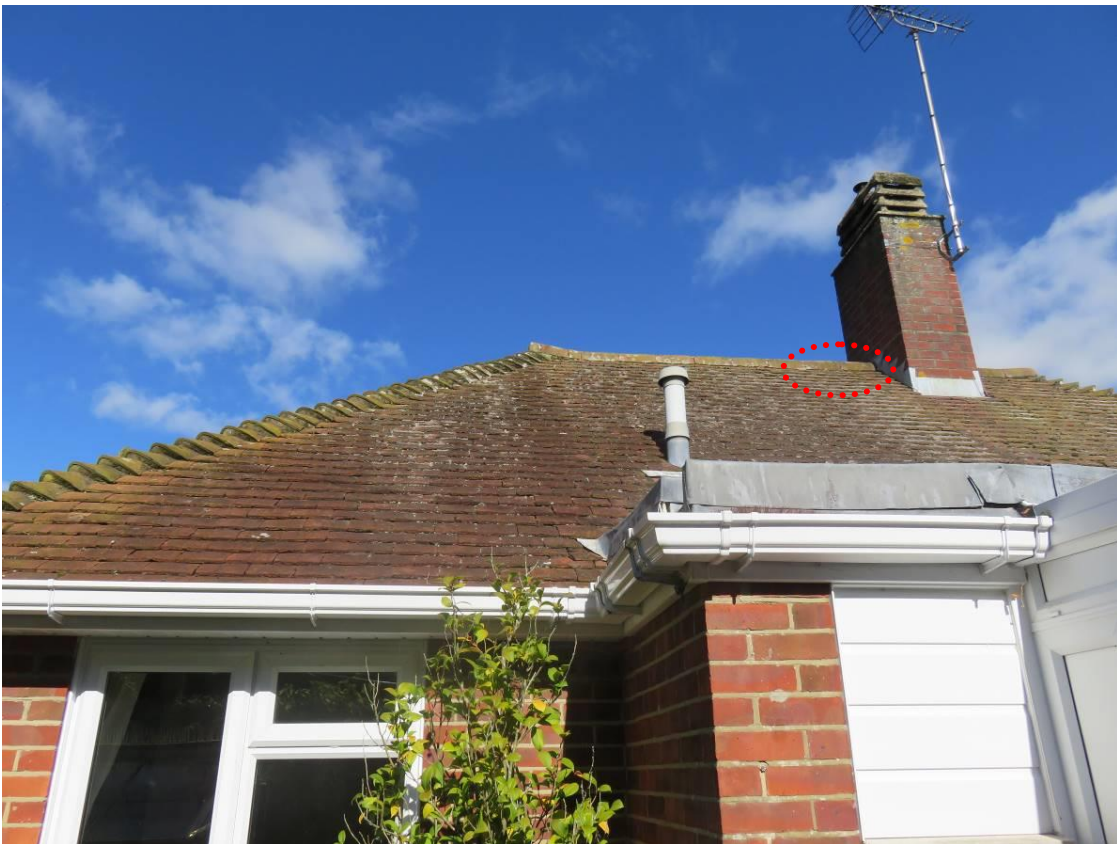
The site is sloping and adjacent to a range of well-spaced residential houses on a road leading out to the rural areas of the Village. See **Photos 1 to 4** of the site. The brick bungalow and garage with concrete interlocking tiles sites between a rural drive and road. The design and age of the building generally presents limited suitable roosting opportunities within the structure. Suitable roosting gaps were located within the property roof structure only (see **Photos 5-17**). There were in particular gaps on the north and south side, just under the ridge tiles by the chimney, a favoured roost location. Internal examination of the loft located c6 droppings under two areas of roof apex. Dropping evidence indicates infrequent use of the void but use of the ridge tiles could not be further quantified fully. Survey confirmed potential roosting.

Photo 1/2 Rosebank (front North and south aspect) ridge tile gap indicated

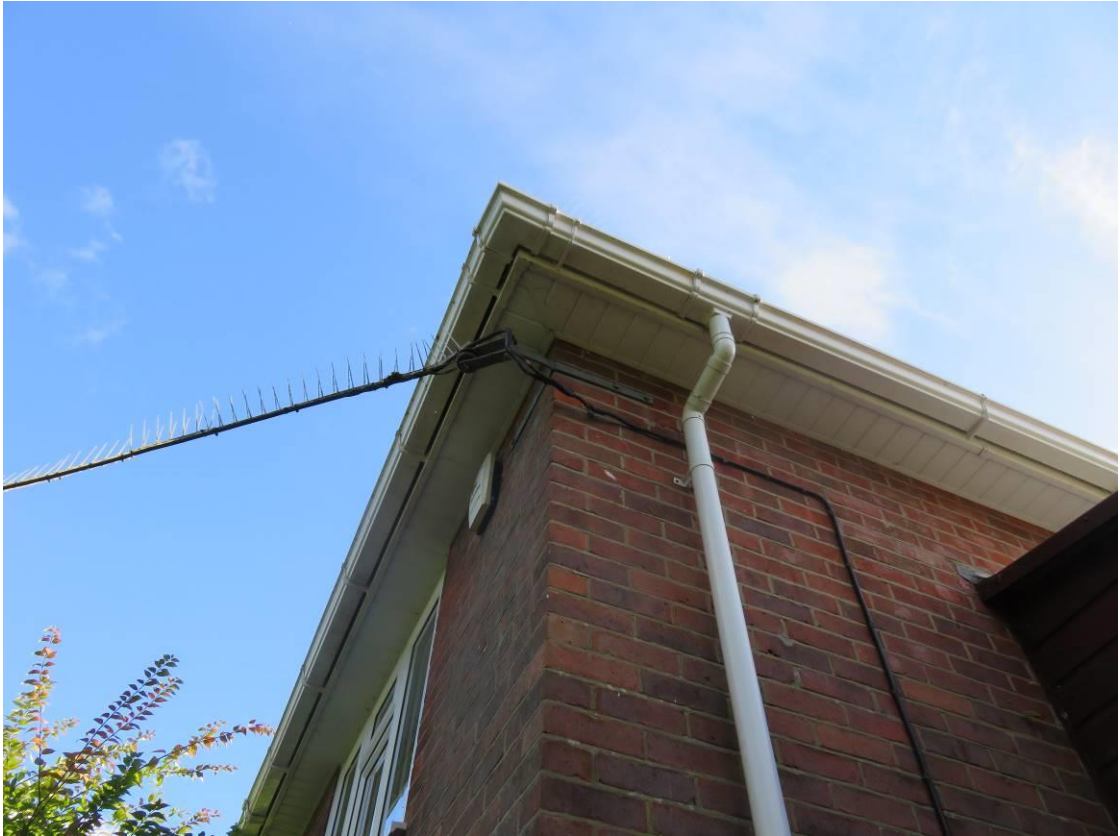
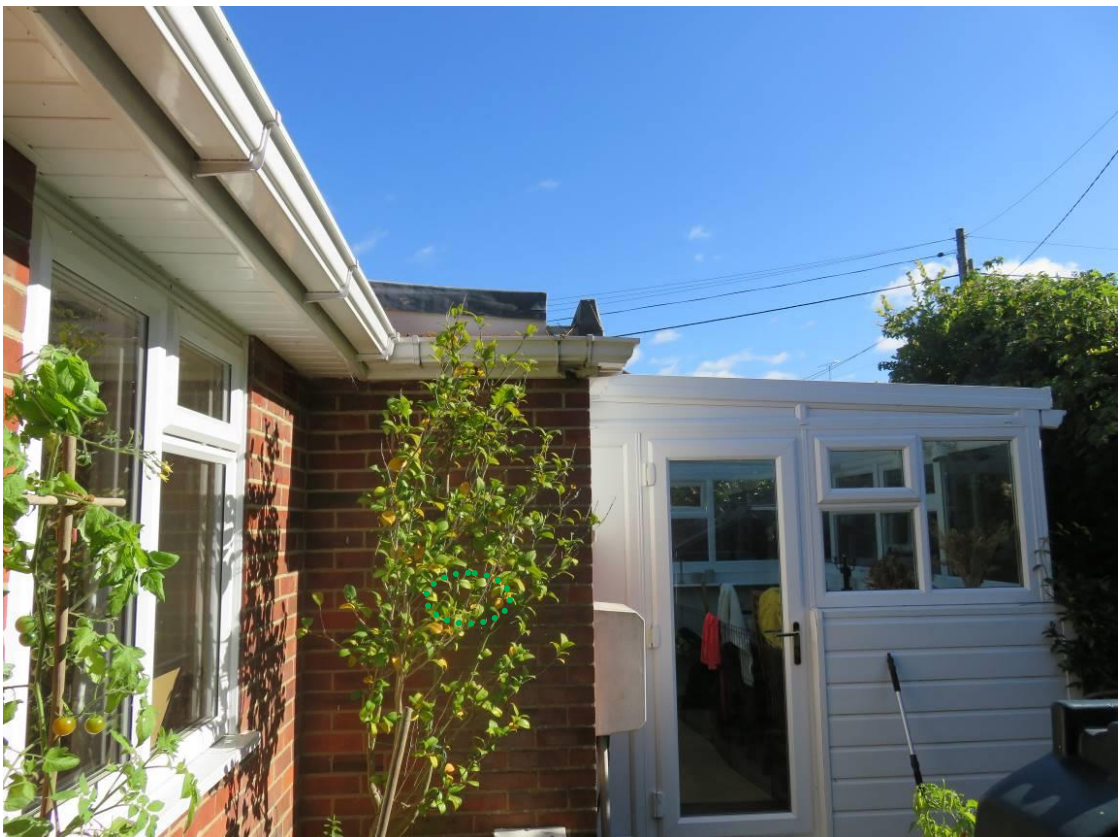
Photo 5/6 Rosebank (south aspect) no potential recorded evidence or potential recorded within eaves and soffit structure

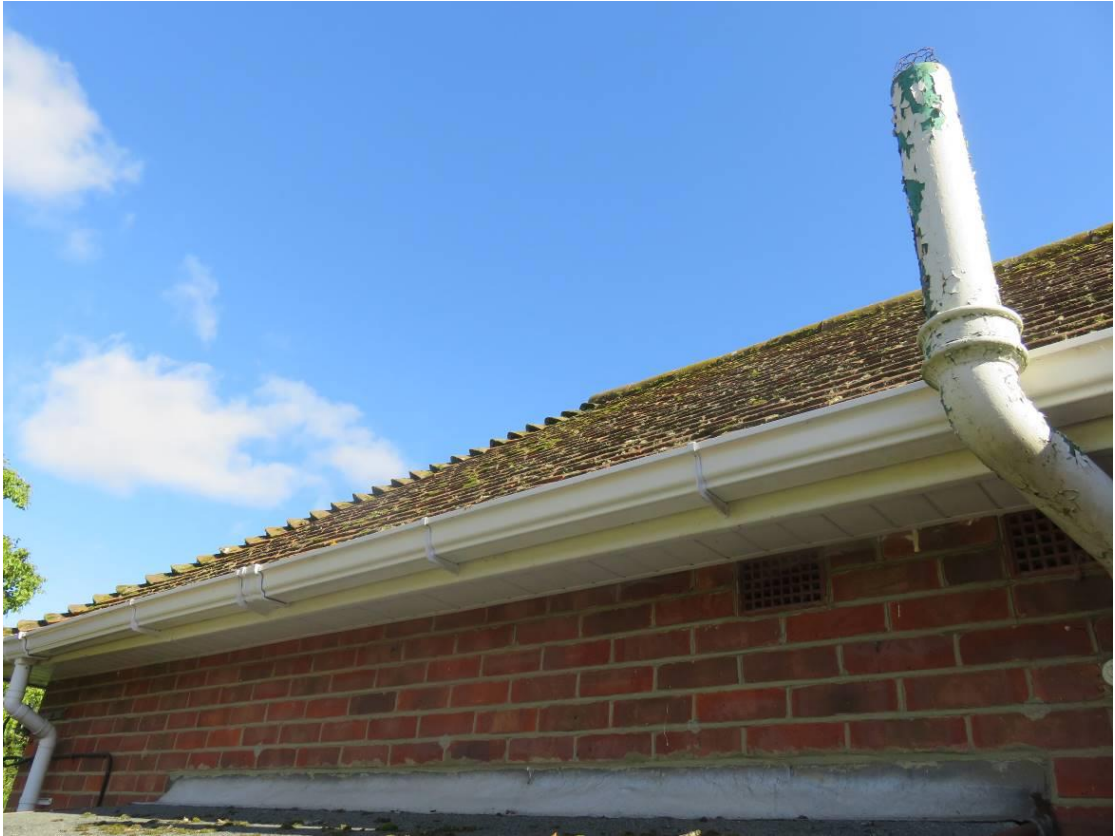
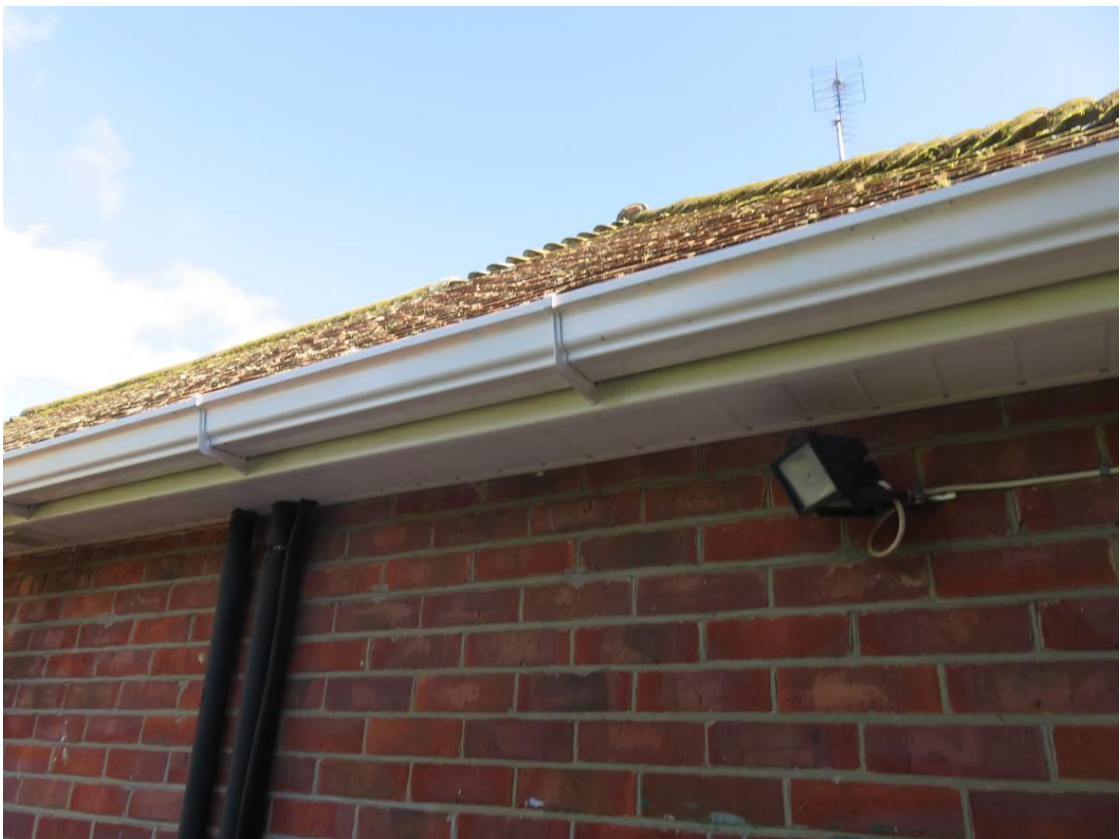
Photo 7/8 Rosebank, no potential recorded evidence or potential recorded within eaves and soffit structure

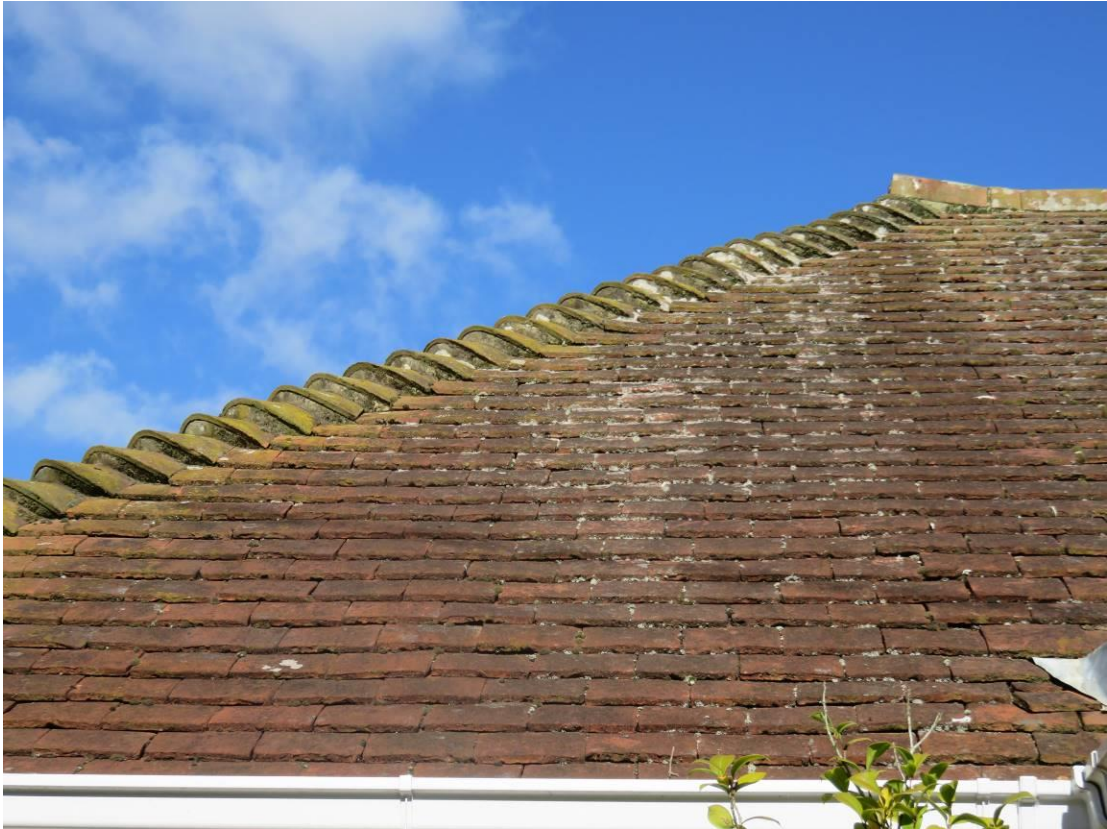
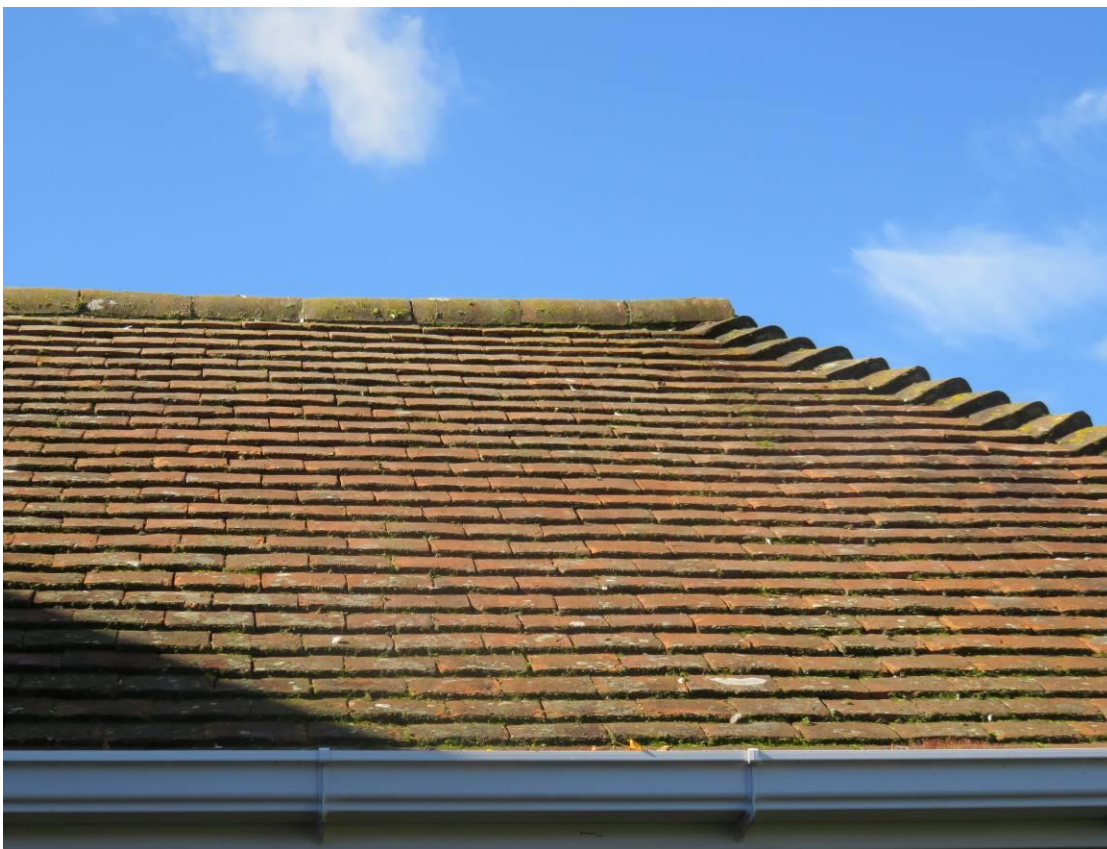
Photo 9/10 Plain tiles. These provide limited bat access potential unless damaged or lifting. Hips and Ridge tiles generally very well pointed with no access gap other than two areas of ridge and tile gaps beneath.

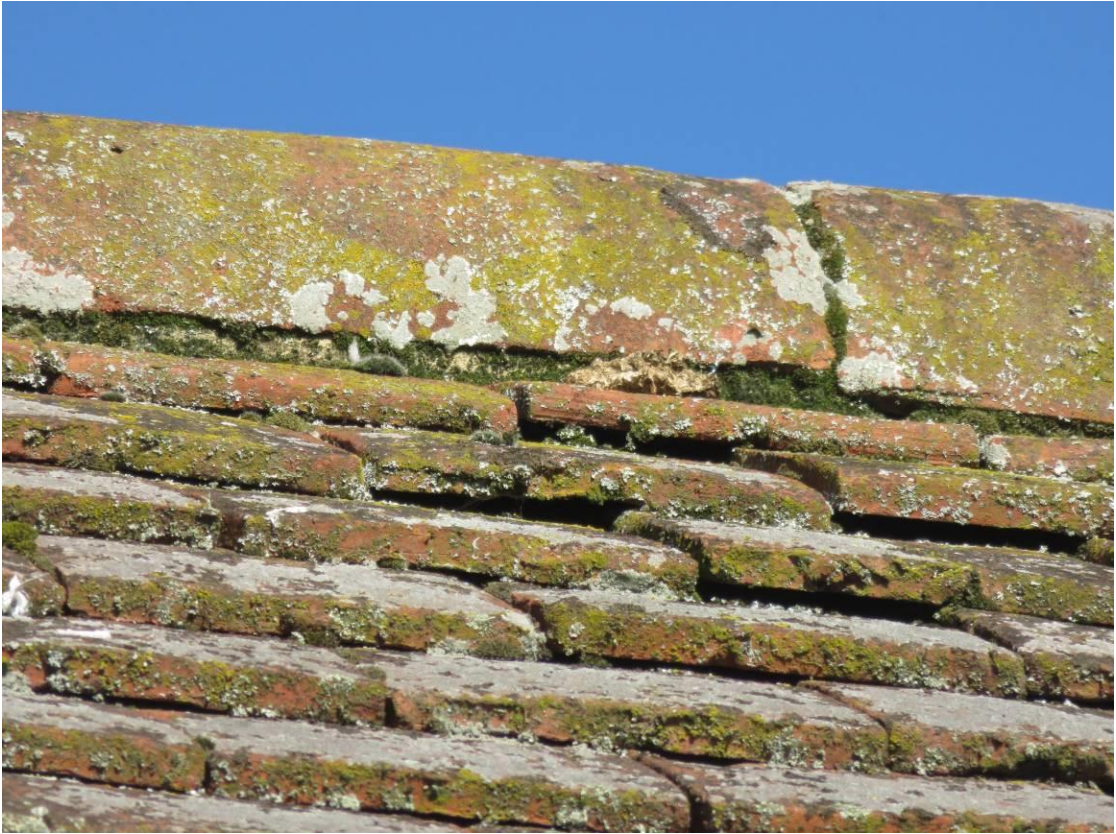
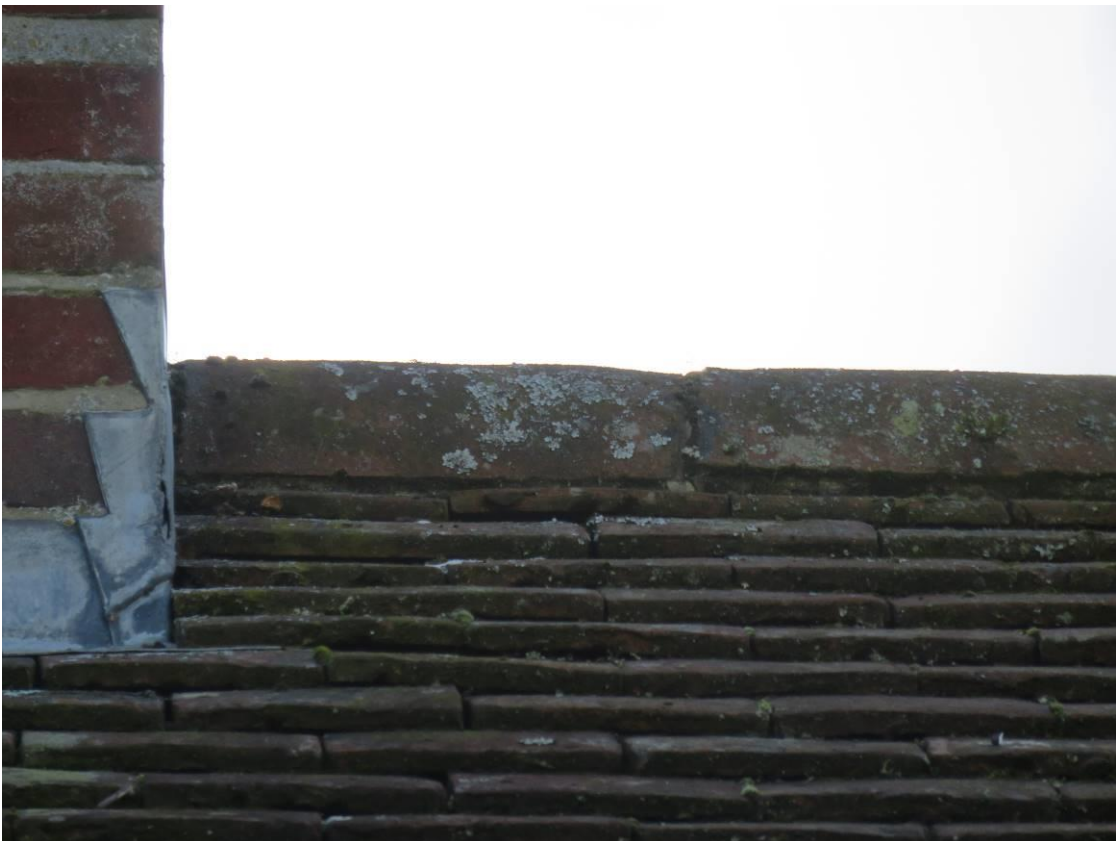
Photo 11/12 Plain tiled roof with two areas 1 north 1 south aspect by chimney with very suitable tile gap just below ridge tiles.

- 2x2fr Roost unit will be built into the new walls of the replacement building (see **Figure 7**). This will be as mitigation and scheme enhancement. The handmade clay tile roof will also provide further niche roosting opportunity.

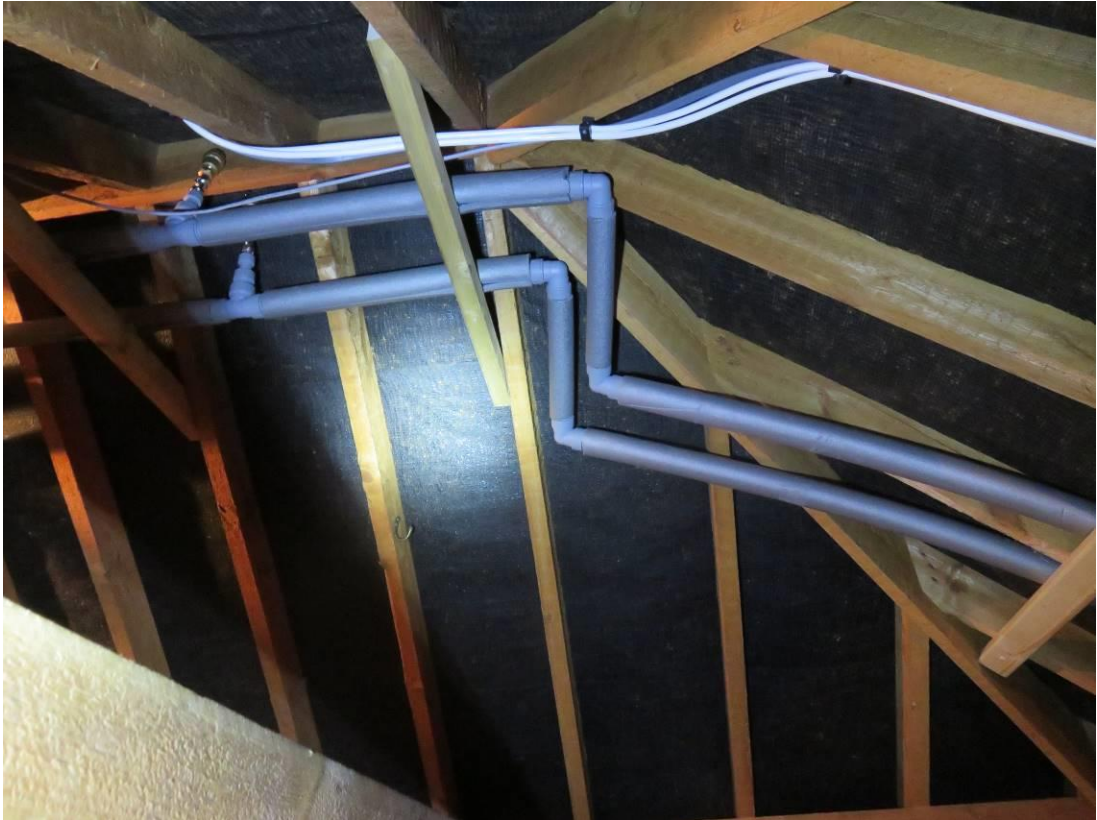
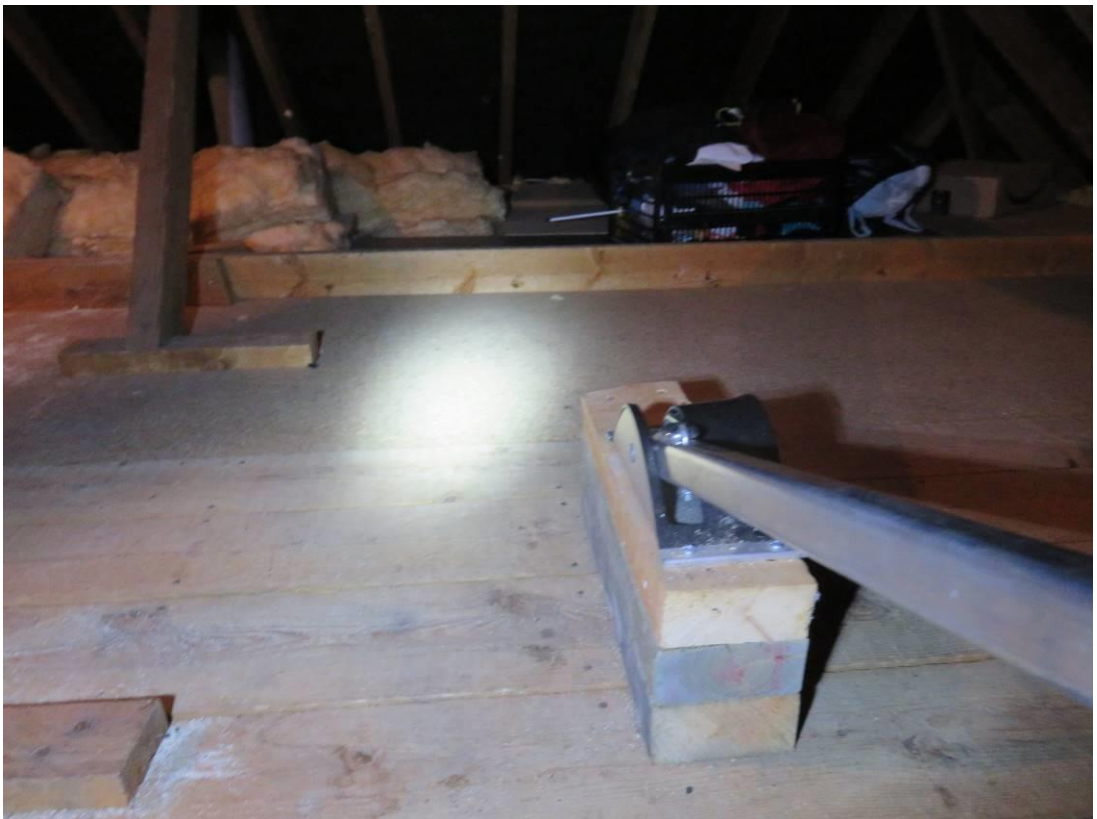
Photo 13/14 internal roof area of building with no long-term accumulation of cobwebs.

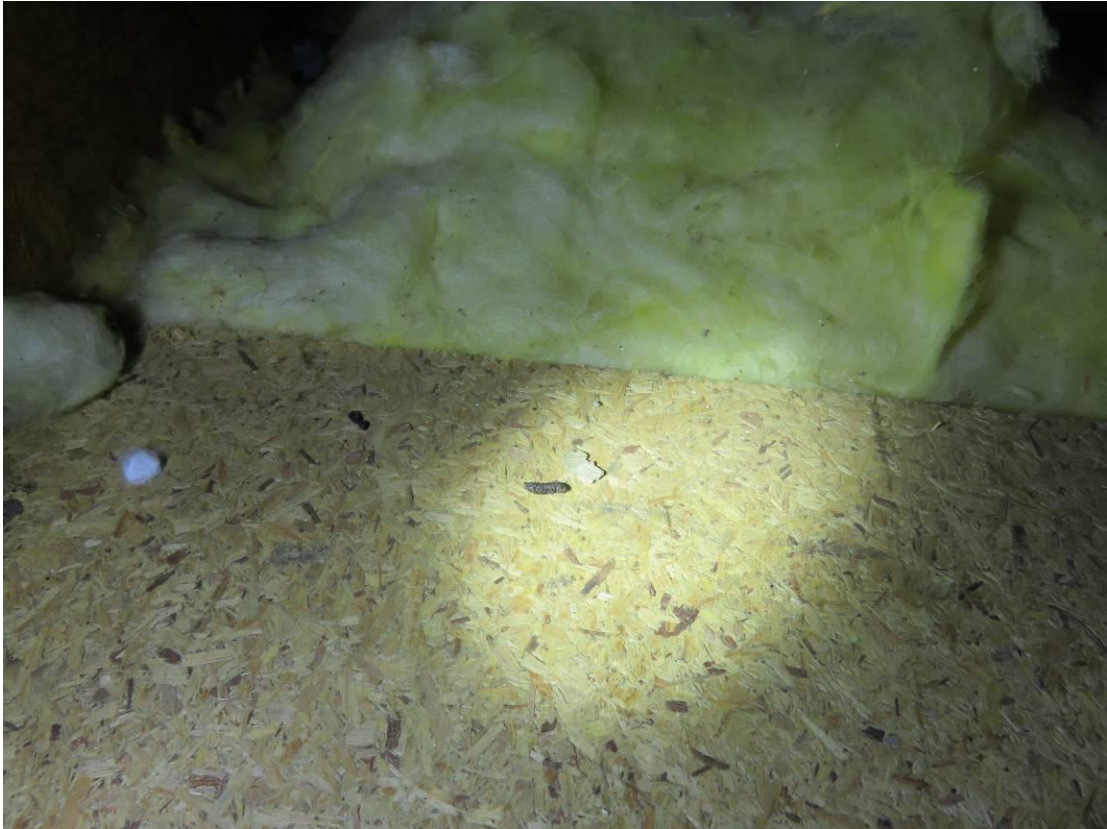
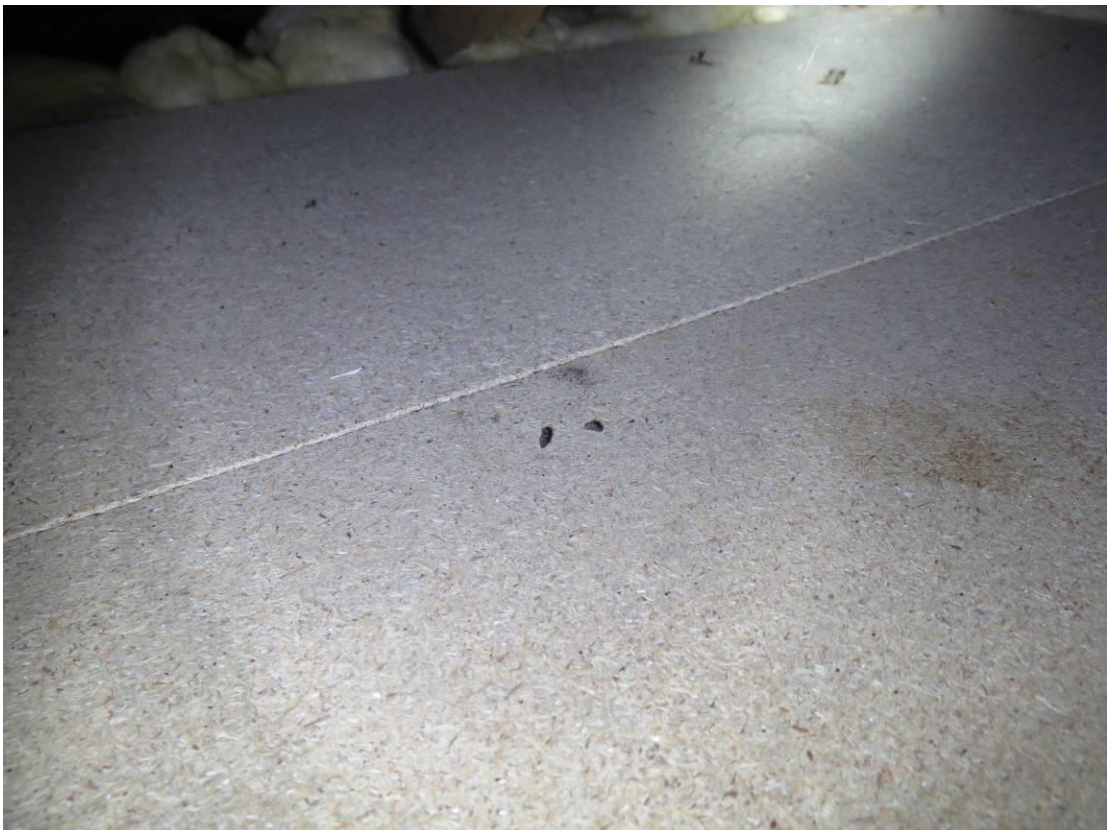
Photo 15/16 internal roof area of building with no long-term accumulation of cobwebs. Evidence internally of Brown Long-eared bats recorded, with a few droppings.

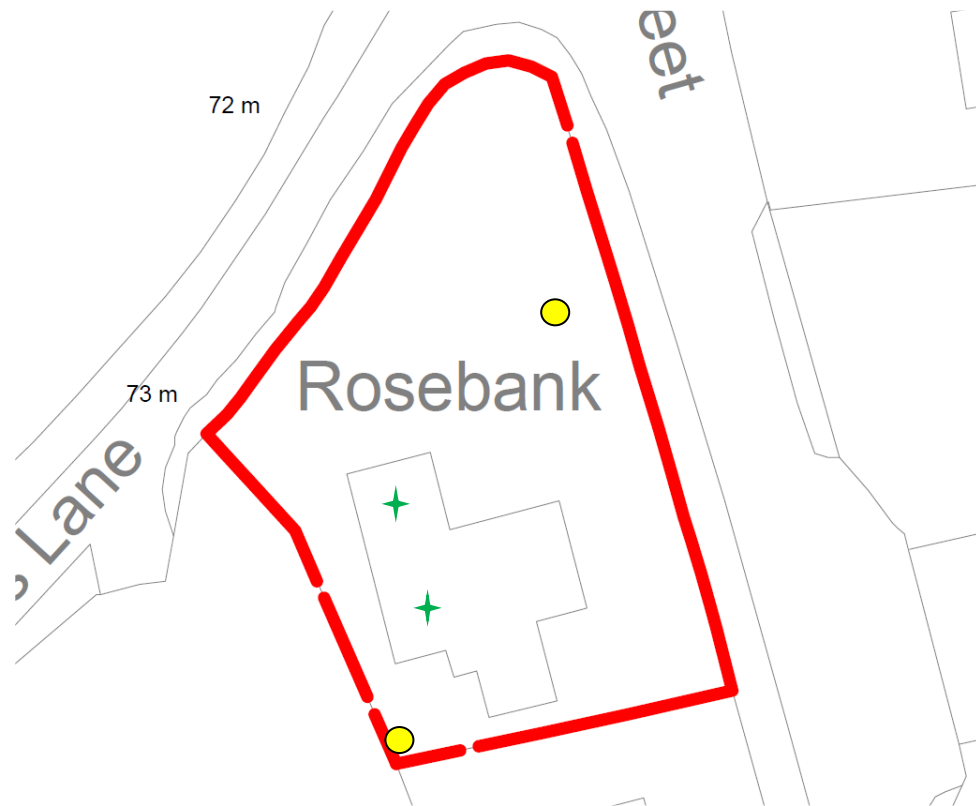
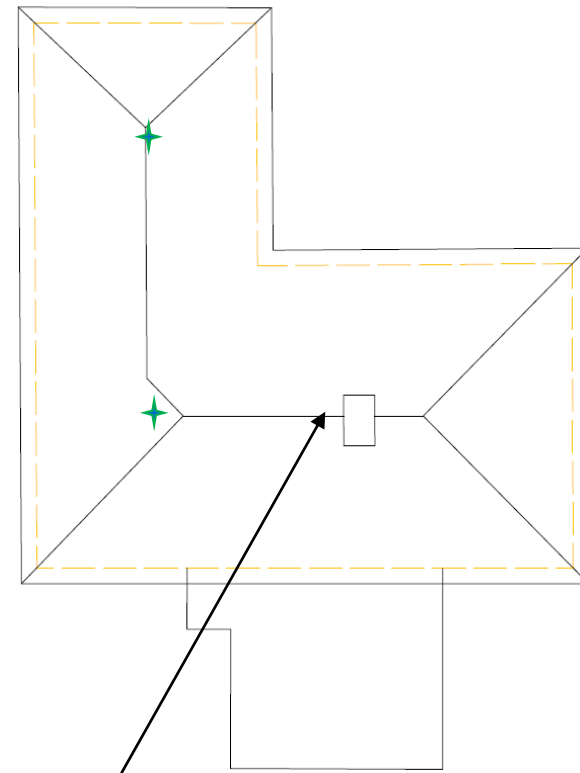
Figure 5 Survey Results

Key		
Brown Long-eared droppings	(in void)	★
Potential Roost entrance	↗	
Main Survey locations	●

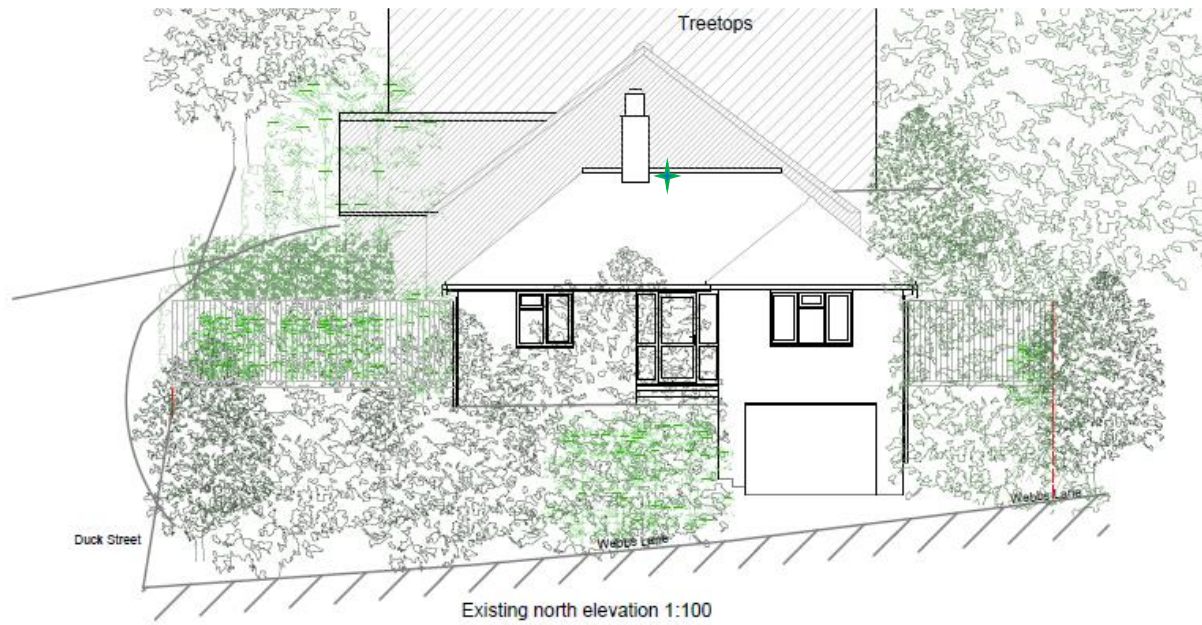
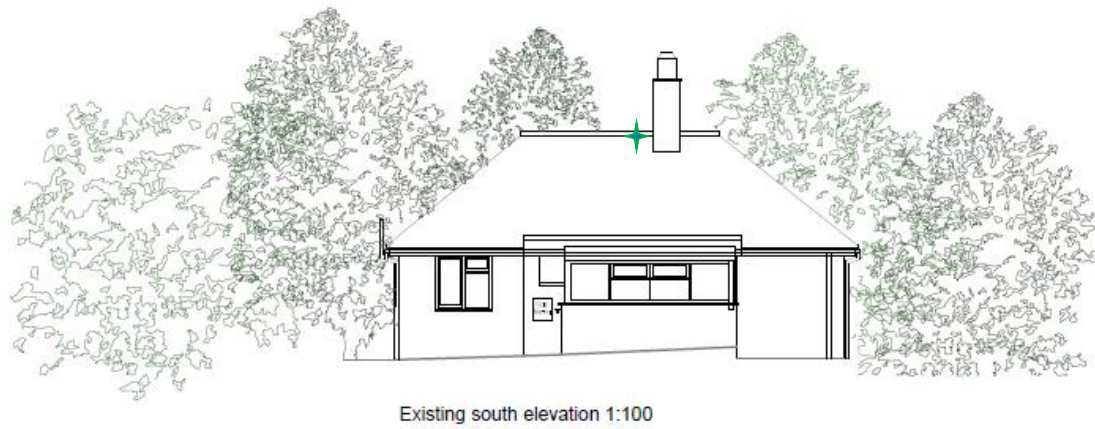
Figure 6 Survey Results

The daytime bat survey was then supplemented by emergence survey applying the standard methodology using the Bat survey guidelines (Bat Conservation Trust, 2016). Results are included in **Table 1, Figure 6** below. Bat survey recorded no roosting / use of the house from the survey to date. In addition, Common Pipistrelle, Noctule Bat and Serotine were all recorded foraging / commuting over the site during survey work

- Brown Long-eared (droppings in roof void)
- Potential Roost entrance/exit
- Tile gap ✦

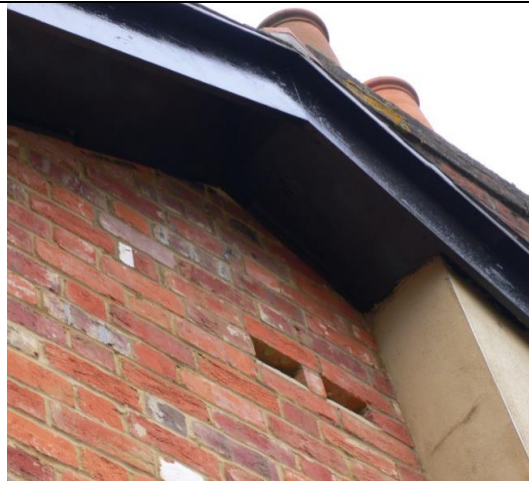
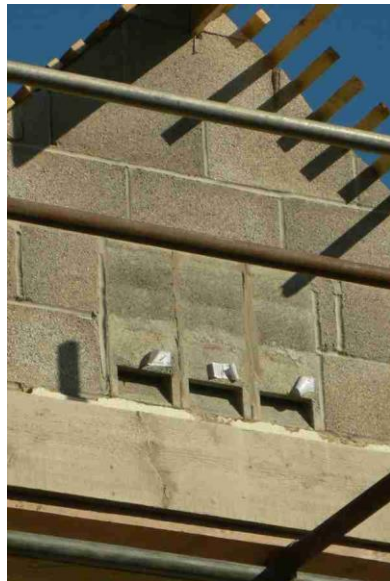
<p>Figure 7a</p> <p>Schwegler 1FF</p> <p>The 1FF has an opening at the bottom, allowing droppings to fall out, it does not need cleaning and is therefore especially suitable for hanging in inaccessible places such as steep slopes and house walls.</p> <p>Depending on their individual temperature requirements, the animals can choose between the cooler wood-concrete or the warmer wooden panel</p>	 
<p>Figure 7b</p> <p>Schwegler Bat Roost Unit 2FR</p> <p>Dimensions: height 47.5 x width 20 x depth 12.5 cm, Entrance: width 15 x height 2 cm, Weight: ca. 9,8 kg</p> <p>The same as a 1FR but with knock-outs to allow</p>

- Prior to starting works a Schwegler Bat roosting box (1x 1FF) (**Figure 7**) will be installed within a nearby tree within a nearby tree within the garden to provide alternative roosting during the works and to increase local roosting opportunity longer term;

Roosts opportunity will be incorporated into the scheme. This will include a Schwegler 1ff roosting unit within the garden, with 2fr roost units incorporated into replacement dwelling (see **Figure 7**)

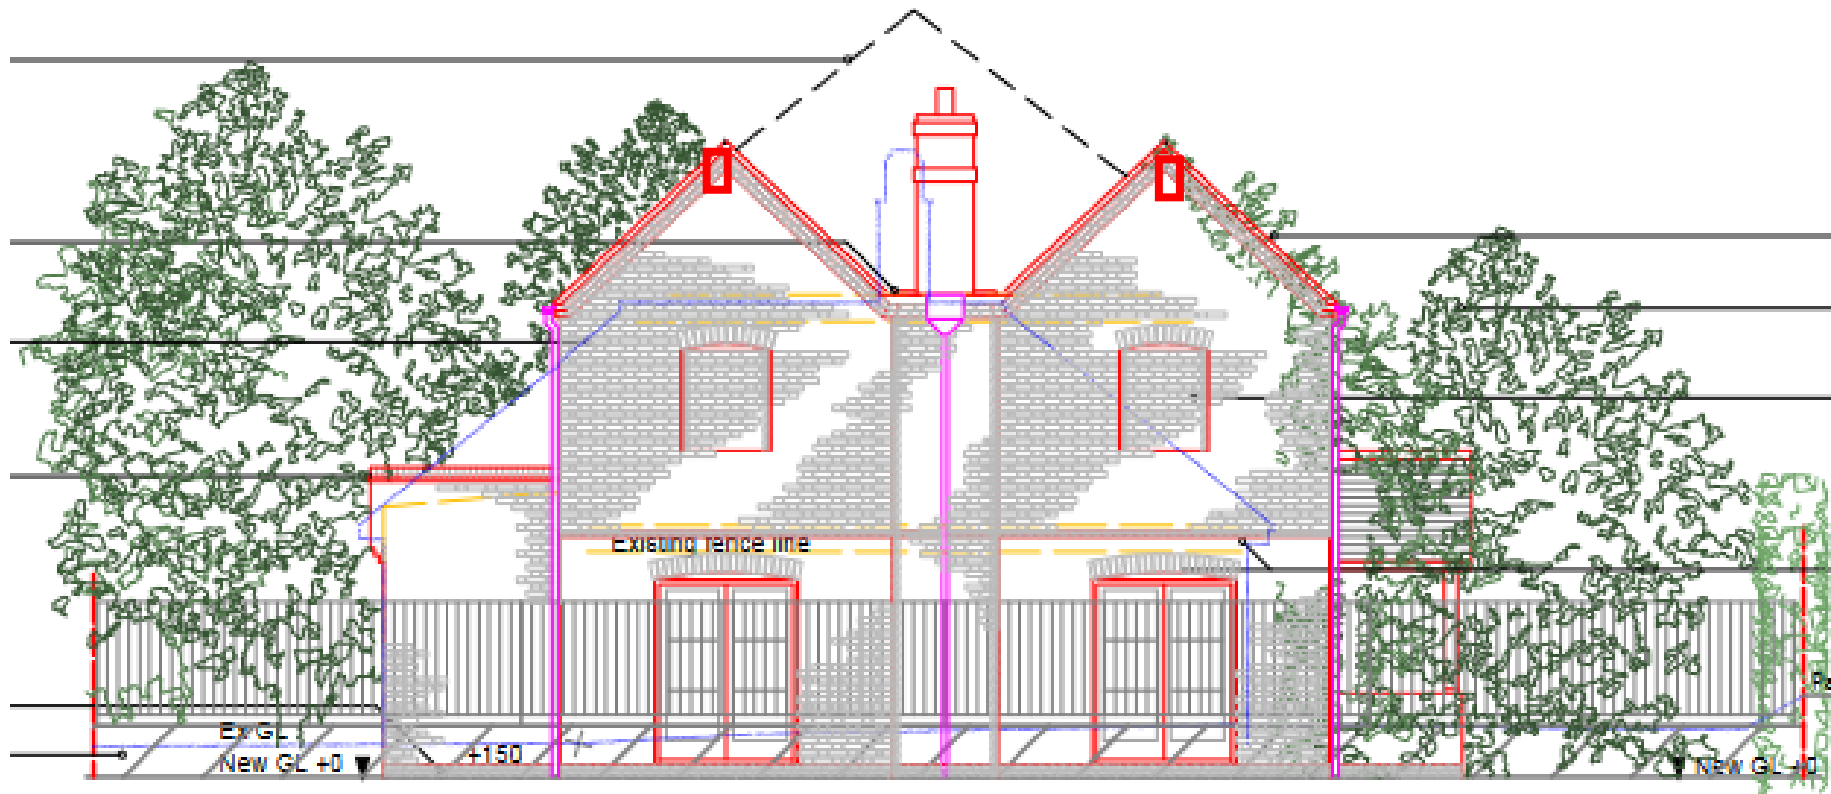
Figure 7c Mitigation / enhancement 2fr Roost Unit

Proposed south elevation 1:100

The mitigation proposal is based on allowing access to roosting opportunities within the new building (see **Figure 7**). The new roost sites will be sympathetic and complimentary to the building design.
