**Bat Survey Report for
1a Mill Lane, Old Marston,
Oxford, OX3 0PY**

26th September 2023

1a Mill Lane, Old Marston – Bat Survey Report

Report Number: 4596-CWS-01

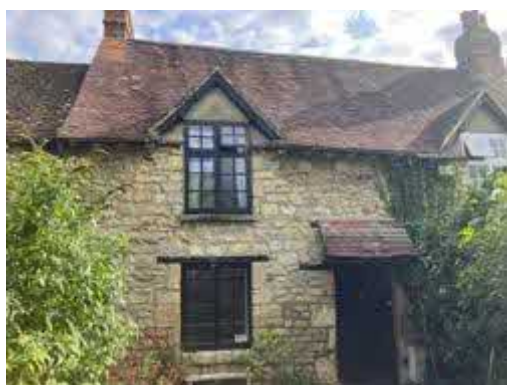
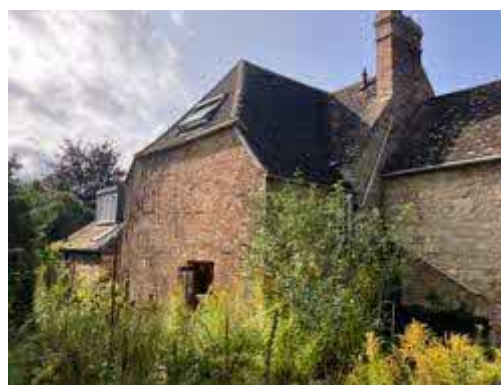
Figs. 1 & 2 1a Mill Lane

The survey site comprised a terraced cottage with a pitched roof and a hipped roofed rear extension (Figs. 1 and 2)

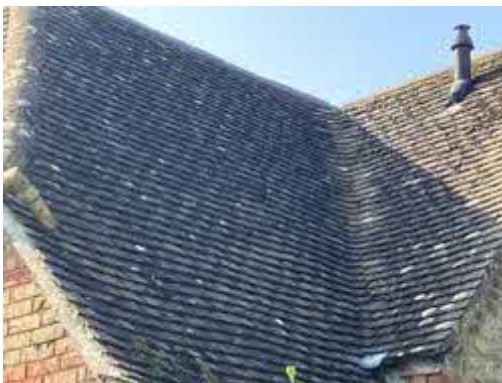
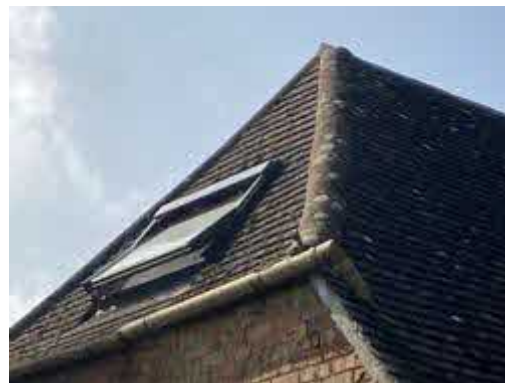
Figs. 5 & 6 Ridge and roof tiles to the rear

The ridge and hipped ridges were intact, whilst the roof tiles to the rear were tightly overlapping, with none raised, missing, broken or dislodged (Figs. 5 and 6).

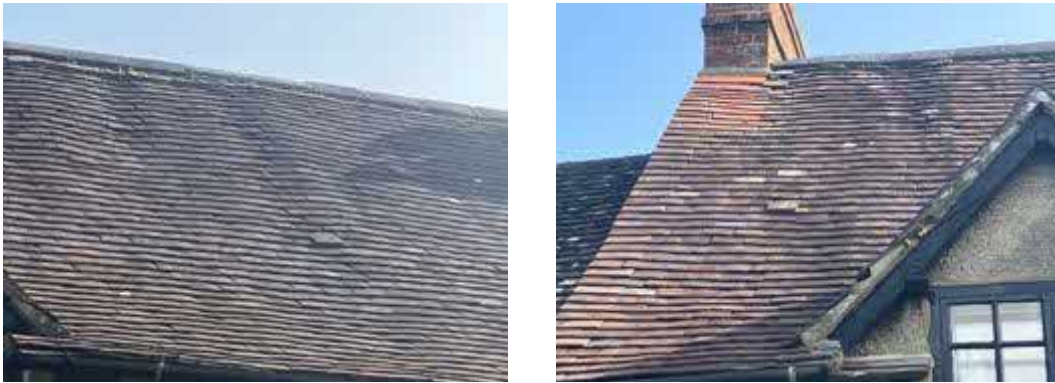
Figs. 7 & 8 Ridge and roof tiles to the front

The suitability for roosting pipistrelles *Pipistrellus sp* was considered to be negligible. Although there were a few gaps under the roof tiles on the west roof slope, this section was unlined and as such all gaps led directly into the roof void and not into a small cavity. No evidence of bat activity or occupation were found.

The roof tiles to the front were much older and unlined, with several raised and a few slipped tiles (Figs. 7 and 8).

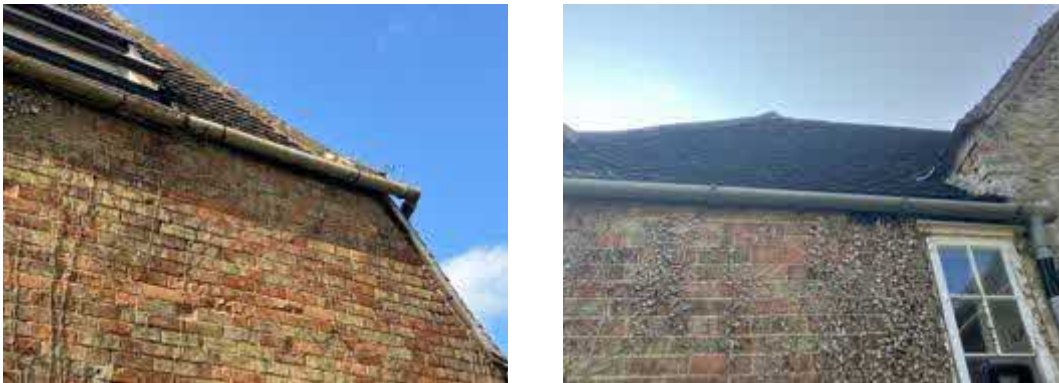
Figs. 9 & 10 Eaves

The eaves were clipped and closed all round (Figs. 9 and 10).

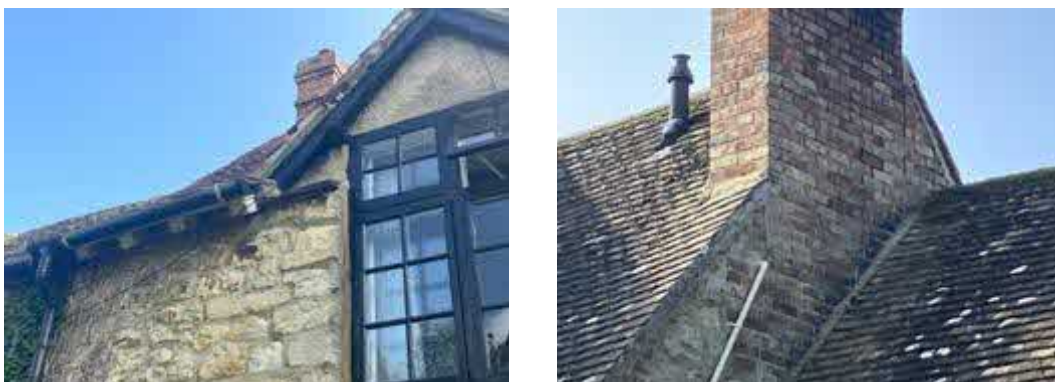
Figs. 11 & 12 Gables

The dormer windows were finished with a timber barge board tightly fitting to the wall, whilst the north gable end of the house was finished with the roof verges cement sealed (Figs. 11 and 12). A couple of areas of missing cement on the roof ends of the dormer windows was noted, but these gaps were all found to be unsuitable for roosting bats due to either being too shallow or choked with cobwebbing.

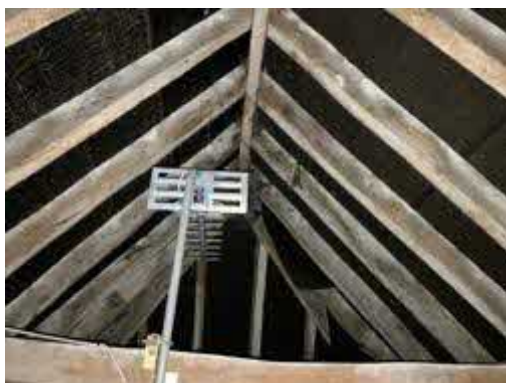
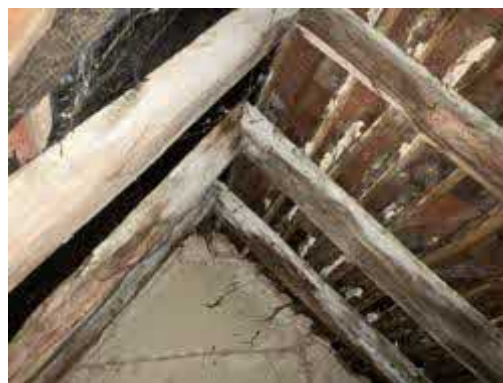
Figs. 13 & 14 Roof void

The roof was lined with tarred felt, apart from the western roof slope to the front which was unlined (Figs. 13, 14, 15 and 16).

Light penetrated through gaps in the unlined section of the roof.

No evidence of bat activity or occupation was found, although there were rat droppings throughout the roof void.
