**50 SYCAMORE AVENUE, SIDCUP, DA15 8PL**

**DESK STUDY REPORT**

**Reference: 1586/DS**

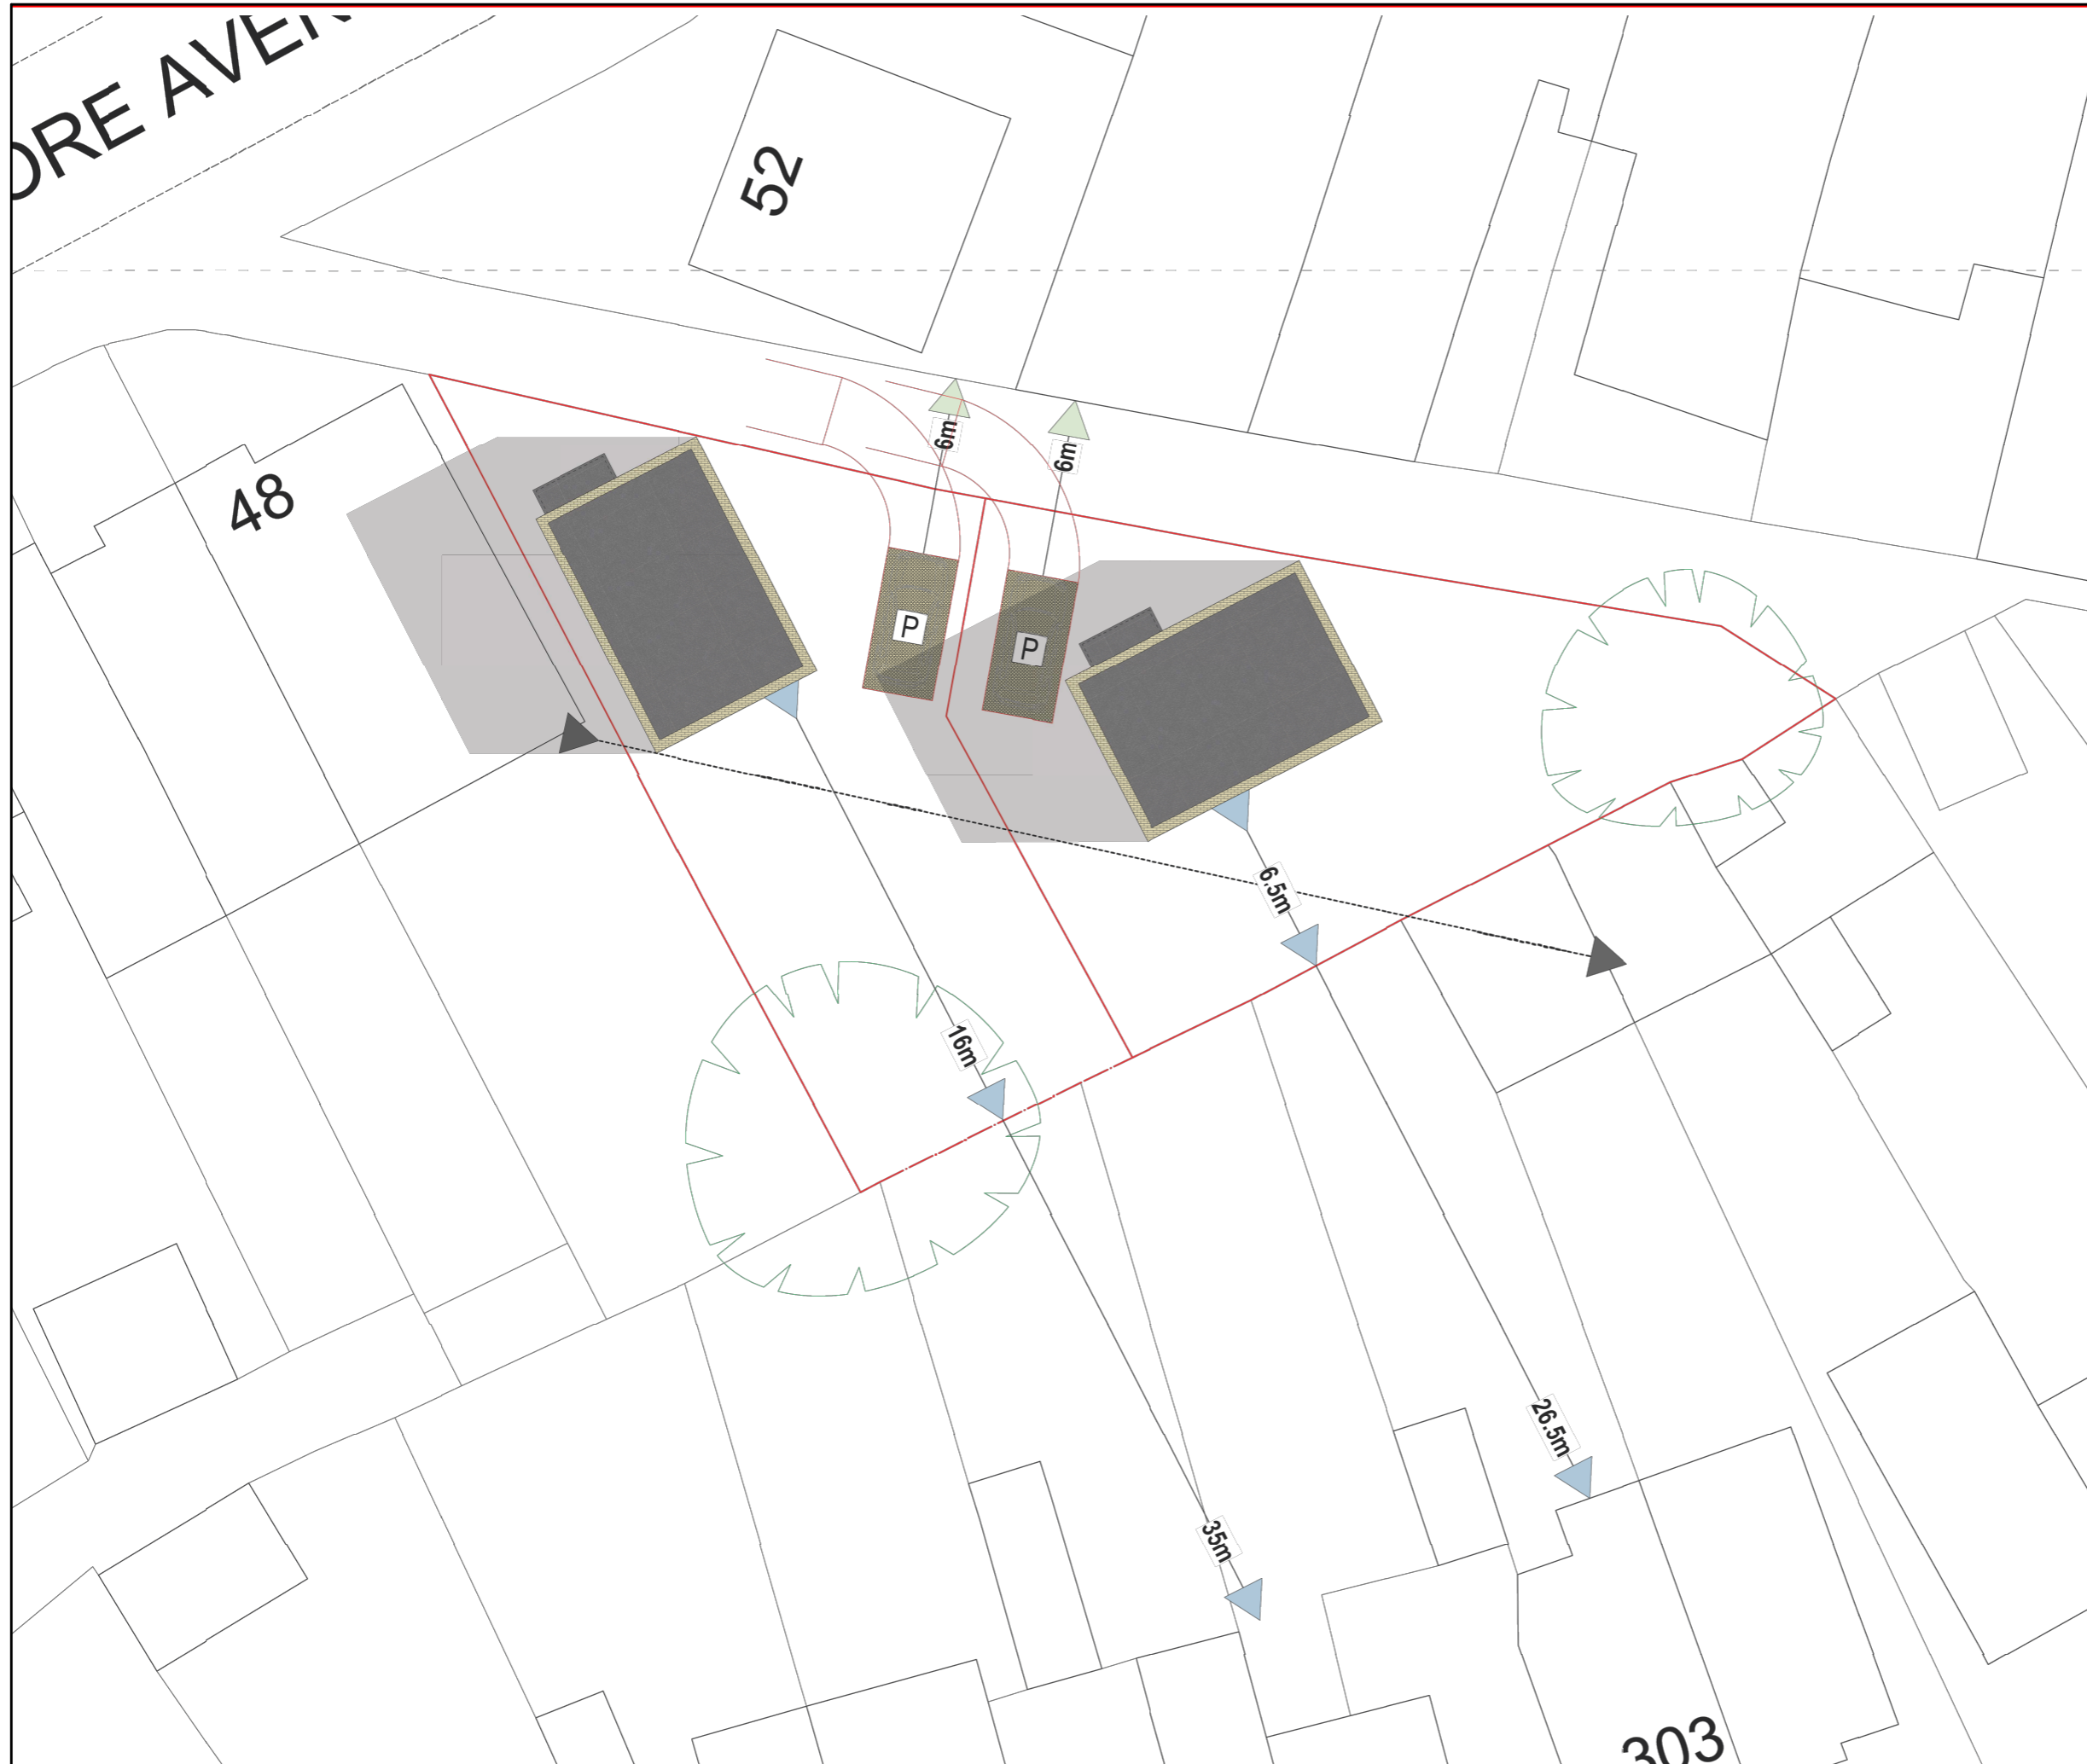
Drawing No. **1586/Figure 1** Rev. **A**

Title  
 Plan of Site

2.1.1 The Site is a triangular plot of land, 700m<sup>2</sup> in area, situated at 50 Sycamore Avenue, Sidcup DA15 8PL. It is accessed via an alley off Sycamore Avenue. The Site's National Grid Coordinates are 546060E, 174490N, and the Site is in the district of Blackfen, approximately 200m south of the A2 and 2km north of Sidcup railway station, on the south east fringe of London.

2.1.2 The site contains a single story prefabricated building, which has been boarded up, a paved car park, and a number of mature trees. The Site is bounded on two sides by residential housing and to the north by a paved vehicle access, which also serves properties on Blacken Road. The Site is flat and secured by low fences. Blacken is a suburban district of low rise housing dating mainly from the interwar period.

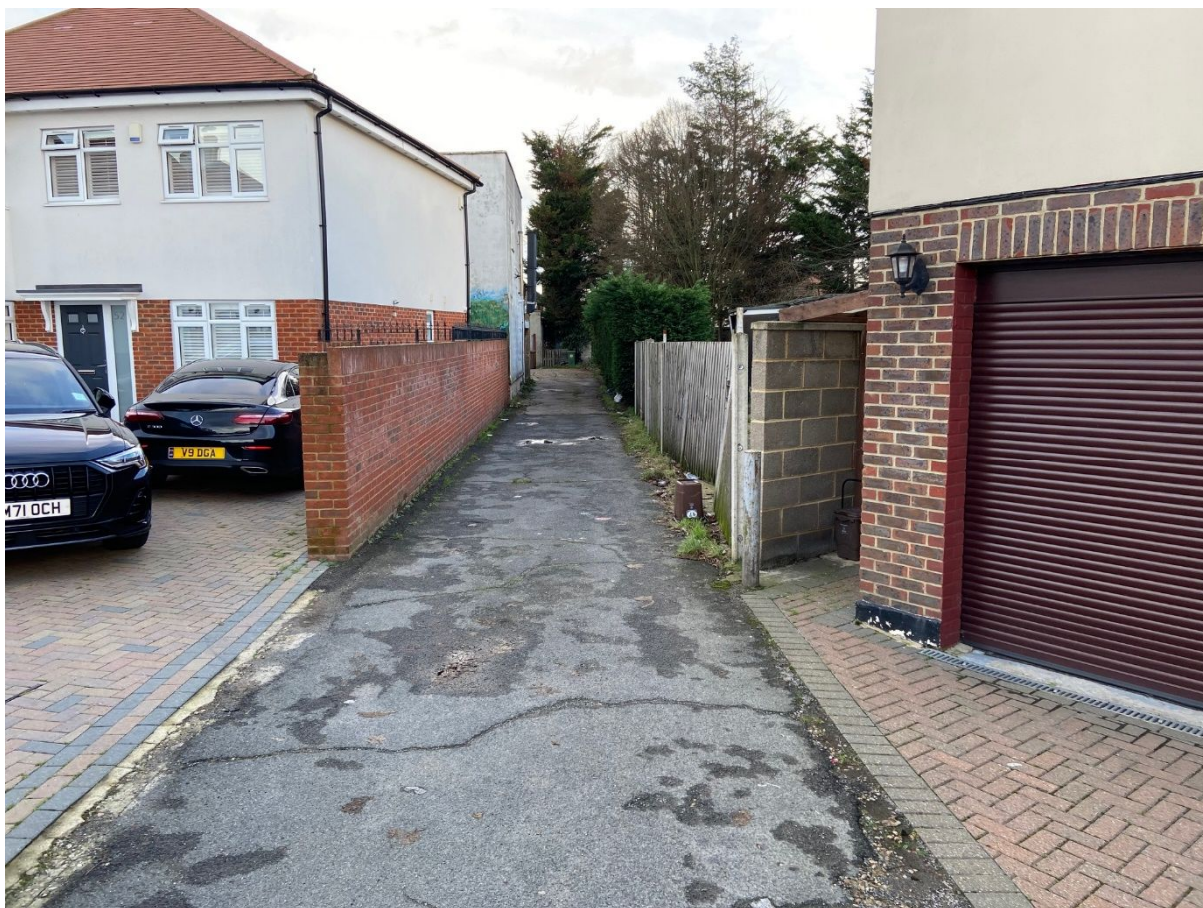
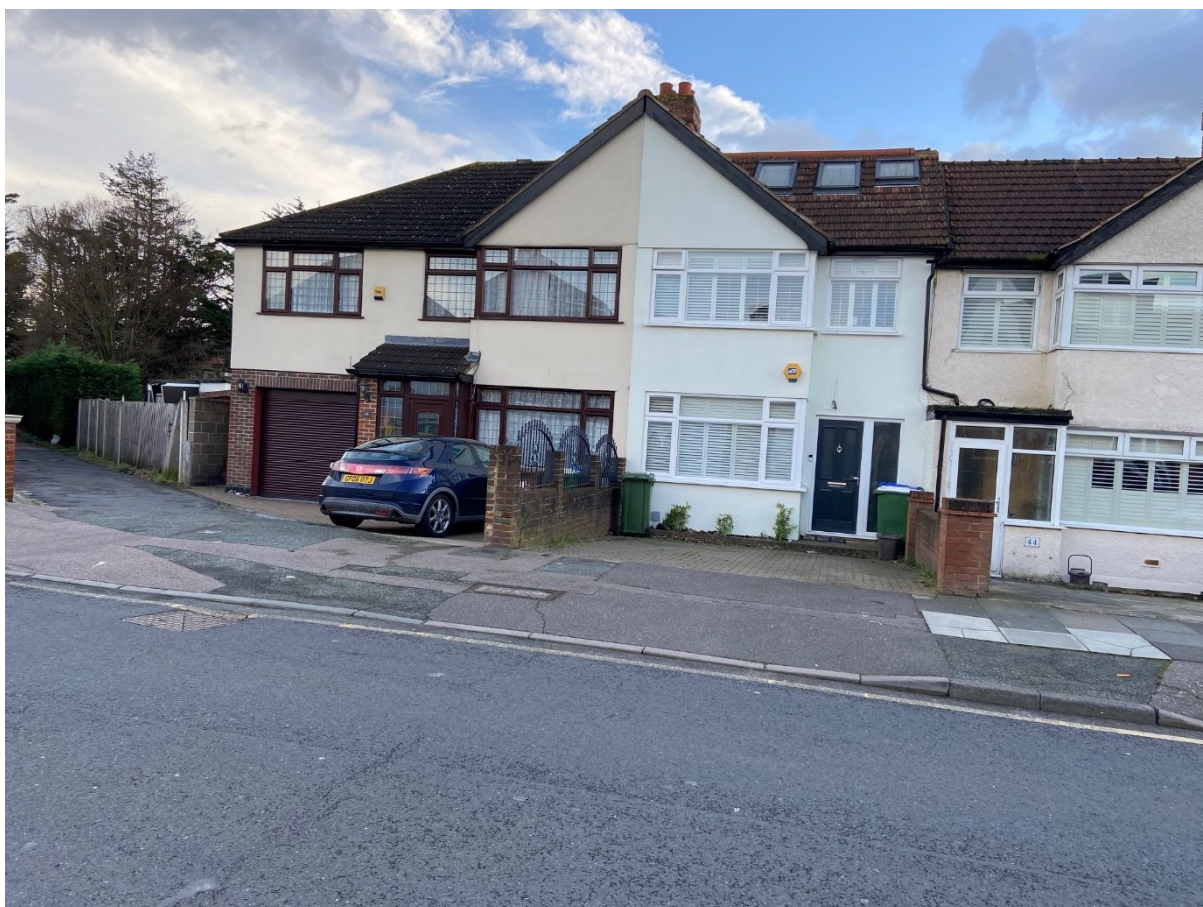
The Site 14<sup>th</sup> January 2023 viewed east top and south east bottom

- 4.1.1 The Site was visited in the afternoon of 9<sup>th</sup> January 2023 by a PBA geologist. The weather was dry and cold. The Site could not be entered due to a faulty padlock, but was viewed and photographed over the perimeter fence.
- 4.1.2 The Site contained a single storey prefabricated building of estimated 60m<sup>2</sup> area which had been boarded up. The south east boundary of the Site was lined by a hedge of mature conifers.
- 4.1.3 The Site was secure from pedestrian and vehicle access, with a 1.8m high fence along the alleyway to the north. No fly tipping, debris or stains were observed on site, although some litter was observed.
- 4.1.4 The Site is shown on Figure 1 and in photographs in Appendix B.

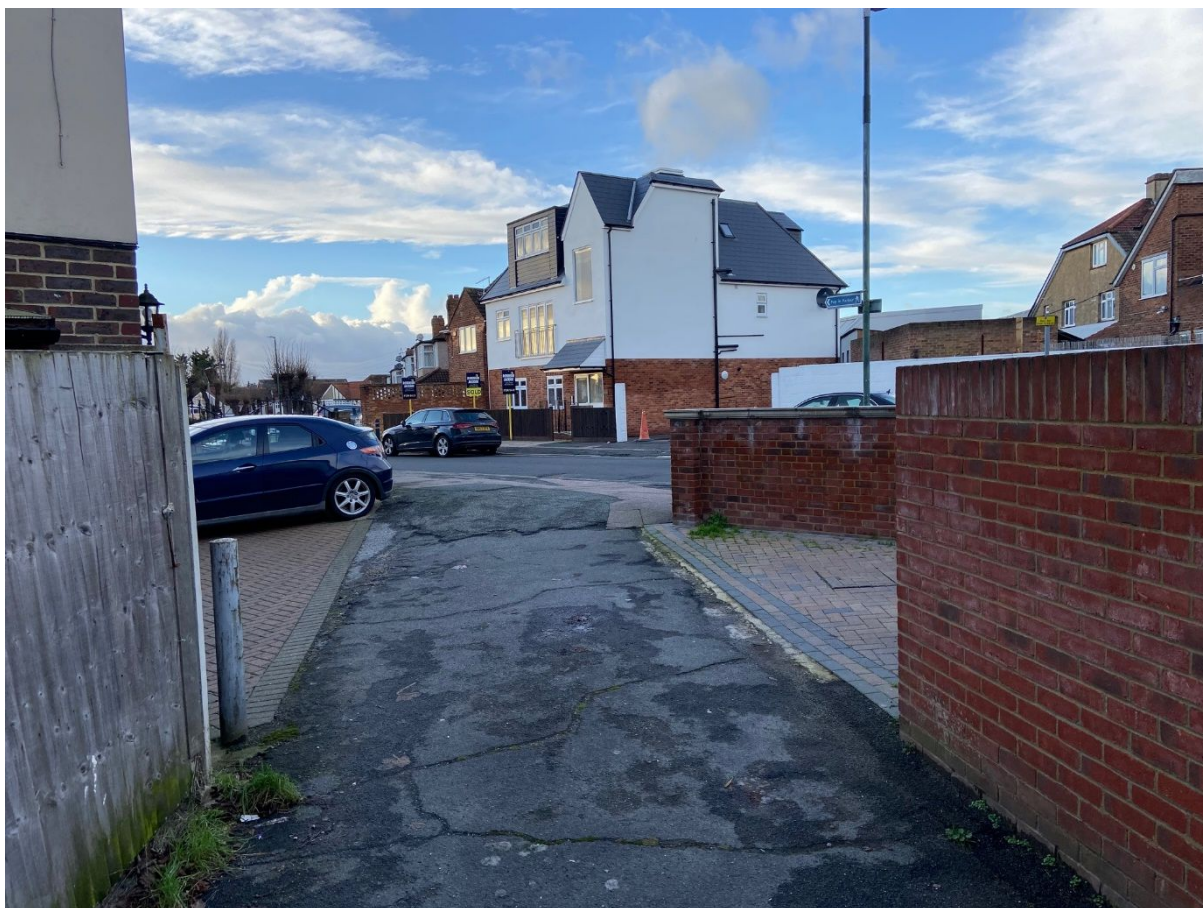
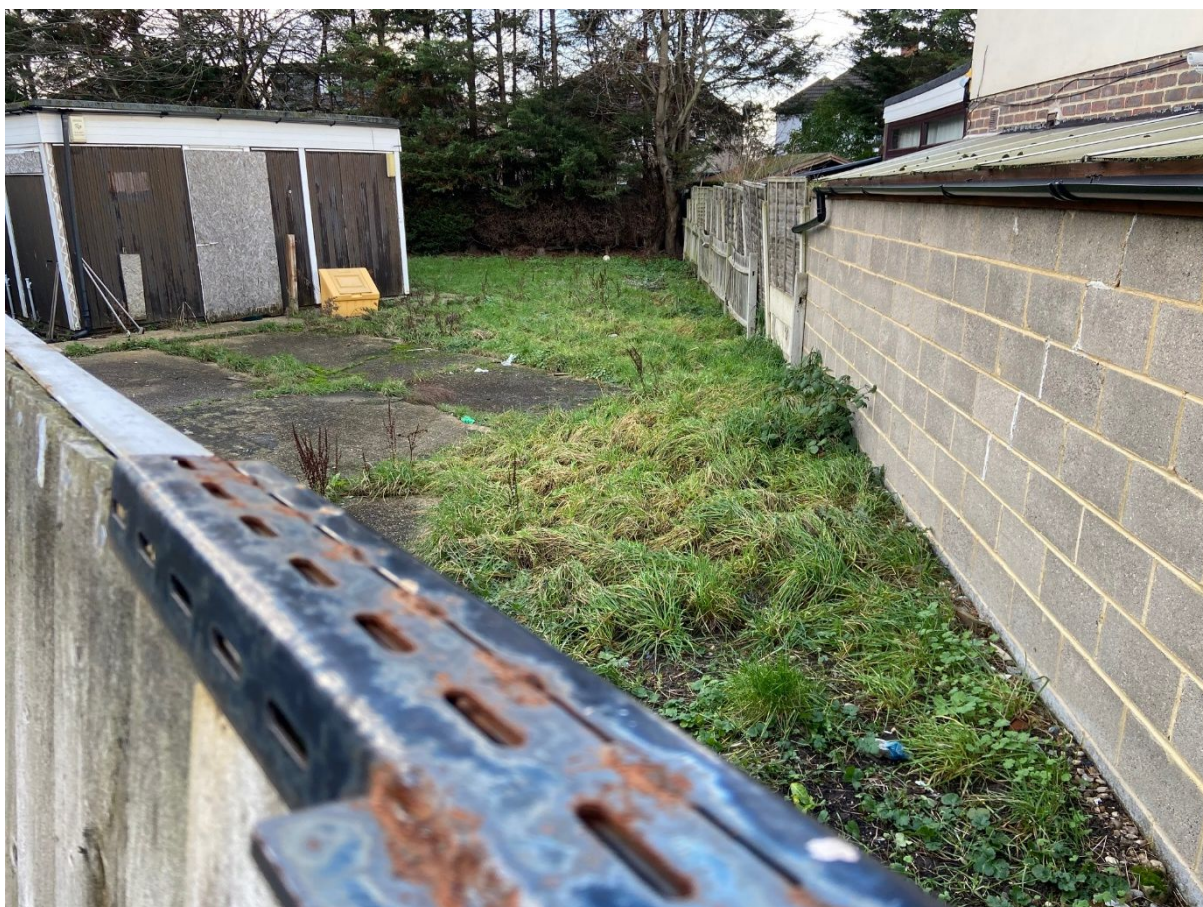
The Site 14<sup>th</sup> January 2023 viewed west top and south east bottom

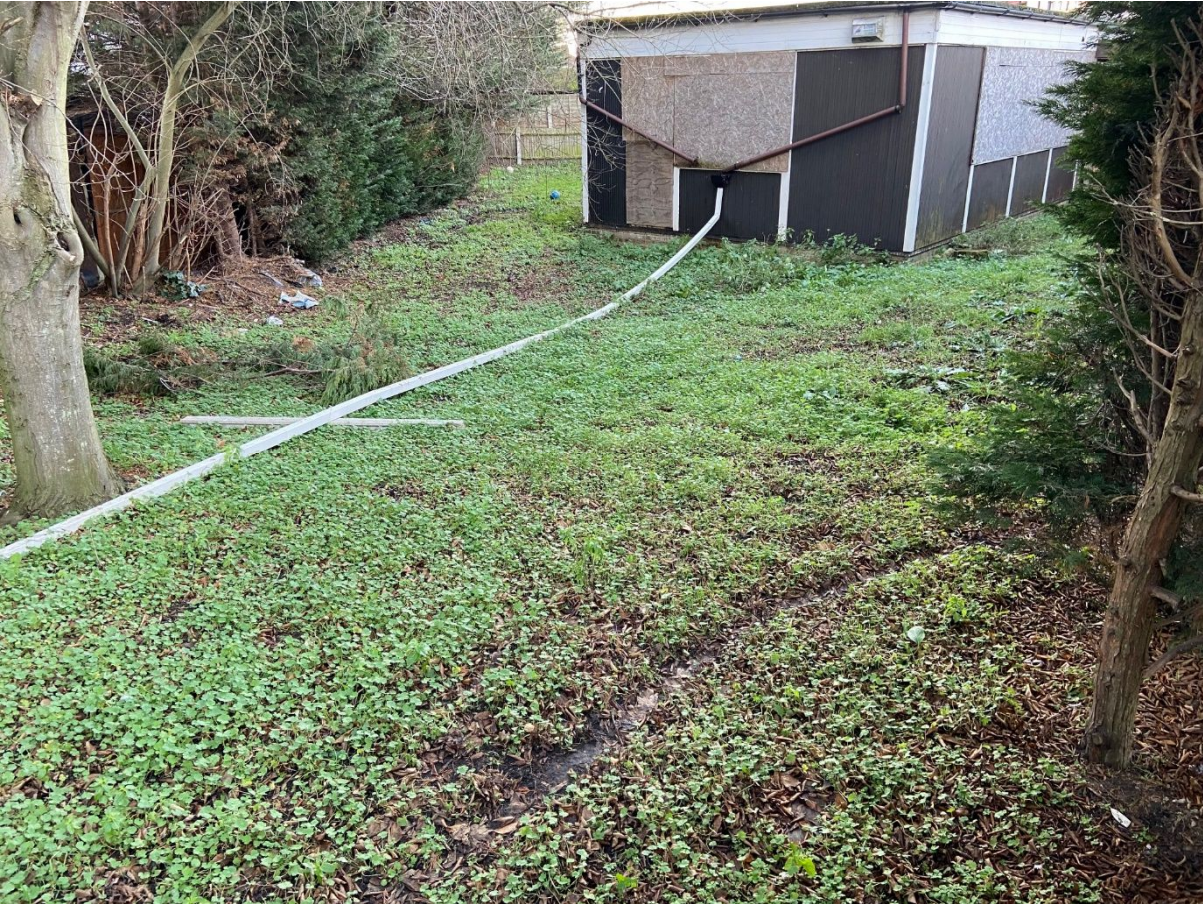
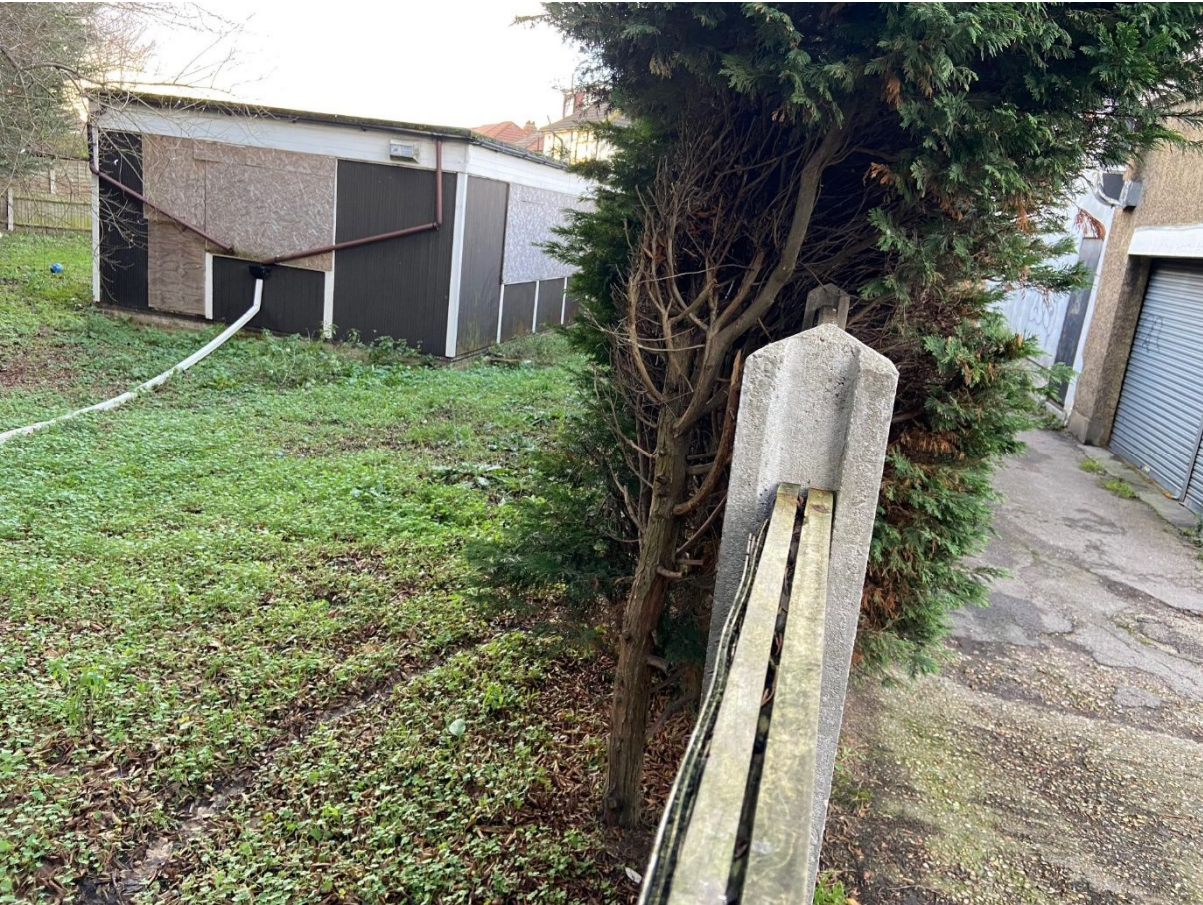
The Site 14<sup>th</sup> January 2023 viewed south west top and west bottom
