## Supplementary Ground Investigation Report

Residential Development

Goldings, TN12 6EQ

February 2024

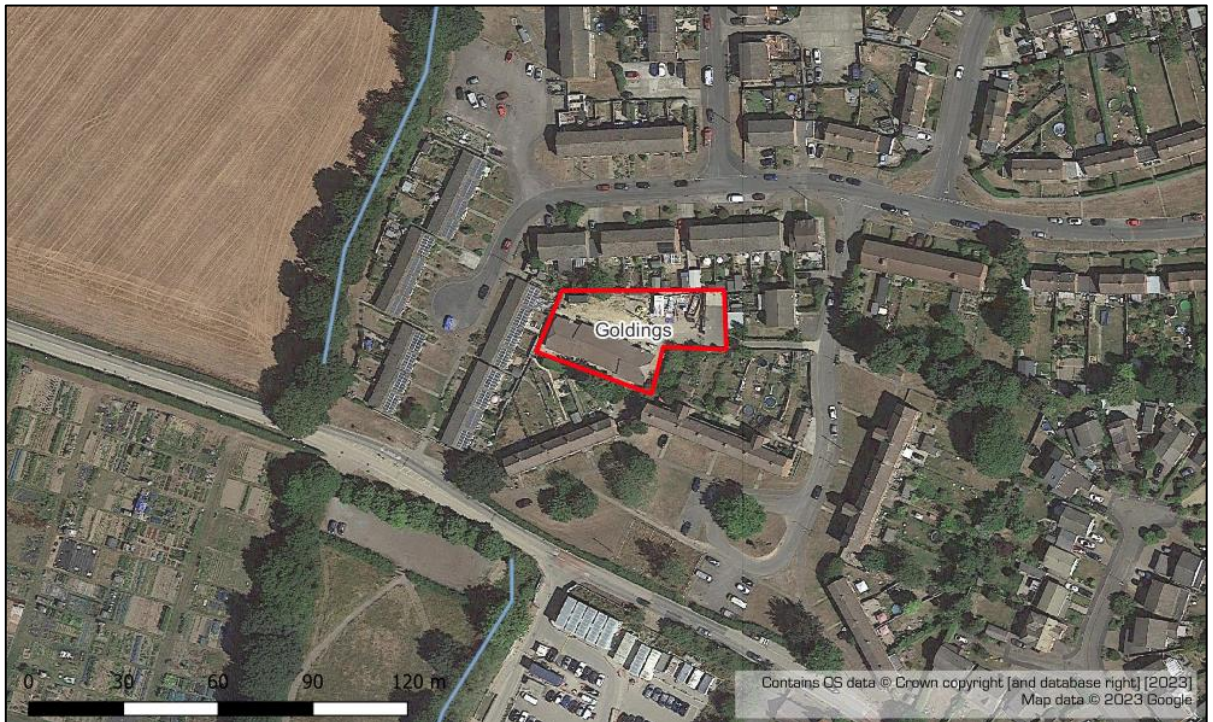
Figure 1-A: Aerial photograph and approximate site boundary

1.1.3 An aerial image showing the approximate site boundary is presented below, and a series of site plans is provided within Appendix A. The development is nearing completion.

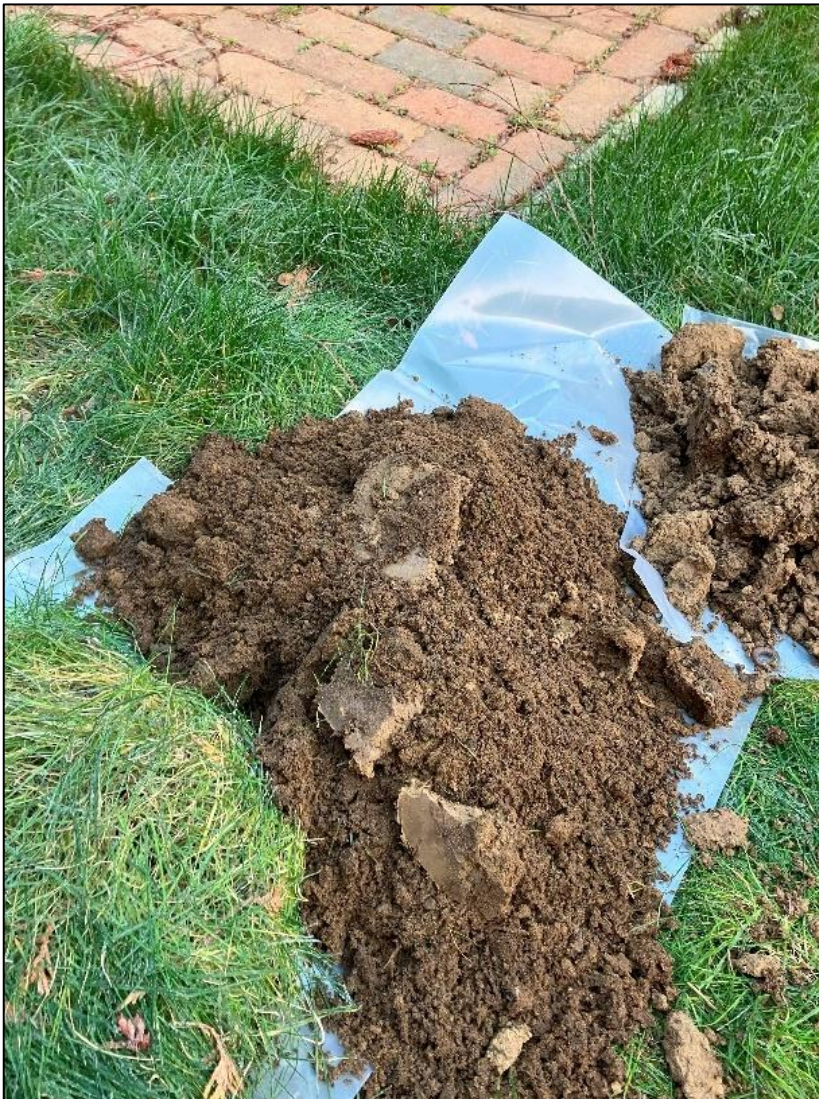
Figure 4-A: Photograph of the Topsoil deposits encountered from S1-TP01

- 4.1.1 Topsoil was encountered in all exploratory holes across the site. The base of the unit was typically 0.2m bgl with the exception of S1-TP03 where it was 0.15m.
- 4.1.2 Topsoil within the rear garden of the northernmost property (S1-TP01) was encountered as a brown slightly gravelly fine to medium organic sand.
- 4.1.3 The topsoil to the front of the southernmost property and the topsoil within the soft landscaping area within the northwest of the site (S1-TP03 and S1-TP02 respectively) was encountered as a brown slightly gravelly slightly clayey fine to coarse sand and occurred as a slightly sandy slightly gravelly clay in S1-TP03.
- 4.1.4 The topsoil within the POS location had a small portion of anthropogenic materials were present such as brick, concrete, plastic, and wood.
- 4.1.5 Photographs of the topsoil deposits encountered is presented below.

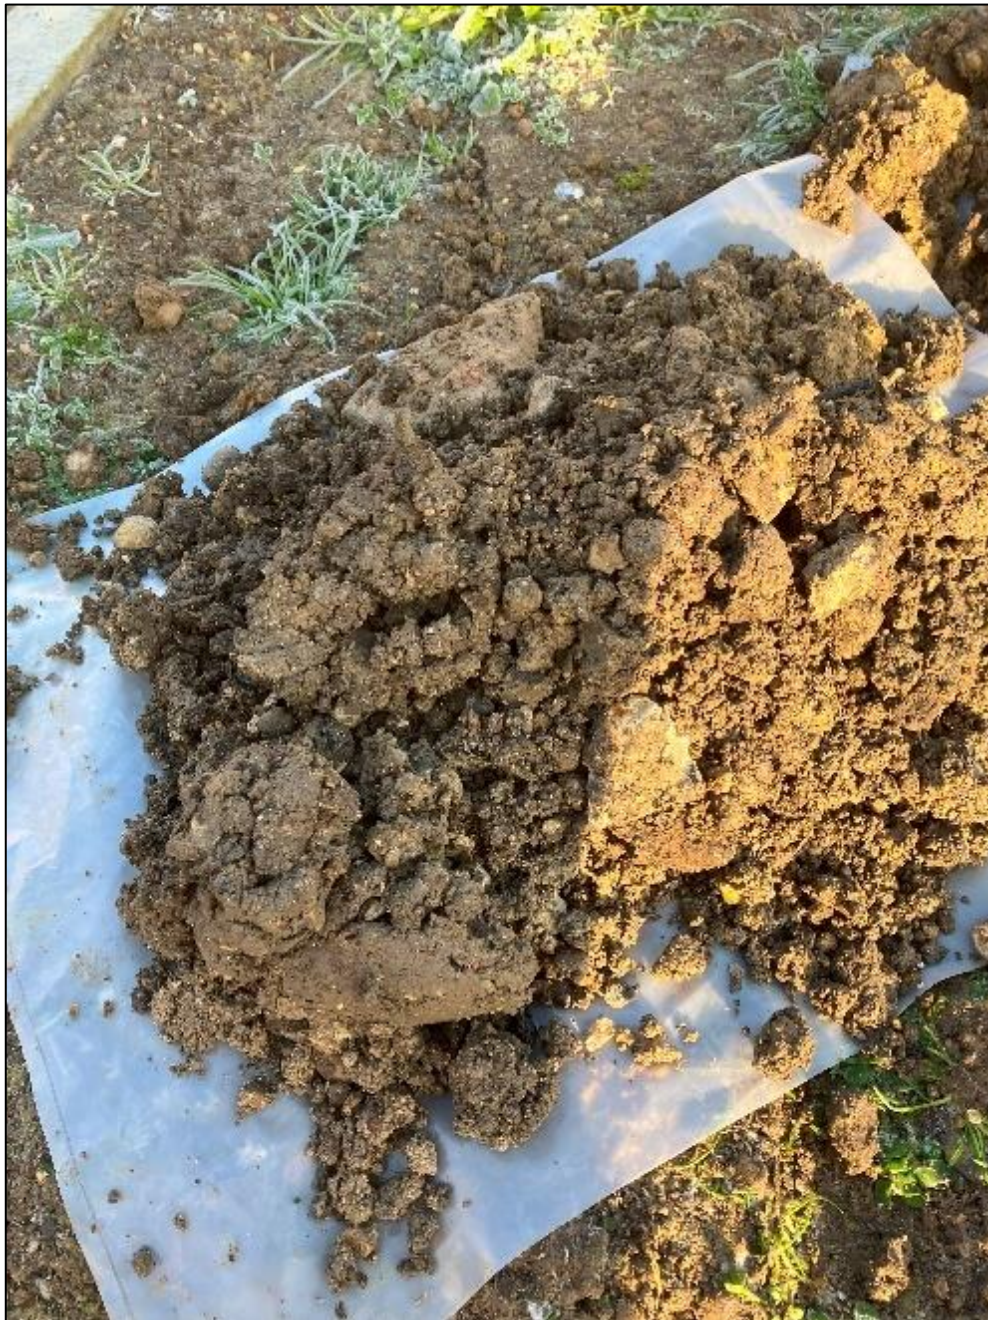
Figure 4-D: A photograph of the typical Made Ground encountered on site

- 4.2.1 Made Ground was encountered across all exploratory holes. The Made ground was 0.45m thick in S1-TP01, and the base of the Made Ground was not penetrated in trial pits S1-TP02 and S1-TP03. In all cases the Made Ground resembled a reworked natural subsoil, with occasional inclusions of anthropogenic materials. It generally consisted of soft greyish brown slightly sandy slightly gravelly clay.
- 4.2.2 Within the POS are in S1-TP02 the Made Ground comprised of a clayey sand with occasional cobbles of concrete.
- 4.2.3 A photograph of the Made from S1-TP02 is presented below.

4.5.1 During the ground investigation works, no significant visual or olfactory evidence of contamination was noted, except for the presence of anthropogenic materials contained within the Made Ground (ash, brick, concrete, clinker-like material).

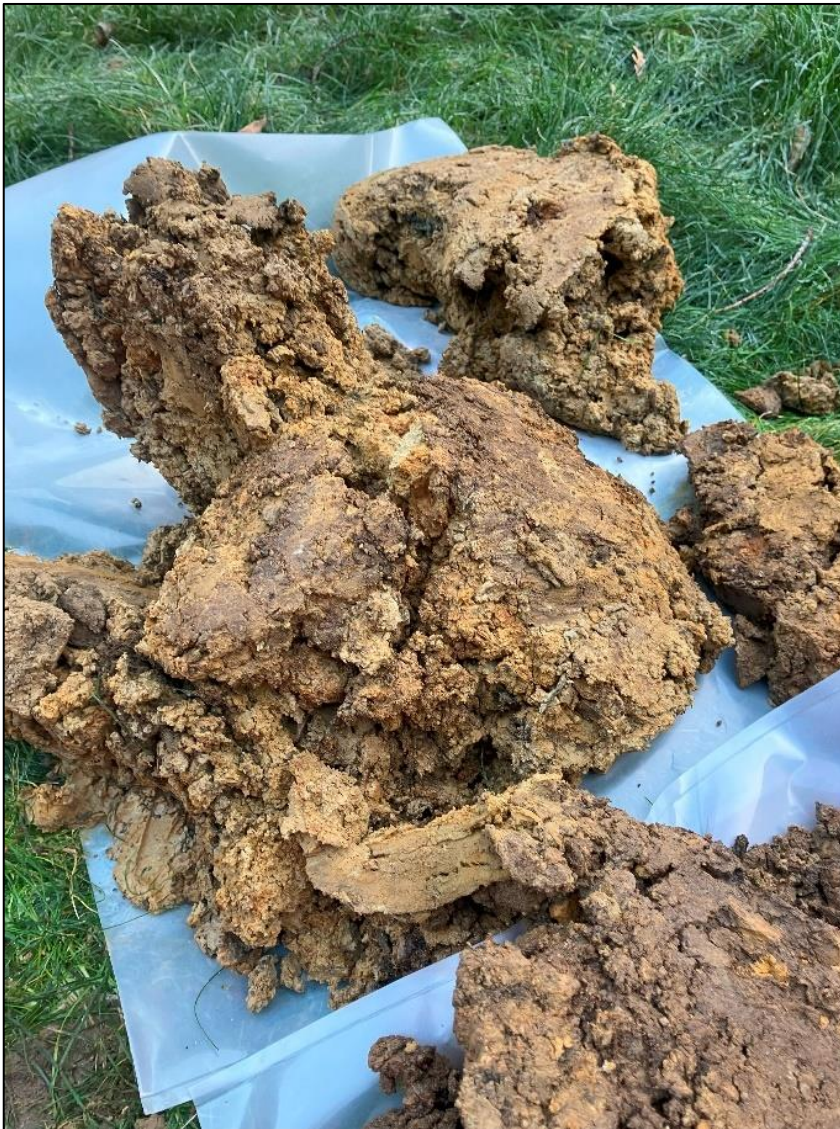
*Figure 4-E: A photograph of the River Terrace Deposits encountered in trial pit S1-TP01*

4.3.1 River Terrace Deposits were only encountered in trial pit S1-TP01 (0.65-1.0m) and occurred as a soft orangish brown mottled brown slightly sandy slightly gravelly clay. The gravels consisted of fine to coarse sandstone.

4.4.1 Groundwater was observed in trial pit S1-TP01 during the fieldwork, at 1.0m depth, filling the hole to 0.95m after 20 minutes.

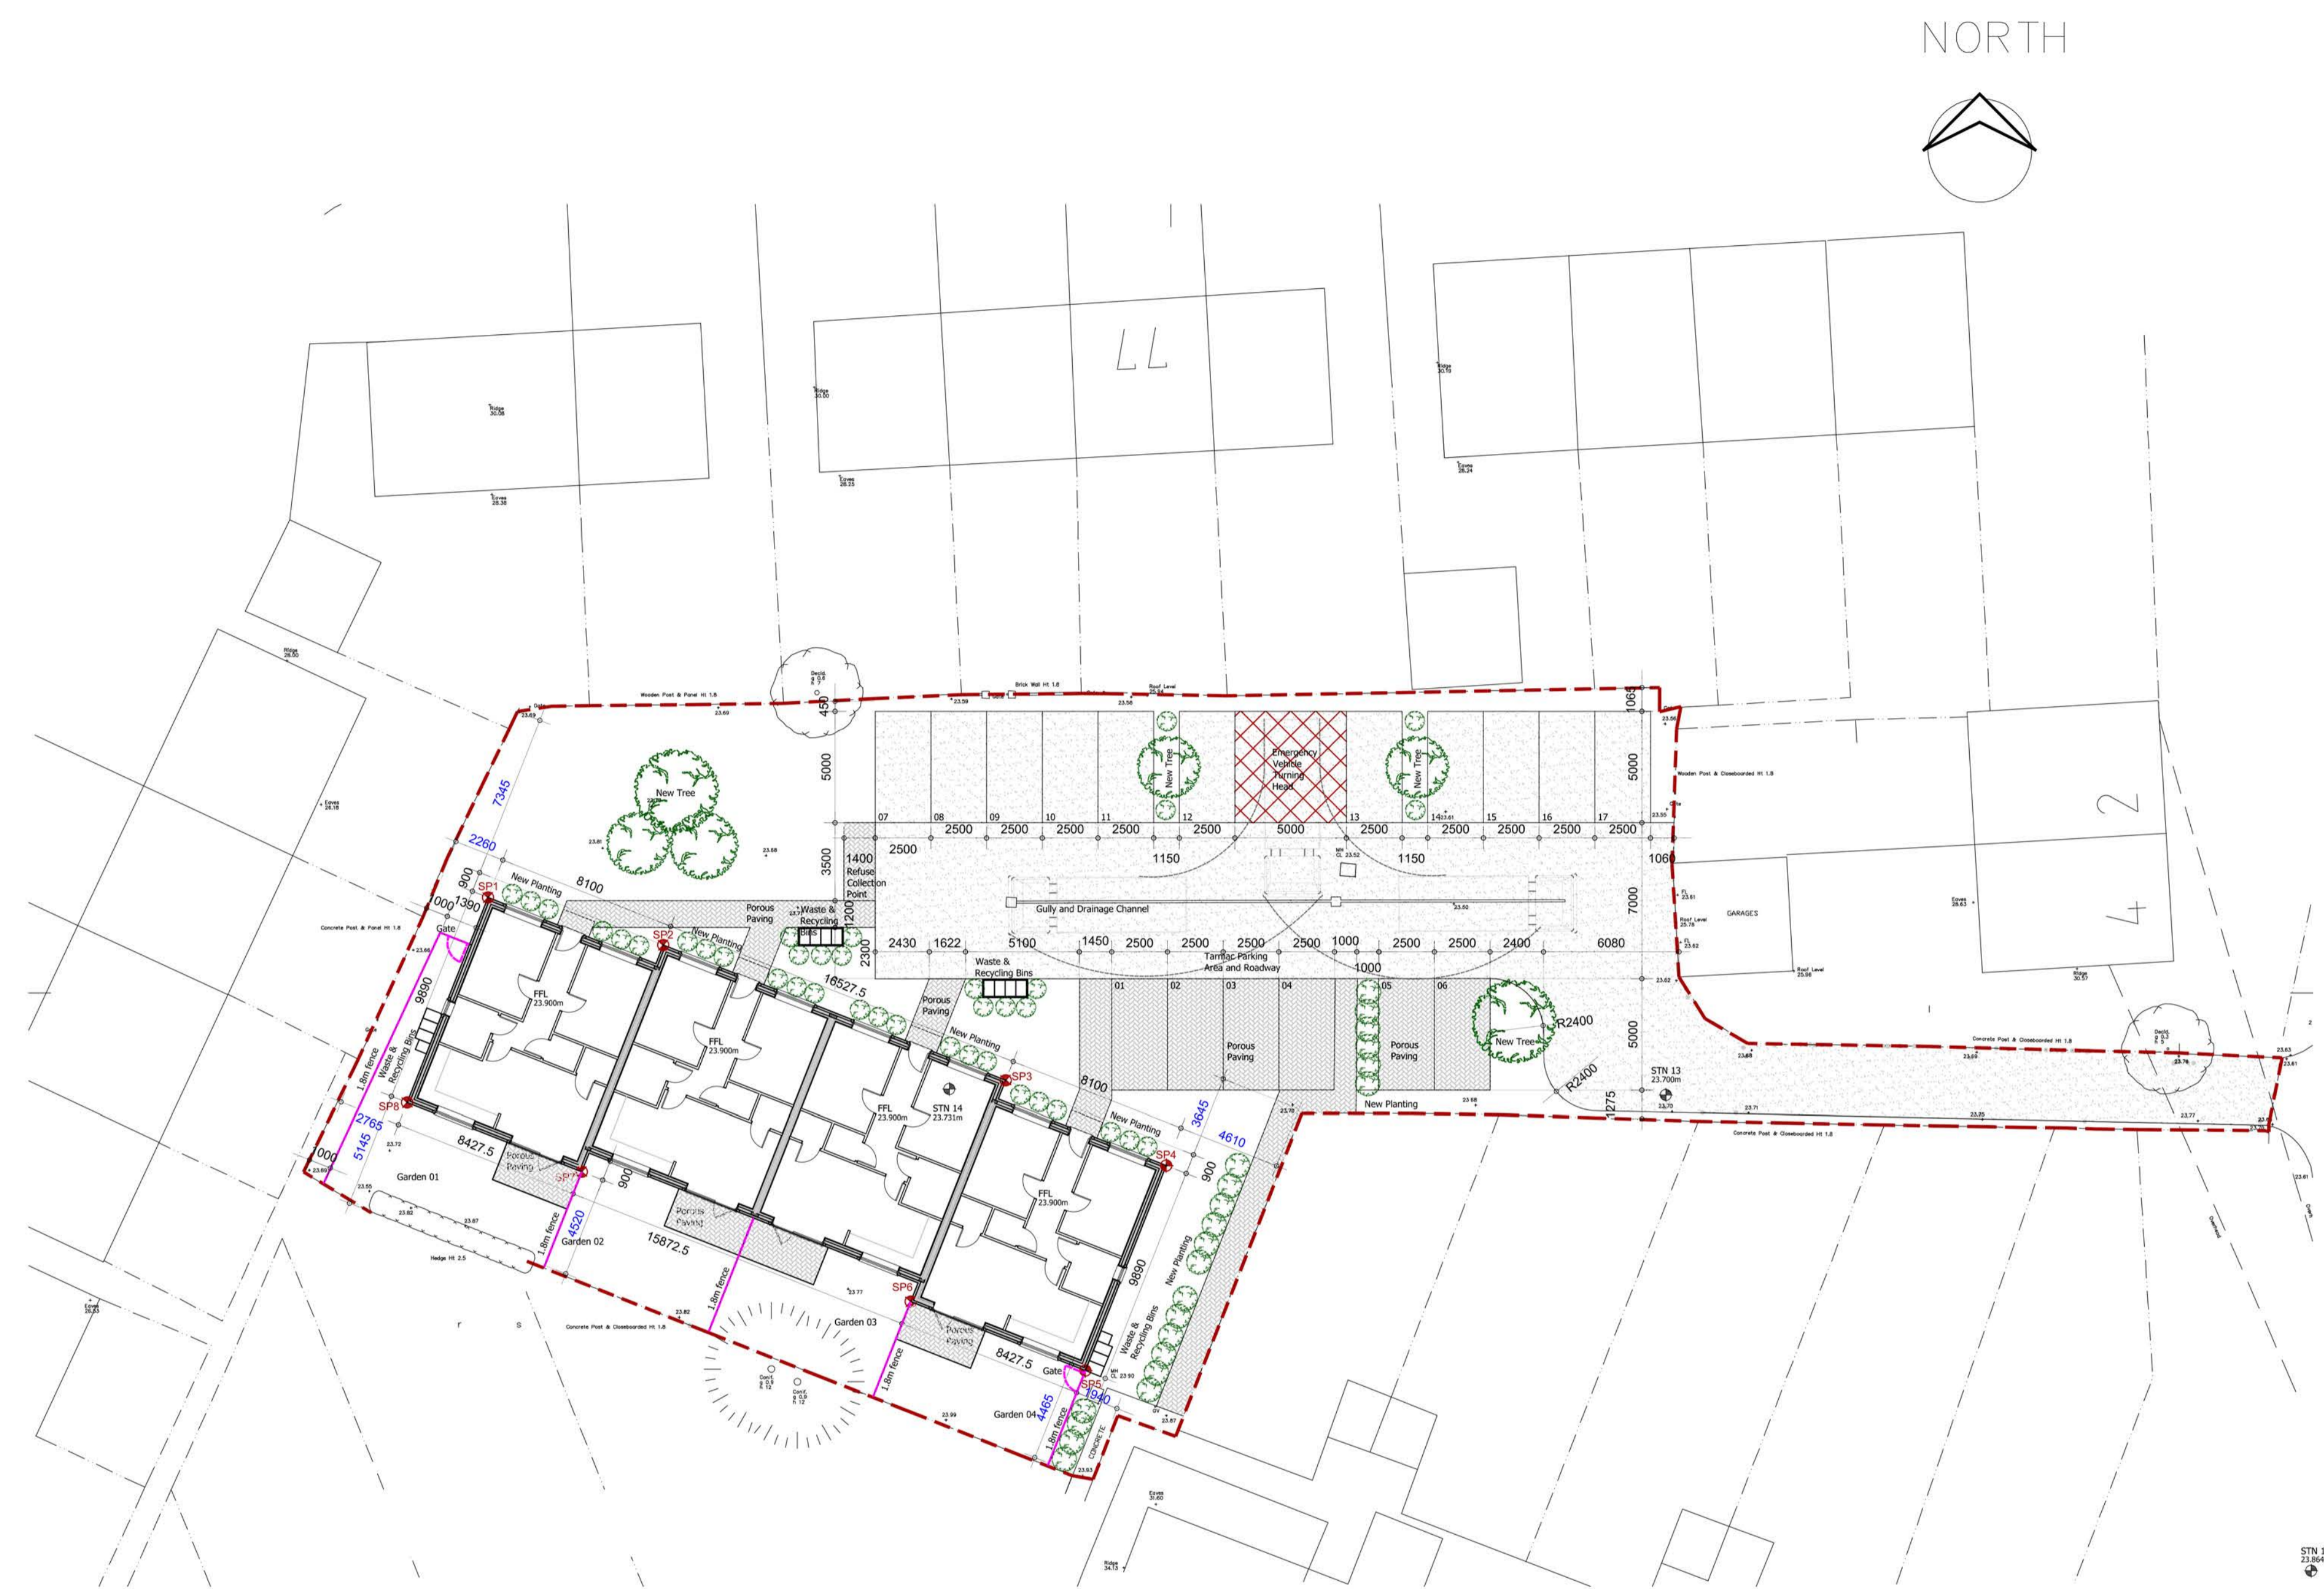
Drawing Description: <b>Proposed Site Plan</b>		
Scale @ A1:	Date: <b>September 2023</b>	
1:200		
Drawn By: <b>OSG</b>	Checked By: <b>BH</b>	
Purpose: <b>CONSTRUCTION</b>

**TOTALS**  
 Site Area 0.15 Ha  
 4 x 2 Bed 4 Person Bungalows  
 12 Habitable Rooms  
 27 Units/Ha  
 80 Habitable Rooms/Ha  
 17 Parking Spaces (6 allocated)  
 4 Cycle Spaces
