**GEOENVIRONMENTAL AND GEOTECHNICAL ASSESSMENT
81-88 BERESFORD STREET
WOOLWICH
B WOOLWICH LTD
GEA-22277-23-283 REV 4
FEBRUARY 2024**

Document Issue Record

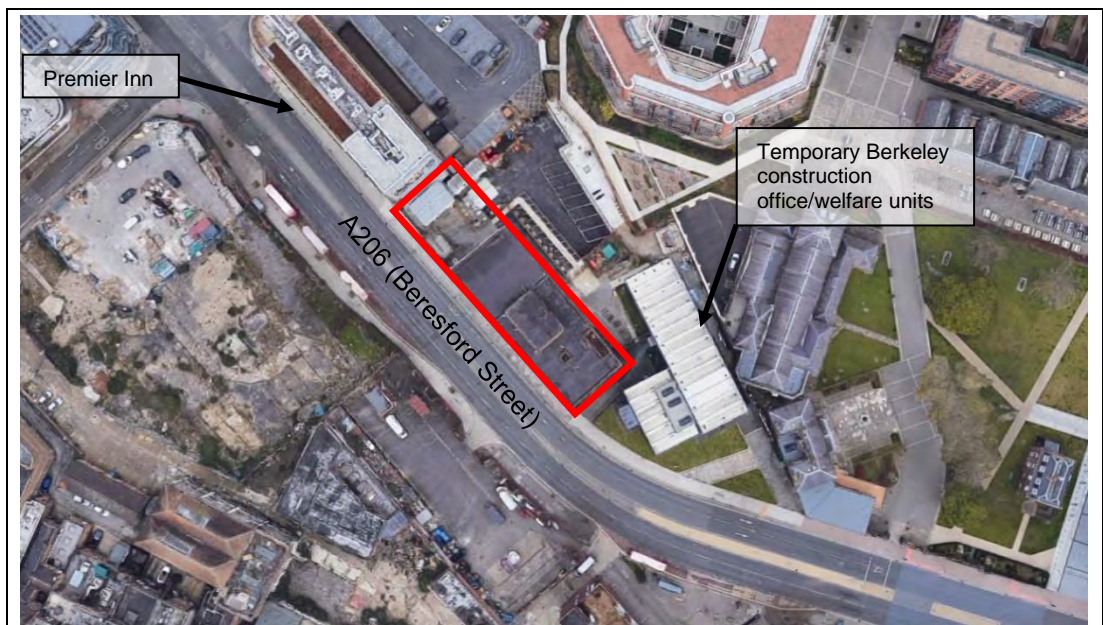
Figure 1: Recent satellite imagery of site (red boundary) and surrounding land.

2.2.1 The site is located approximately 13.7 km east of London City centre to the northeast of Beresford Street, Woolwich. The National Grid Reference (NGR) for the approximate centre of the site is ⁵43678 ¹79059. A site location plan is presented on the drawing 22277-001-001 in Appendix 1. Figure 1 shows the redline boundary of the site and nearby landmarks.

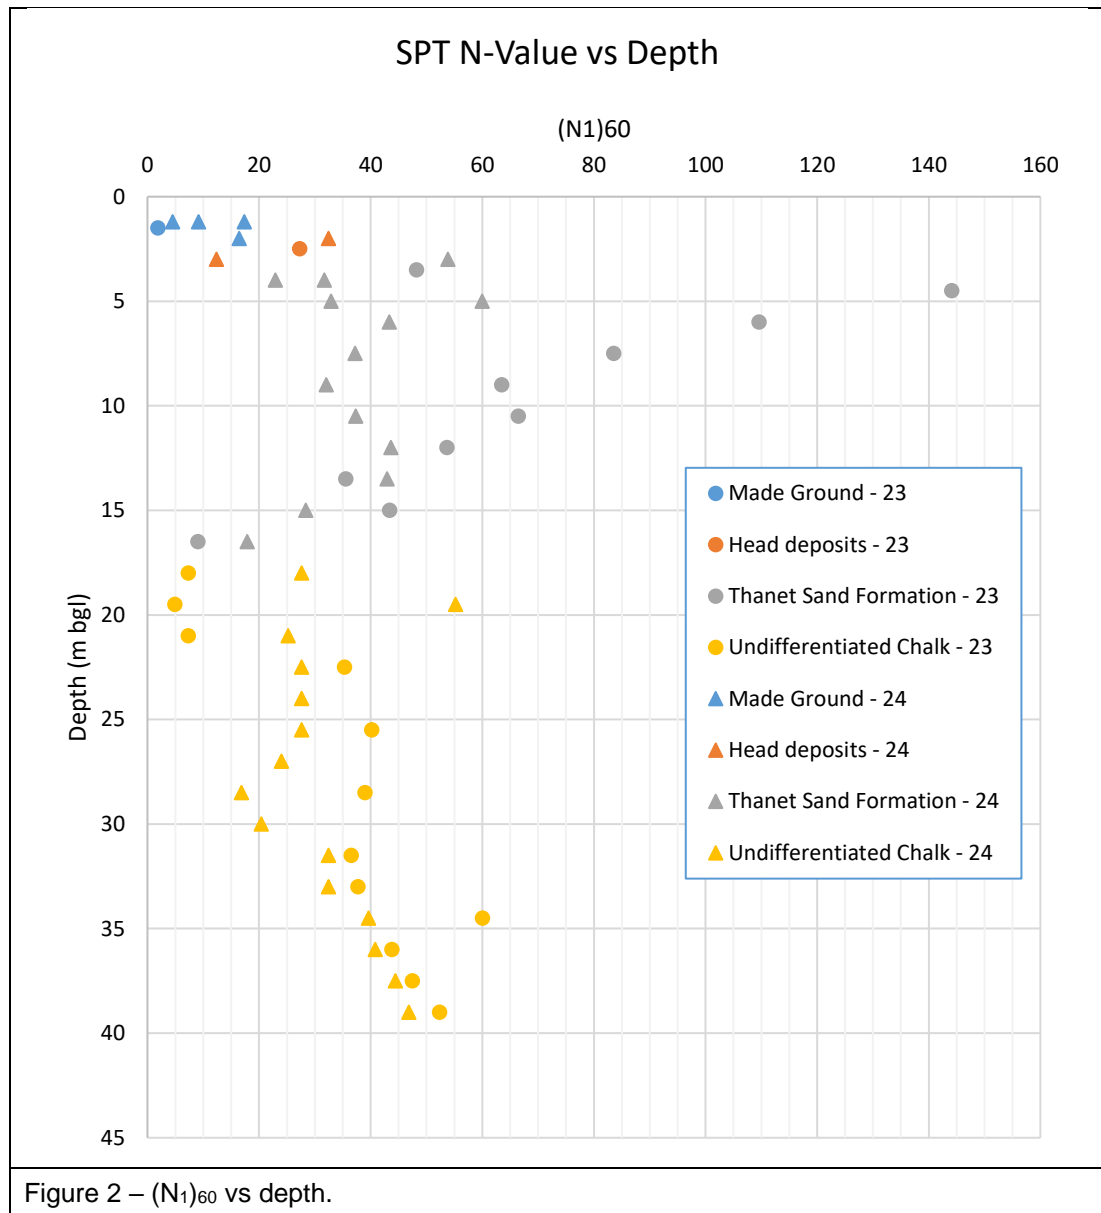
- 5.2.3 Figure 2 below presents the relationship between $(N_1)_{60}$ values and depth for the individual geologies. The revised graph no longer presents historic data local to the area in light of the recently undertaken ground investigation which provides more substantial site-specific data. The figure presents the results from the 2023 and 2024 investigations separately.

5.2.4 The following are the design SPT values adopted for correlation to obtain the geotechnical parameters.

- i. Made ground N = 3
- ii. Heads Deposits N = 20
- iii. Thanet Sand Formation N = 40
- iv. Undifferentiated chalk N = 30
