**GEOENVIRONMENTAL AND GEOTECHNICAL ASSESSMENT
81-88 BERESFORD STREET
WOOLWICH
B WOOLWICH LTD
GEA-22277-23-283 REV 4
FEBRUARY 2024**

GEOENVIRONMENTAL AND GEOTECHNICAL ASSESSMENT
 81-88 BERESFORD STREET
 WOOLWICH
 B WOOLWICH LTD
 GEA-22277-23-283 REV 4
 FEBRUARY 2024

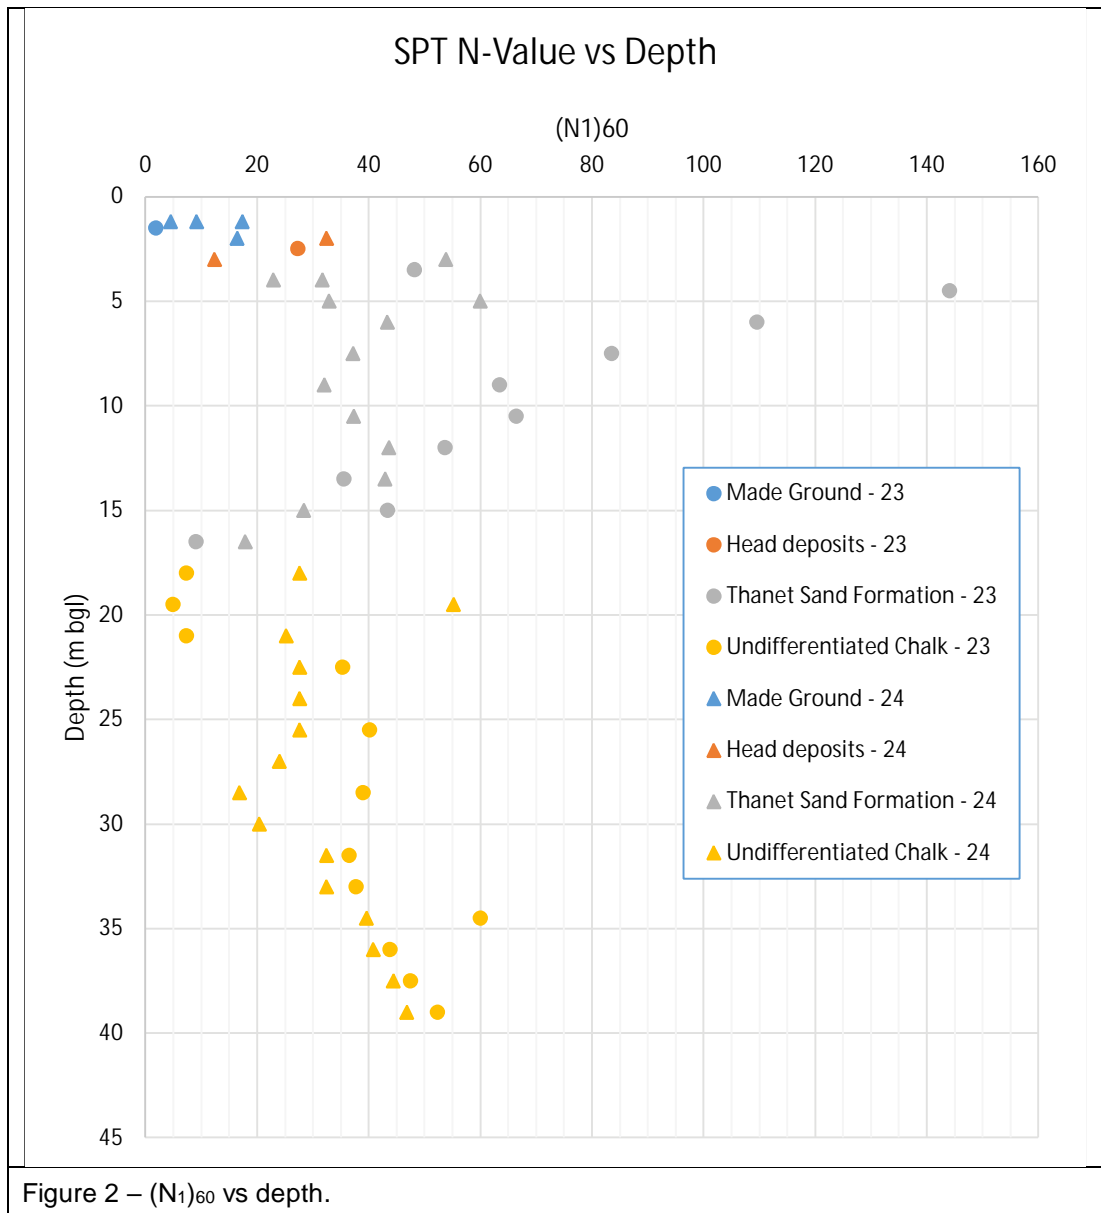
- 5.2.3 Figure 2 below presents the relationship between $(N_1)_{60}$ values and depth for the individual geologies. The revised graph no longer presents historic data local to the area in light of the recently undertaken ground investigation which provides more substantial site-specific data. The figure presents the results from the 2023 and 2024 investigations separately.

5.2.4 The following are the design SPT values adopted for correlation to obtain the geotechnical parameters.

- i. Made ground N = 3
- ii. Heads Deposits N = 20
- iii. Thanet Sand Formation N = 40
- iv. Undifferentiated chalk N = 30

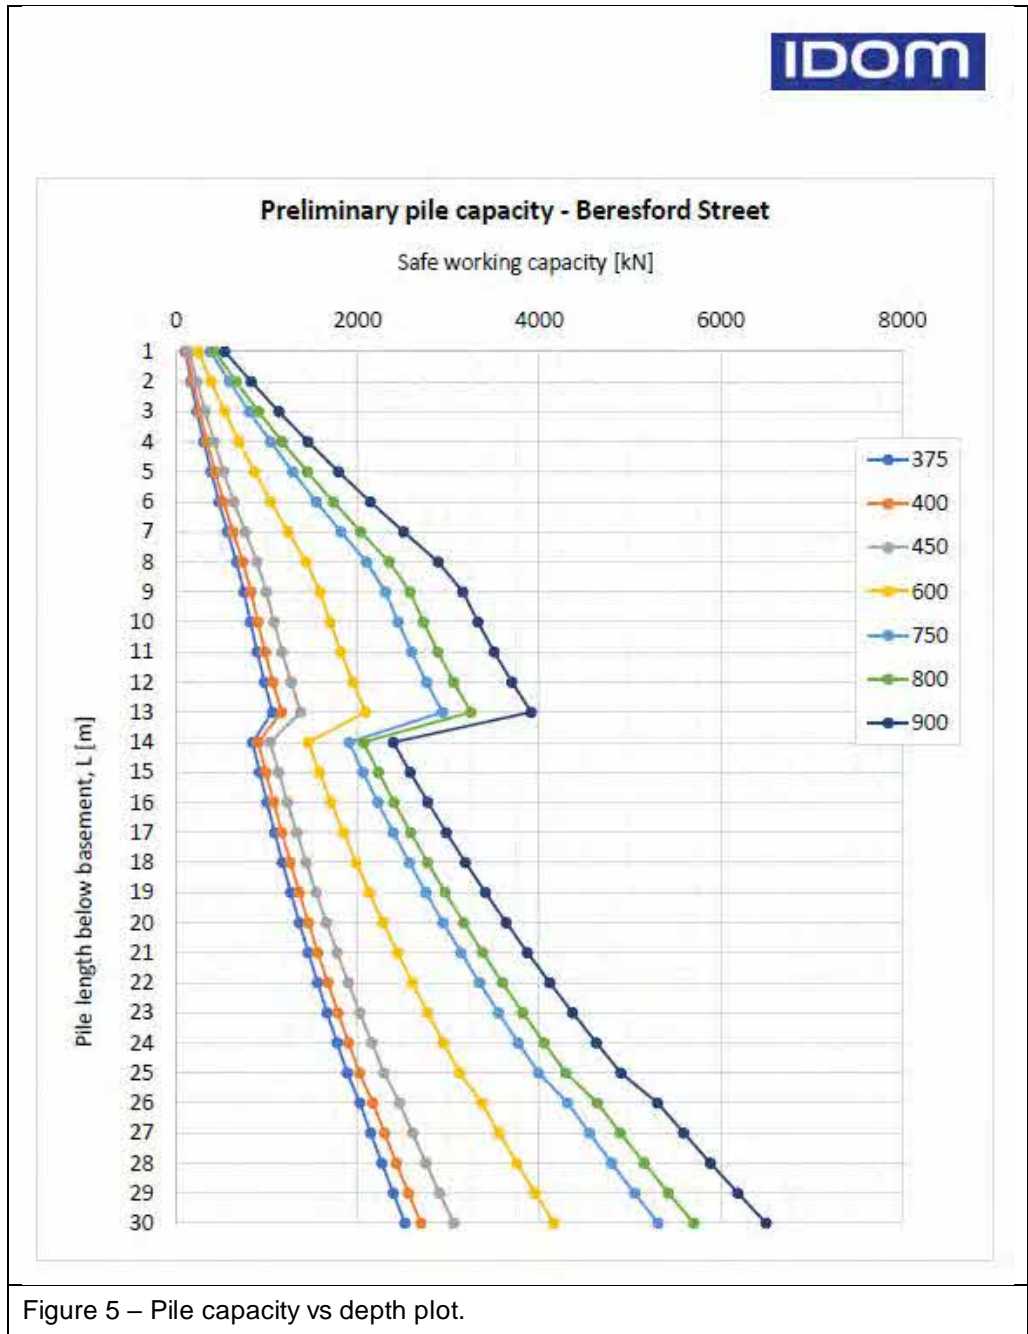
Figure 5 – Pile capacity vs depth plot.

- 1 - Stratigraphy based on MBH01 and MBH201
- 2 - Pile bearing capacity based on the N-values reported on the borehole logs and within CIRIA C574: Engineering in Chalk
- 3 - Basement assumed to be approximately 5m below ground level
- 4 - Shaft resistance factor of safety = 2.5
- 5 - Base resistance factor of safety = 3.0

| Rev | Prepared | Approved | Date of Issue | Reason(s) for Revision |
|---|---|---|---|---|
| 2 | KM | SE | 06/12/2023 | Update preliminary pile design: Table 13 and Figure 5 |

- 5.6.3 Where piling is required, due to the dense sands underlying the site, CFA or bored cast in-situ piling methods are recommended. It is considered necessary to undertake further ground investigation work targeted at the underlying chalk if piles are anticipated to end bear within, or within influencing depth of the chalk. Furthermore, it is also recommended that a Piling Work Risk Assessment, vibration assessment and working platform design are undertaken for a piled foundation solution. The preliminary pile capacity calculations provided are indicative only and detailed calculations in accordance with Eurocode 7 should be undertaken for the pile group by a specialist contractor.
