Phase 2: Site Investigation

25 Porter Street, Staveley, Chesterfield

M23-006

PHASE 2 SITE INVESTIGATION REPORT

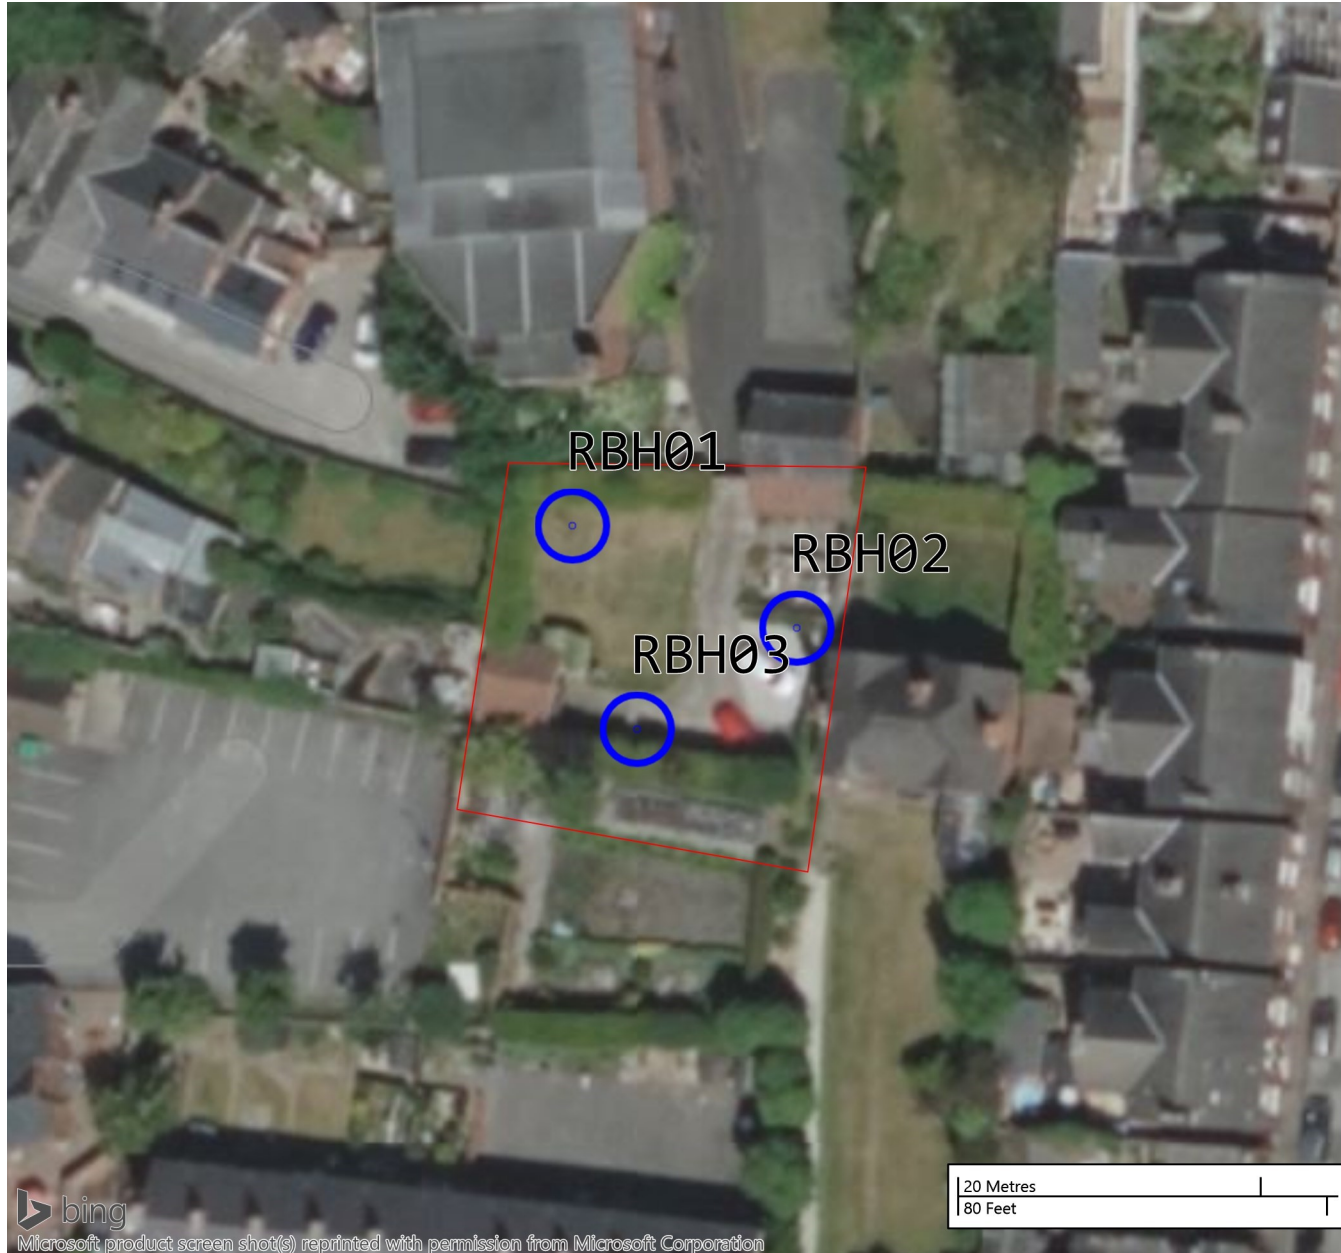
Figure 2

Exploratory Hole Location Plan

A plan showing the location of the boreholes can be found in Appendix A (Figure 2).
