# Dell DESIGNS LTD

for Mr Stephen Bourne-Smith

### Lux Light Level Report for Caerphilly Planning

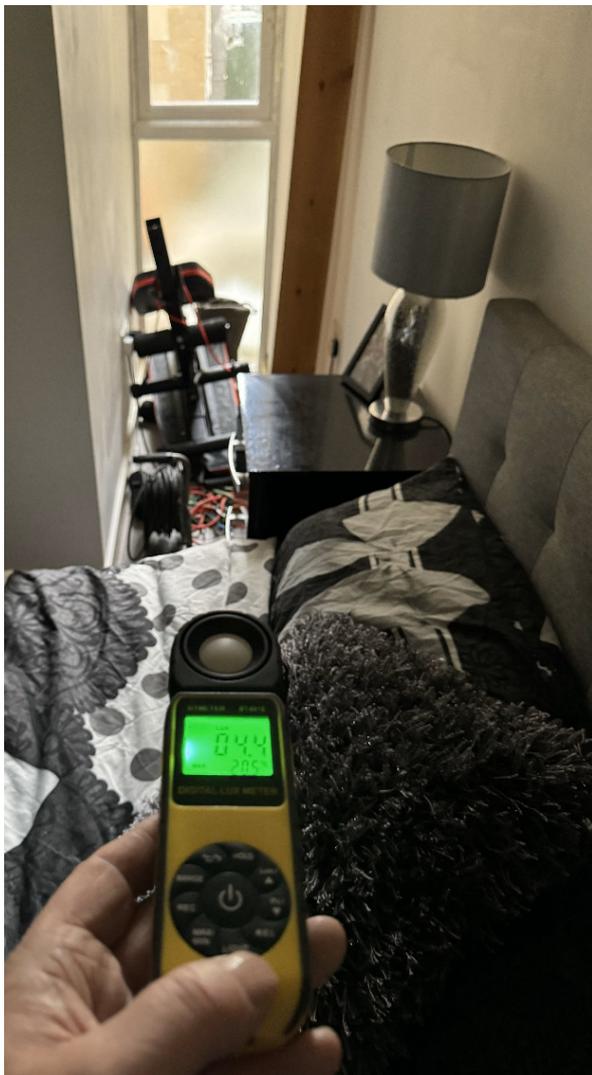
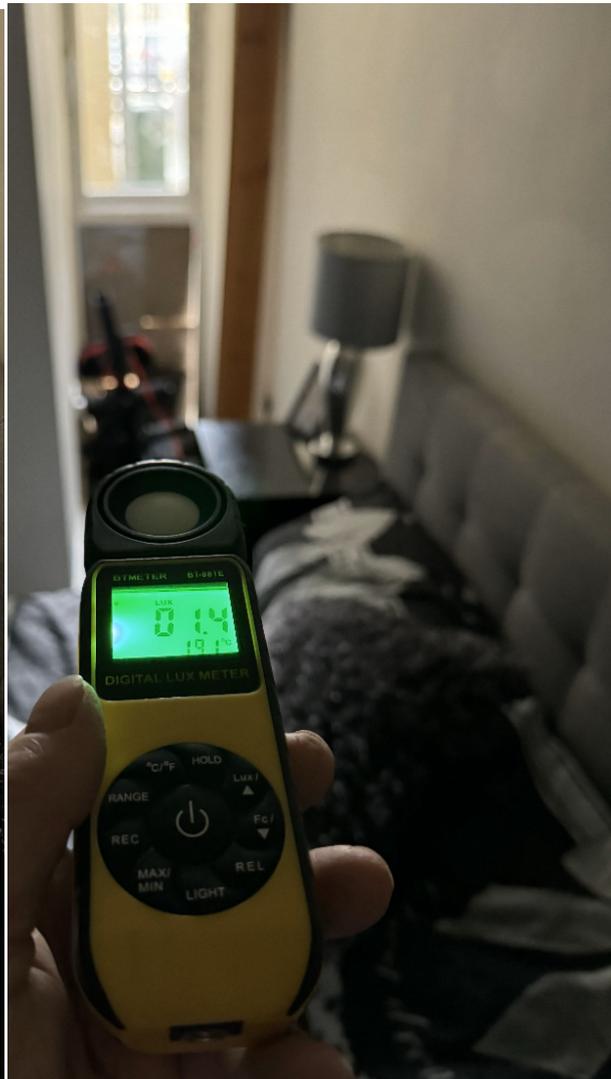
Luminance tests conducted 2.45pm 7<sup>th</sup> February 2024, overcast, dry day, a new calibrated instrument being used. Photographs of readings attached; numbers below are “Lux”

- Internal Reading, three metres back from the side window:1.4
- Internal Reading window panel & door panel exchanged for translucent, three metres back from the side window:4.4

1. The room presently has relatively poor light
2. There is a very significant improvement in removing the plastic non glazed panels.
3. Light reduction at 68%, is the point the residence would be affected.
