Preliminary Roost Assessment

The Pottery House,
Binham, Norfolk

Reference: 2106-GE-NP

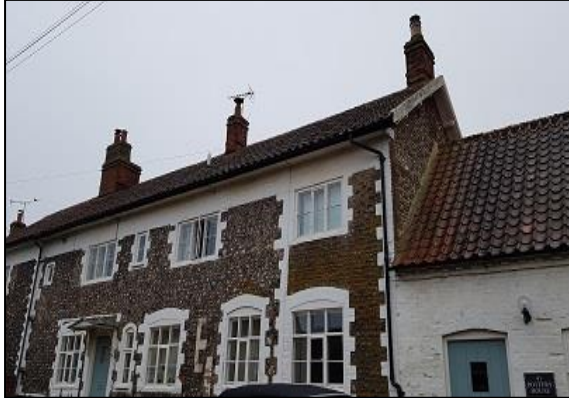
Figure 1: Eastern aspect.

5.2.2 The house is a two-storey brick, stone and flint building built in the late 16th or early 17th Century with additional extensions on the west and north in the 18th Century. The north wing is a single storey brick addition which encompasses the main entrance hallway of the property. There is a pantile roof throughout. Figures 1 and 2.

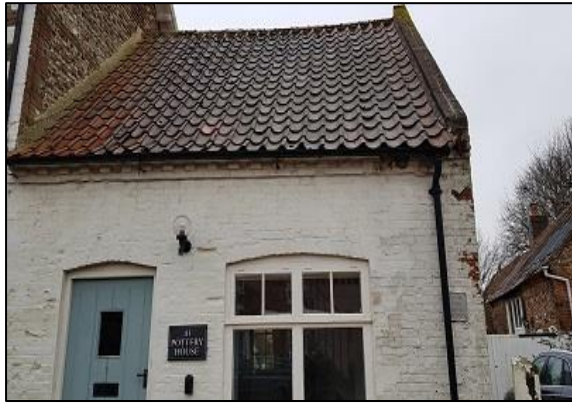
Figure 3: Northern wing – eastern aspect.

5.2.5 There was some lifting of the tiles on the north wing roof, specifically on the western aspect. The eastern aspect was in good condition and the tiles were relatively tightly fitted (Figures 3 and 4).

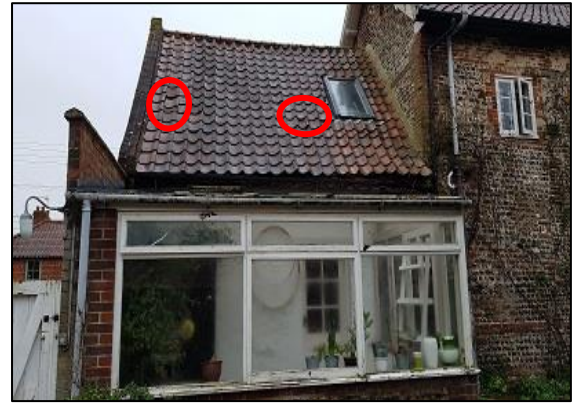
5.2.6 There was a Velux window in the western aspect, the flashing around the base was well fitted and didn't offer any roosting opportunities.

Figure 4: Northern wing – western aspect - lifted tiles circled.

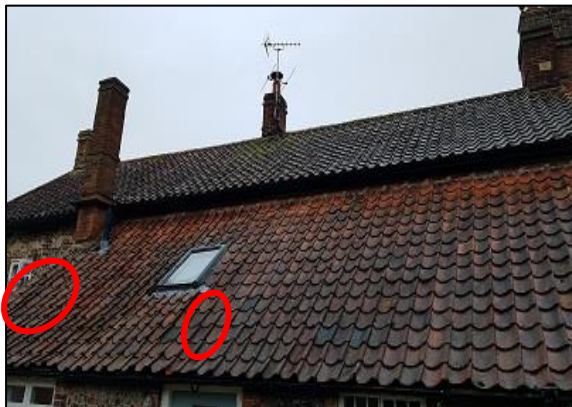
5.2.7 The western extension roof had some raised tiles at the northern end below the chimney stack (Figure 5).

Figure 5: Western extension roof - lifted tiles circled.

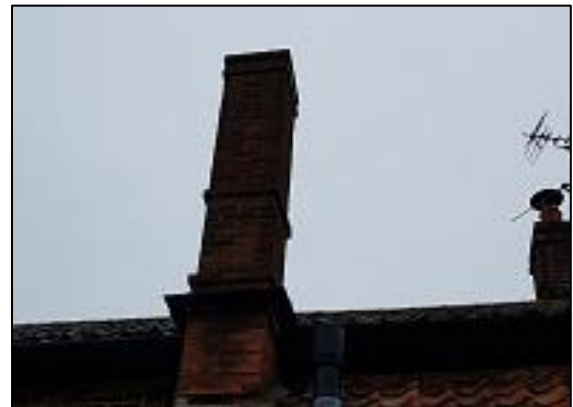
Figure 6: Chimney stack.

5.2.8 The chimney stacks had no flashing around their bases. The chimney stack on the western extension (due for removal) was in good condition and there were no gaps or cracks in the brickwork or mortar (Figure 6).

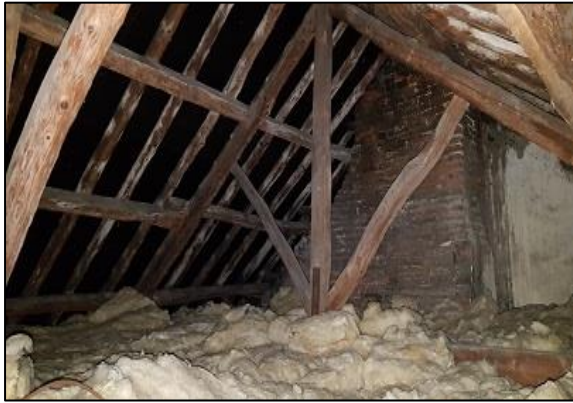
Figure 7: Internal view of main house roof void.

5.2.12 The main house roof is not being affected by the works, but to gain an overall picture of the house the internal roof space was inspected (Figures 7 and 8).

5.2.13 The space was a narrow void accessed via a hatch on the landing. It was fully lined (Figure 8) and the lining appeared to be in good condition.

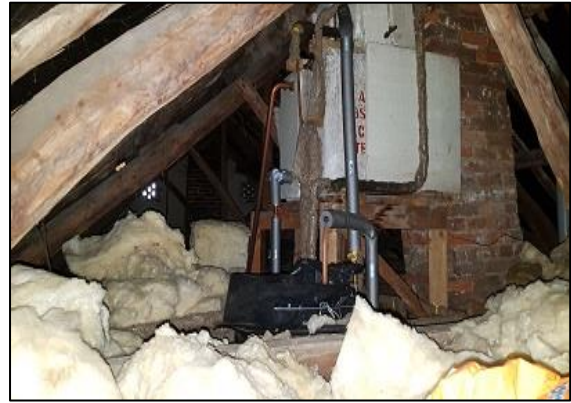
Figure 8: Internal view of main house roof void.

5.2.14 There were a pattern of bricks missing in the northern gable end (visible in Figure 8), probably for ventilation, but no other access points were noted. A large wasps' nest was next to the holes.

5.2.15 The roof space was heavily cobwebbed throughout, especially at the apex and gable end walls. The cobwebs at the apex came down to the floor in places.

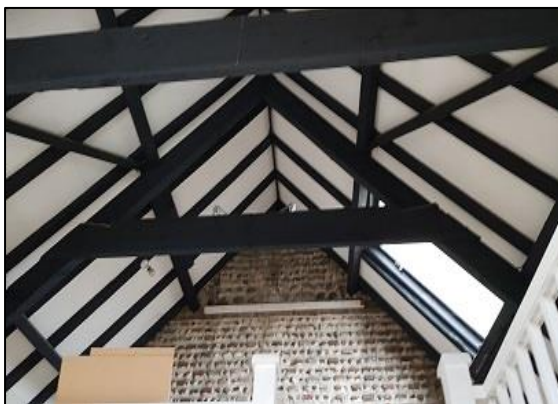
Figure 9: Internal view of northern wing.

5.2.18 The northern wing was open to the roof space (Figure 9) and there were signs of damp on the boarding. The space was bright and airy, partly due to the large Velux window in the western aspect.

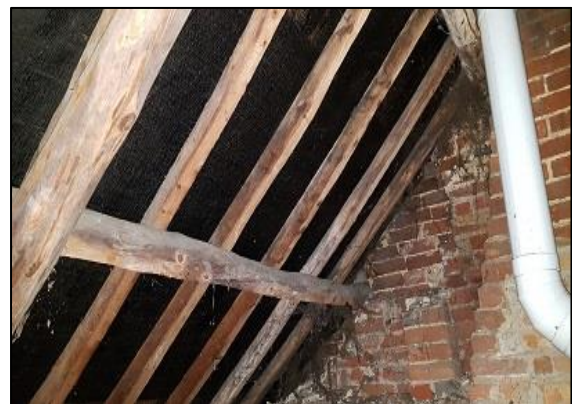
Figure 10: Western extension roof void.

5.2.19 The roof void of the western aspect was small and low and very heavily cobwebbed (Figure 10). The lining was generally in-tact apart from some tearing at the eaves where it was damp and weatherworn. The beams were narrow and without splits or cracks.

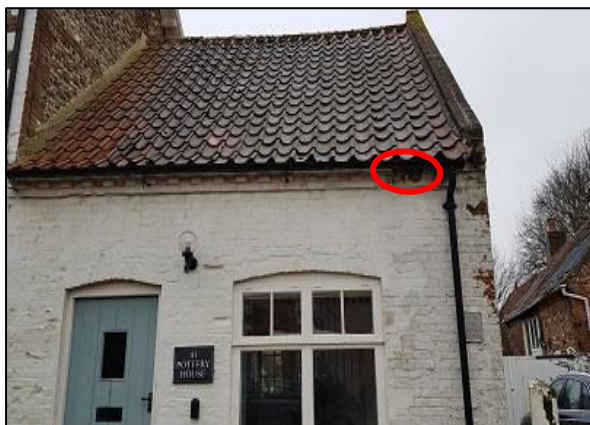
5.3.1 There was little bird activity around the site during the survey, but there is an old house martin nest on the eastern aspect of the north wing (Figure 11).

Figure 11: House martin nest location circled.
