Planning Condition 19 of planning application reference 19/04978/FUL

This Letter Report has been prepared by Red Kite Network Limited (Red Kite) in order to discharge planning condition 19 of Shropshire Council's planning application reference 19/04978/FUL.

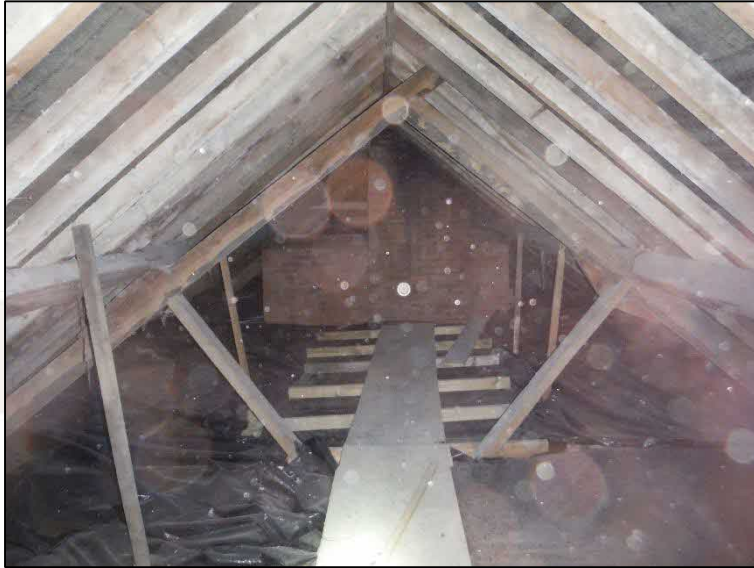
Image 1: Retained and enhanced (6no access tiles, maintenance/monitoring walkway) brown long-eared bat loft in Building 1.

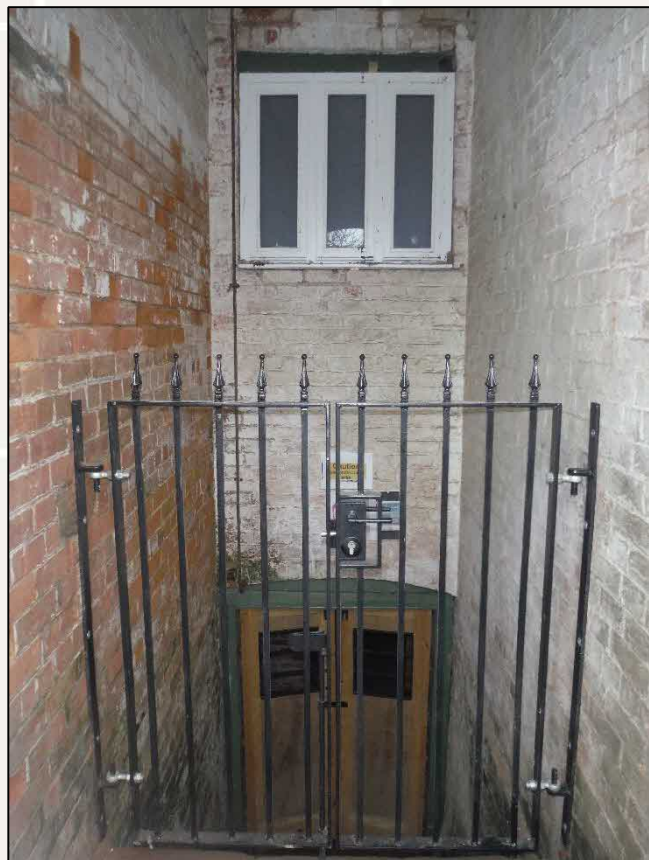
Image 2: Retained and enhanced (2no Kent bat box, baffles, cooling tower, locked barred door & gate, enhanced second access point) lesser horseshoe & brown long-eared hibernation and day roost in basement of Building 3.

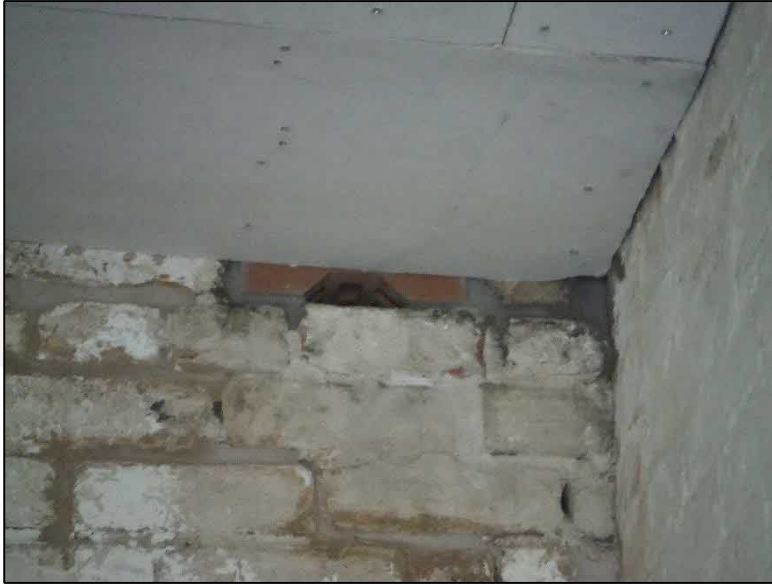
Image 3: Retained and enhanced (bat access brick) brown long-eared maternity roost in Building 3 wall cavity.

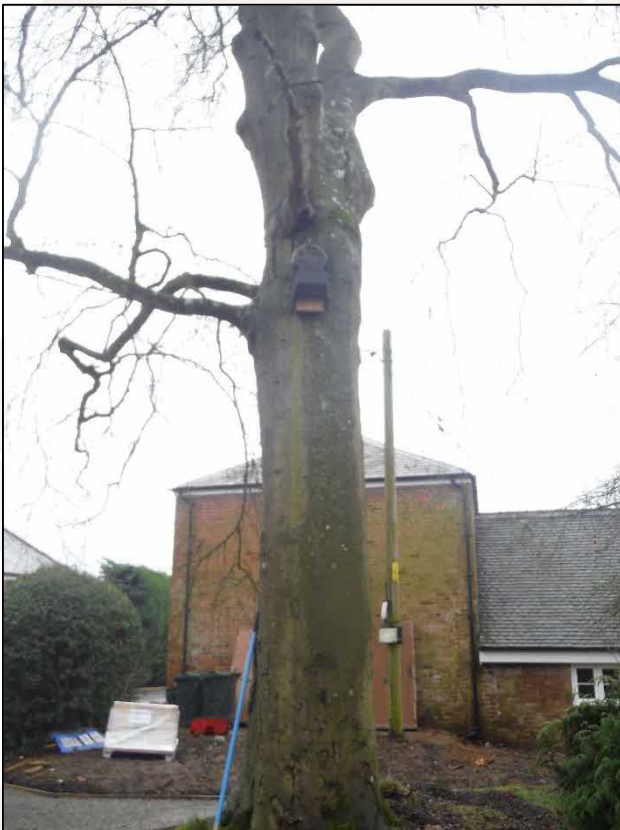
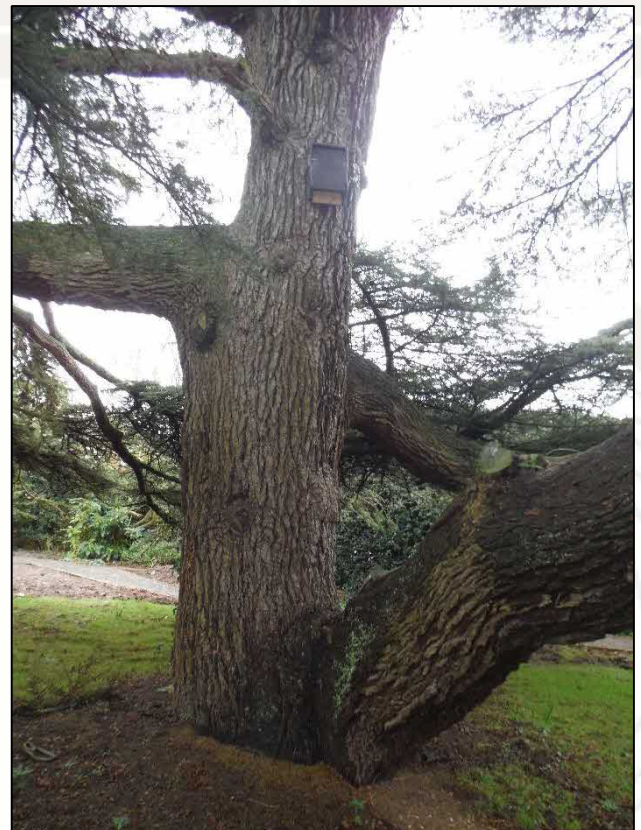
Image 4 & 5: Schweglar 1FF bat boxes x2 on retained trees
