cornwall  
environmental  
consultants LTD

**Bat and Barn Owl Assessment  
September Lodge  
Wheal Hope  
Goonhavern  
Truro  
TR4 9QJ**

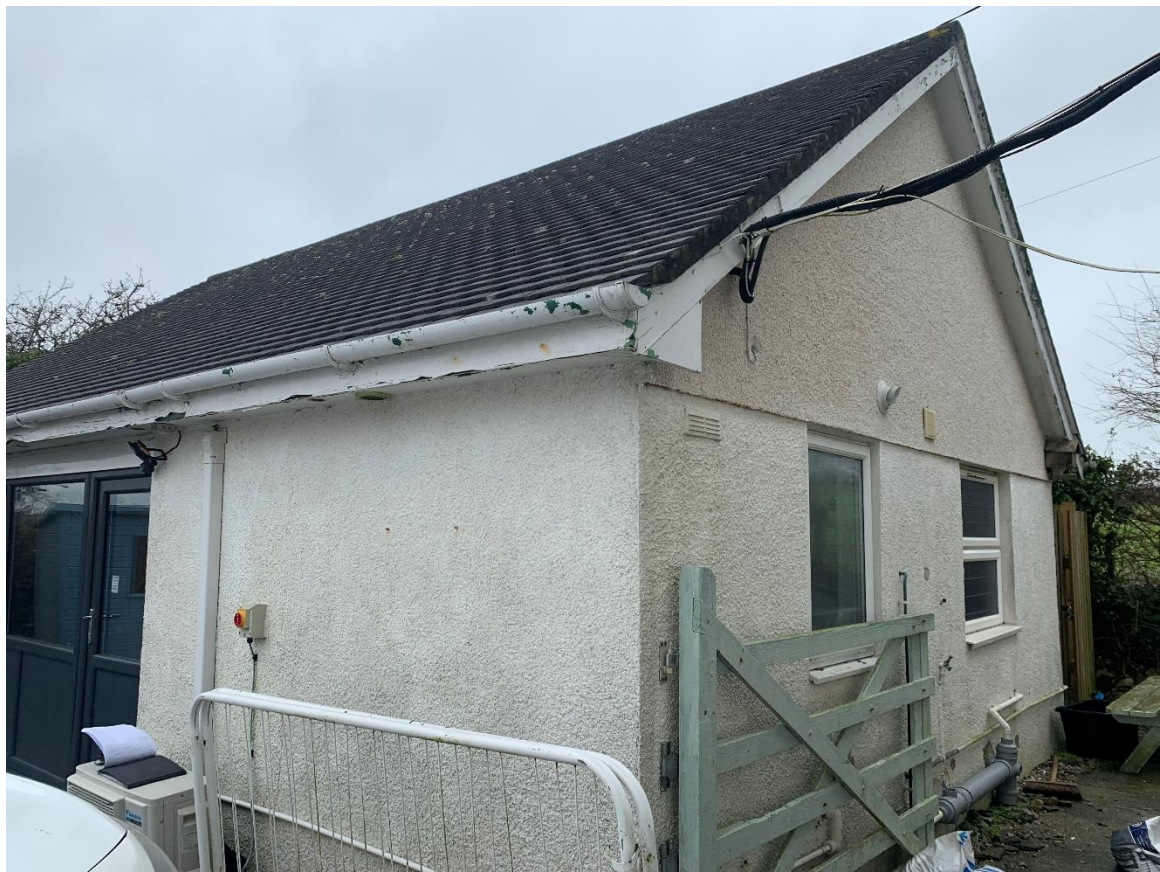
Figure 1: Southern elevation of building assessed

The building surveyed is a detached ground floor annex. The pitched roof is constructed from cement fibre tiles underlined with bitumen felt, rendered block cavity walls and wooden soffits.

The exterior of the building, including the soffits, roof tiles and at the apex of the gable ends are all well sealed. The exterior walls, floor and windowsills were all searched for signs of bats.

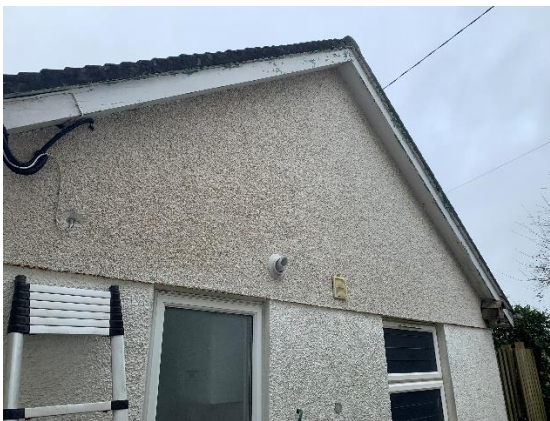
Figure 2: Eastern gable end of annex

It was noted that a bird box with a house sparrow *Passer domesticus* nest on the eastern elevation had been used within the last year. This box will be unaffected by the work. Although no sign of nesting birds was recorded within the areas that will be impacted at the time of the survey, if the works are to be carried out within the bird breeding season (March to September) the building should be searched for nesting birds. If nesting birds are present, works should not commence and further advice sought from Cornwall Environmental Consultants (tel 01872 245510) or Natural England (tel 01872 245045) as the nests and eggs of all wild birds are protected against taking, damage or destruction under the Wildlife and Countryside Act 1981.

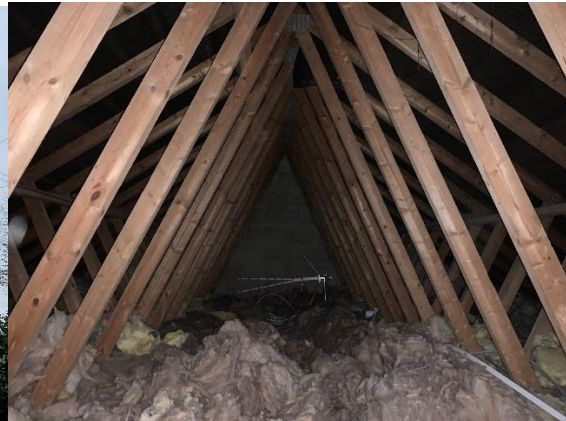
The loft void of the building is insulated with mineral wool insulation and the floor partially boarded. The rafters were searched from the apex to the soffits as well as the insulation.

No evidence of bats was noticed at the time of the assessment.

Figure 3: Building interior.

Although no current evidence of roosting bats was found it cannot be assumed that bats are not present when works commence. Care should therefore be taken during the work as bats could roost unseen deep within crevices in the structure. If any bats are discovered during the work they must not be handled: works must stop immediately and advice sought from CEC (tel 01872 245510).
