Statement Heritage

Chenhall Farm, Crelly, Trenear, TR13 0EY

Historic Building Record Level 2-3

SH Ref CHEN0821 Archive Report v.1.0

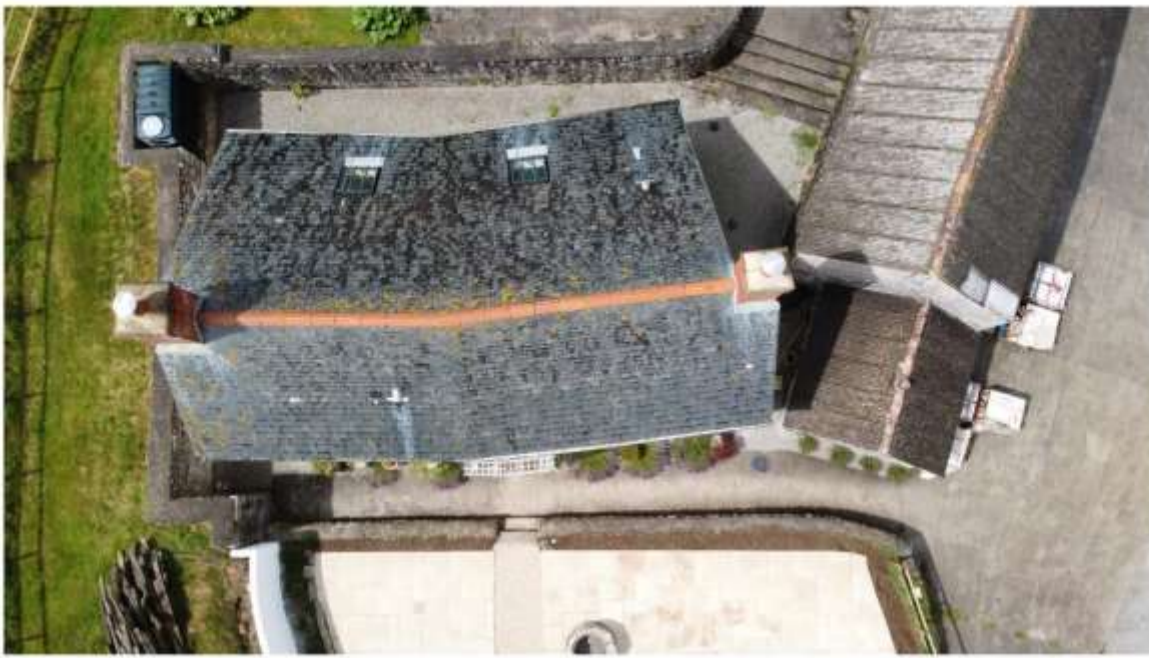
i) Vertical aerial photograph of roof, probably dating to the renovation of the building consented in 2007. A good quality natural slate laid to diminishing courses with orange ceramic ridge. Note pronounced crank in the plan of the building (Archive ref CHEN0821_DJI__0772.JPG)

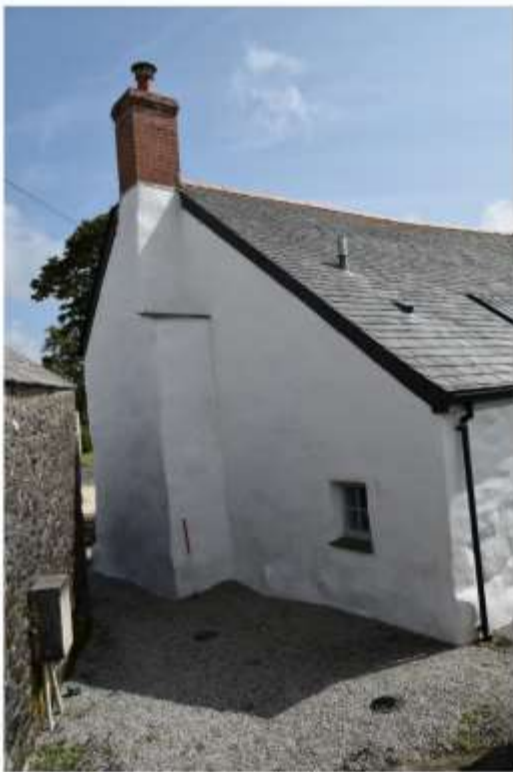
- 3.13 The rear (north-west – figure 7v) and north-east elevations (figure 7iii) each feature modern casement windows – the gable window is a fixed light; the rear window has a single opening casement and is flush fitting.

iii) [far left] Northeast elevation. Archive ref CHENH0821_0037.JPG
1m scale.

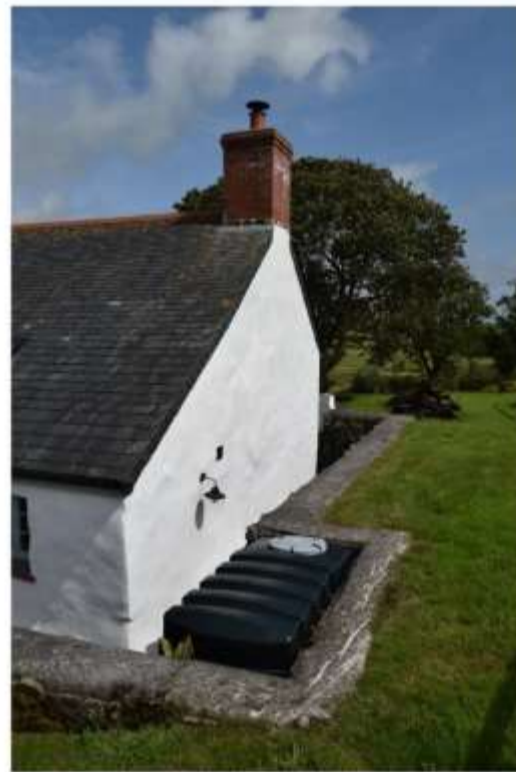
- 3.14 The southwest elevation (figure 7iv) is blind (no openings).

iv) [near left] Southwest elevation. Archive ref CHENH0821_0042.JPG

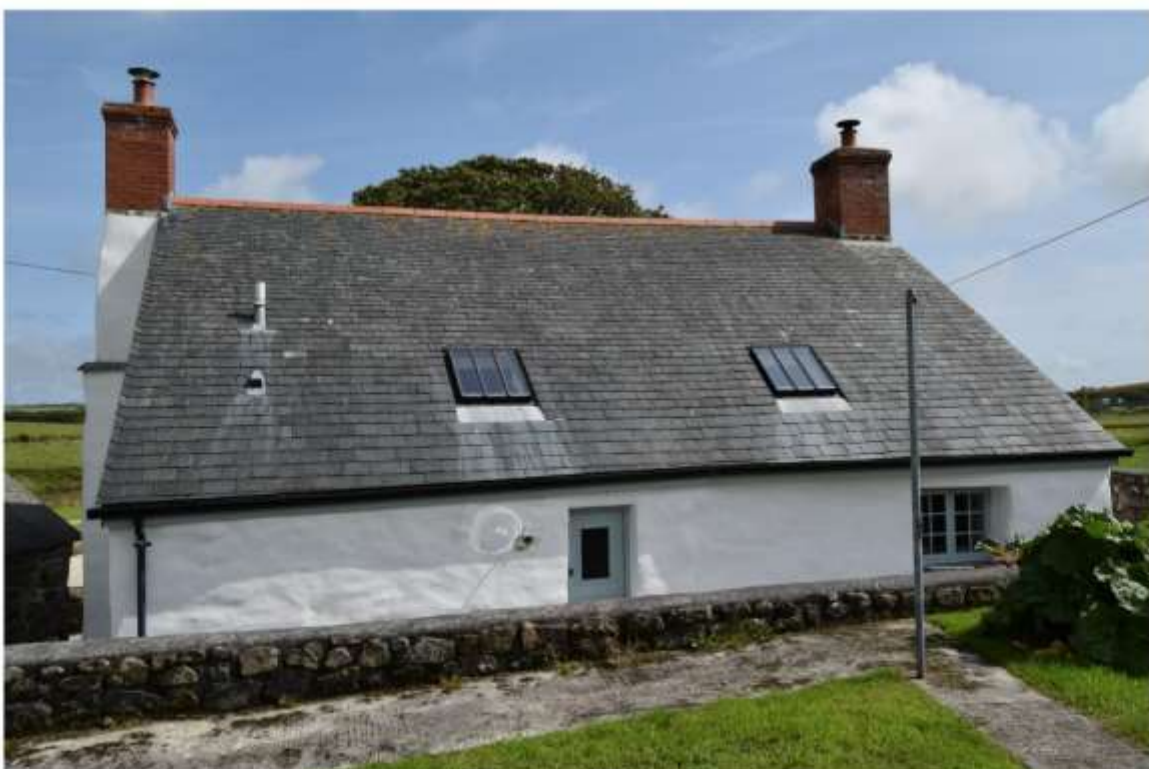
v) Northwest elevation. Archive ref CHENH0821_0041.JPG

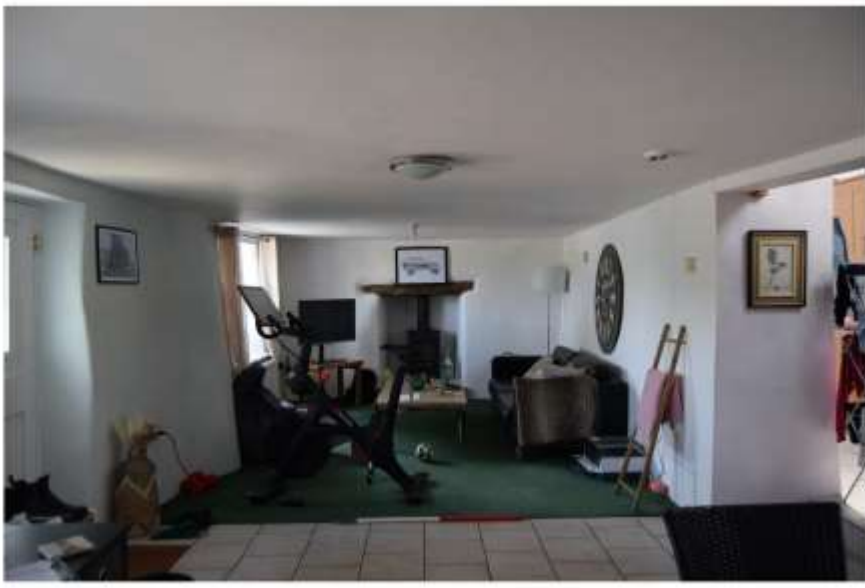
- 3.15 **Internally** the *ground floor* of the main range is now a single space (figure 8i and ii) 9m x 3.4m, with internal timber partitions having been removed since 2007. There are granite lintelled fireplaces to both ends of the building – the larger being at the right-hand end (figure 8ii). The massive (c1.5m) lintel of this fireplace has a rough unstopped possible lower chamfer with three drill holes in its face. A slighter granite lintel is above the fireplace at the western end. Both fireplaces are fitted with modern log burner appliances. The ceilings are modern plasterboard. The floor is surfaced in modern ceramic tiles. Walls are irregularly plastered, presumably in the lime finishes specified in 2007.

i) Looking southwest along the ground floor
Archive ref: CHENH0821_0043.JPG
Scale 1m

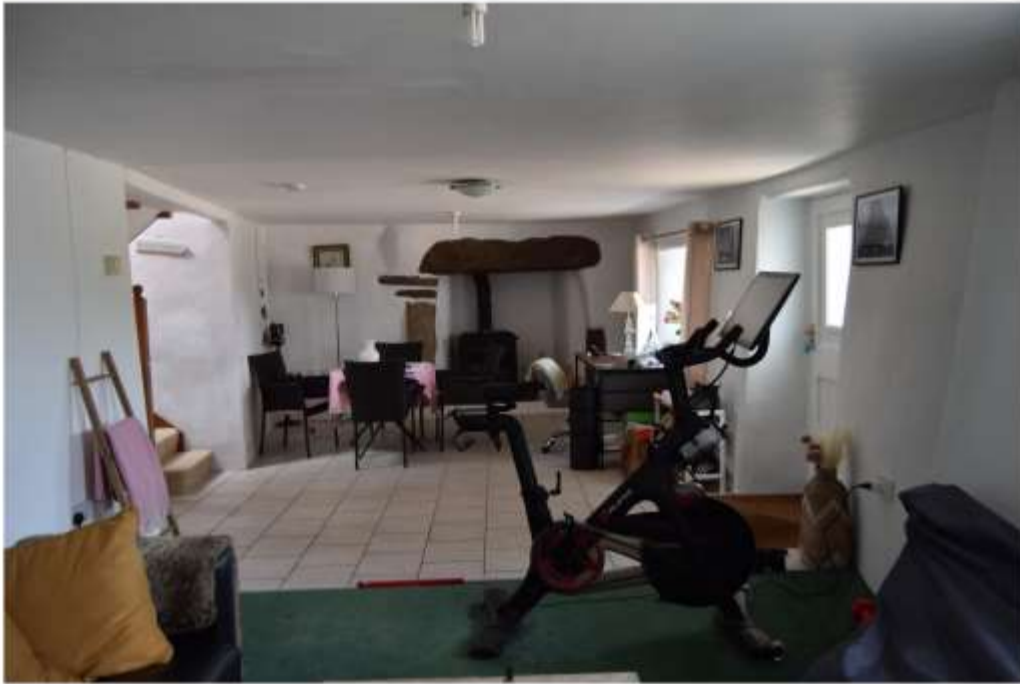
ii) Looking northeast along the ground floor
Archive ref: CHENH0821_0044.JPG
Scale 1m

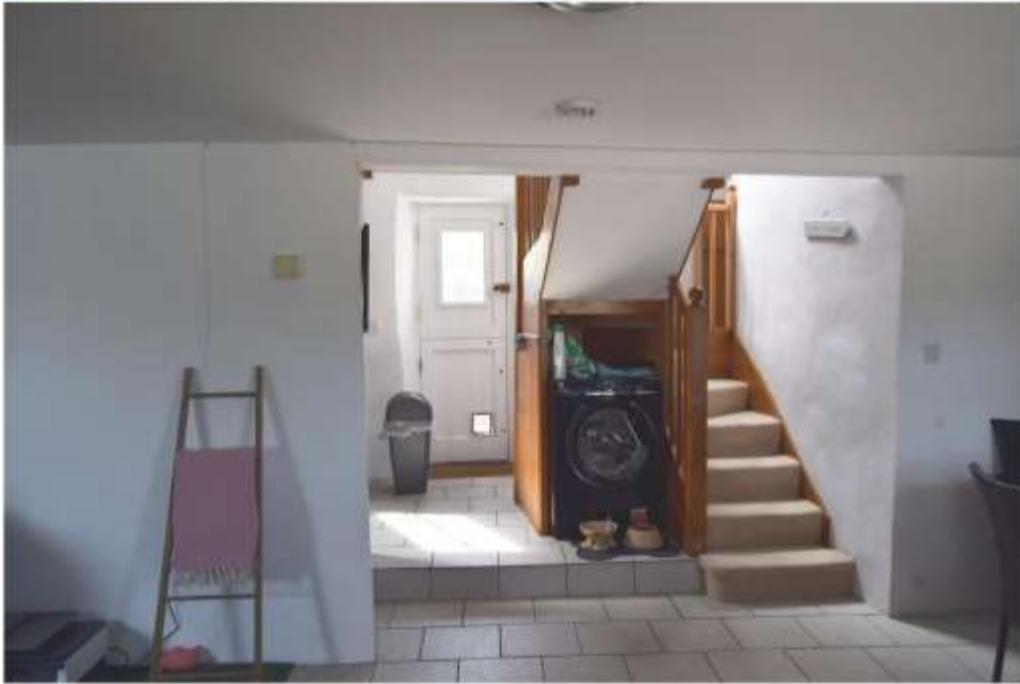
iii) Looking northwest towards the modern stairs
Archive ref: CHENH0821_0045.JPG

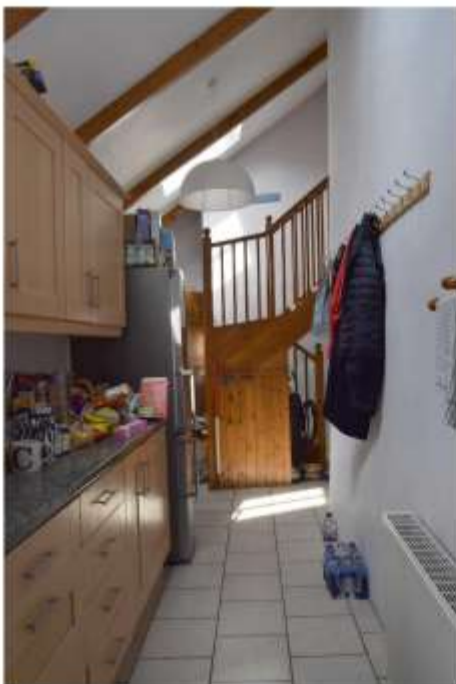
iv) Outshot, looking northeast
Archive ref: CHENH0821_0046.JPG

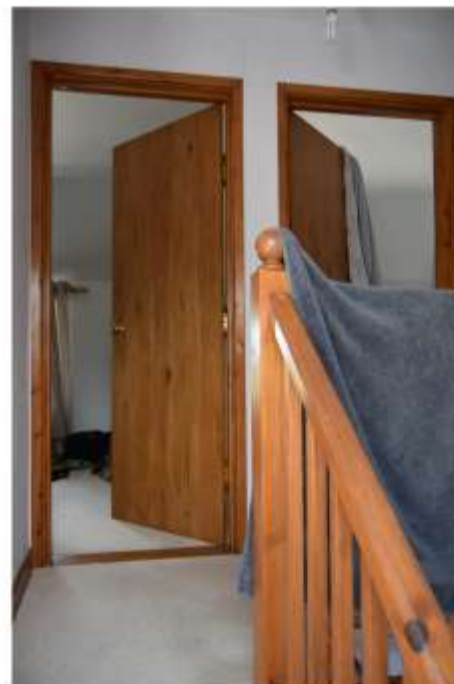
- 3.18 First floor spaces (figure 8v) have been finished in modern plasterboard linings with modern joinery doors and frames fitted. These are robust ledge and brace doors appropriate in character to the age and style of the building but do not have the authenticity and use-wear of originals.

v) First floor modern stud walls
and doors
Archive
ref:CHENH0821_0048.JPG

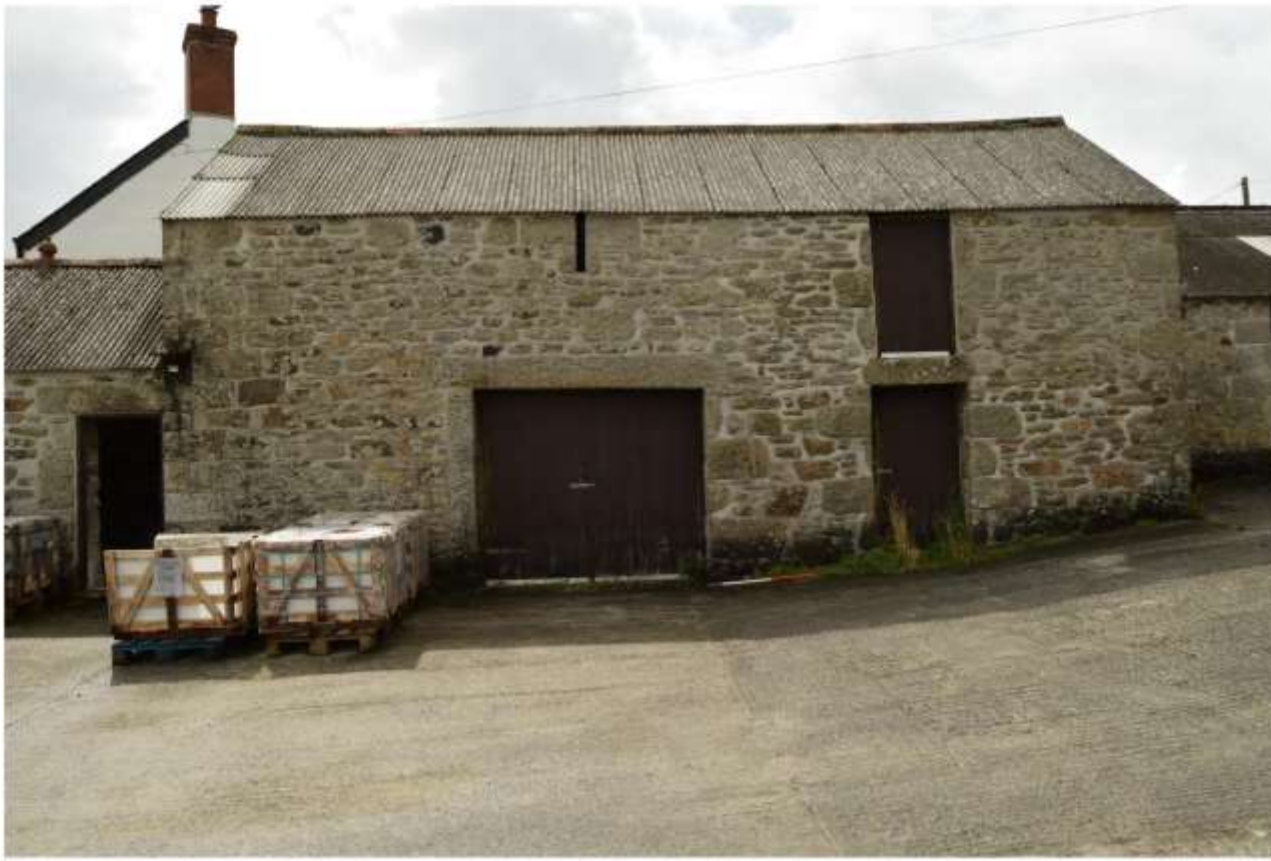
- 3.26 The barn has a mid-late 20th century corrugated asbestos roof covering with aged ceramic ridge tiles. Its principal elevation (figure 13i) has a first-floor threshing door towards the northern end (distinguishable from an ordinary loading door by being mirrored in the western elevation), and a ventilation slit to its southern end (again mirrored in the western elevation indicating the use of this part of the building for storage of cut crops or grain. Below the slit is a large cart entrance under a granite lintel (possibly a twentieth century adaption as its left jamb, a massive piece of cut granite, contrasts with the alternating granite quoins of the right jamb) to left and a doorway to right. All door joinery has been renewed with modern plank and batten units.

i) North east elevation
Archive Ref: CHENH0821_0364.JPG
Scale 1m

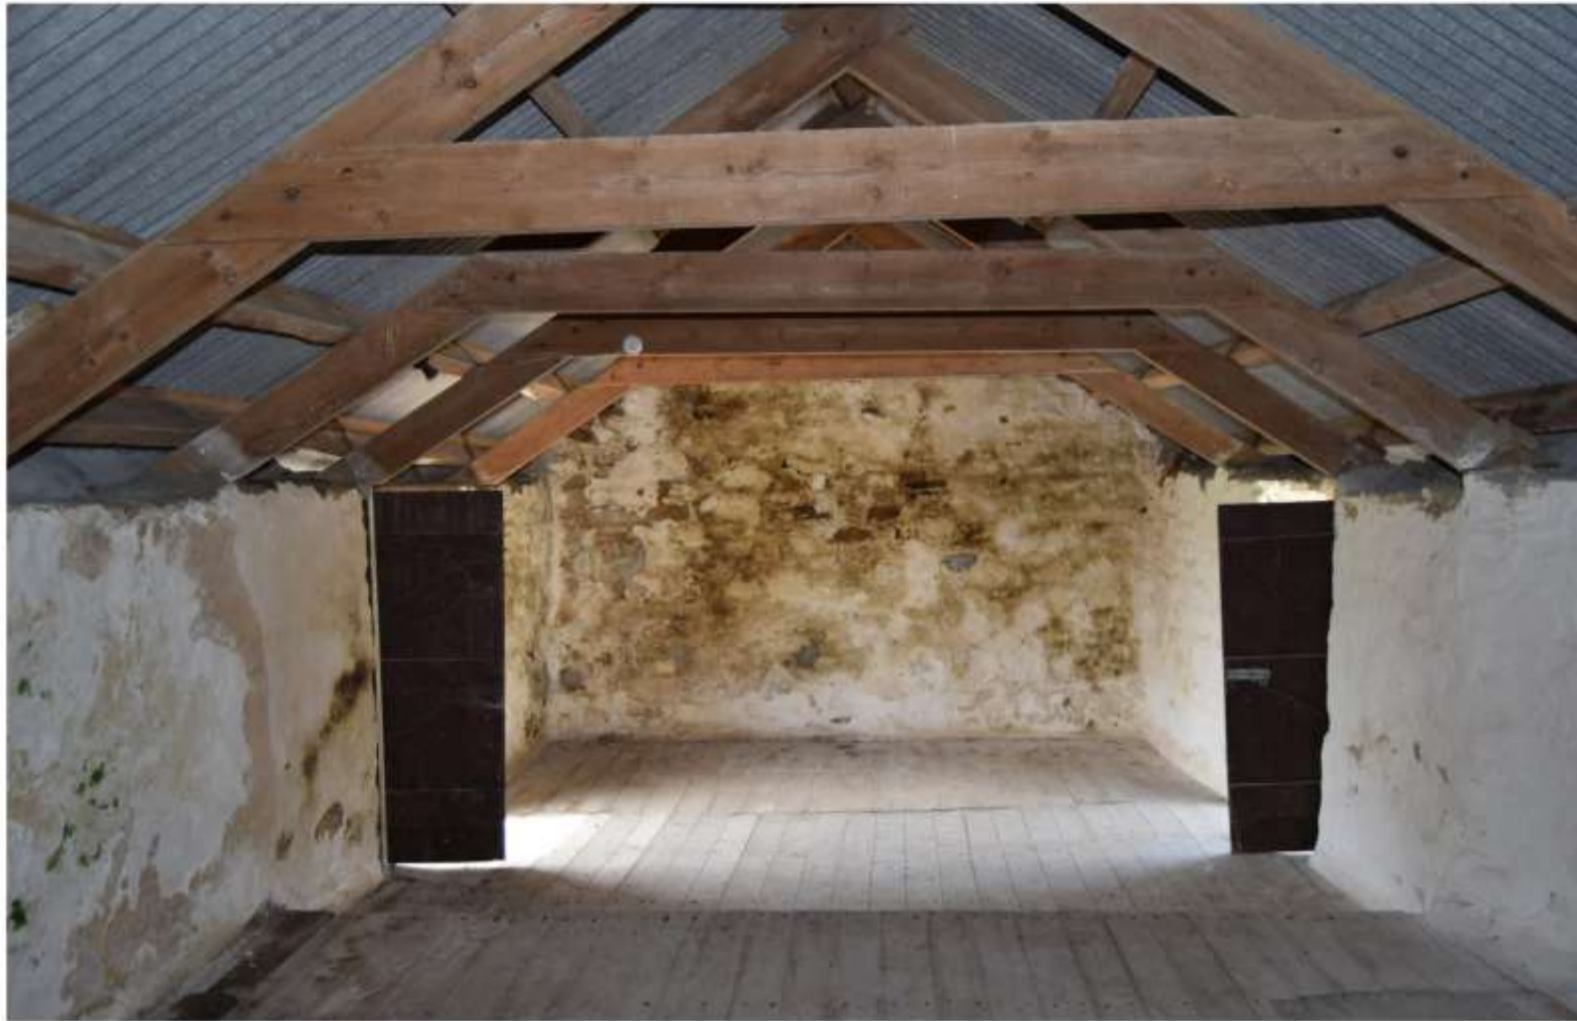
i) Looking northwest across the threshing bay.
Archive ref:
CHENH0821_0029.JPG

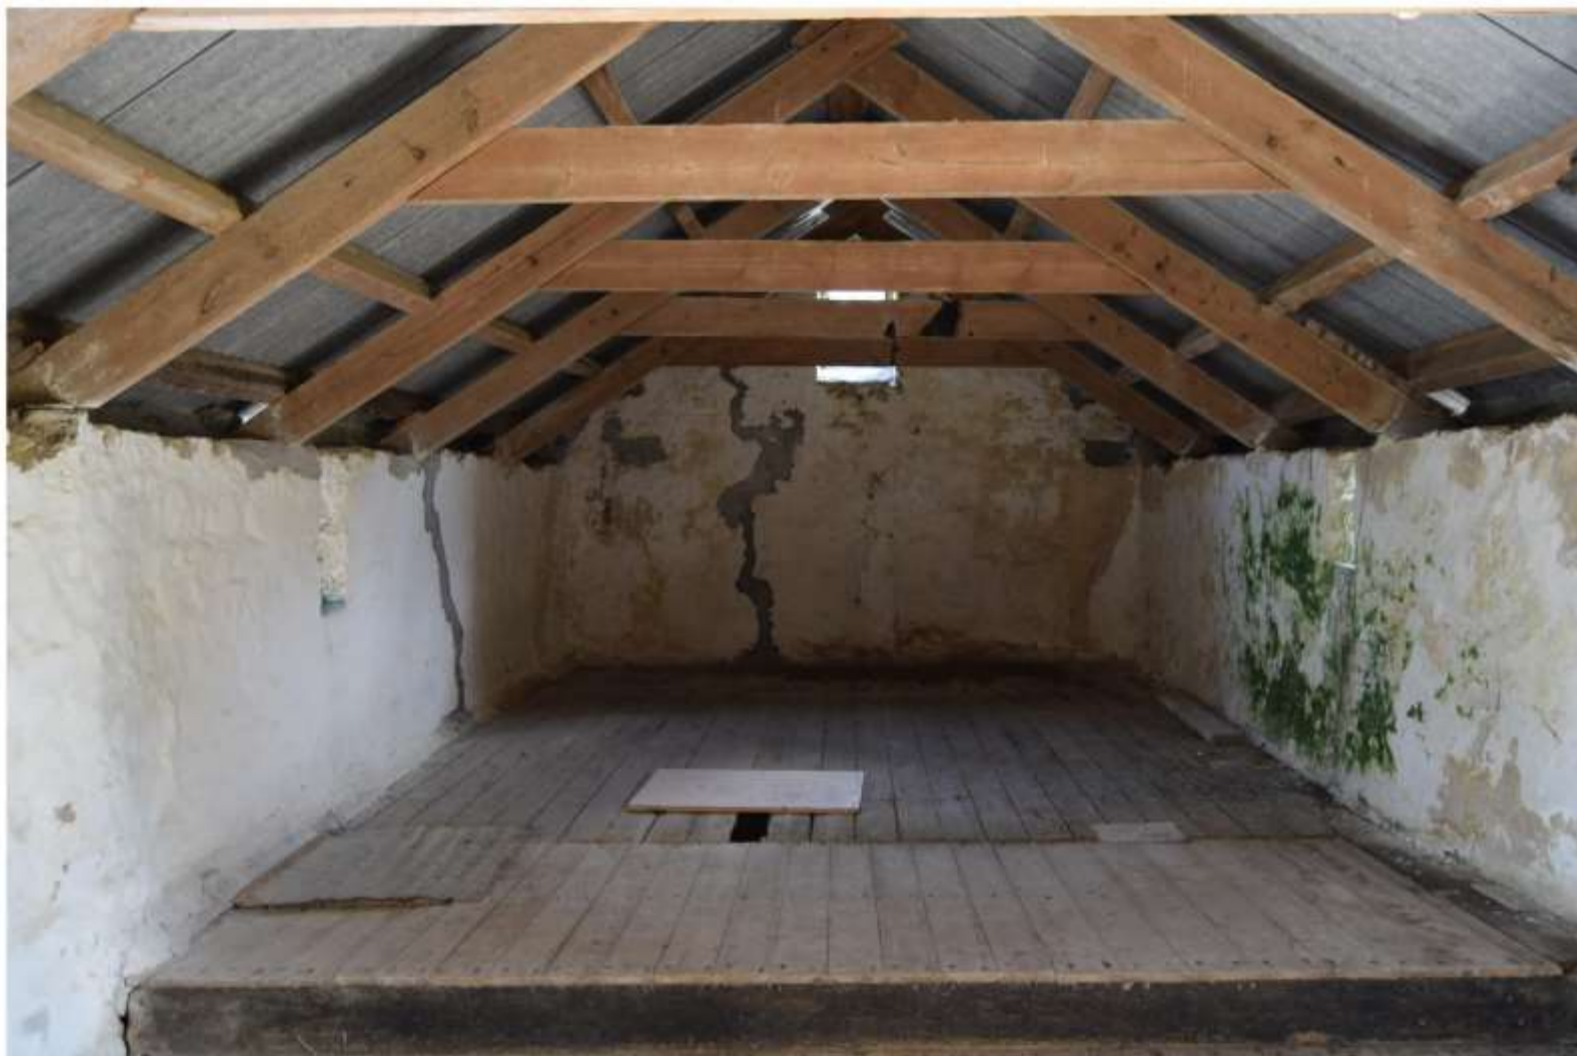
ii) Looking southeast across the granary space.
Archive ref:
CHENH0821_0030.JPG

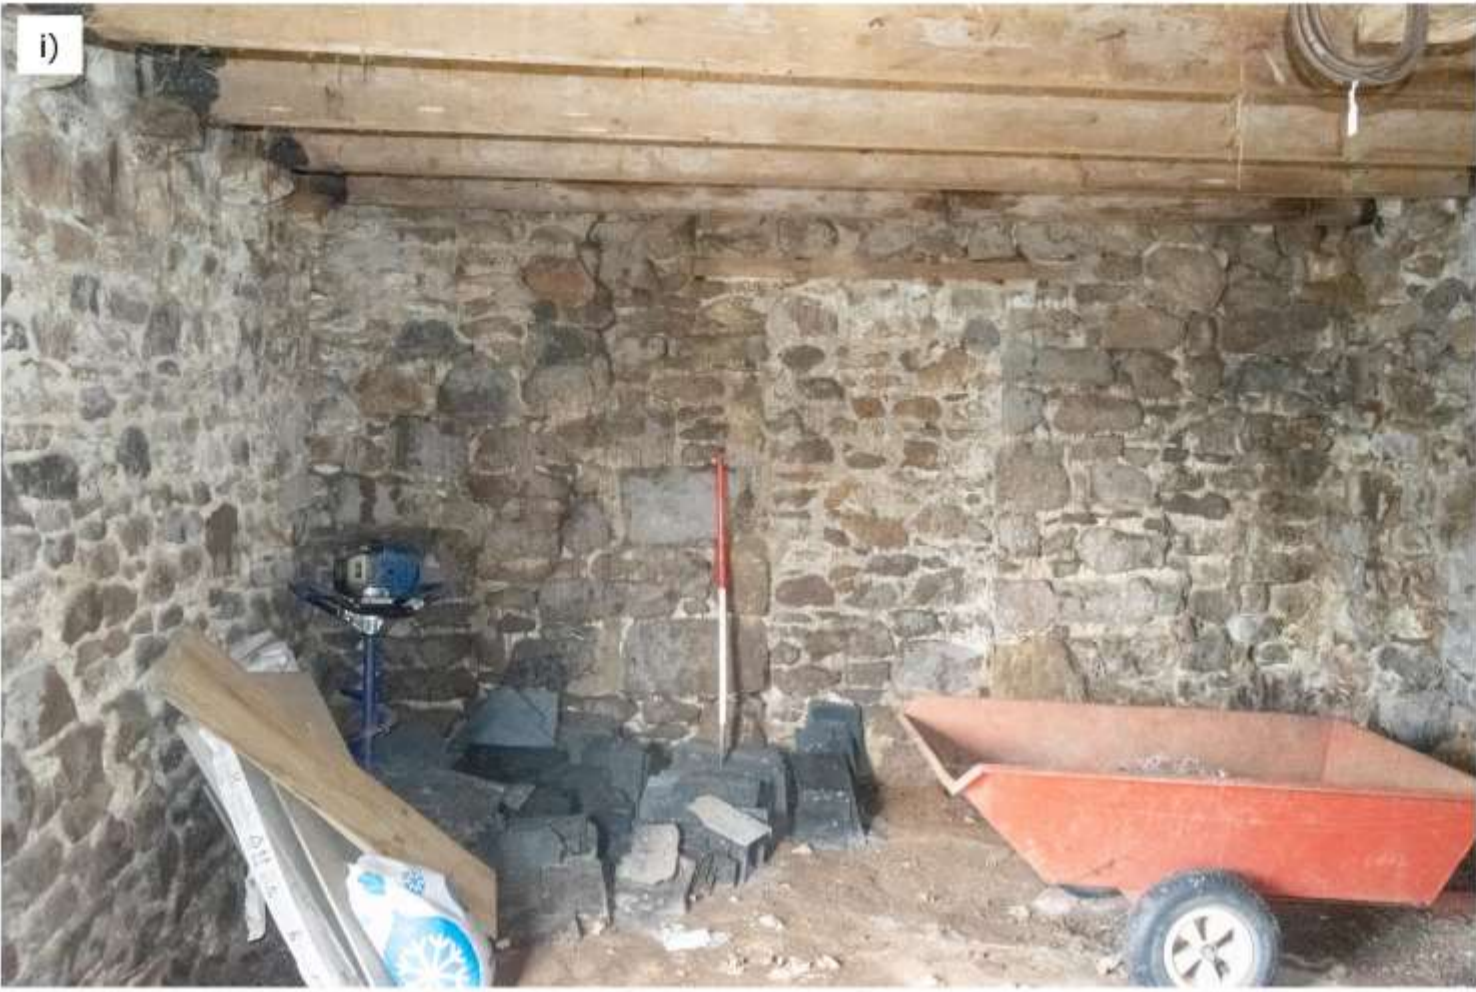
i) Looking southeast across the southern space beneath the granary. Note former doorway to Building 1C, blocked in granite rubble and lime mortar under a timber lintel.

Archive ref: CHEN1223_0068.jpg
Scale 1m

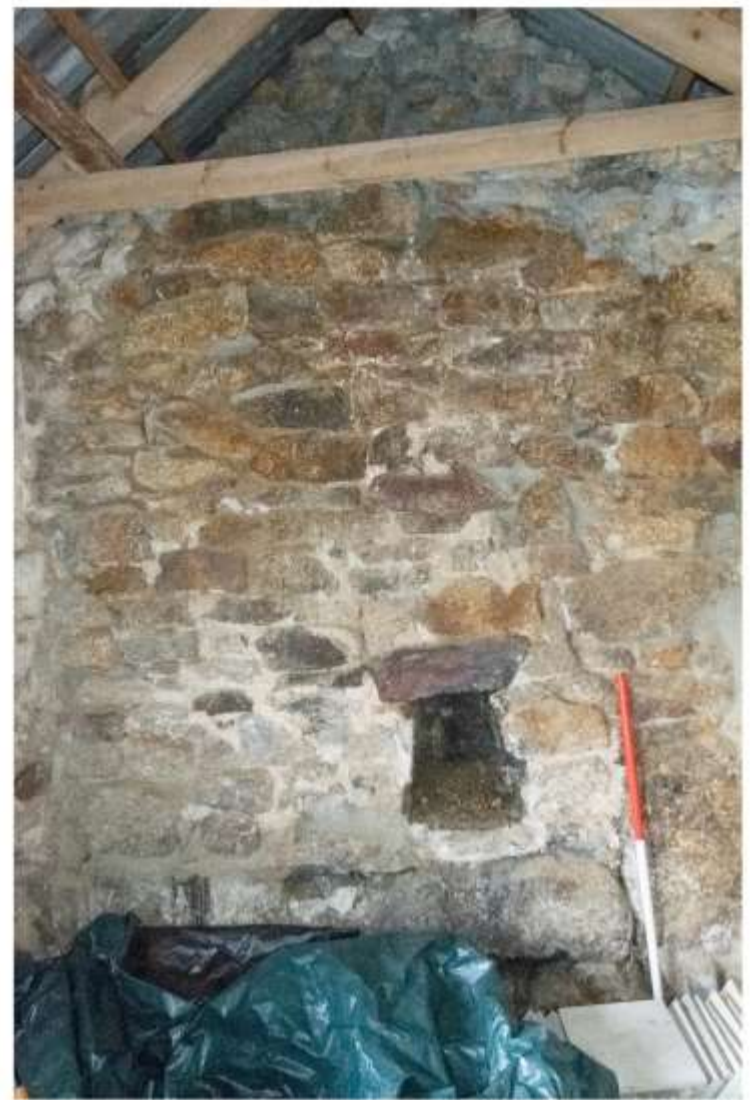
ii) Southeast wall, showing
lantern niche
Archive ref: CHEN1223_0070.jpg
Scale 1m

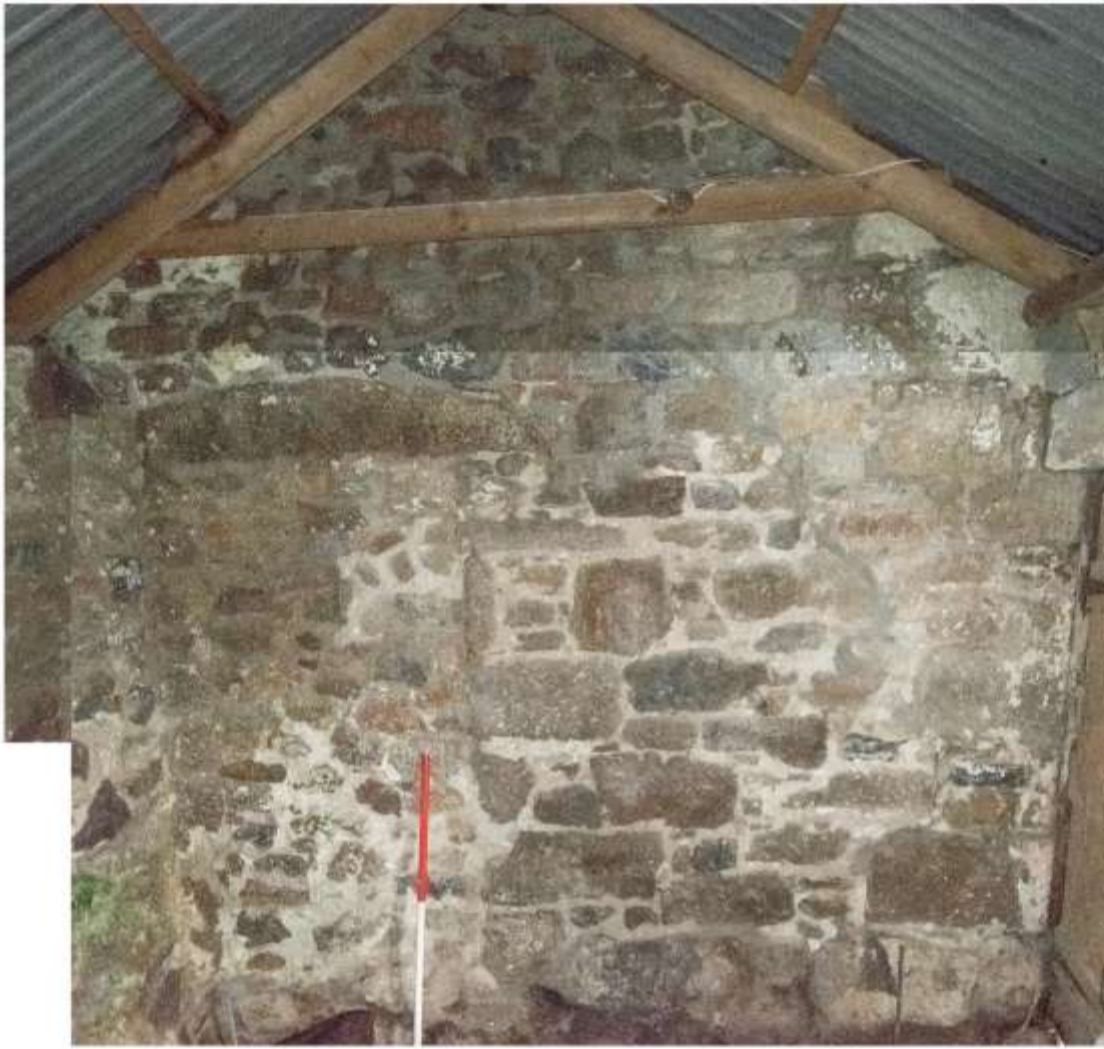
iii) Looking northwest, showing blocked door
to B1a
Composite image
Archive refs: CHENH1223_0073.JPG;
CHENH1223_0074.JPG
Scale 1m

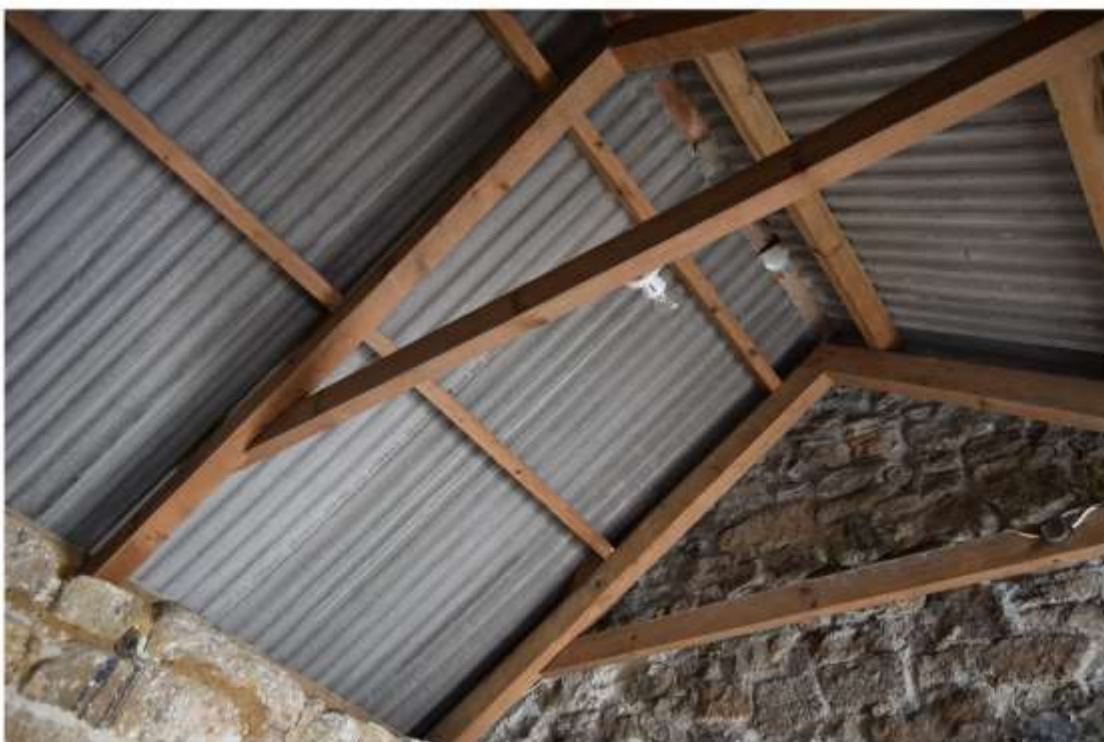
iv) Looking west, roof structure
Archive ref: CHENH1223_0073.JPG

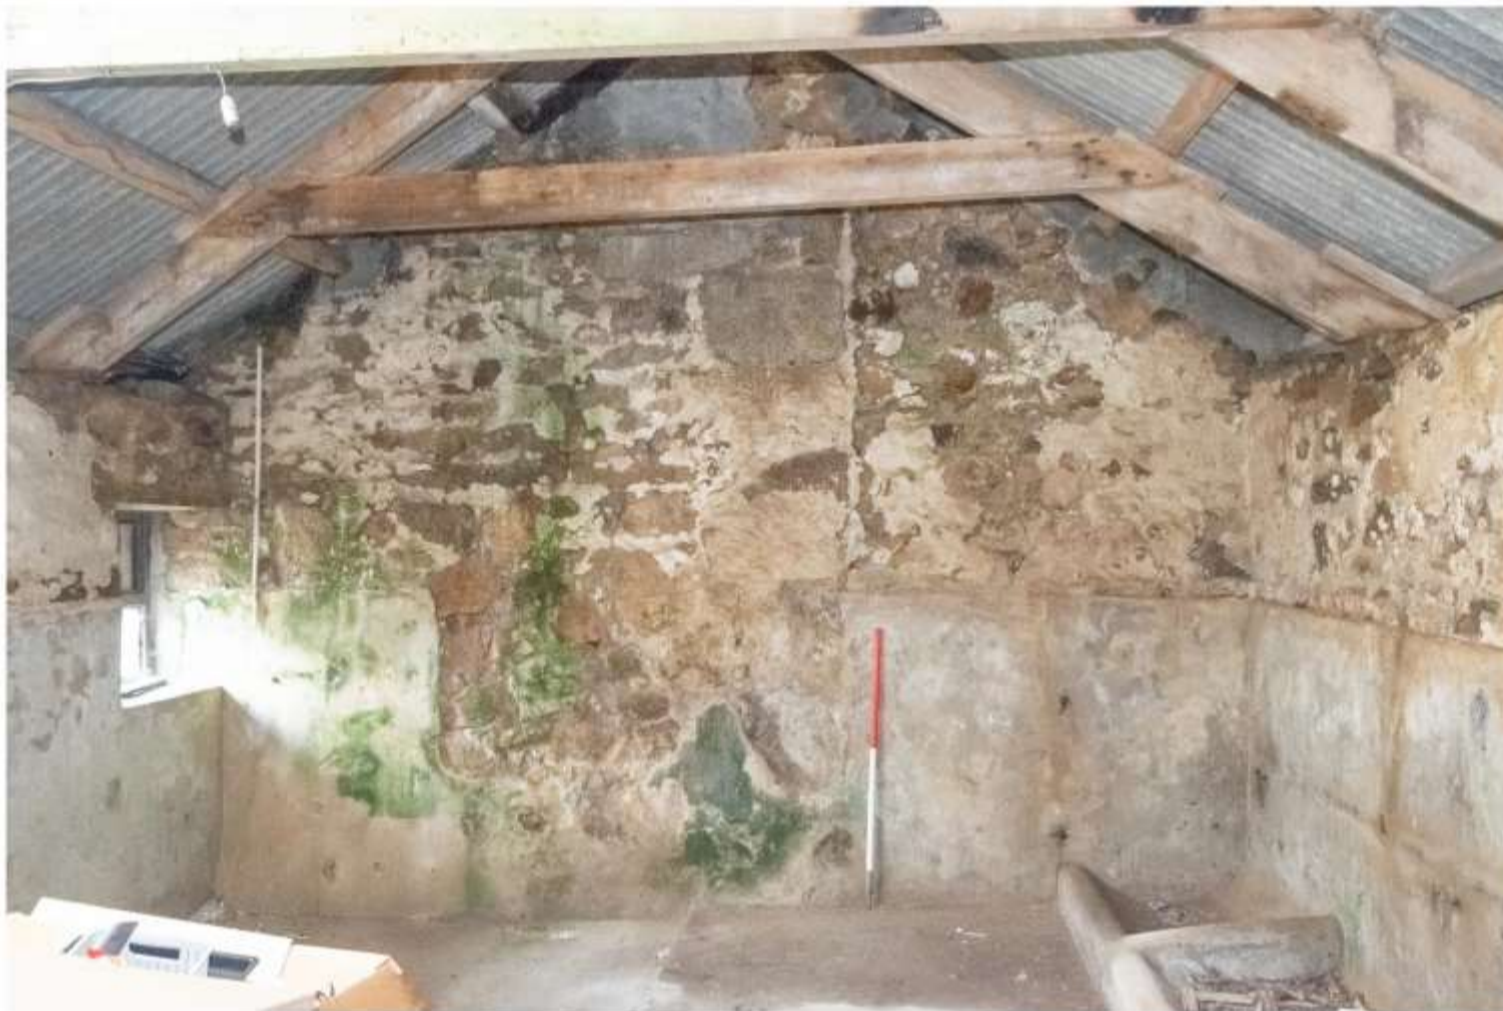
- 3.31 **Part 1c** (figure 18), is a single storey cowshed (5.4m x 4.3m internally), built of quarried granite rubble set in a cement matrix. Very loosely datable through historic map evidence to between 1907 and 1971 the use of materials would suggest an early-mid 20th century date. The building has two windows and a central door set in cut granite quoins with slate cills – all joinery is considered contemporary with the modern joinery elsewhere within Range 1. The building has a corrugated asbestos roof on probably early to mid-20th century modern nailed timbers. Internally the building has limewashed walls and concrete troughs and floor with drain.

ii) southwest wall and roof structure. Note quoins of the barn (B1a) just to the left of the scale rod, demonstrating that the walling of this part of the building to right is later.
Archive ref: CHENH1223_0067.jpg
Scale 1m

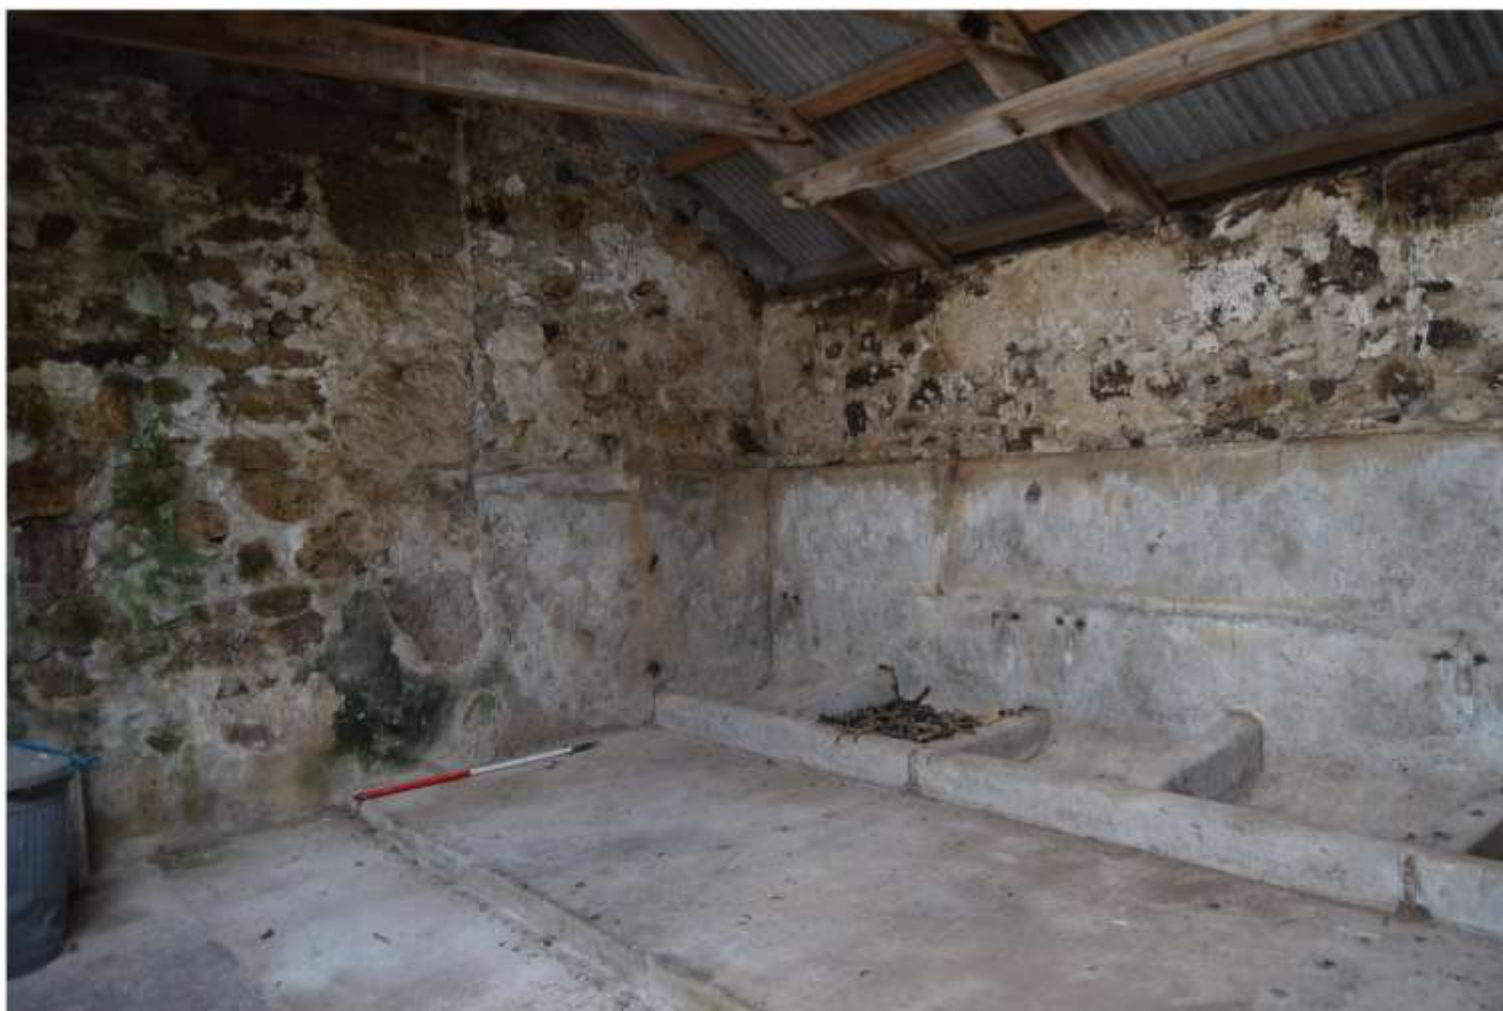
iii) southwest wall and roof structure
Archive ref: CHENH0821_0026.JPG
Scale 1m
