23 Downview Close,
East Wittering,
Chichester,
PO20 8NS

PHASE 1 BAT SURVEY

February 2024

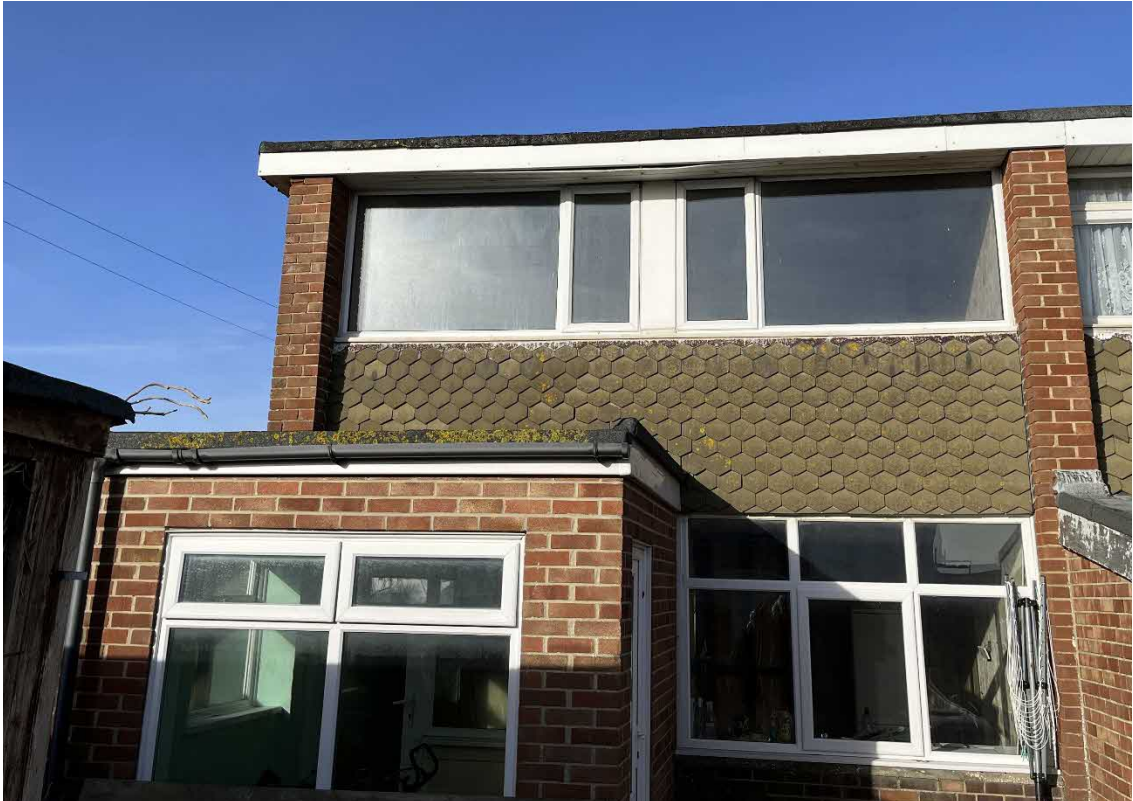
The roof has a low single pitched roof faced with cement tiles which are close fitting, The upper storey on the front and rear are faced with close fitting fish scale type hang-tiles (See figures 2 and 3). The soffits are all sealed and in good order. The ground floor extension off the southeast corner has no enclosed voids and with an interior permanently illuminated via side windows. This has negligible potential for roosting bats.

Figure 1. Eastern elevations of 23 Downview Close looking west.

The property has negligible potential for crevice roosting bats; therefore a phase 2 emergence survey is not recommended.

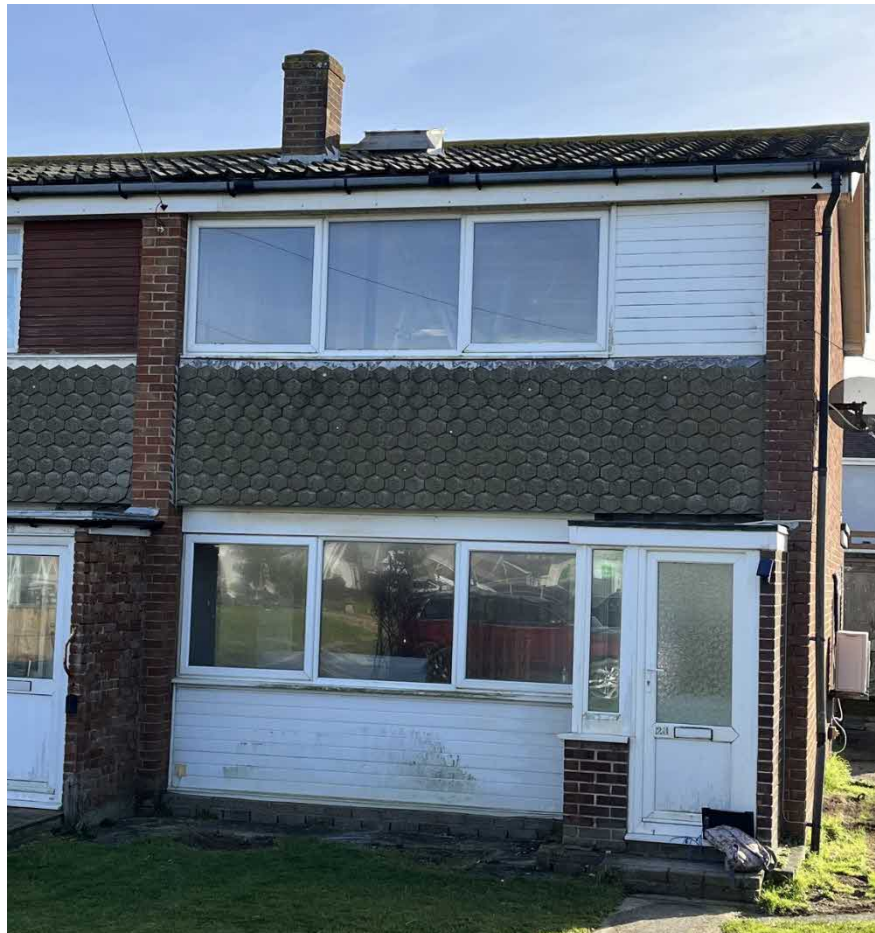
Figure 2. Western elevations looking east.

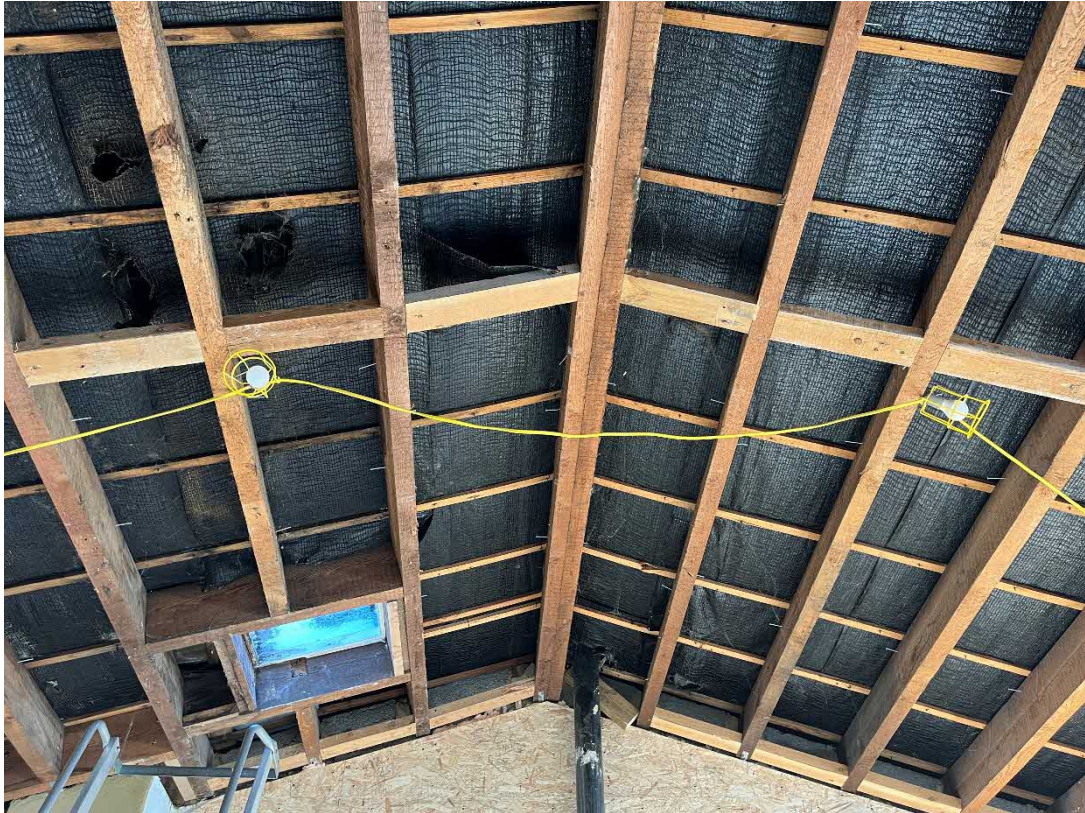
The roof space is open and integral to the upstairs living spaces (see figure 4). The roof is lined with bituminous felting and there was no sign of any bat activity within. There is a skylight on the west face of the roof.

Figure 3. Roof interior view from upstairs living space, looking west
