22 Gloucester Street, Cirencester GL7 2DJ.

Design, Access & Heritage Statement:

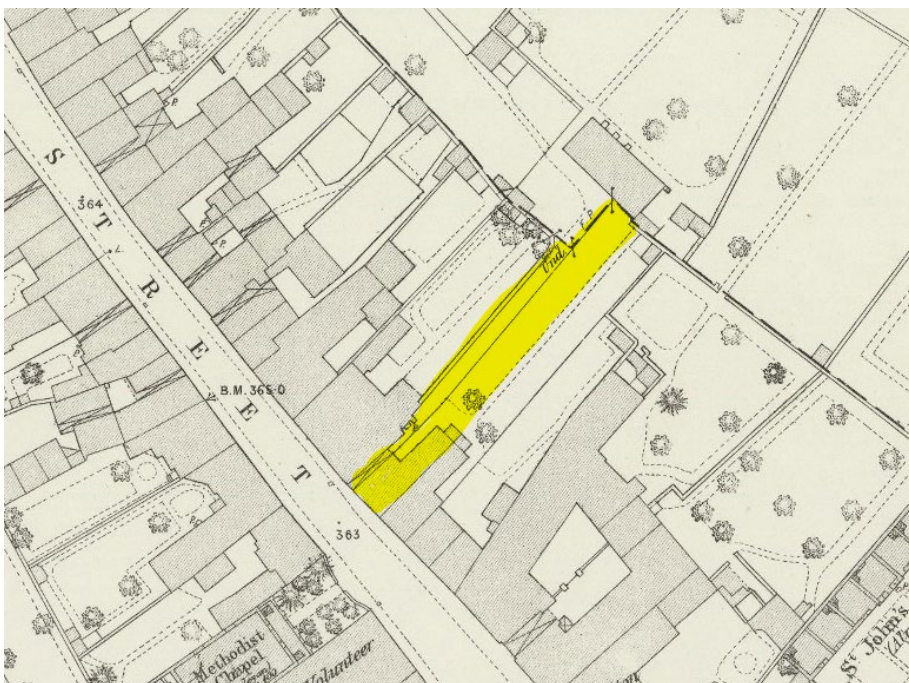
Know Your Place Map: 1879-1888:

Dwelling still appears to be the same, only obvious differences is it appears the garden is shared with the neighbouring property.

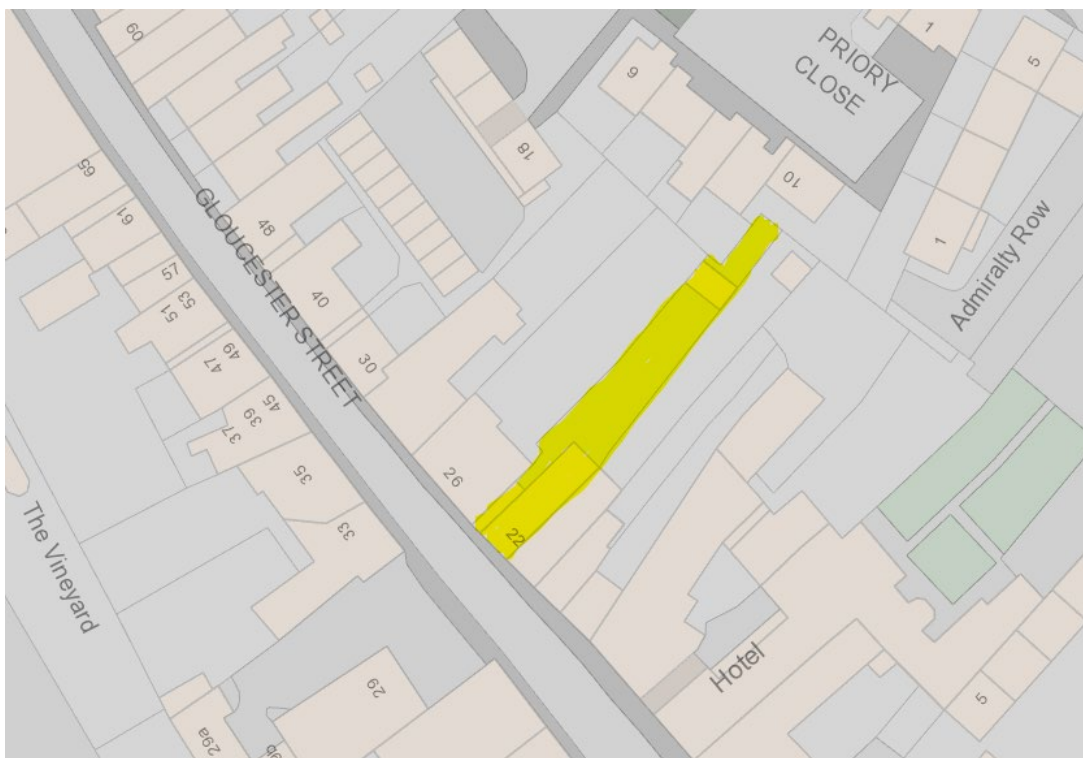
*Know Your Place Map: 2019:
The dwelling has a much larger footprint, with the garden extension shown as currently found. The garden has also been separated and an additional structure is shown within the garden.*

As shown within the historic map regression, after 1939 there is evidence of the rear range having been demolished, and replaced, which has resulted in significant alterations to the rear. There is a clear separation between the front of the house and the later extension. We would conclude that the dwelling's significance lies in the historic character and architectural interest of the street elevation and its relationship to the surrounding buildings on the street scene. For this reason, the proposal consists of a modest range of alterations which affect only modern fabric or parts of the building that have already been substantially altered.

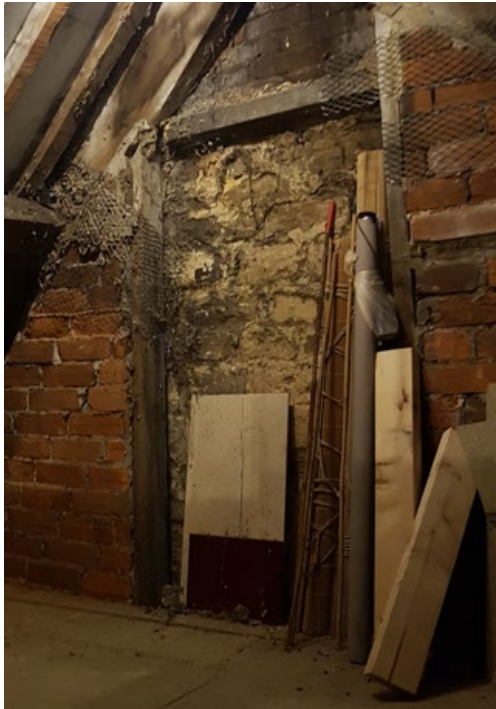
Blocked doorway in loft.

The photos above show an historic doorway in the gable wall. The ceiling appears to have been raised above the level of the original loft space or third floor. This is also supported by the modern timber used in the construction of the loft floor, and the modern ceiling finish in the room below.

For 22 Gloucester Street, historic alterations leave no historic partitions in place and there are indications that the ceiling of the second floor has been raised. See photos overleaf. The raised ceiling means that the staircase must be longer than that constructed in the adjacent property and so it cannot sit in the same position. A key aim of the proposal was to remove the modern partition that divides the historic rear window.

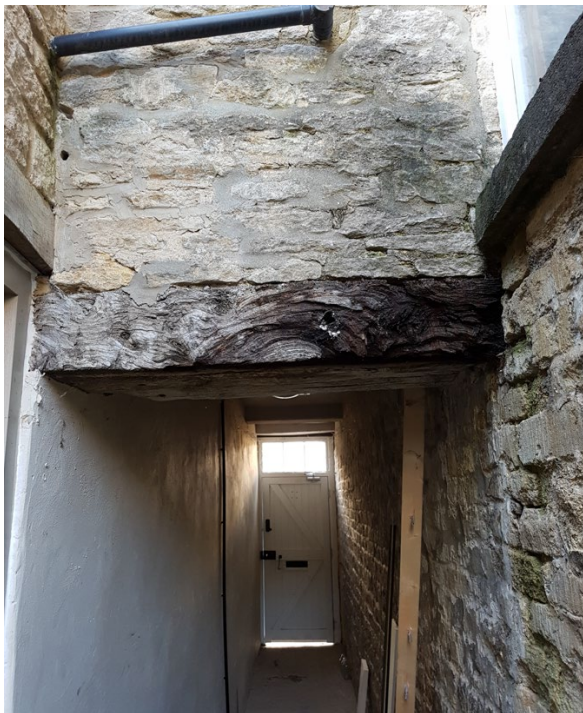
The lintel above is located over the side access where the various junctions between the walls and windows above have resulted in rainwater seeping into the timber causing significant and deep-rooted rot.

Over 40% of the timber is very soft and is therefore beyond the scope of a scarf or resin repair. Given the amount of masonry supported above and the level of exposure to the elements, the appropriate solution is to replace the lintel with a new timber of the same species and dimensions.

The thick stone walls are supported by several timber lintels stacked one in front of the other. It is only the facing lintel which has failed but it has also served to protect the historic lintels behind. By replacing the exposed lintel, we will be able to ensure the other lintels behind remain protected and can be retained indefinitely.

In addition to the layout alterations consent is also sought to replace a rotten timber lintel:

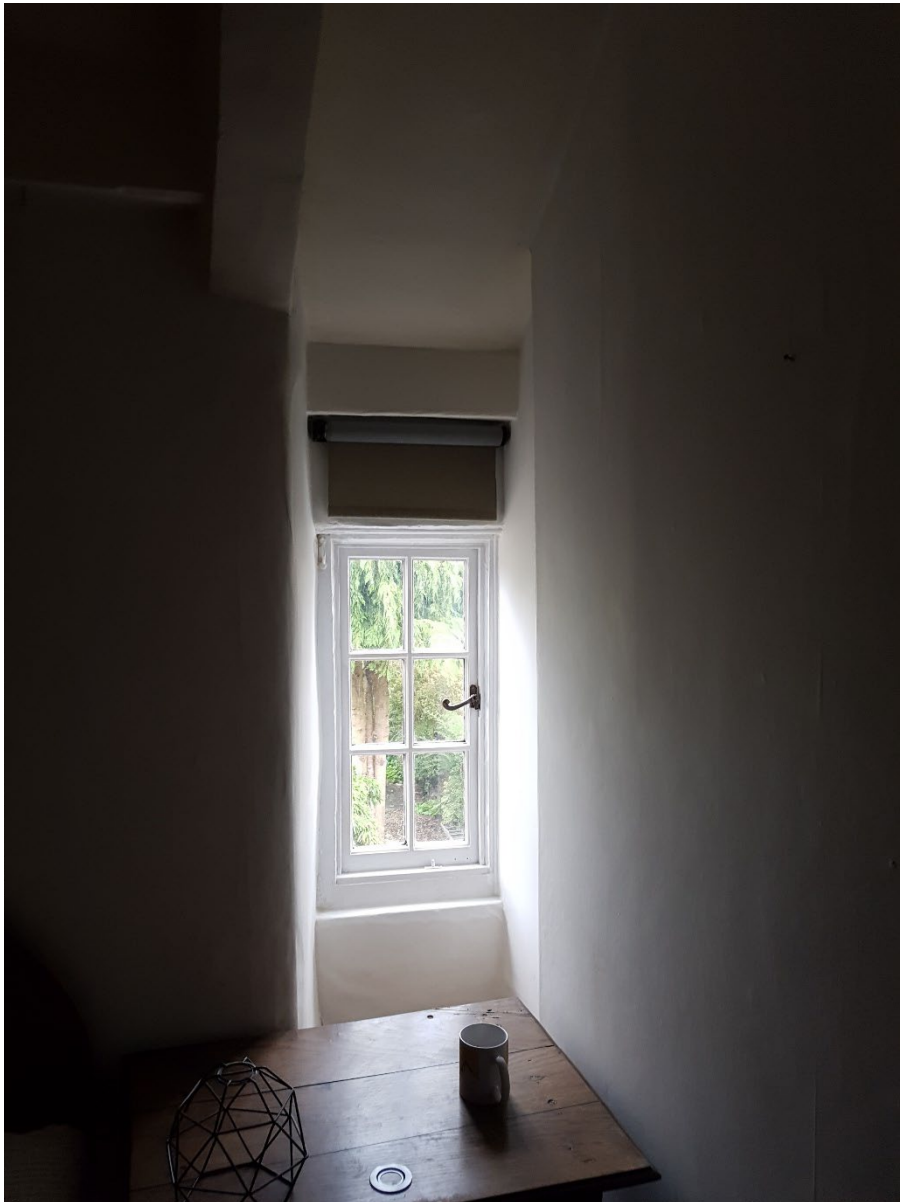
Rear bedroom divided window.

Within the first and second floors, the dwelling has been divided into two rooms by modern timber stud walls and plasterboard. The rear window has been divided by a stud wall which indicates that the layout on these floors is not original.

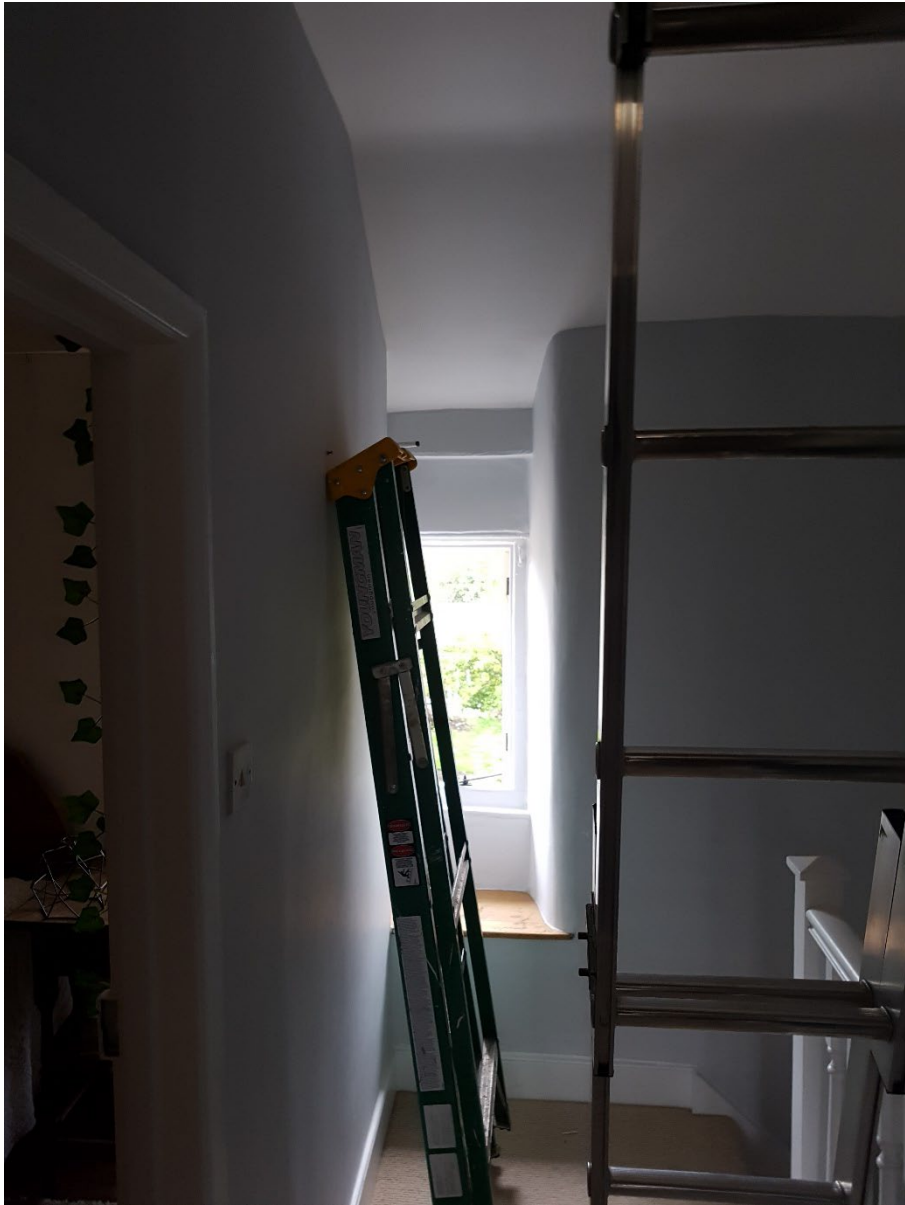
Second Floor divided Window.

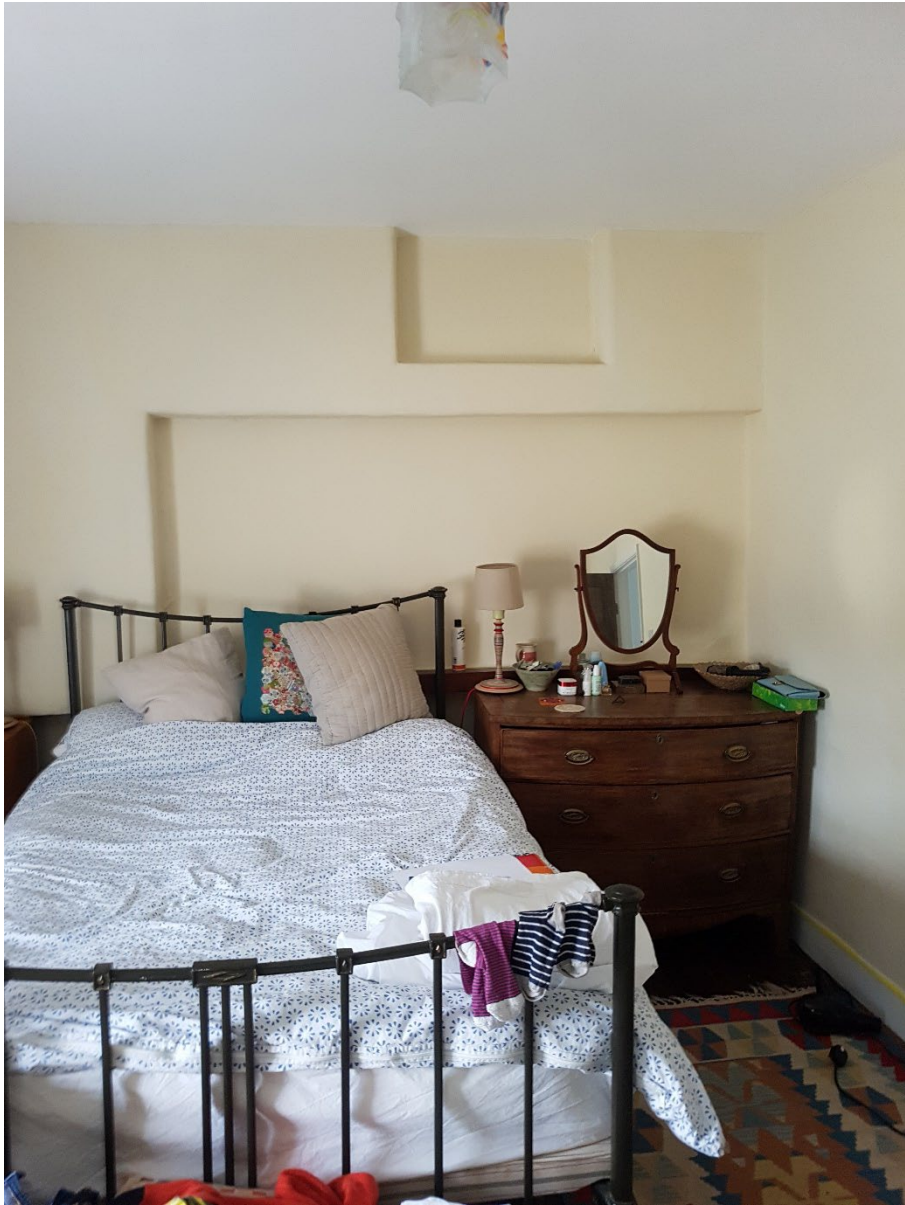
Master Bedroom showing the former opening in the gable wall.

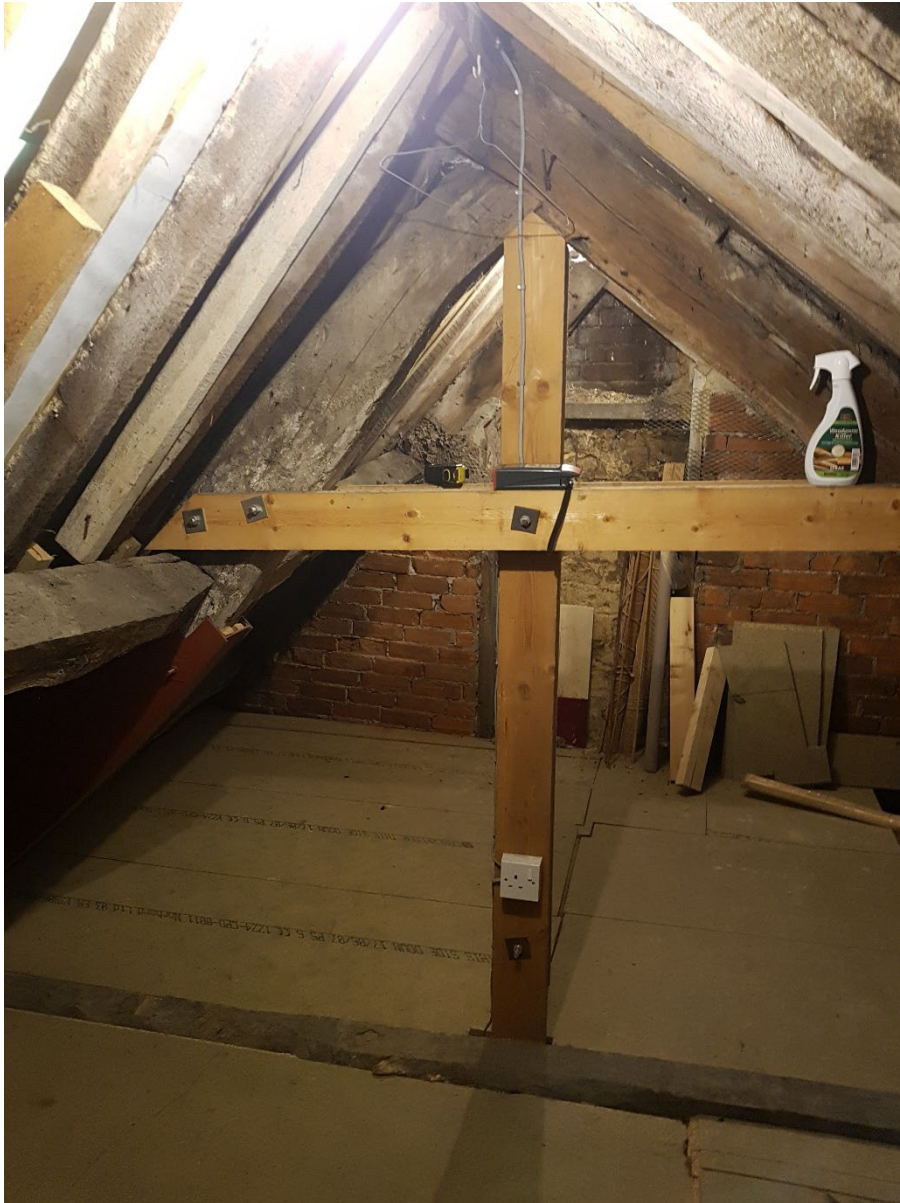
Attic – the bottom chord of the historic truss is visible in the floor. It appears that the ceiling below was raised up to line through with the truss and create storage space.

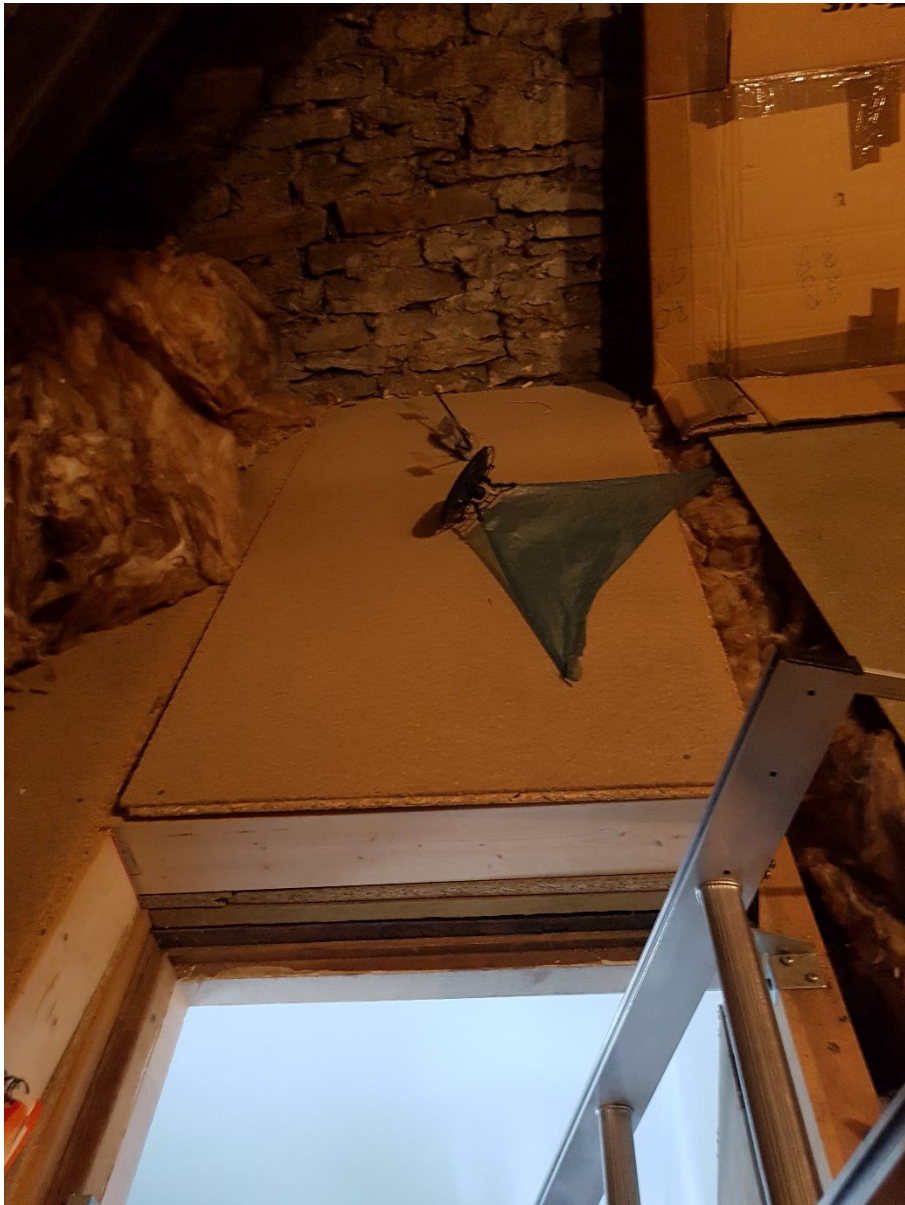
Attic – modern timber floor structure and boarding.

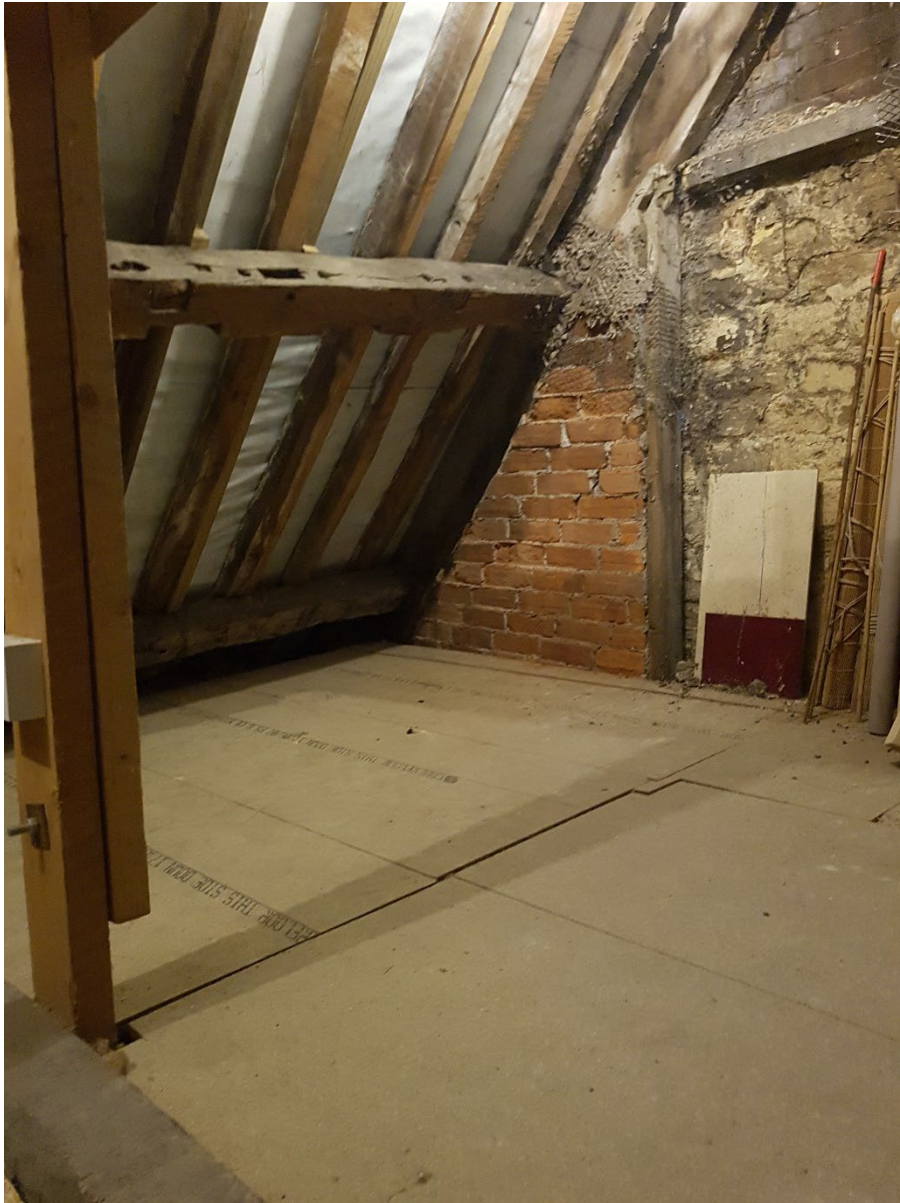
Attic – rafters are not contemporaneous with the purlins which may have been salvaged from another building given the notches which do not correlate with the rest of the roof structure.

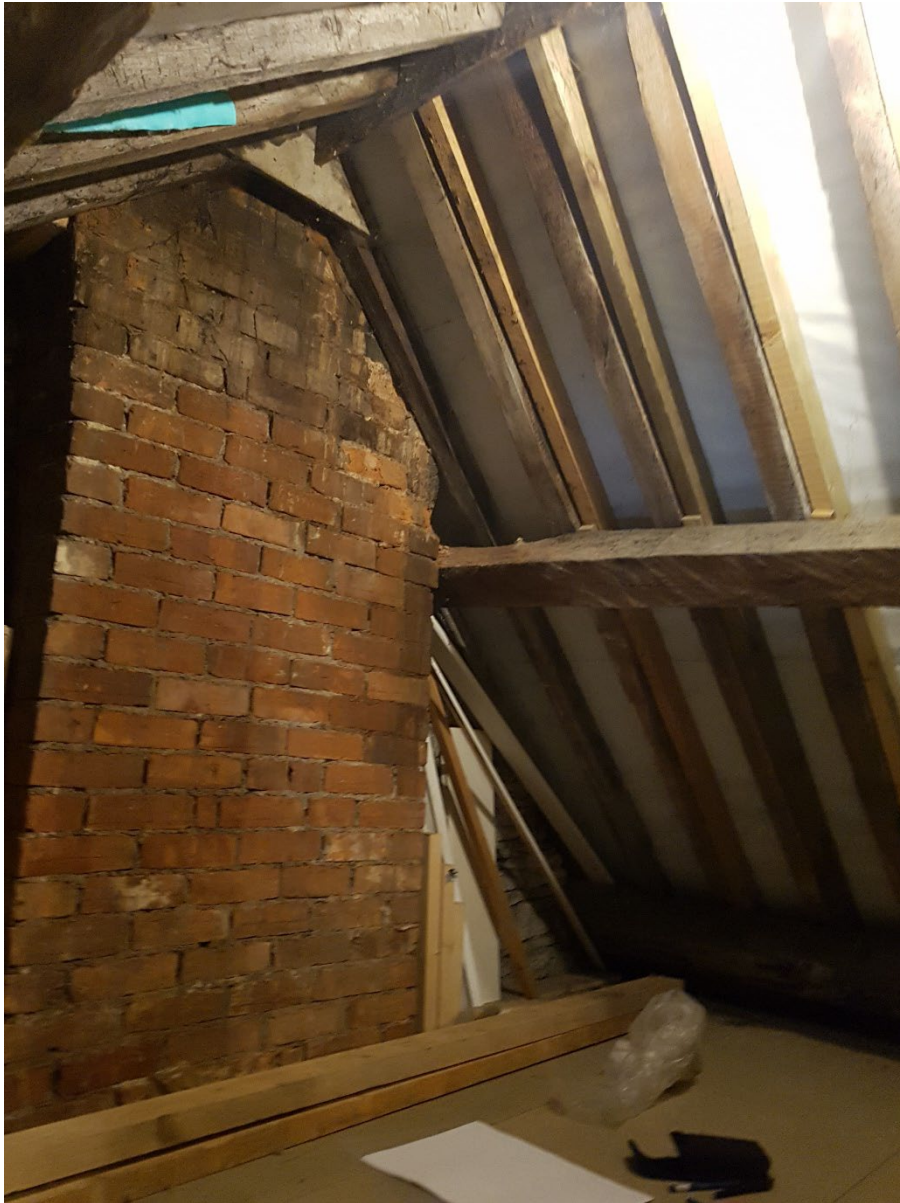
Attic – brick chimney breast and the roof slope to the street elevation showing modern breather membrane and rafters.

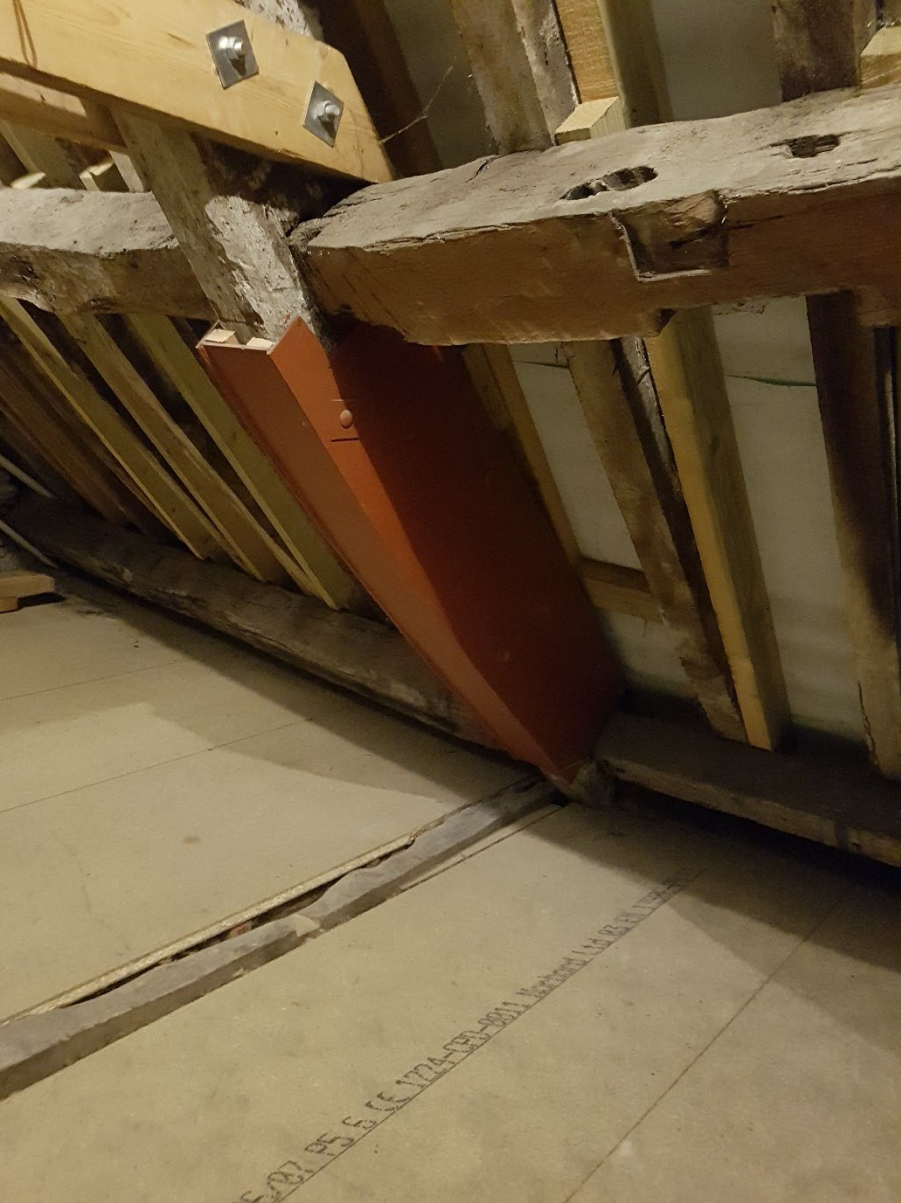
Attic – previous structural works necessary to retain the roof truss.
