The Western,
Rickmansworth, Hertfordshire

Protected Species Scoping Report

Report Reference KE/23/0051/2

31st January 2024

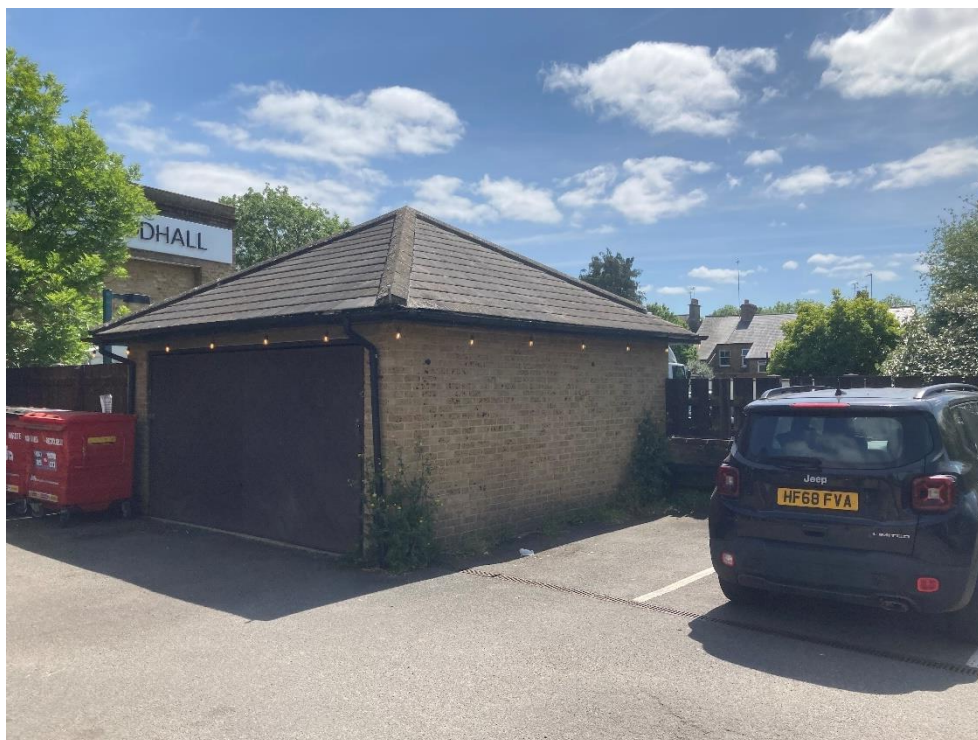
Externally, the garage has a double garage door at the buildings north face. The building has wooden soffits extending around its perimeter, these are tightly fitted to the external brickwork. There is a row of fairy lights running beneath the building's eaves.

Photograph 1- North and west face of garage building

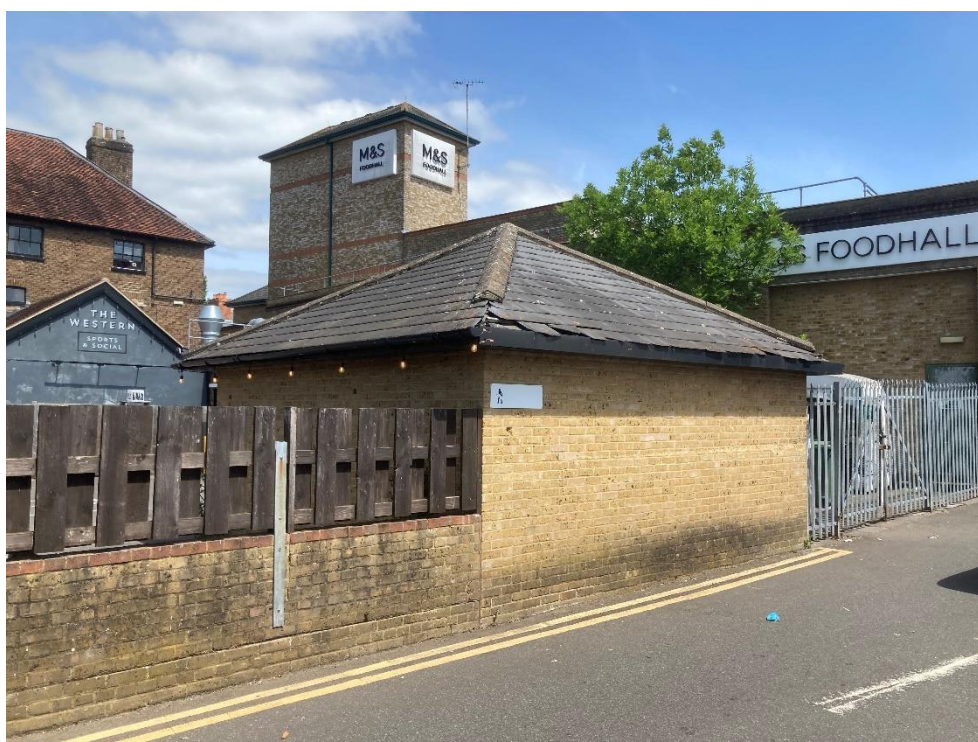
The roof slates and concrete hip tiles are mostly intact and in good condition apart from at the buildings south-west and south-east corners where there are some minor areas of damaged tiles near the base of the roof. The damage sections of the roof are located at a height of approximately 2.5 m

These locations were inspected from a ladder using a torch and endoscope. The damaged tiles provide access to a small cavity between the slates and the roof felt and situated between two sections of roof batten.

Photograph 2- South and west face of building showing damaged slates

Nevertheless, it is recommended that a precautionary approach is followed during demolition works. Roof tiles should be carefully removed by hand if any evidence of roosting bats is found, works should immediately stop and an appropriately qualified ecologist should be contacted for further advice.

It is therefore recommended that works to remove the building avoid taking place during the breeding bird season (March-August inclusive). Where this is not possible, a check for nesting birds should be completed immediately prior to removal by an appropriately qualified ecologist.

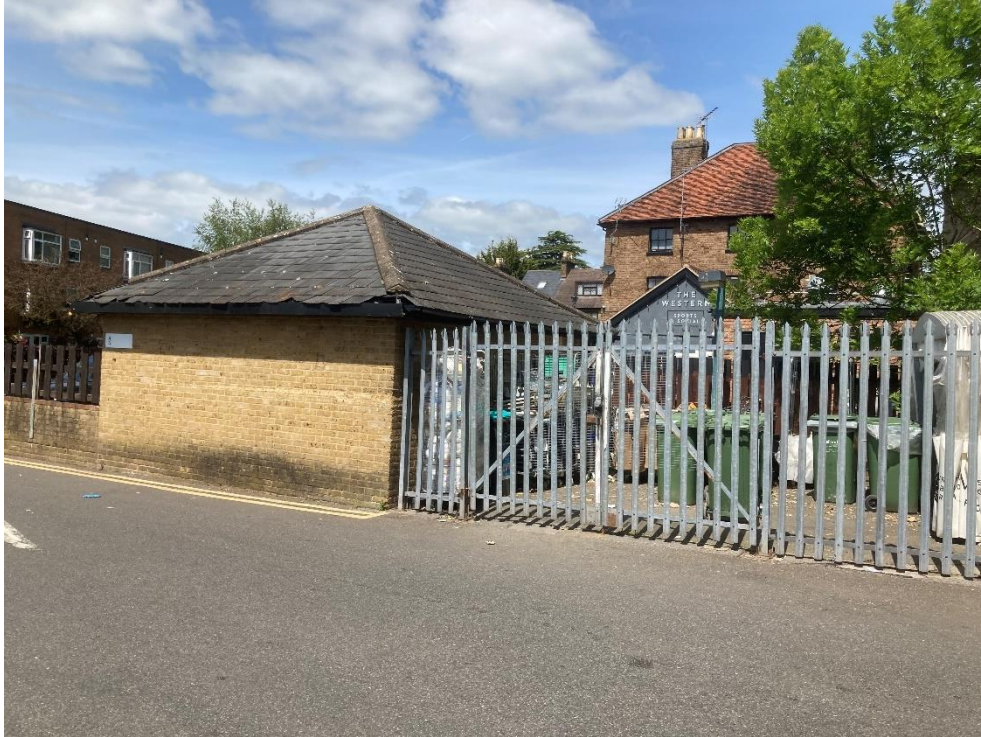
Photograph 3- South and east face building

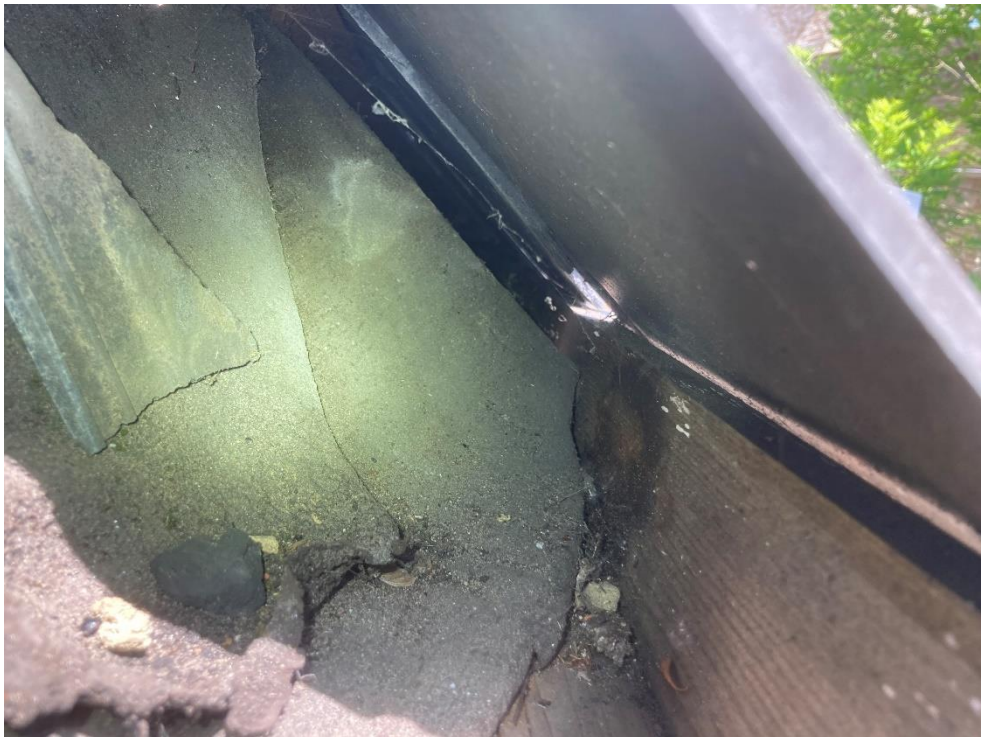
These sections were inspected from a ladder and could be fully viewed. No bat droppings or other bat field signs were observed. The features were found to have areas of light cobwebbing including within the cavities themselves, indicating that they have not been used by roosting bats in the recent past.

The identified cavities could be used by nesting however no evidence of previous nesting bird activity was identified.

Photograph 4- Open cavity under damaged section of slates

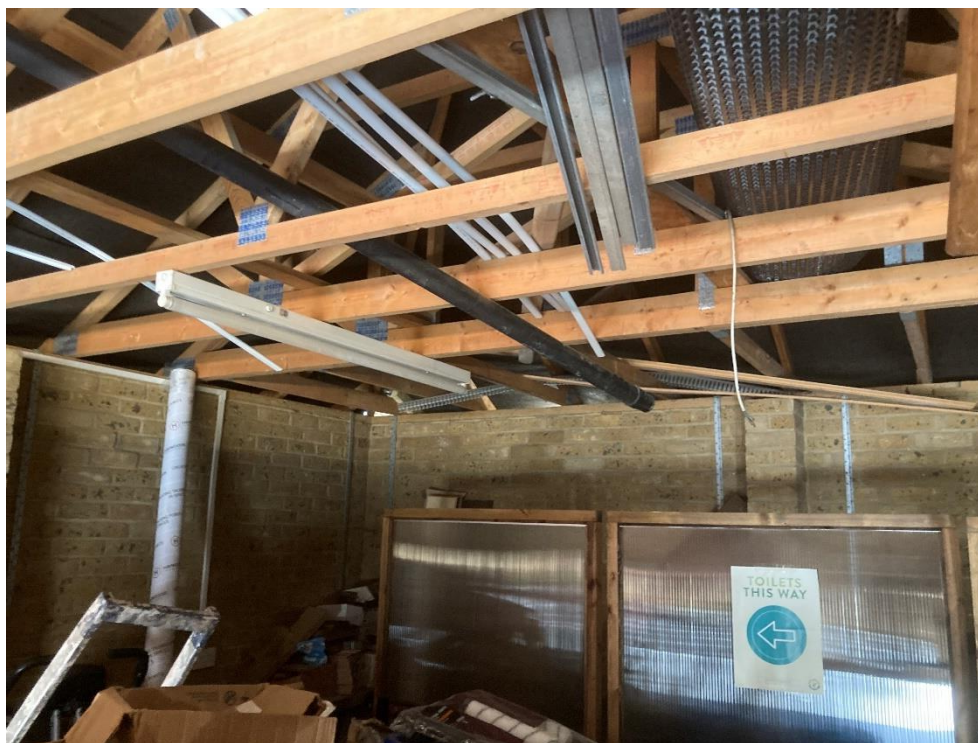
Internally, the building does not have a separate roof void. The internal face of the roof is lined with bitumen hessian felt and the roof is supported on latticed, narrow, softwood trusses. The building does not have a ridge beam. The building does not offer any obvious suitable bat roosting habitat internally.

Photograph 5- Interior of garage

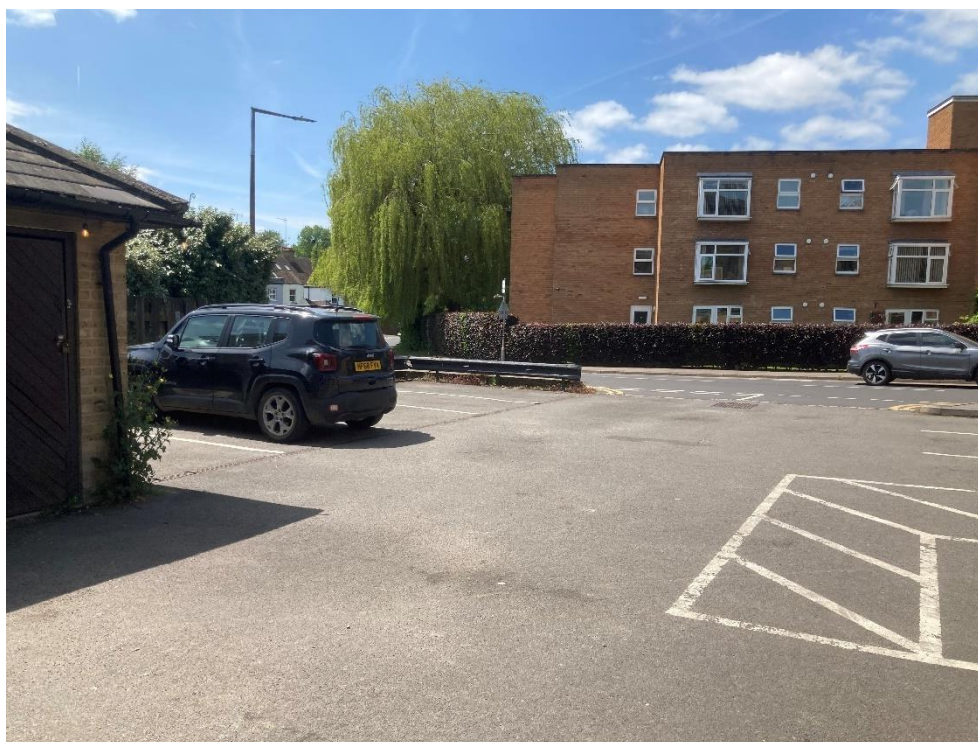
The carpark at the rear of the pub comprises of sealed-surface, hard standing. There is a young ash tree located at the south-east corner of the car park. The tree is entirely unsuitable for roosting bats as it doesn't support any potential bat roosting features. In any case, the tree will be retained as part of development proposals.

Vegetation at the site is very limited. However, there are some scattered, common urban herbs around the fringes of the carpark including sparse patches of ivy-leaved toadflax, herb Robert, smooth sow-thistle, dandelion and common chickweed.

Photograph 6- Carpark habitats

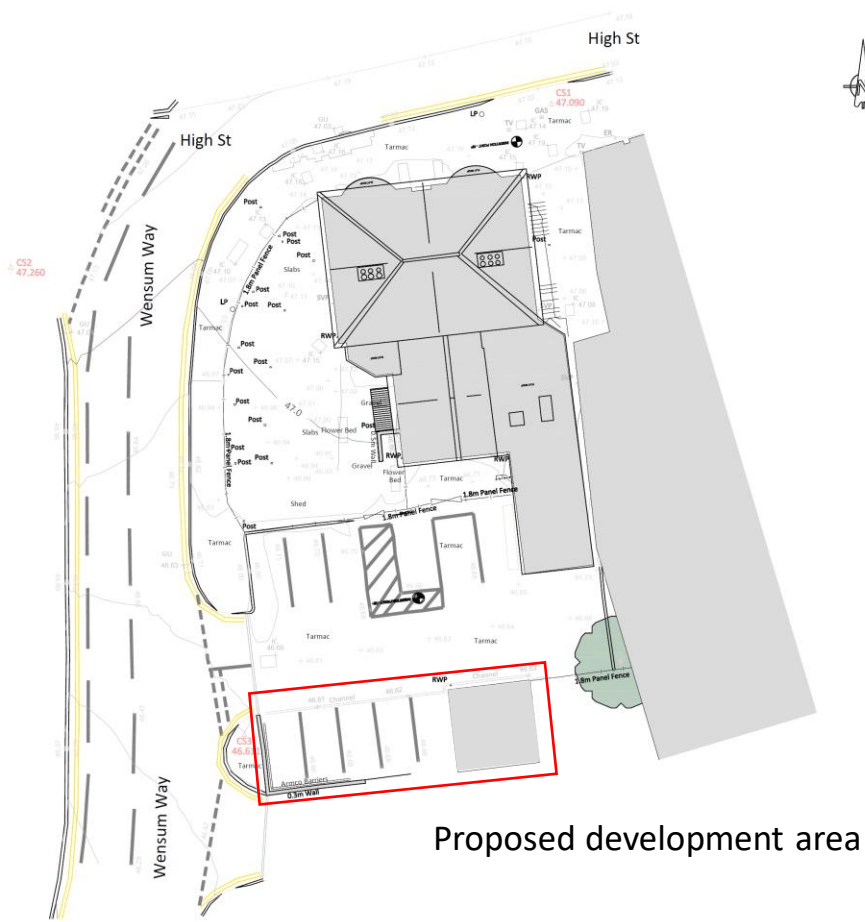
Figure 2- Site Plans

The proposed development area is located to the rear of the Western Pub. Development proposals would comprise of the construction of a new apartment block of three flats constructed within the existing pub carpark. The works would affect an area of existing hardstanding carpark and an existing garage building. The adjacent pub and the pub carpark are currently in use. The main pub building would not be affected by development proposals. The site location is shown on Figure 1 whilst the existing and proposed habitats are shown on Figure 2 in the Appendix.

Proposed development area

Existing

Proposed
