# **No. 95A Eltham High Street, London SE9 1TD**

## **Written Scheme of Investigation**

**January 2024**

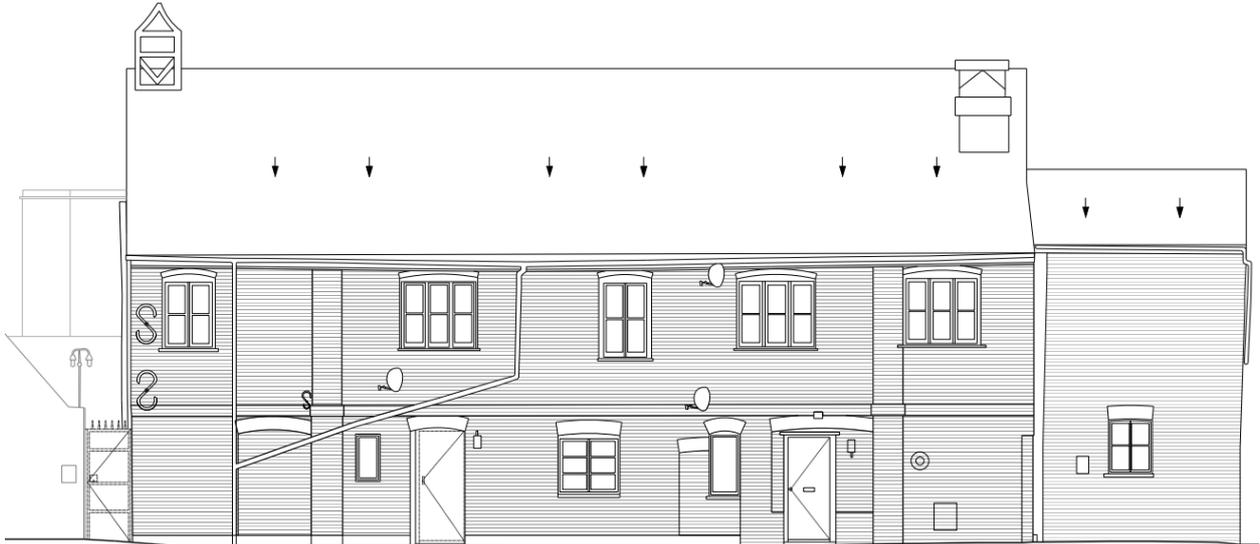
Figure 1: Existing front (east) elevation of no. 95A Eltham High Street.

architectural features include diagonal “twisted” chimney stacks and a “cupula” on the roof, and a cast iron bracket (likely originally used for hanging a gas lamp) to the south elevation. The building is in poor repair, as acknowledged by the fact it is on Historic England’s Heritage at Risk Register. (Its Heritage and Risk description states that the building is weather-tight, but shows “*lack of maintenance*”.) The Architectural and Artistic Interest of the subject site is **medium**.

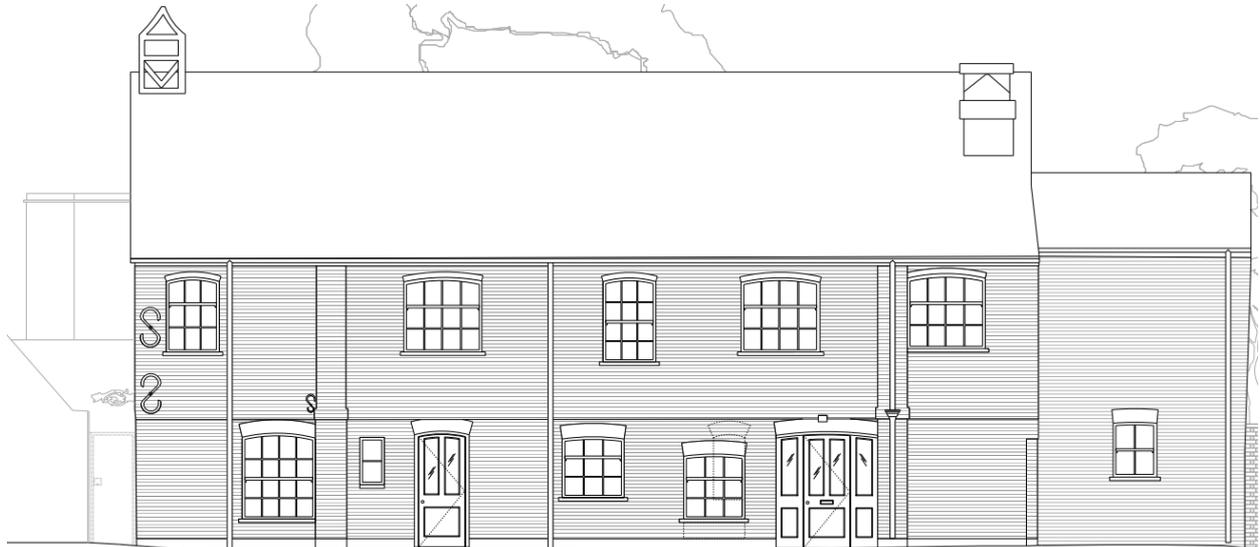
Figure 2: Proposed front (east) elevation of no. 95A Eltham High Street.

- 3.2.1. **Alterations and repair-work** [*Figure 2 & Figure 4*]: As set out in the condition survey, schedule of repairs and methodology statement, the proposals involve sensitive repair-work to the brickwork. The repair-work would therefore involve minimal intervention, with any necessary replacement fabric using like-for-like red brickwork and lime-based mortar, and traditional building techniques. The existing sash windows would similarly be repaired according to those principles. The existing casement windows would be replaced with timber-framed sashes. In addition, sash windows would be reinstated to the existing bricked-up window openings to the west and east elevations. The new windows to the south elevation at ground floor level would involve minimal loss of historic fabric. Scarring to the brickwork of the east elevation indicates that the north door has been relocated – and the proposals would involve the reinstatement of the door to its former location. The existing modern idiom doors would be replaced with Victorian-style timber doors.

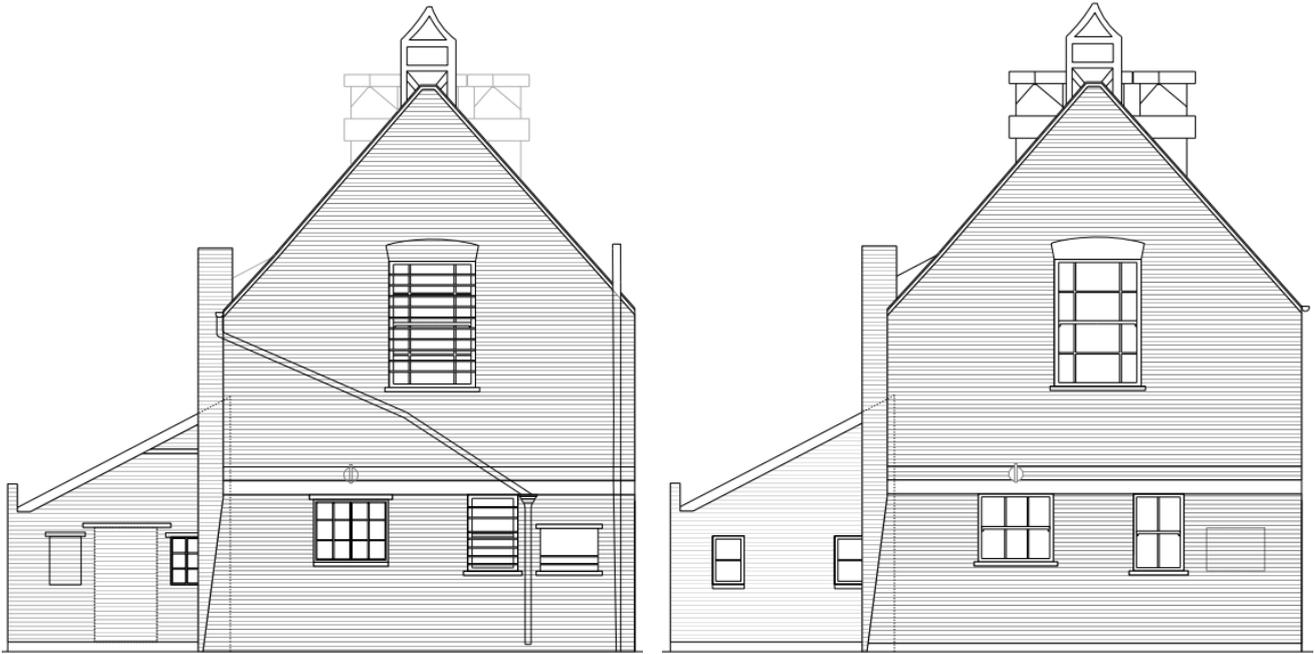
Figure 5 (left): Existing south elevation of no. 95A Eltham High Street.

Figure 6 (right): Proposed south elevation of no. 95A Eltham High Street.

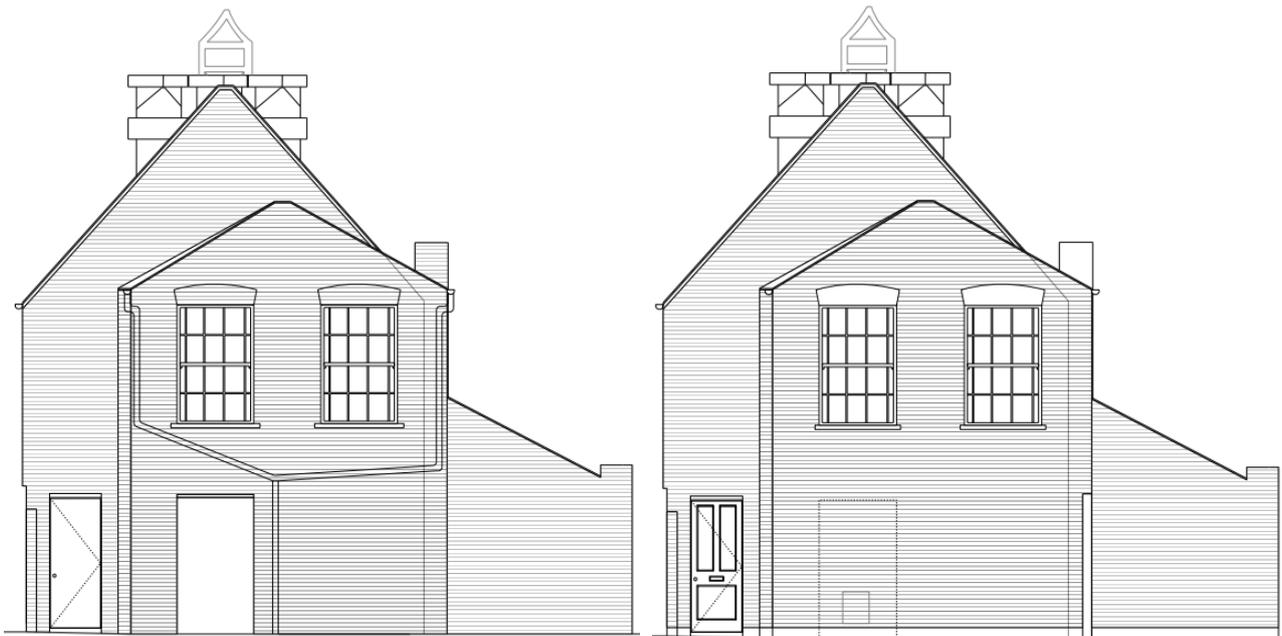
Figure 7 (left): Existing north elevation of no. 95A Eltham High Street.

Figure 8 (right): Proposed north elevation of no. 95A Eltham High Street.

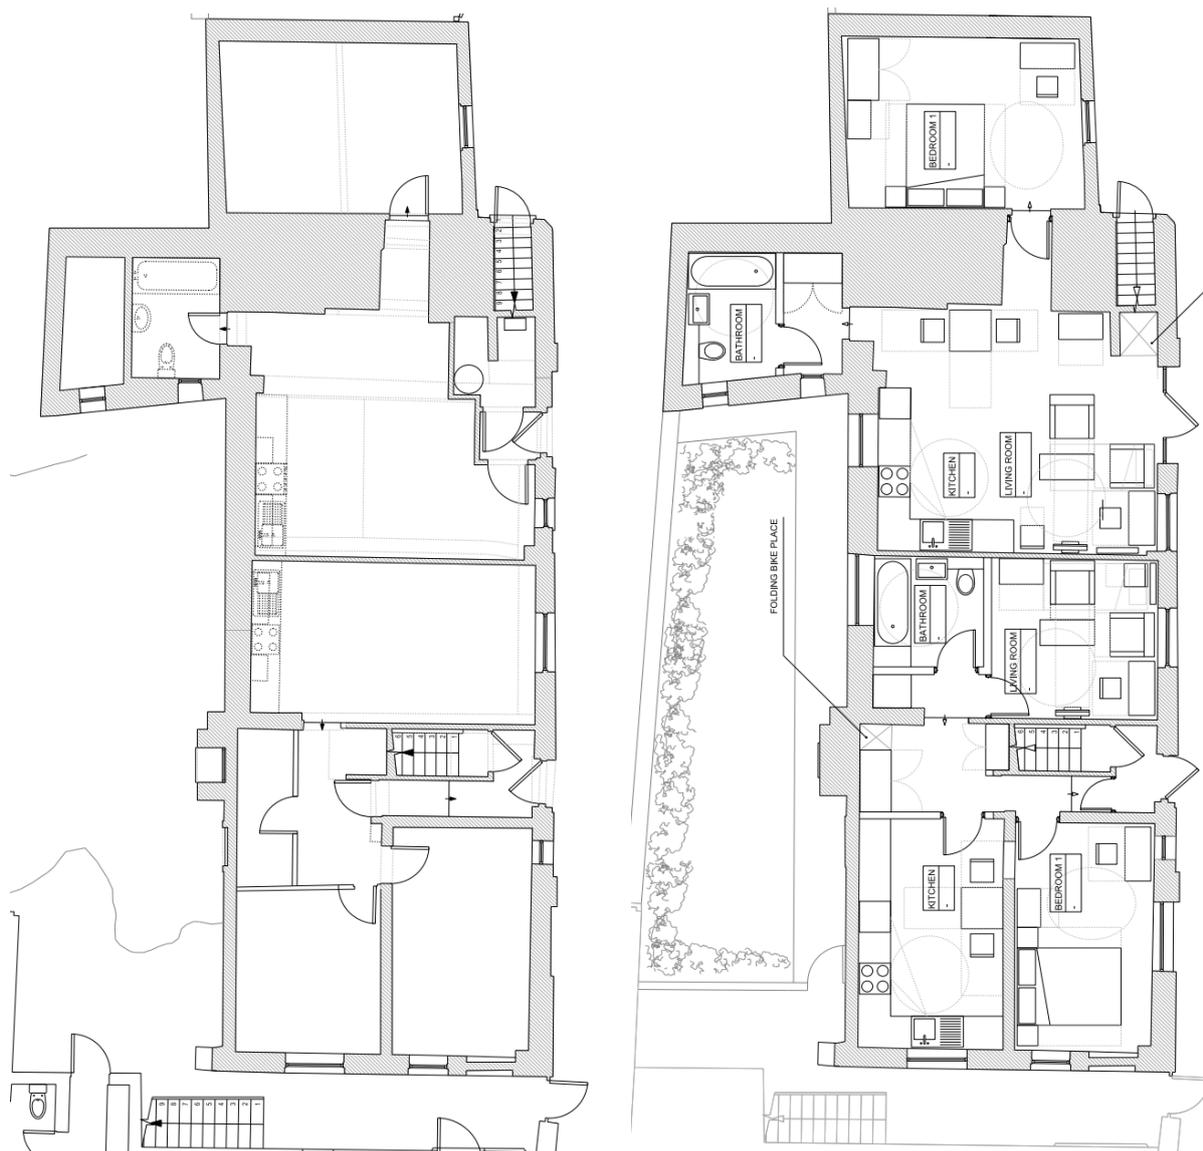
Figure 9 (left): Existing ground floor of no. 95A Eltham High Street.  
Figure 10 (right): Proposed ground floor of no. 95A Eltham High Street.

- 3.3.2. **North flat at ground floor level** [*Figure 10*]: The proposals involve the retention of the exiting modern planform, save for the removal of the modern stud walling by the front entrance. There would also be some alterations to the small single-storey west extension (i.e. the bathroom), which was likely a later addition to the original building to the north elevation to provide a storage space, and which is thus considered to be of secondary significance. Within the existing bathroom, the boxing-in would be removed in order to enlarge the room, a new window opening would be created in the enlarged space, some stud walling would be provided (which would be easily reversible). The modern door to the existing bathroom would be removed, and a new door would be fitted within the new door opening within the new stud walling.

The door to the existing bedroom would be re-fixed so that it opens the other way. The original width of the front door opening would become more easily legible due to the removal of the modern brickwork, replacing it with a new Victorian-style door with timber-framed glazed panels either side of it. This would not cause any loss of historic fabric.

- 3.3.3. **South flat at ground floor level** [Figure 10]: The proposals involve the reinstatement of the sash windows to the bricked-up openings to the front (east) and rear (west) elevations. The existing planform of the building is likely modern, and its alteration would therefore not cause any harm to the historic interest of the building. The modern partition walling which forms the somewhat curious, “b-shaped” room on the west side would be removed, and new partitioning and doors would be added, in order to reconfigure the hallway, and create a new kitchen. In addition, some partition walling and doors would be added to the room on the north side to create a bathroom, a living room and a lobby area. The new partition walling would be easily reversible, without causing any damage to historic fabric.

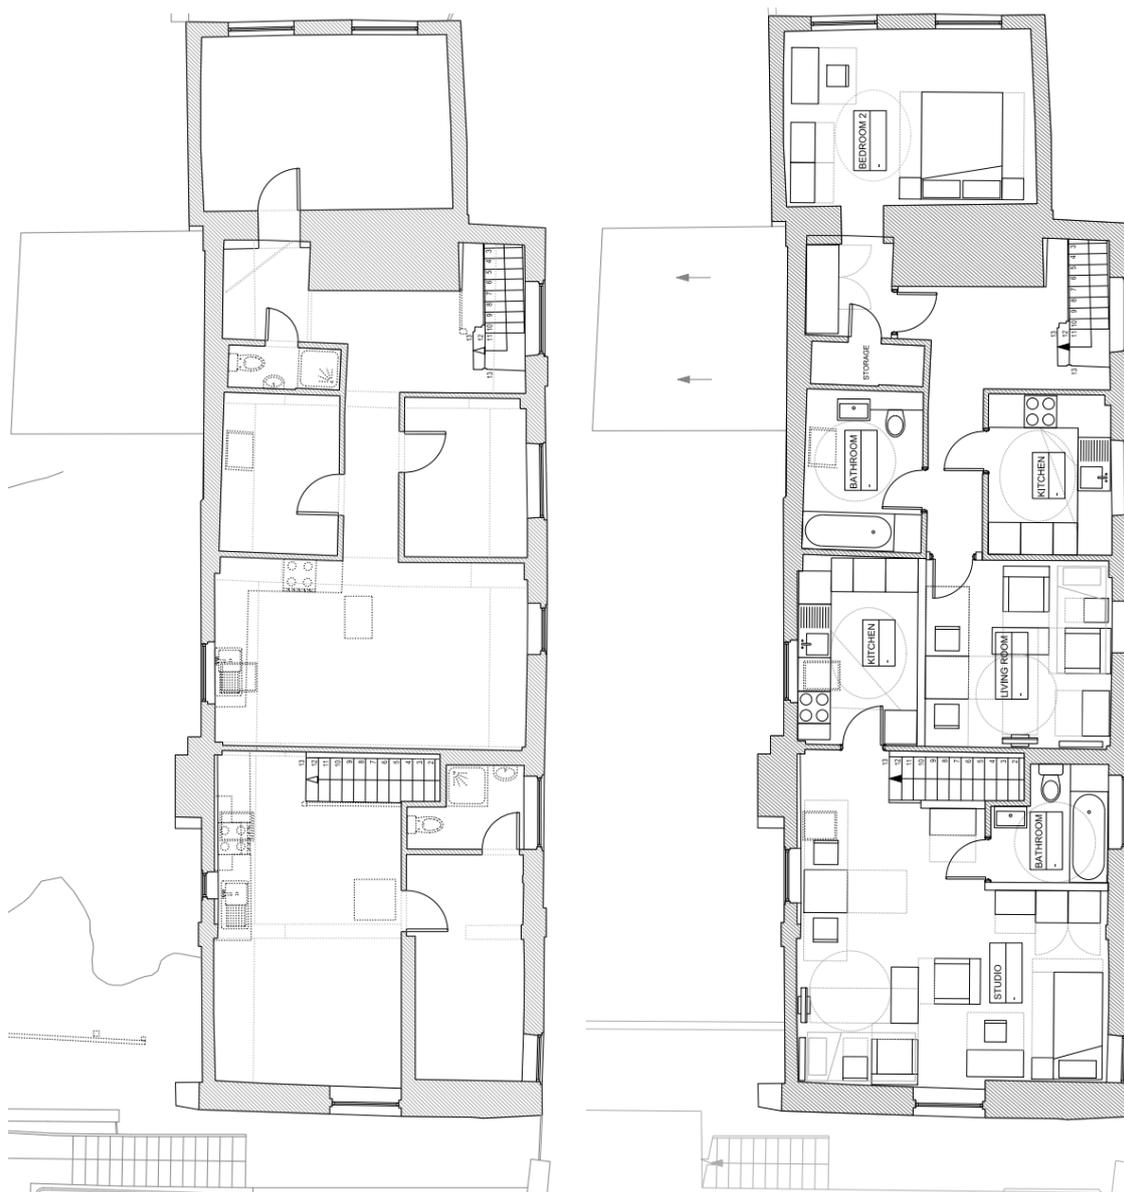
Figure 11 (left): Existing first floor of no. 95A Eltham High Street.

Figure 12 (right): Proposed first floor of no. 95A Eltham High Street.

- 3.3.4. **North flat at first floor level** [Figure 12]: Given that the internal planform of the building is modern, it is considered that the reallocation of some space at first floor level from the north flat to the south flat, would not impact upon the historic and/or architectural interests of the building. This would be the only notable alteration to the north flat – involving the provision of some new partition walling, which would be easily reversible without damaging any historic fabric. In addition, there would be some minor alterations to the door openings – i.e. relocating the door opening to the north bedroom to the corridor, providing a new door between the corridor and south room, and re-fitting the door to the east room so that it opens the other way. None of these alterations would cause any loss of historic fabric.

- 3.3.5. **South flat at first floor level** [Figure 12]: Given that the internal planform of the building is modern, it is considered that the reallocation of some space at first floor level from the north flat to the south flat, would not impact upon the historic and/or architectural interests of the building. This would involve the creation of a new door opening within the existing modern stud walling (causing no loss of historic fabric). The planform of the south flat would also be reconfigured via the removal of some walling which is unlikely to be historic and some modern stud walling, and the provision of some new partition walling and doors (which would be reversible).

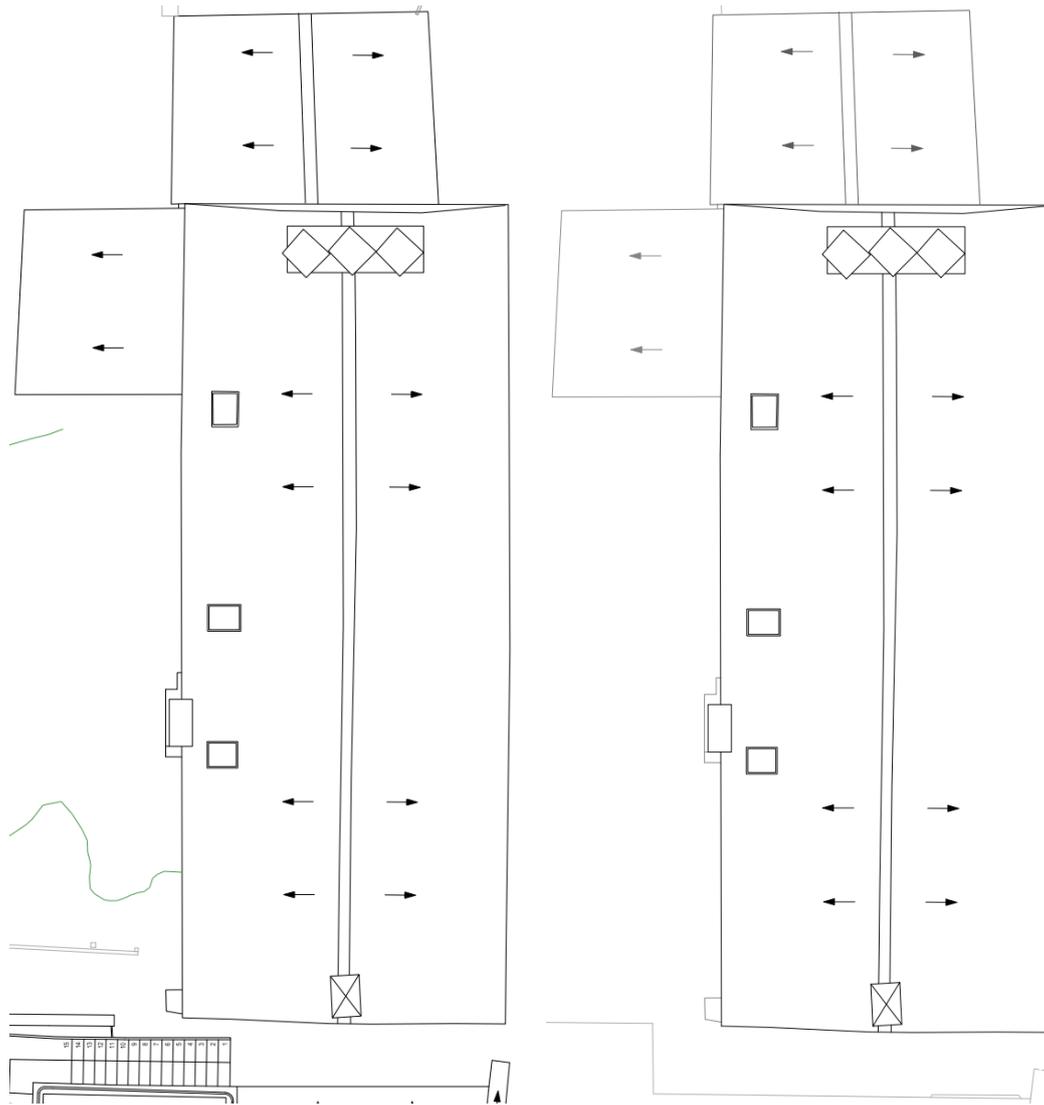
**Figure 13 (left): Existing roof of no. 95A Eltham High Street.**  
**Figure 14 (right): Proposed roof of no. 95A Eltham High Street.**

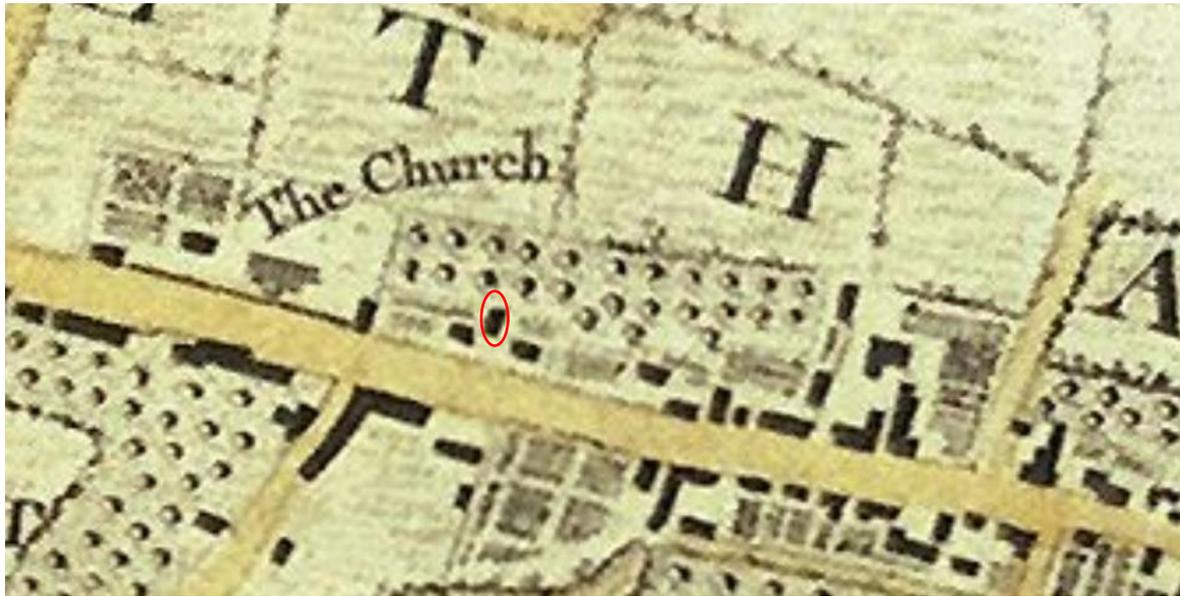
Figure 15: 1761 map (Rocque). Subject site is circled in red.

- 2.1.1. **18<sup>th</sup> century:** Cartological evidence indicates that by the mid-18<sup>th</sup> century, the north side of Eltham High Street comprised some large detached houses with front gardens and large plots to the rear (some including what look like orchards). These include Cliefden House, which was built c. 1720 as a private house (and later used as a military academy for young gentlemen), and what appears to be an ancillary building within the subject site [Figure 15]. This building may, however, pre-date Cliefden House.

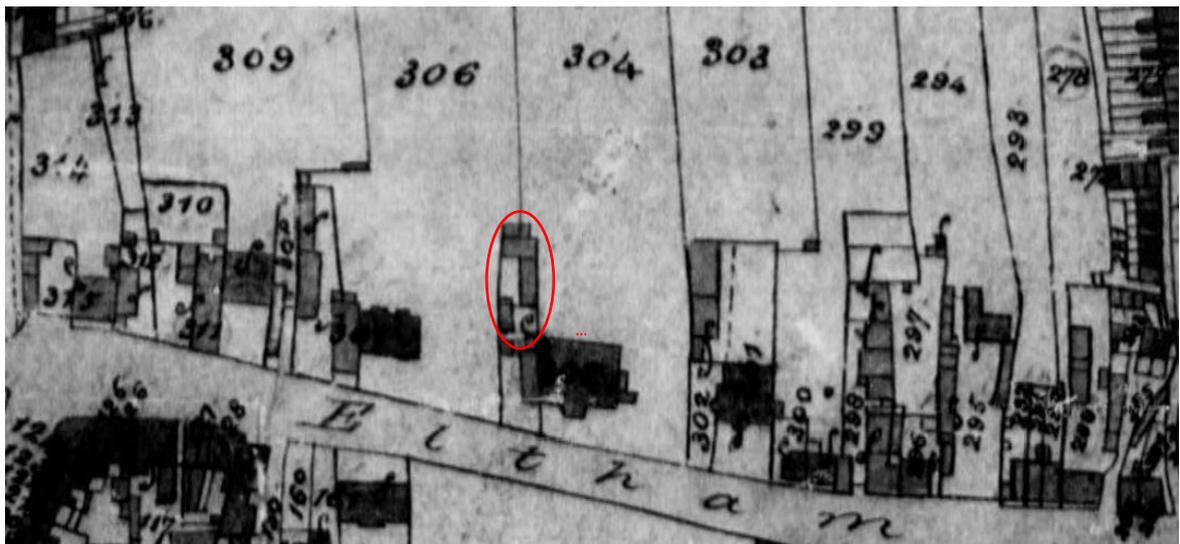
Figure 16: 1839 tithe map (National Archives, IR 30/17/129). Subject site is circled in red.

- 2.1.2. **19<sup>th</sup> century:** The 1839 tithe map [Figure 16] indicates that Cliefden House and its ancillary building (i.e. the subject site) were within a large plot stretching back as far as today's Orangery Lane. The map shows some other outbuildings within this plot, which have since been demolished. The 1862 OS map [Figure 17] shows the footprint of the building within the subject site, and the landscaped gardens to the north of it.

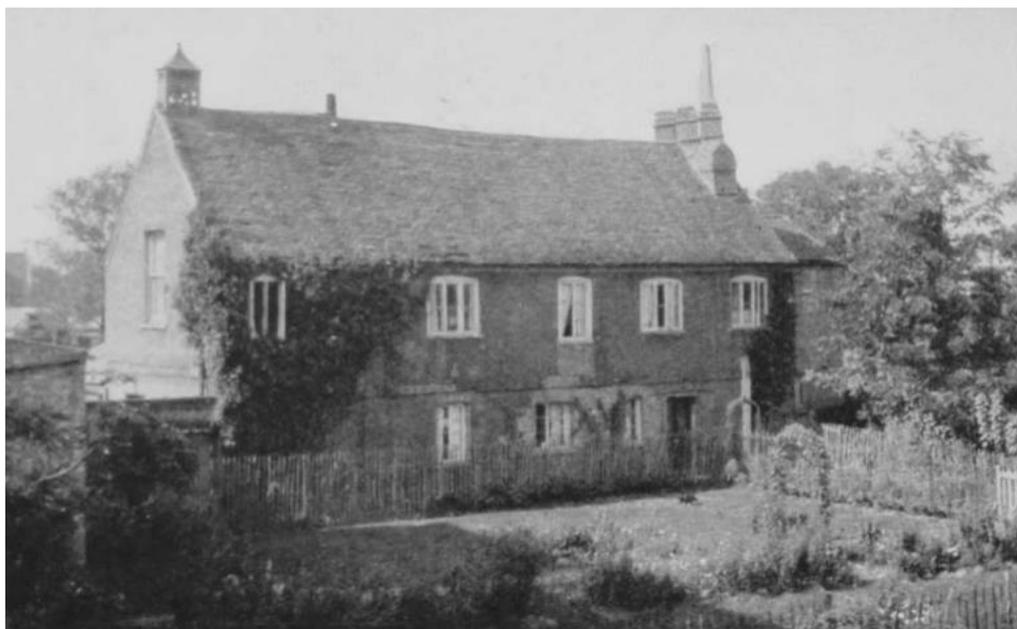
Figure 20: c. 1930 photograph of the east elevation of the subject site. (National Archives.)

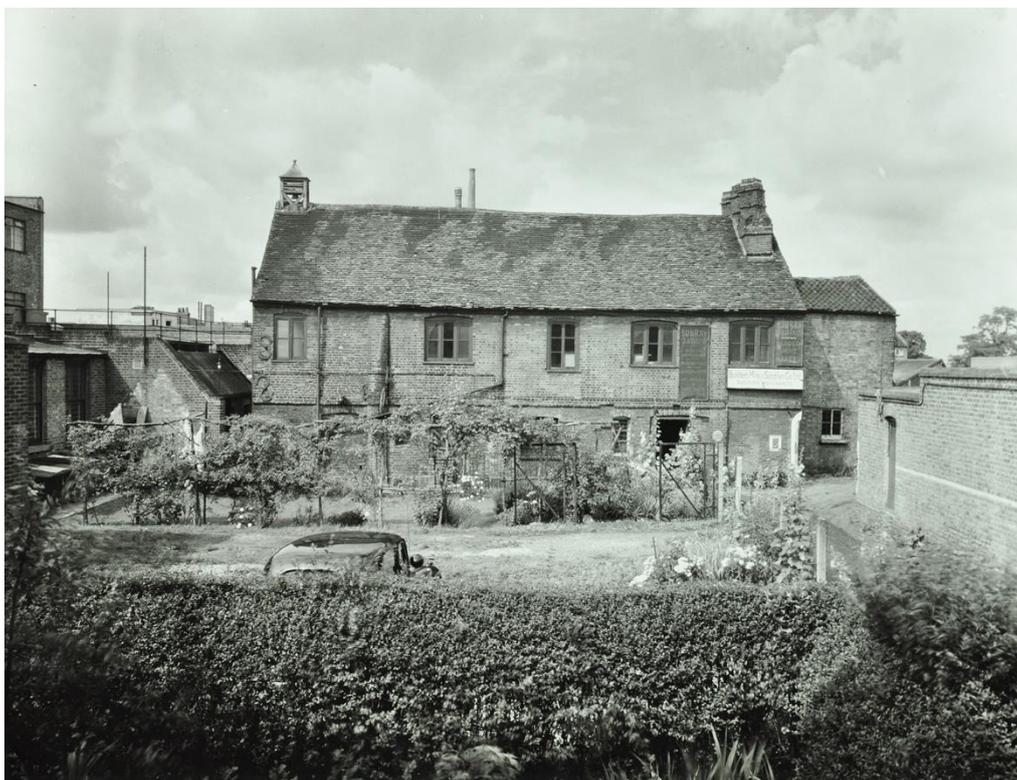
Figure 21: 1962 photograph of east elevation of the subject site. (LMA, 144584.)
