GEOENVIRONMENTAL APPRAISAL REPORT

Jack Lawson Terrace, Wheatley Hill

For Gleeson Regeneration Ltd

Date: August 2023 Report reference: C9843

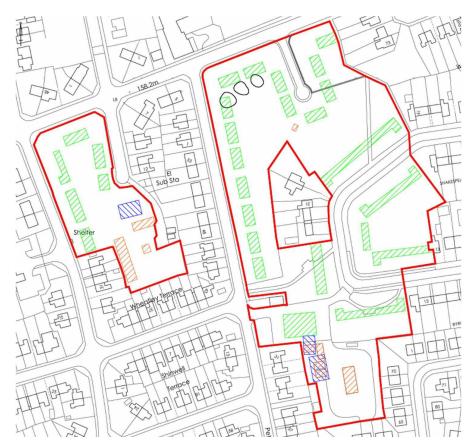
Figure 1.1 Site Boundary Plan

Proposals for the site include the construction of low rise 2 to 3 storey semi-detached and detached residential units and 1 storey bungalows with private gardens, garages and drives. A proposed development layout plan (Drawing No. 2215.03.01 Rev A) has been provided by Gleeson, and is included within Appendix A for reference. The investigation boundary is shown in Figure 1.1, extracted from Drawing No. C9843/02 enclosed within Appendix A.

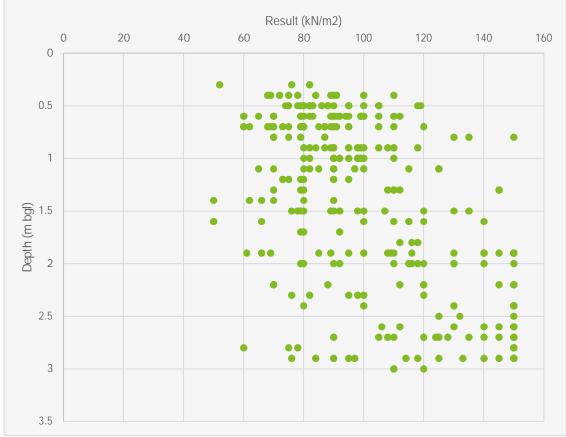
Figure 5.1 Plot of HSV with Depth

Fig 5.1 and 5.2 below summarise the in situ data and lab testing for cohesive soils within the site.

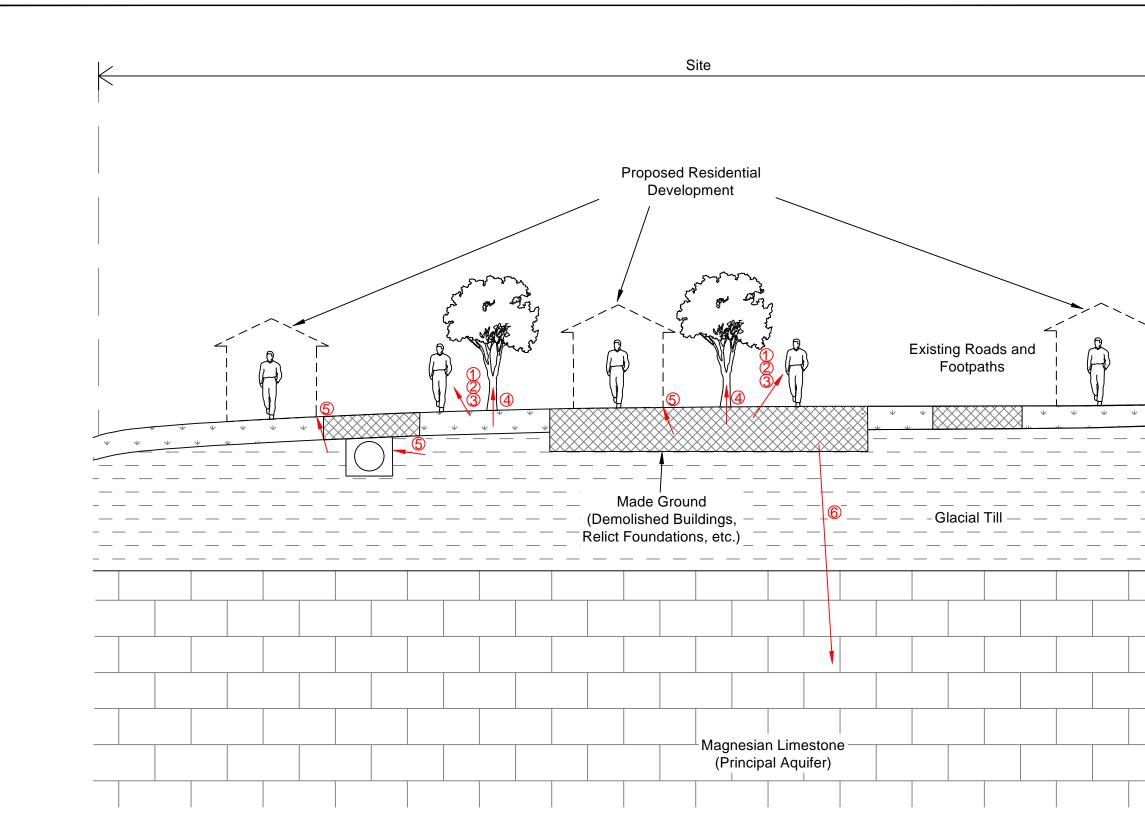
Contamination Sources	Contamination Pathway	Potential Receptors	Risk
Metal, organic and inorganic contaminants in	1. Direct and indirect ingestion	End users	Moderate
shallow disturbed topsoil/ made ground	2. Inhalation of contaminant particles/dust/vapours		
associated with demolished residential and	3. Dermal contact		
industrial units	4. Plant uptake	Gardens and landscaping (phytotoxic effect)	Low
	5. Direct contact with construction materials	Construction products incl. buried concrete	Moderate
		and plastics (chemical attack/degradation)	
	6. Leaching	Controlled waters	Low
Asbestos fibres and ACMs in shallow disturbed	2. Inhalation of contaminant particles/dust/fibres	End users	High
topsoil/ made ground associated with demolished		Adjacent site users	
residential and industrial units

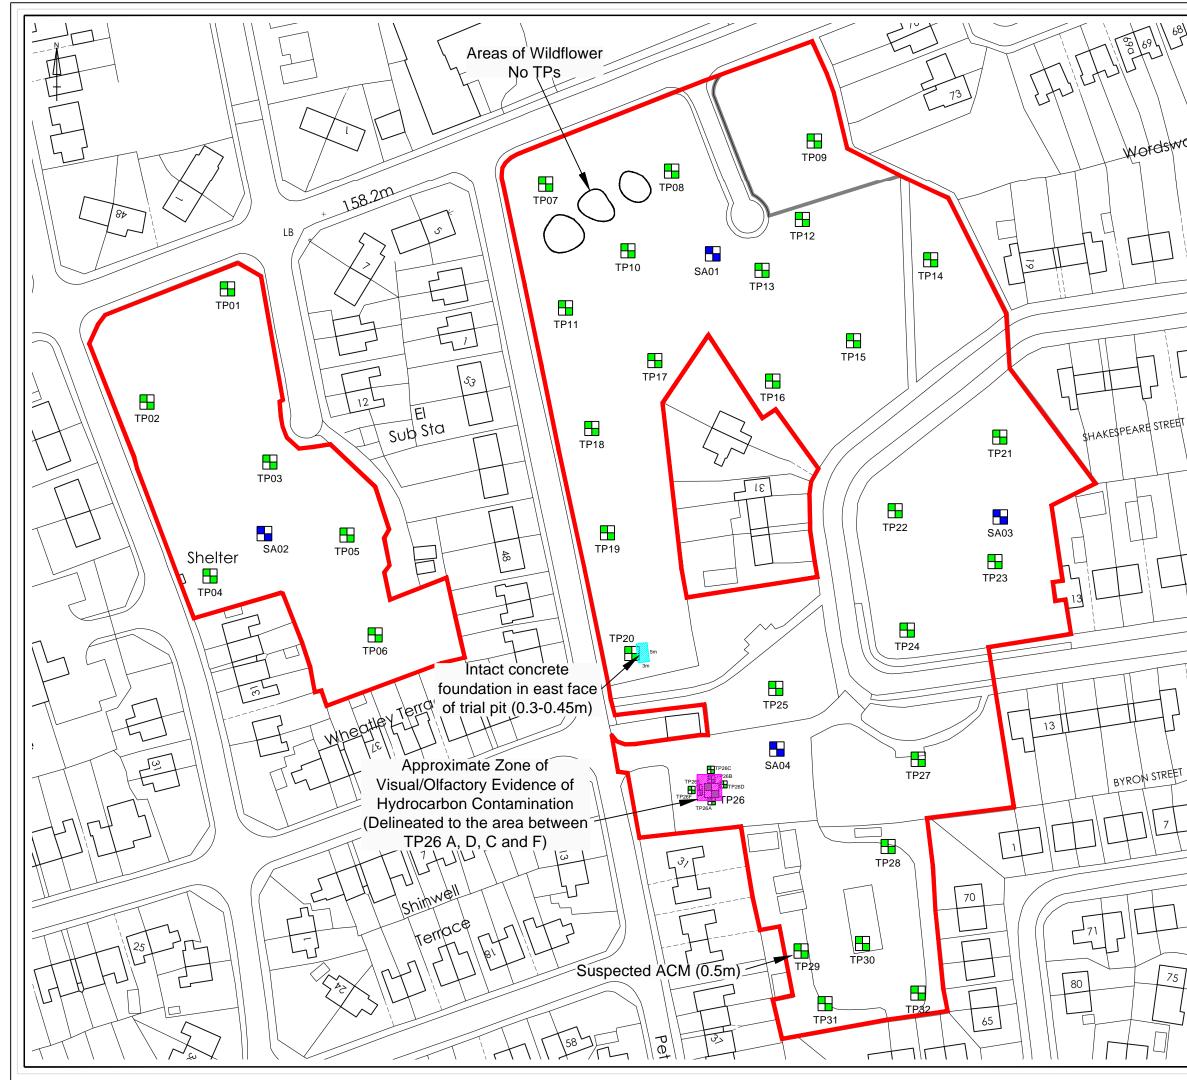
Exploratory Hole	Rationale
TP01 to TP25	Trial pits excavated to expose any relict building slabs/foundations and for general site coverage within the former residential area.
TP26 to TP32	Trial pits excavated to expose any relict building slabs/foundations and for general site coverage within the former industrial area.
TP26A to TP26F	Trial pits excavated to further investigate and attempt to delineate the presence of identified hydrocarbon contamination in the vicinity of TP26.
SA01 to SA04	Soakaway test pits excavated and constructed to achieve a general site coverage to ascertain soil infiltration rates.

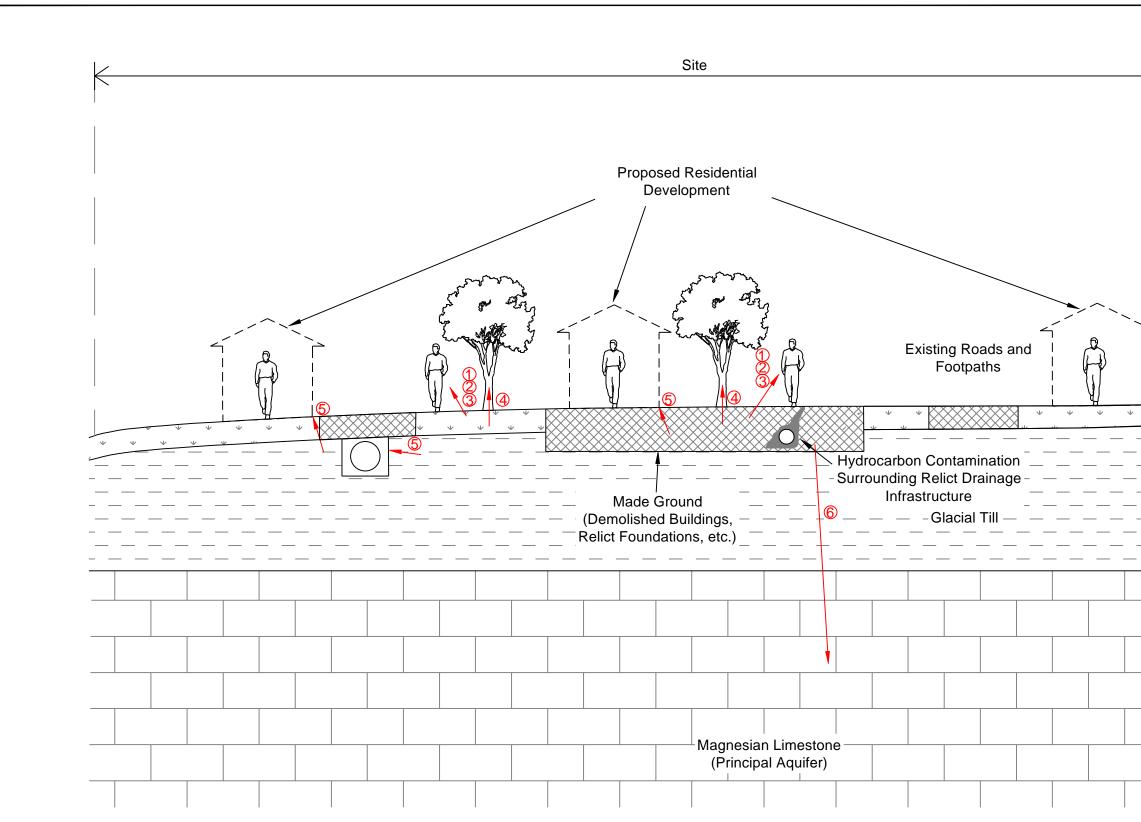
Contamination Sources	Contamination Pathway	Potential Receptors	Risk
Hydrocarbon contamination (aromatic C16-C35	1. Direct and indirect ingestion	End users	Moderate
fractions) in made ground local to TP26, linked to	2. Inhalation of contaminant particles/dust/vapours		
relict drainage infrastructure below former	3. Dermal contact		
industrial units	4. Plant uptake	Gardens and landscaping (phytotoxic effect)	Low
	5. Direct contact with construction materials	Construction products incl. buried concrete	Moderate
		and plastics (chemical attack/degradation)	
	6. Leaching	Controlled waters	Low
Asbestos fibres and ACMs in granular made	2. Inhalation of contaminant particles/dust/fibres	End users	High
ground associated with demolished residential		Adjacent site users	
and industrial units

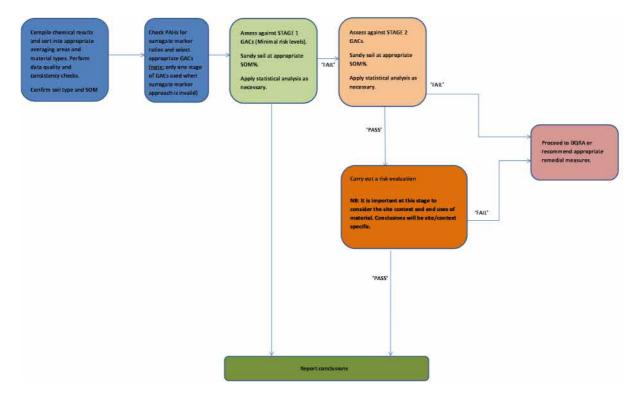
Figure 1. GQRA Process.

A staged approach to GQRA has been adopted by Sirius for the evaluation of soil concentration data, as shown schematically in Figure 1.
