# GEOTECHNICAL

## for Subsidence Management Services

### 3 High Meadows, Kirk ella, Hull, HU10 7NJ

# Drainage Investigation Report

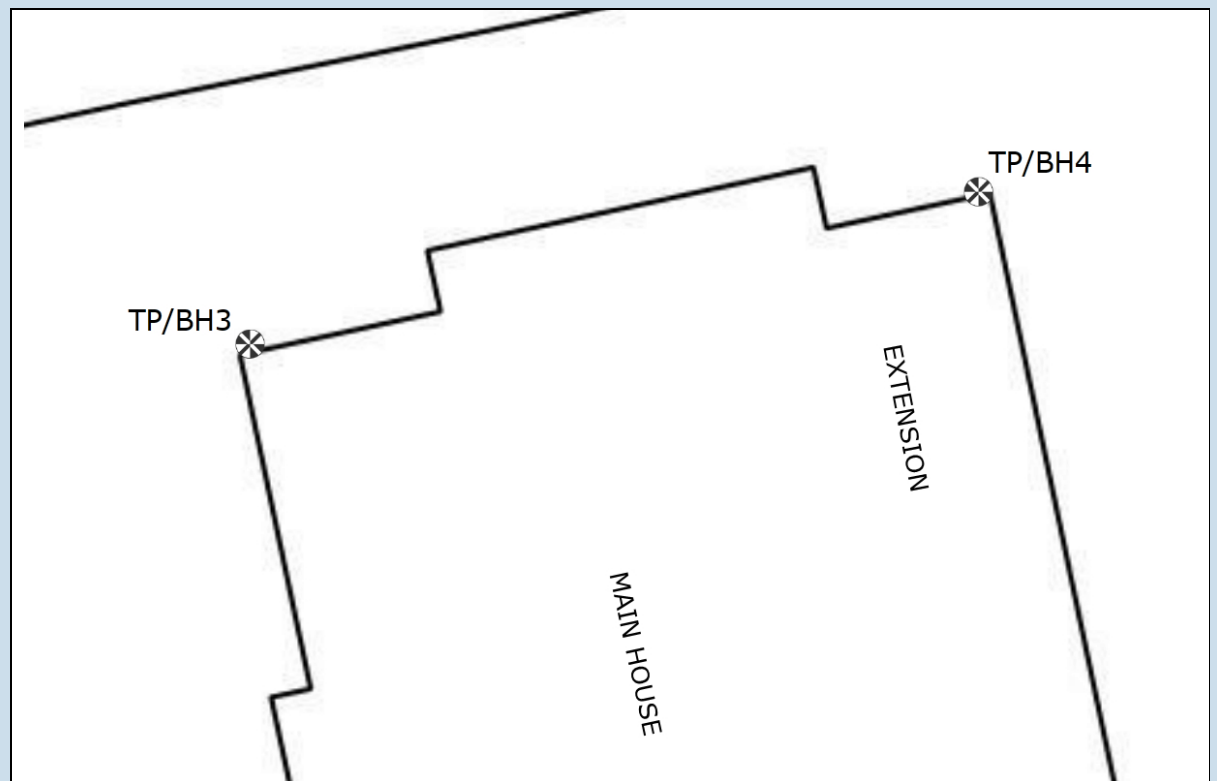
#### Site Plan

Borehole		Foul Water Drain		Foul Manhole		Foul Rodding Point		Foul Vent Pipe
	Trial Pit / Borehole		Surface Water Drain		Rain Water Manhole		Surface Rodding Point		Rain Water Gully
	Trial Pit		Combined Drain		Combined Manhole

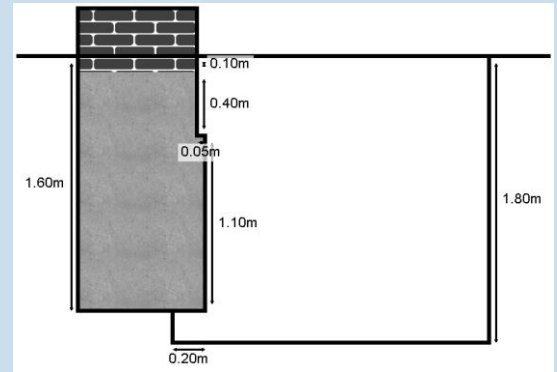
## TP/BH3 Foundation Detail and Borehole Log

House foundation comprised of brick wall to 100mm bgl, bearing on stepped concrete to 1600mm bgl, with a total projection of 50mm from the elevation. Underside of foundation (USF) was exposed to 200mm back from the face of the foundation and probed 200mm back from the face of the foundation.

— End of borehole at 4.00m —  
Trial pit excavated to 1.80m bgl. Borehole completed by hand held percussive window sampler. Roots not encountered. Extensive inspection of soil samples encountered no roots. Groundwater strikes not encountered. PEN = Hand Penetrometer (kg/sq cm). MP = Mackintosh Probe (blows per 75mm).

At 1.60m bgl UNDERSIDE OF HOUSE FOUNDATION in TP/BH3.

At 0.00m to 4.00m bgl no roots encountered. Extensive inspection of soil samples encountered no roots in TP/BH3.

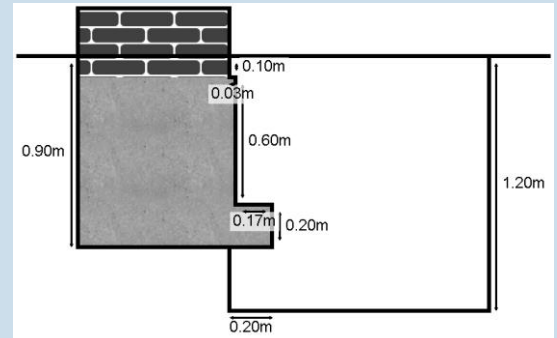
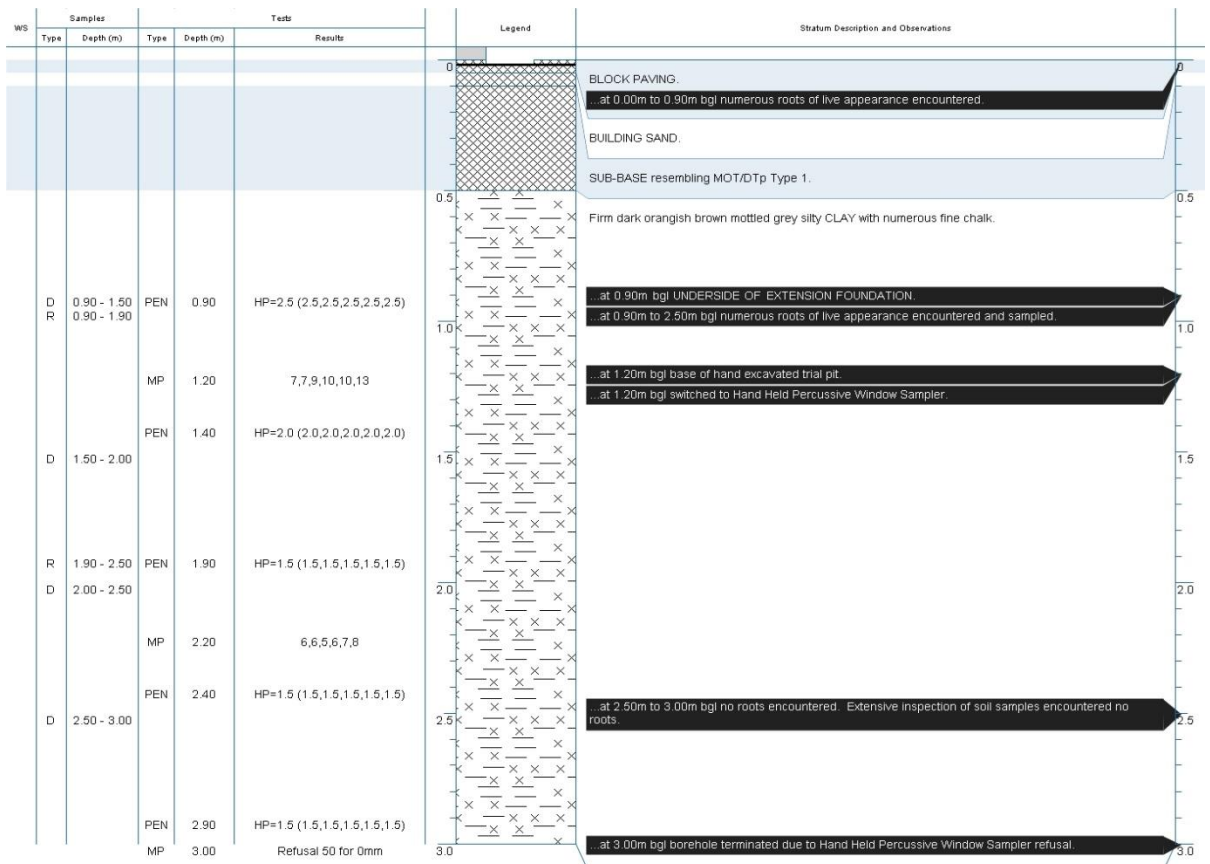
## TP/BH4 Foundation Detail and Borehole Log

Extension foundation comprised of brick wall to 100mm bgl, bearing on stepped concrete to 900mm bgl with a total projection of 200mm from the elevation. Underside of foundation (USF) was exposed to 200mm back from the face of the foundation and probed 200mm back from the face of the foundation.

-- End of borehole at 3.00m --  
Trial pit excavated to 1.20m bgl. Borehole completed by hand held percussive window sampler. Roots encountered to 2.50m bgl. Groundwater strikes not encountered. PEN = Hand Penetrometer (kg/sq cm). MP = Mackintosh Probe (blows per 75mm).

At 0.90m bgl UNDERSIDE OF EXTENSION FOUNDATION in TP/BH4.

Hand Held Percussive Window Sampler refusal at 3.00m bgl due to cobbles within the clay (TP/BH 4).

At 0.00m to 0.90m bgl numerous roots of live appearance encountered in TP/BH4.

At 0.90m to 2.50m bgl numerous roots of live appearance encountered and sampled in TP/BH4.

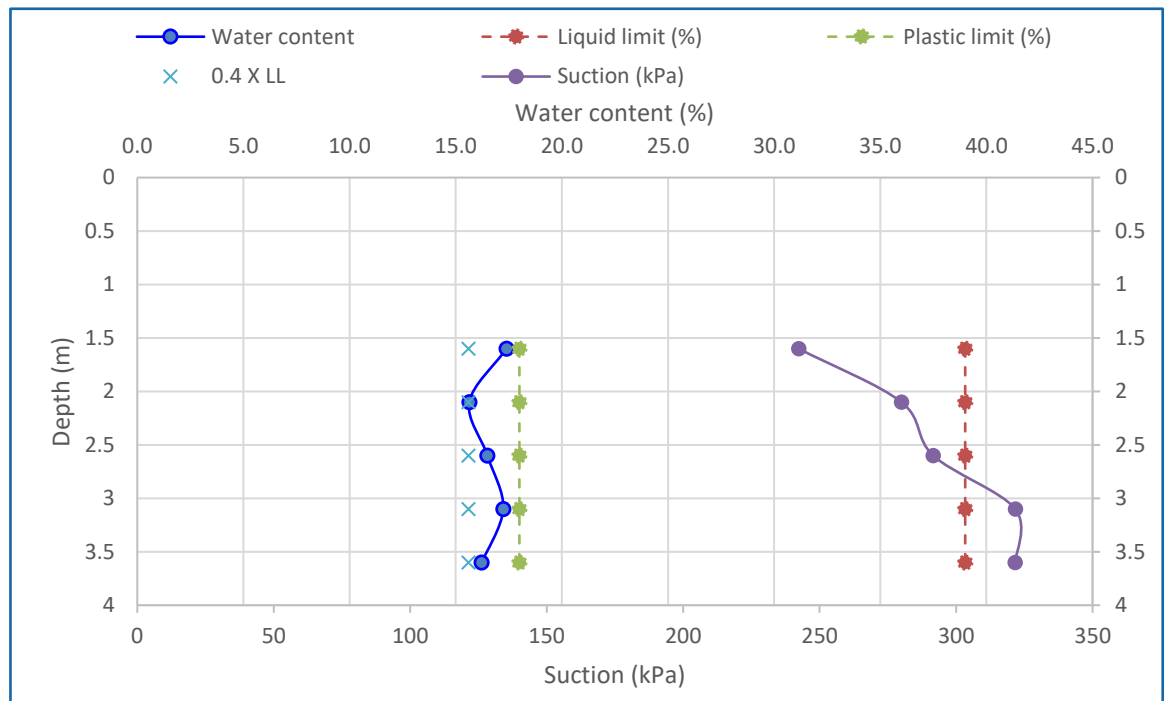
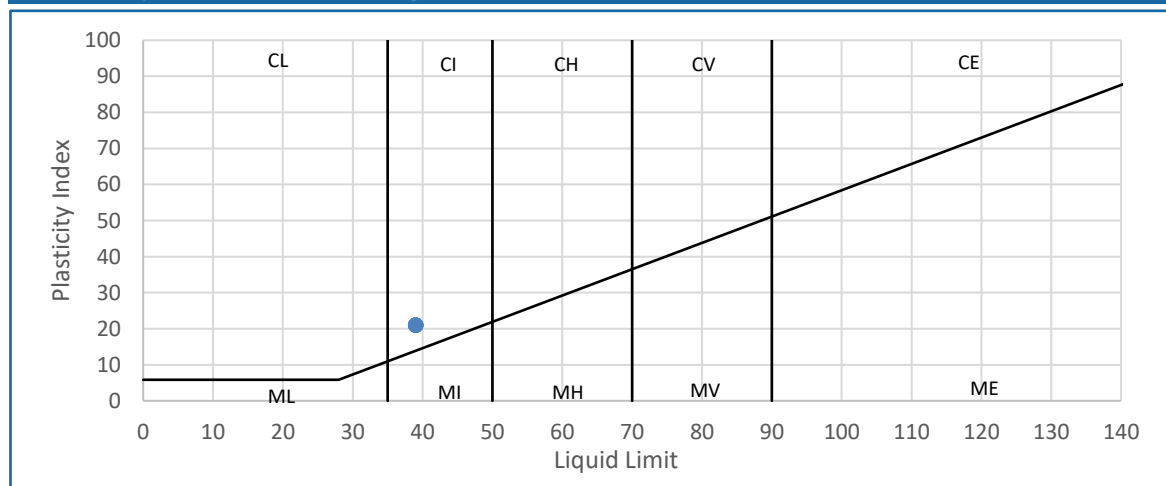
### Samples from BH3

Lab Ref	Depth (m)	WC (%)	LL (%)	PL (%)	PI (%)	.425 mm(%)	mod. PI (%)	Av. Suc. (kPa)	Description
1	1.6	17.4	39	18	21	89	19	242	Firm brown slightly gravelly silty CLAY . Gravel is fine and medium.
2	2.1	15.6	39	18	21	89	19	280	Firm brown slightly gravelly silty CLAY . Gravel is fine and medium.
3	2.6	16.5	39	18	21	89	19	292	Firm brown slightly gravelly silty CLAY . Gravel is fine and medium.
4	3.1	17.2	39	18	21	89	19	322	Firm brown slightly gravelly silty CLAY . Gravel is fine and medium.
5	3.6	16.2	39	18	21	89	19	322	Firm brown slightly gravelly silty CLAY . Gravel is fine and medium.

### Plasticity Chart for Casagrande Classification

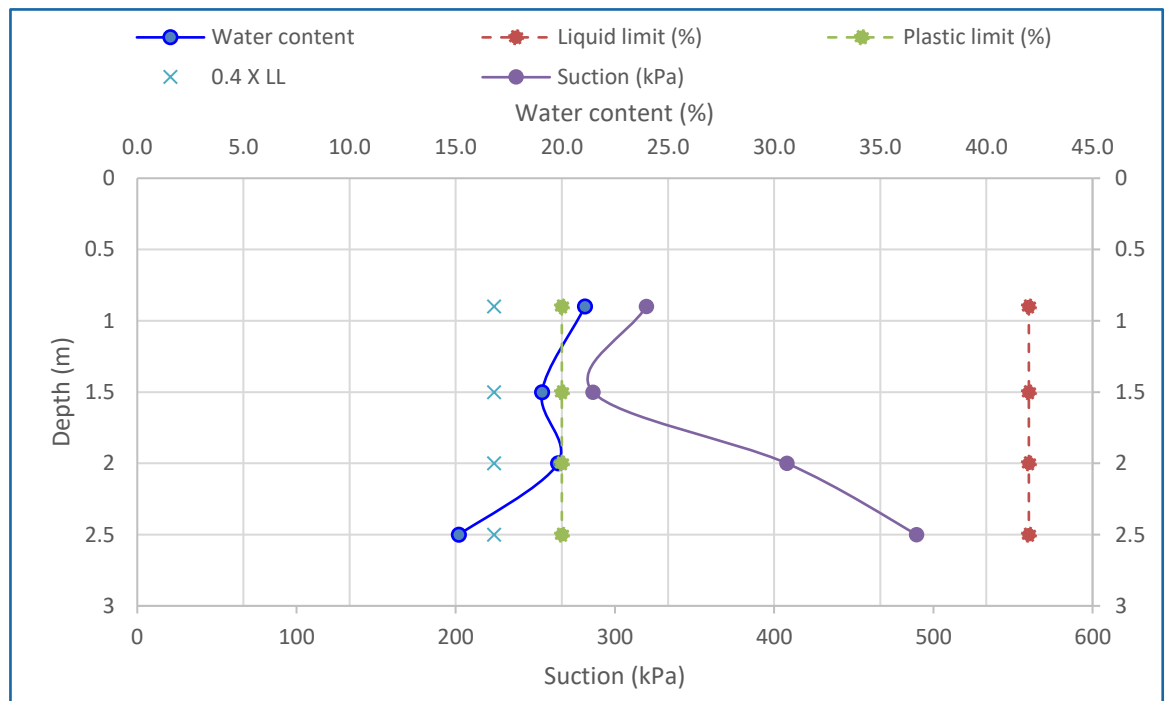
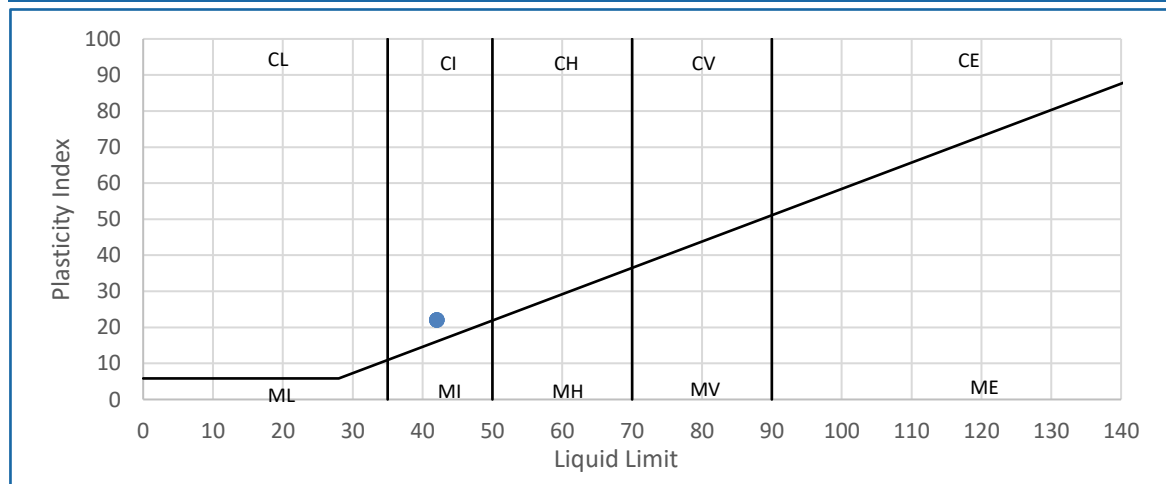
### Samples from BH4

Lab Ref	Depth (m)	WC (%)	LL (%)	PL (%)	PI (%)	.425 mm(%)	mod. PI (%)	Av. Suc. (kPa)	Description
6	0.9	21.1	42	20	22	99	22	320	Firm brown silty CLAY with rare gravel. Gravel is fine and medium.
7	1.5	19.1	42	20	22	99	22	286	Firm brown silty CLAY with rare gravel. Gravel is fine and medium.
8	2	19.8	42	20	22	99	22	408	Firm brown silty CLAY with rare gravel. Gravel is fine and medium.
9	2.5	15.1	42	20	22	99	22	490	Firm brown silty CLAY with rare gravel. Gravel is fine and medium.

### Plasticity Chart for Casagrande Classification

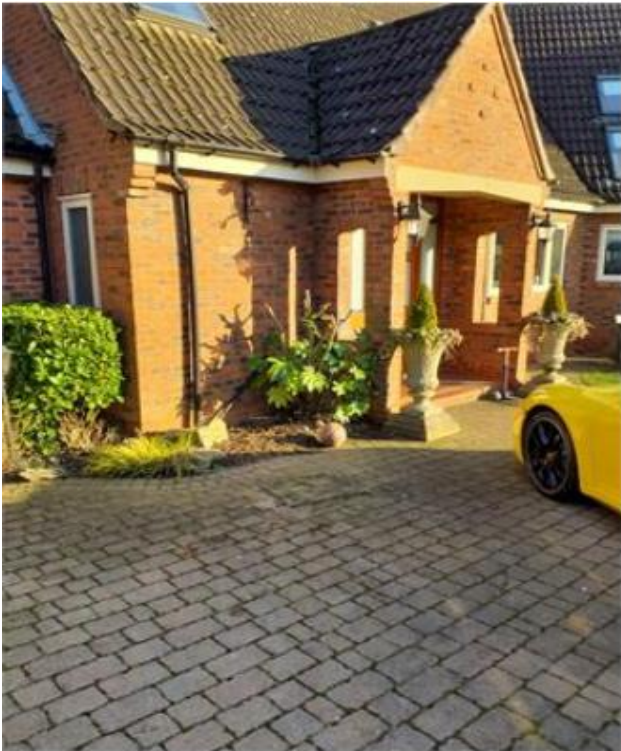
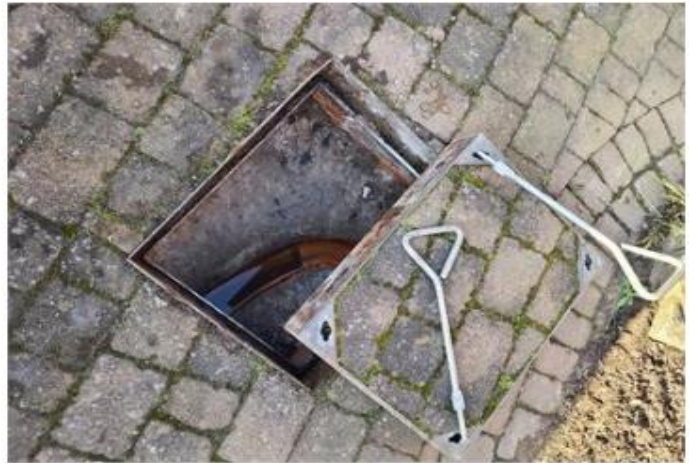
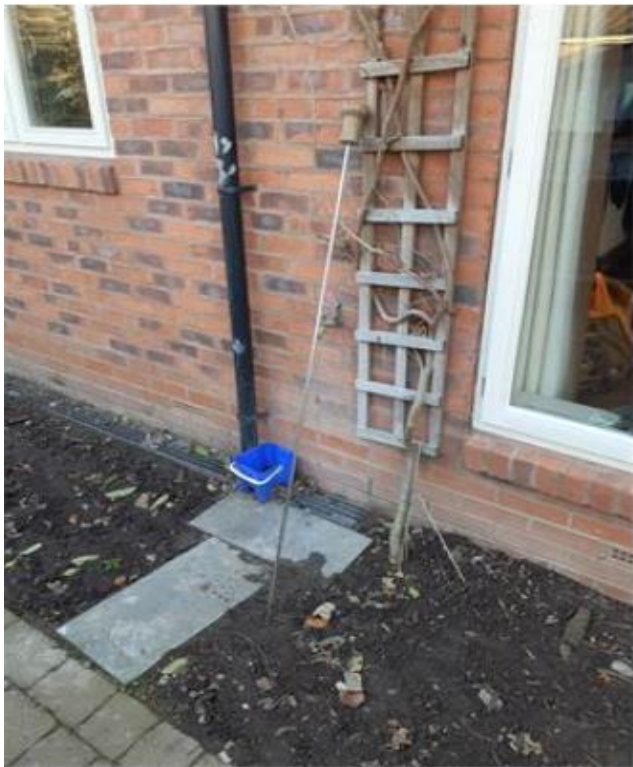
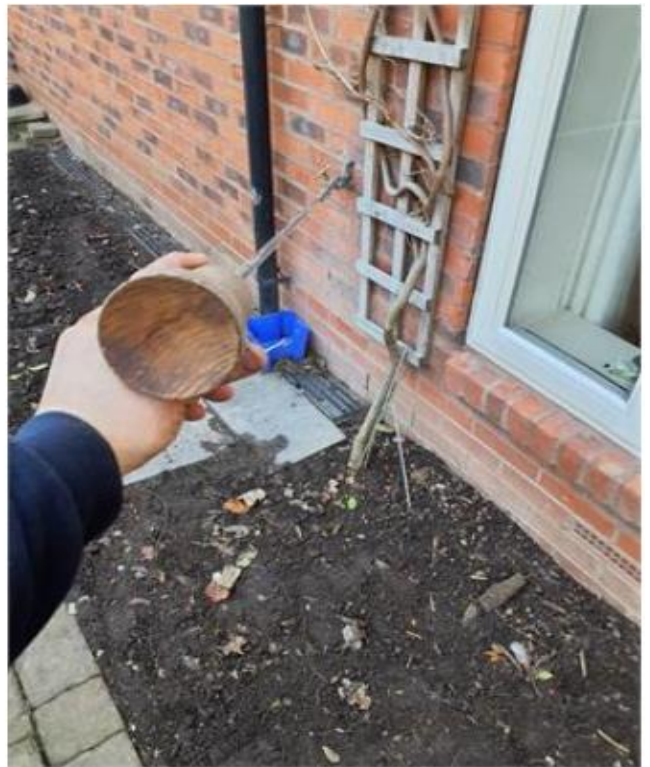
**CCTV Survey Result:** No structural damage

No repairs have been recommended as the drain line was found to be free from defects.
