RECORD OF SITE VISIT

JNP GROUP
CONSULTING ENGINEERS

Site: Bridge Road, Ascot

Job No: M41977

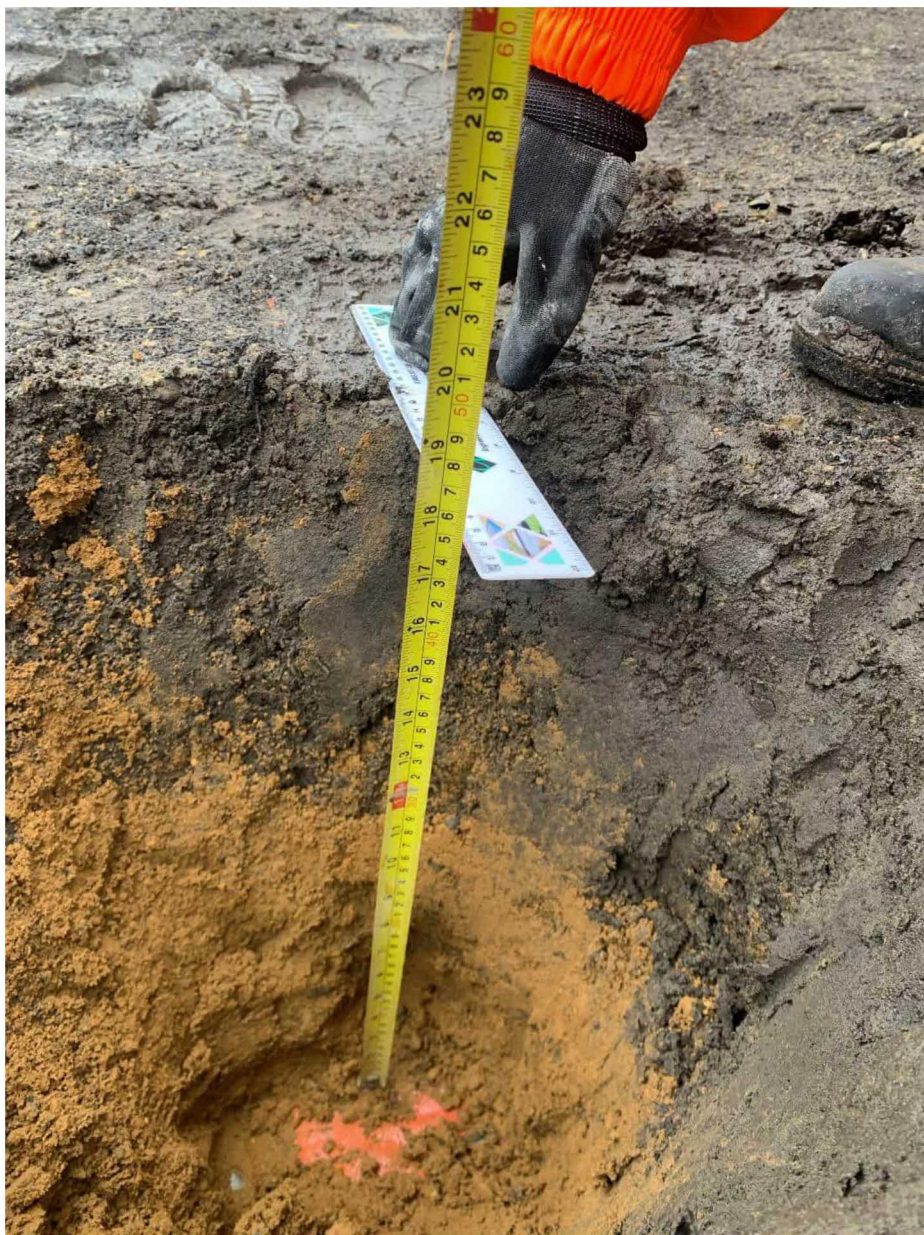
Photo 1: Plot 12 Front Garden showing topsoil, subsoil and geotextile.

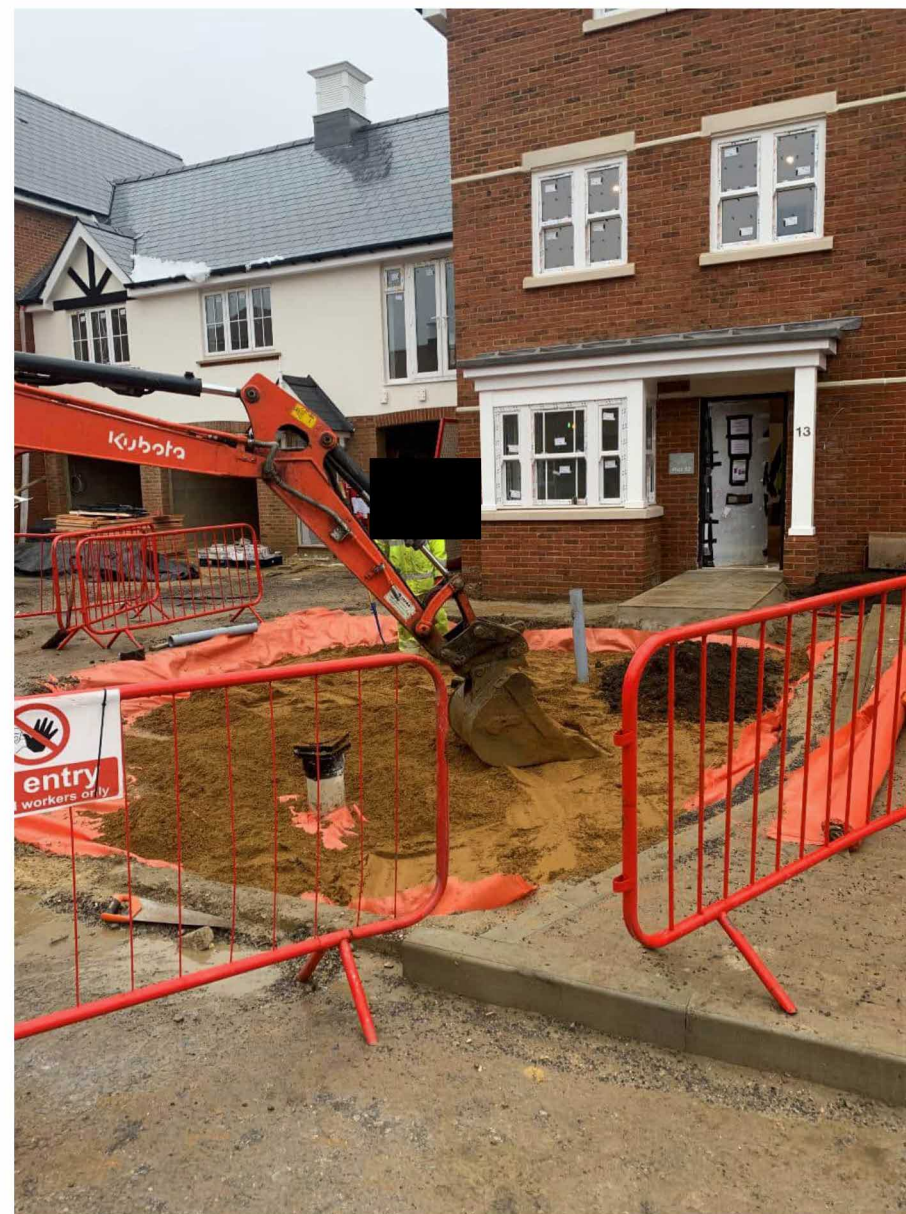
Photo 2: Plot 32 Front garden showing subsoil deposition over orange geotextile.

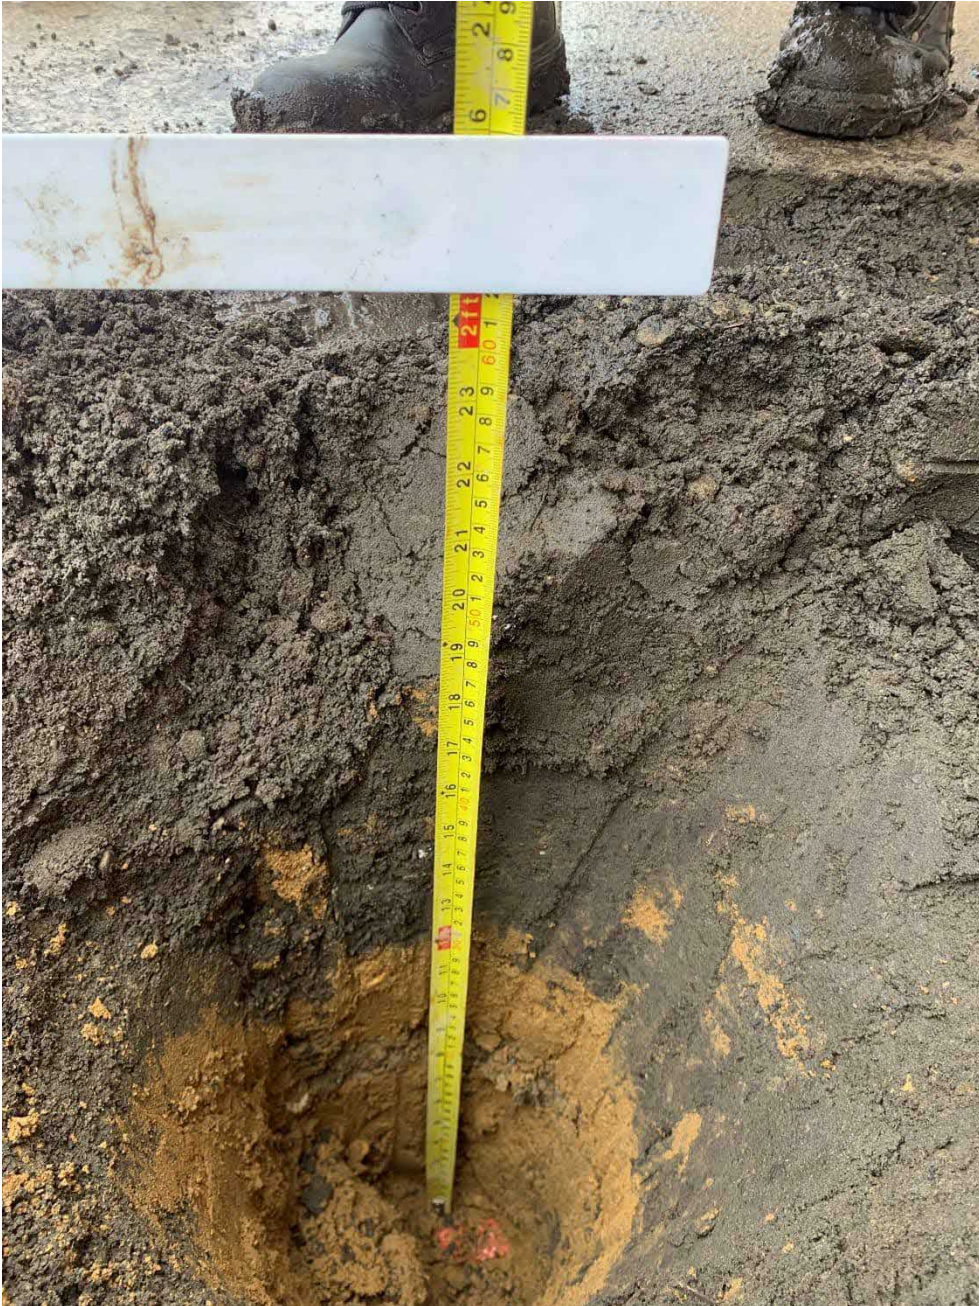
Photo 3: Plot 34 Front garden showing topsoil, subsoil and geotextile.

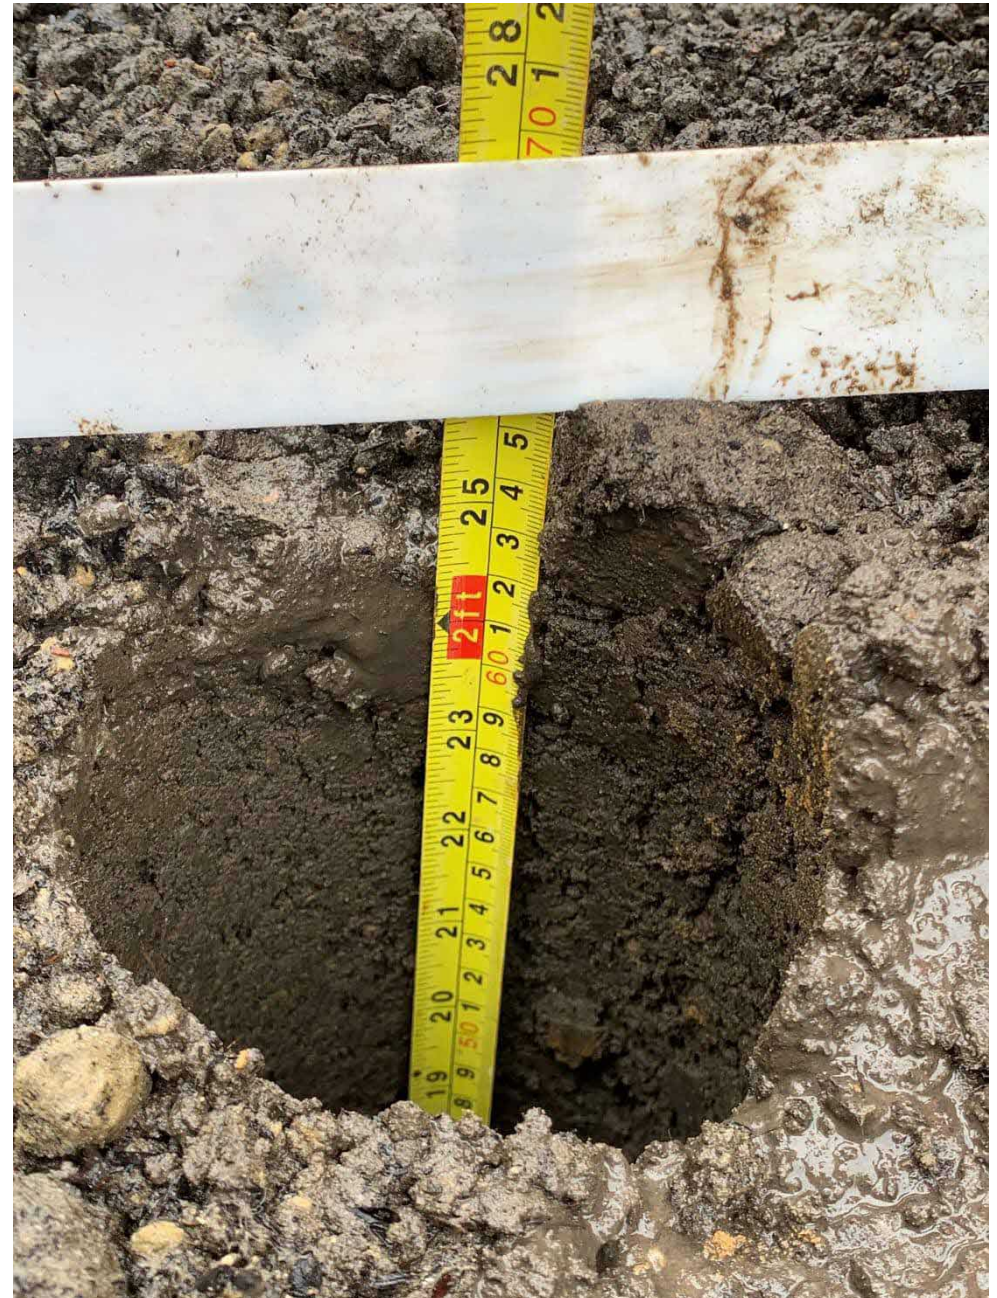
Photo 4: Plot 35 Front garden showing the depth of pit. Geotextile visible on site.

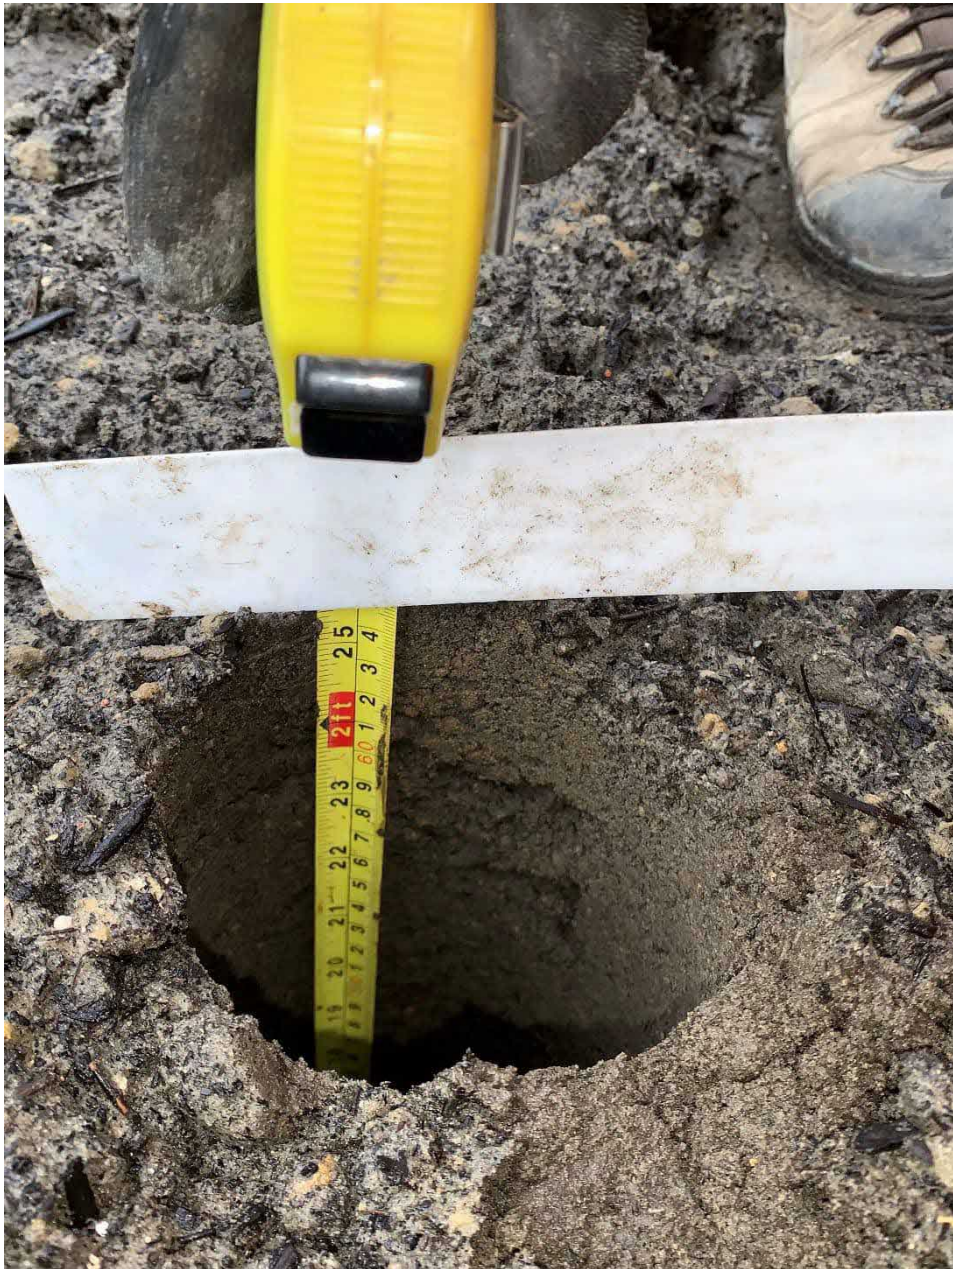
Photo 5a: Plot 33 rear garden showing depth to geotextile.

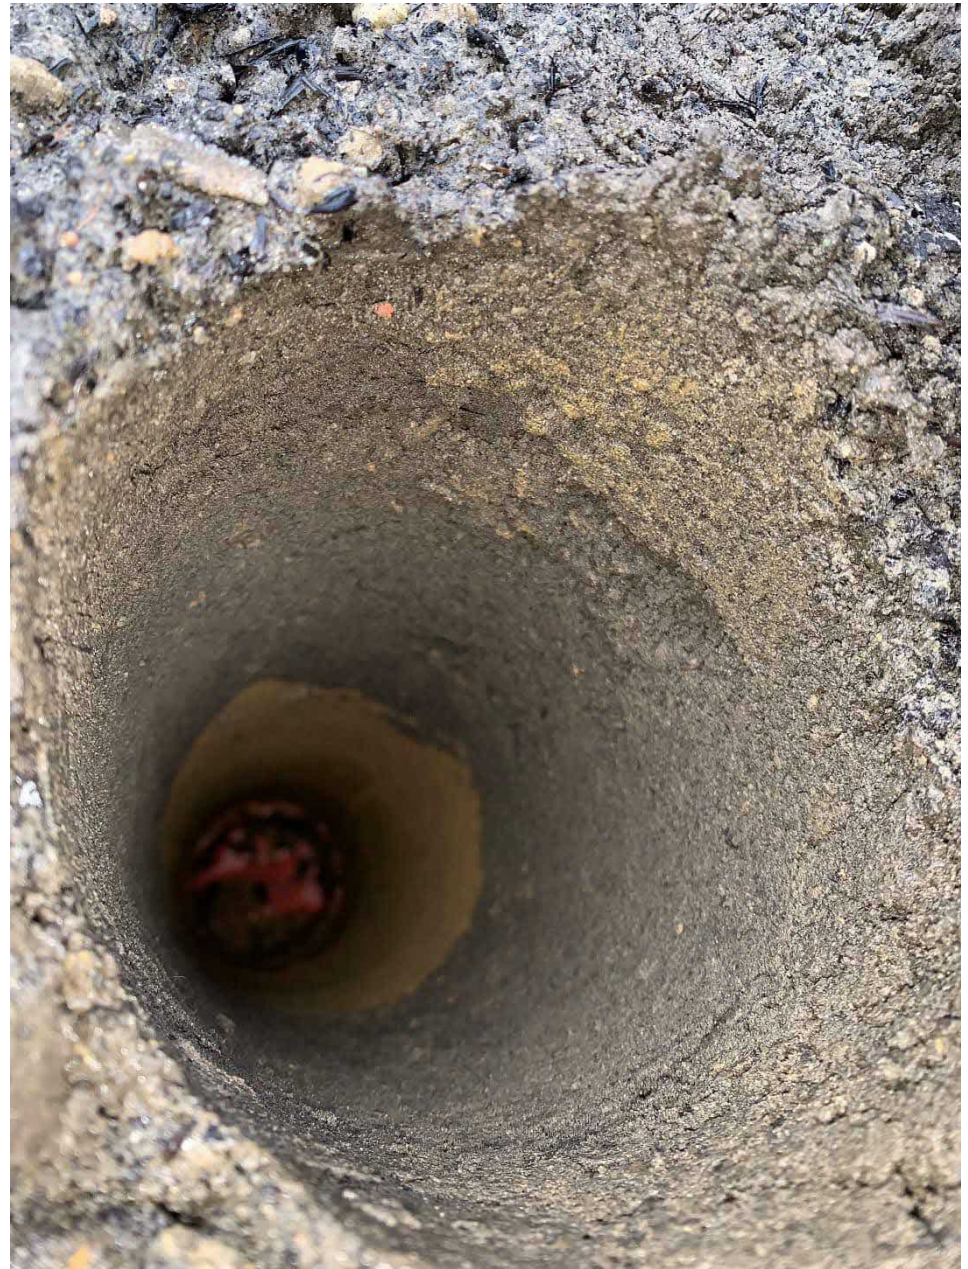
Photo 5b: Plot 33 rear garden showing the topsoil, subsoil and geotextile.

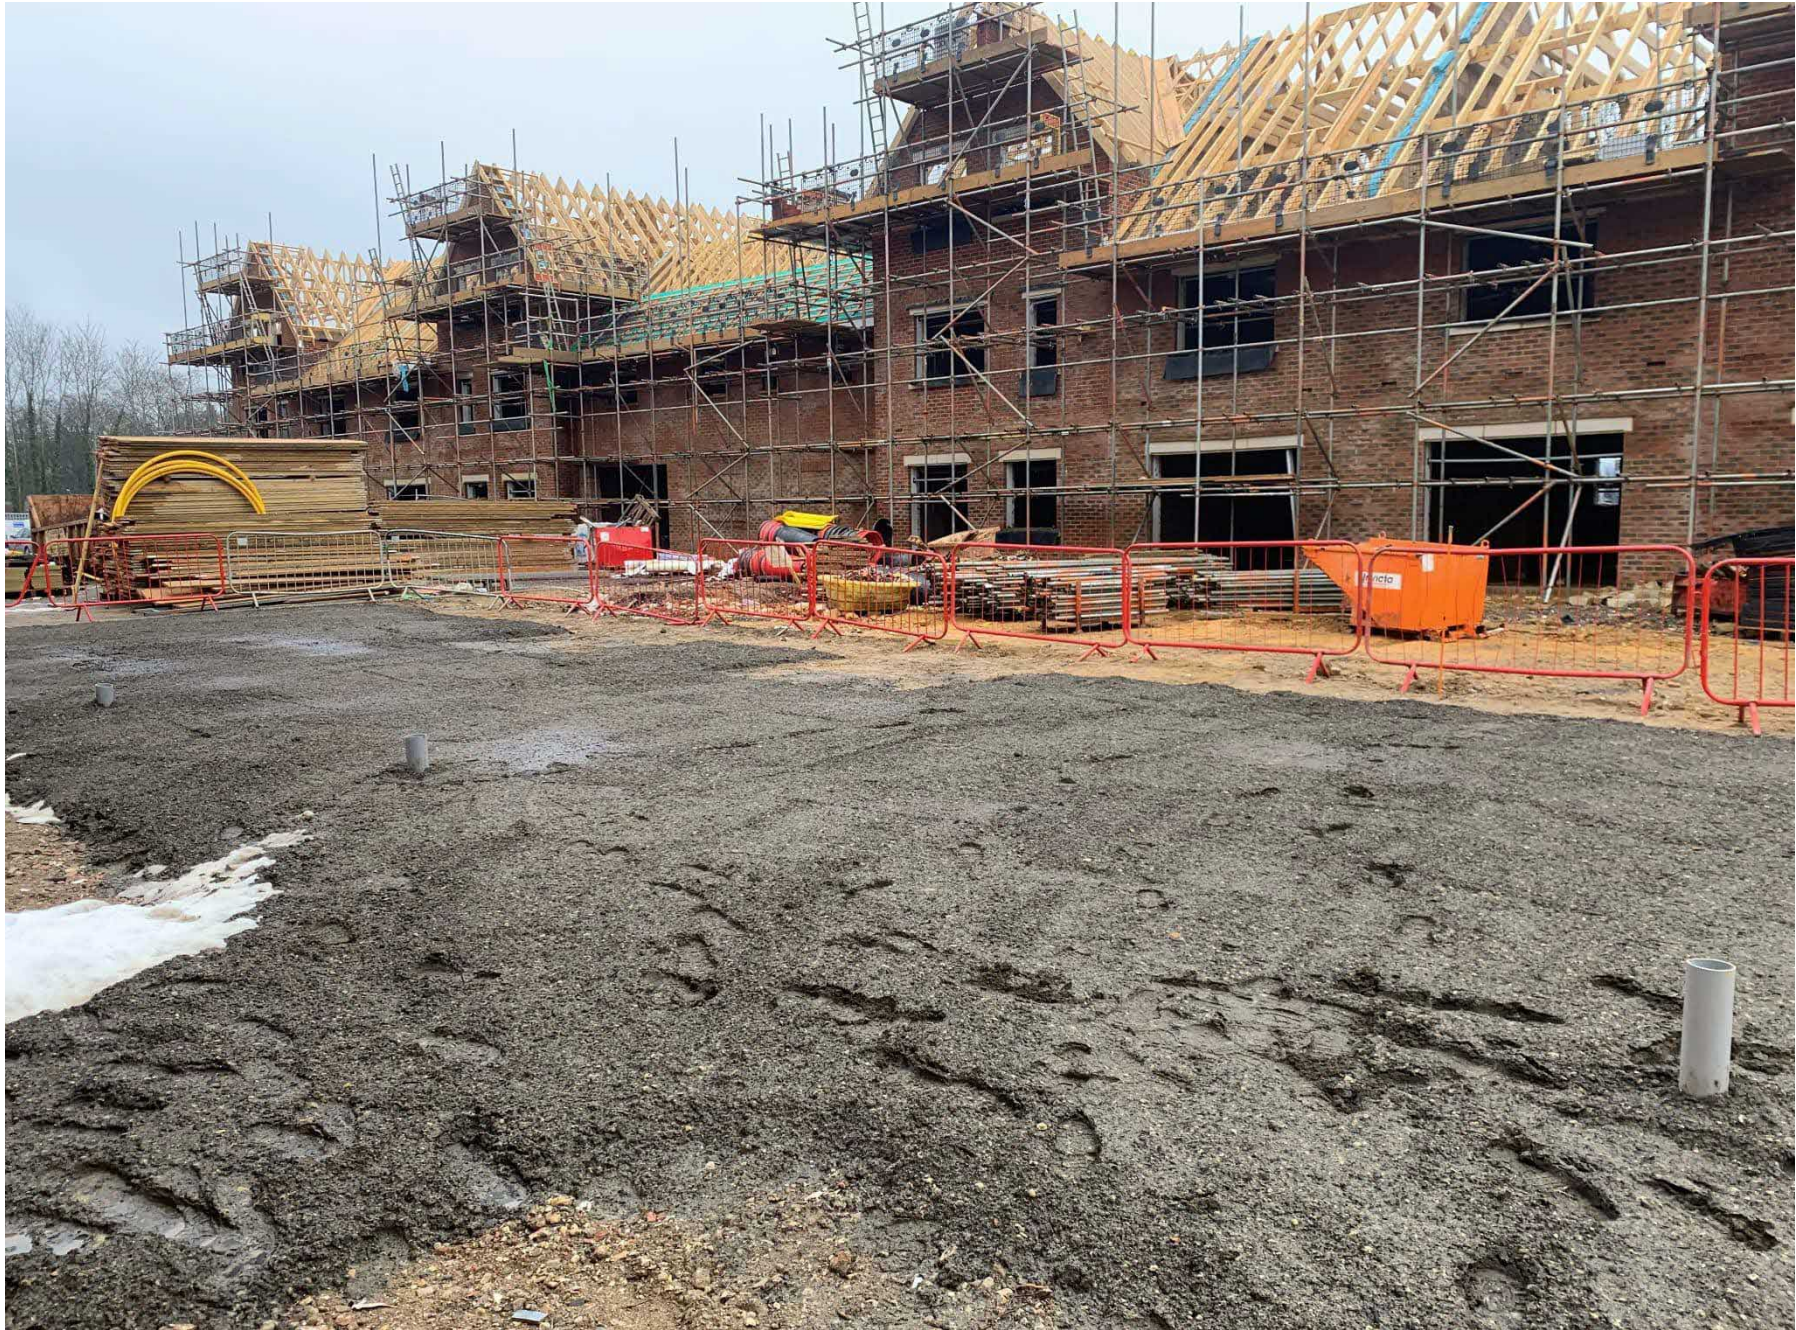
Photo 6: Plot 32-35 Rear Gardens showing the topsoil layer. Grey tubes reveal the subsoil and geotextile layers.

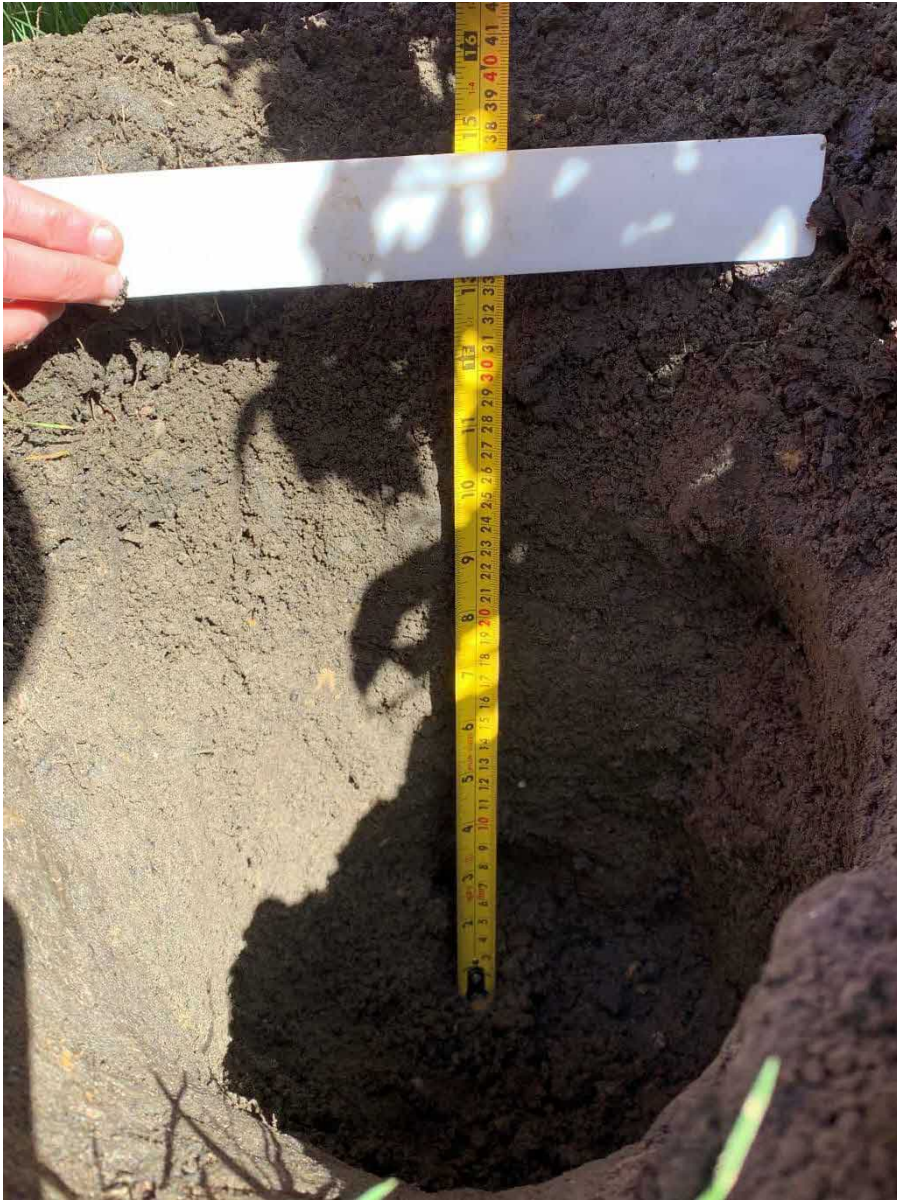
Plot 27 front garden had 300 mm bgl of topsoil visible. Proving subsoil and the geotextile was not viable due to hand pit location. Topsoil was sampled at 0.30 m and scheduled for heavy metals, speciated PAH, TPH CWG, asbestos, SOM and pH. Refer to Photo 1 in the Appendices.

Photo 1: Plot 27 Front Garden showing topsoil depth.

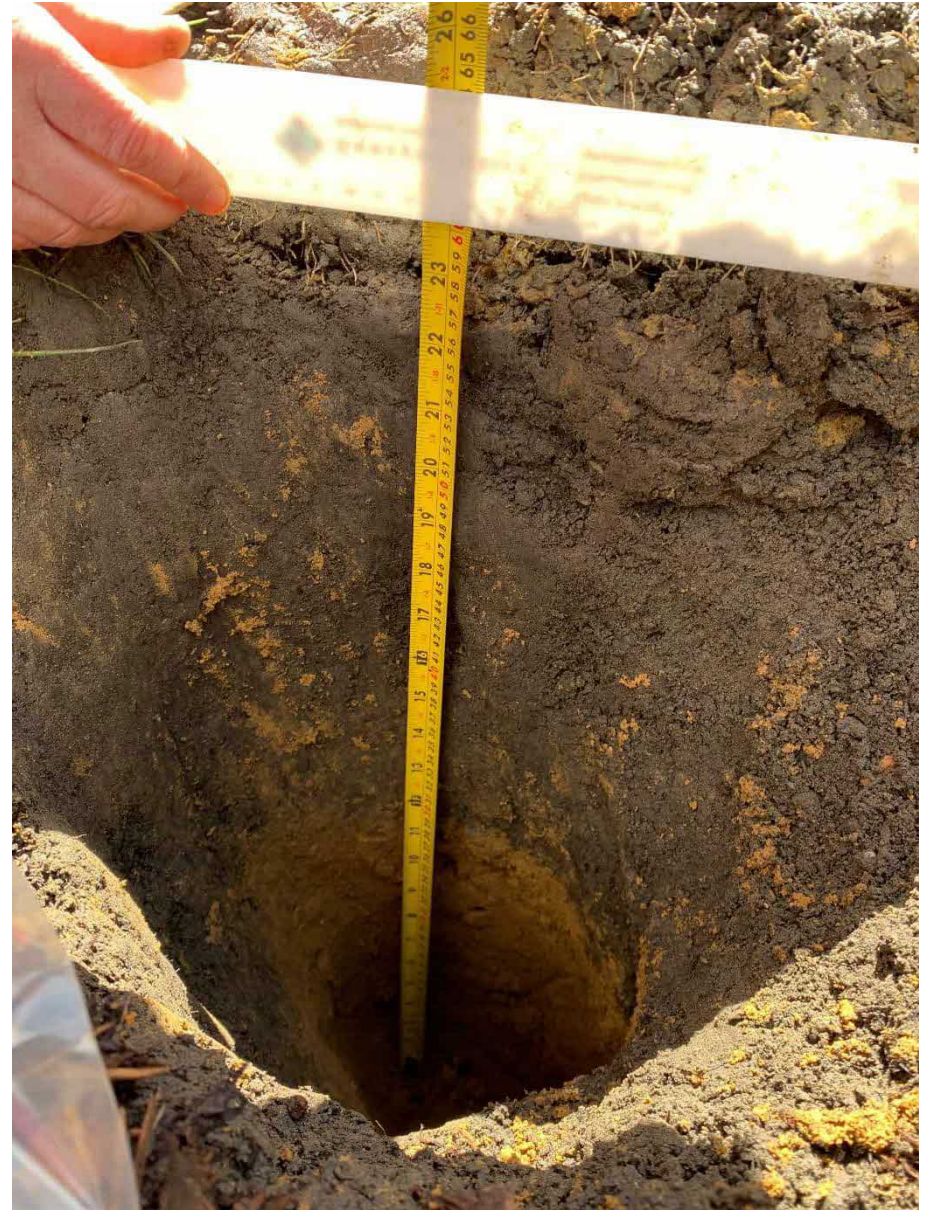
Plot 30 front garden had 400 mm bgl topsoil and 200 mm bgl subsoil, with visible geotextile at 0.60 m. Subsoil was sampled at 0.50 m and scheduled for heavy metals, speciated PAH, TPH CWG, asbestos, SOM and pH. Refer to Photo 2a and 2b in the Appendices.

Photo 2a: Plot 30 Front garden showing topsoil and subsoil depth

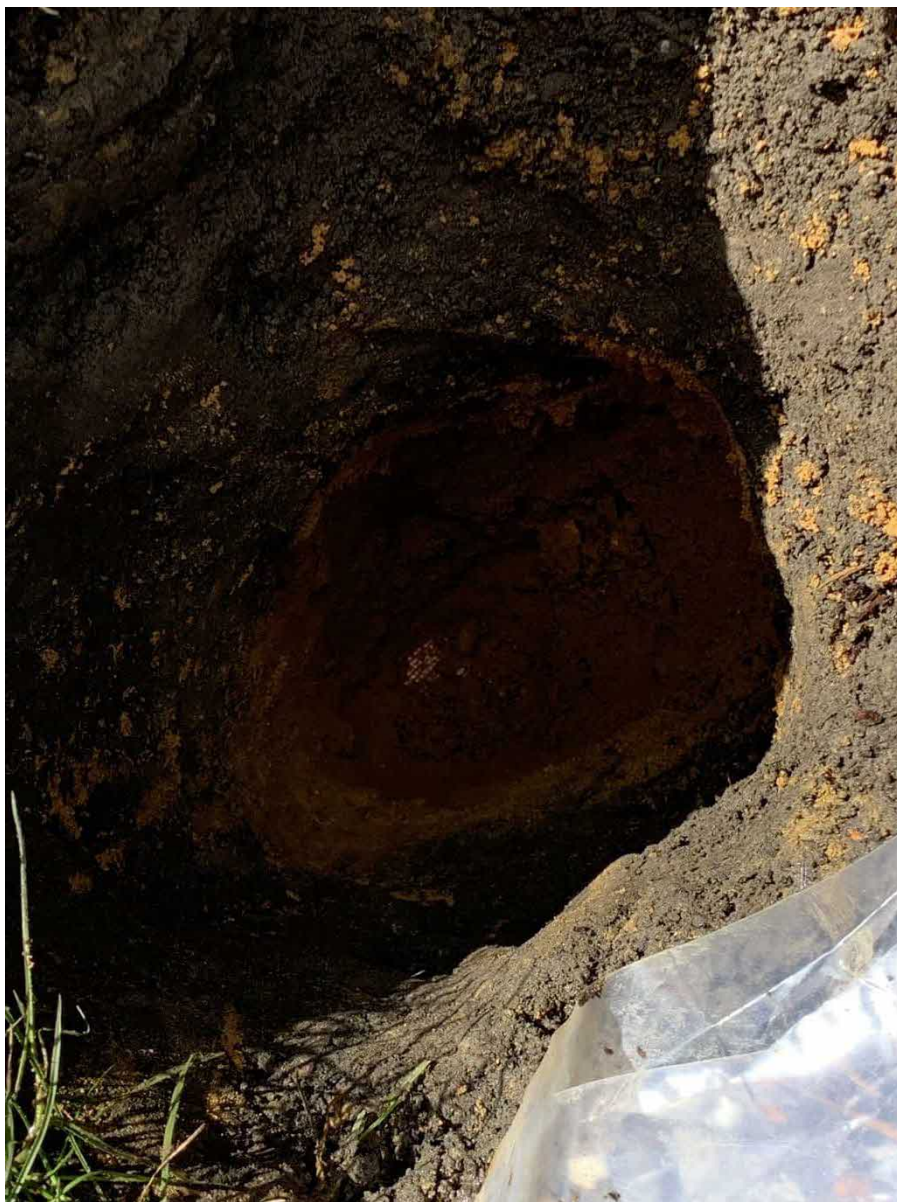
Photo 2b: Plot 30 Front garden showing geotextile.

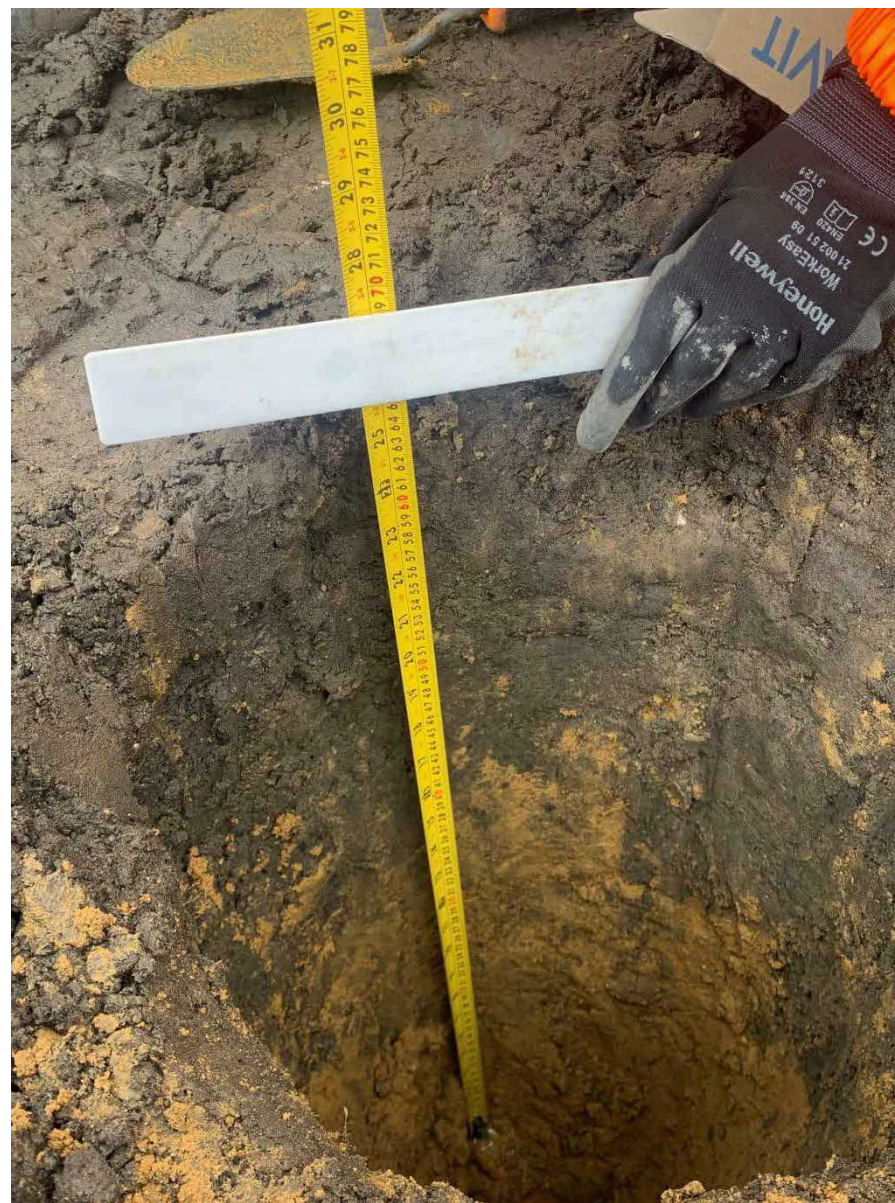
Plot 28 rear garden had 400 mm bgl of topsoil and 300 mm bgl of subsoil, with visible geotextile at 700 mm bgl. Topsoil was sampled at 0.20 m bgl and scheduled for heavy metals, speciated PAH, TPH CWG, asbestos, SOM and pH. Refer to Photo 3 in the Appendices.

Photo 3: Plot 28 Rear garden showing the depth of topsoil and subsoil and the geotextile.

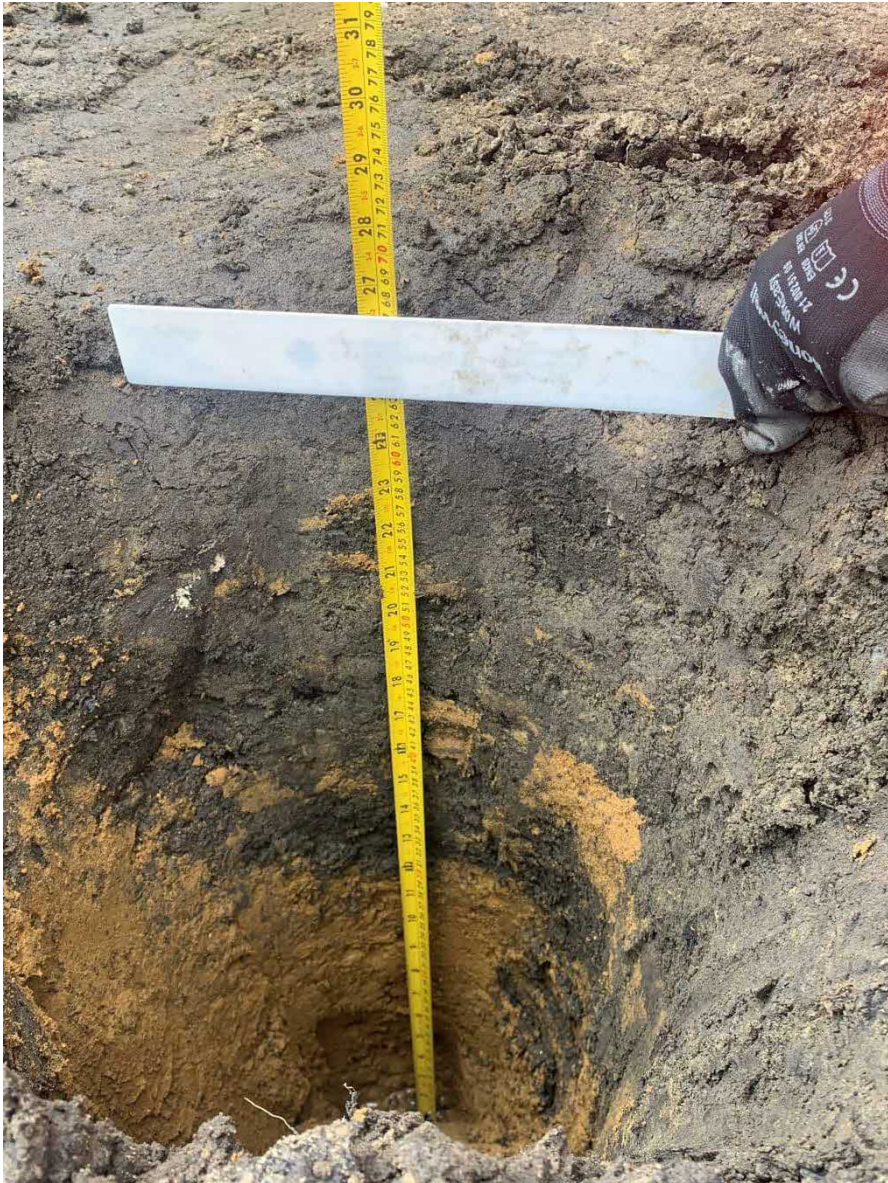
Plot 30 rear garden had 400 mm bgl of topsoil and 200 mm bgl of subsoil, with visible geotextile at 600 mm bgl. Subsoil was sampled at 0.50 m bgl and scheduled for heavy metals, speciated PAH, TPH CWG, asbestos, SOM and pH. Refer to Photo 4a and 4b in the Appendices.

Photo 4a: Plot 30 rear garden showing topsoil and subsoil depths..

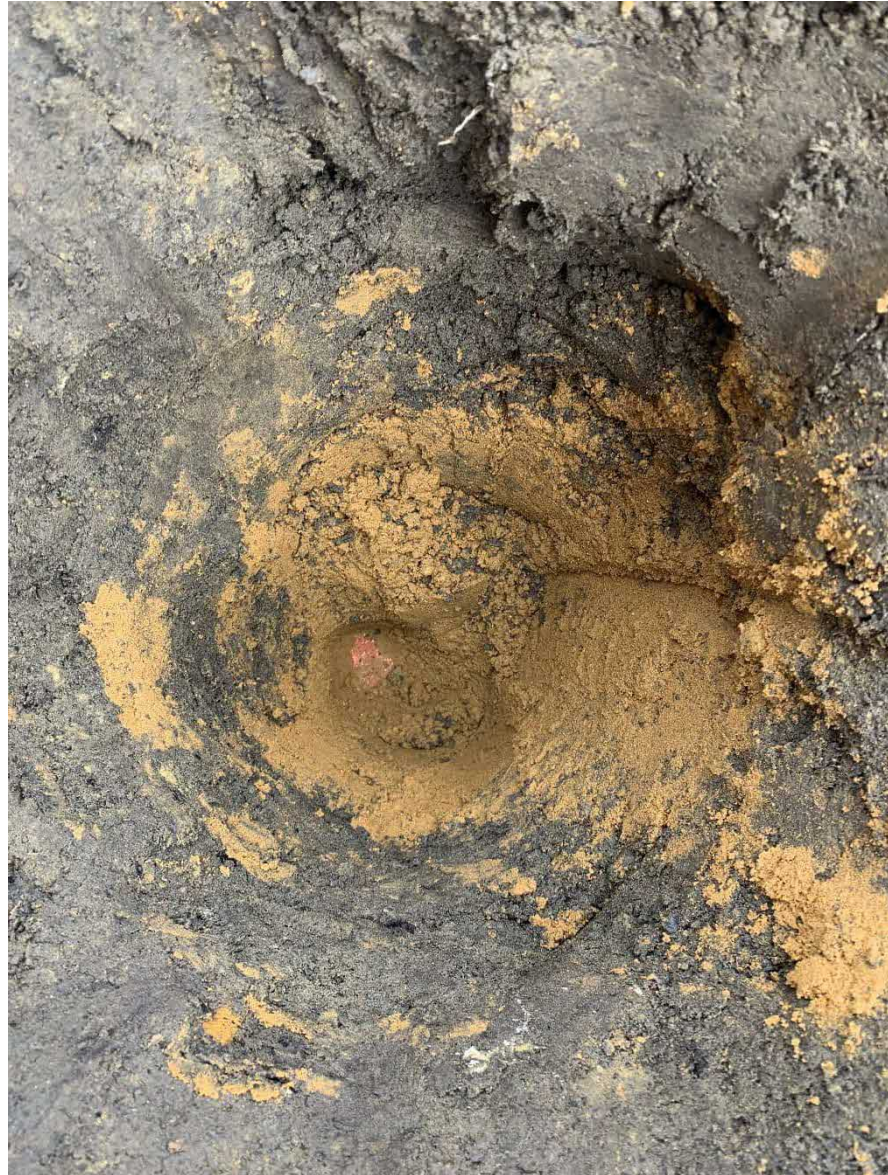
Photo 4b: Plot 30 rear garden showing the geotextile

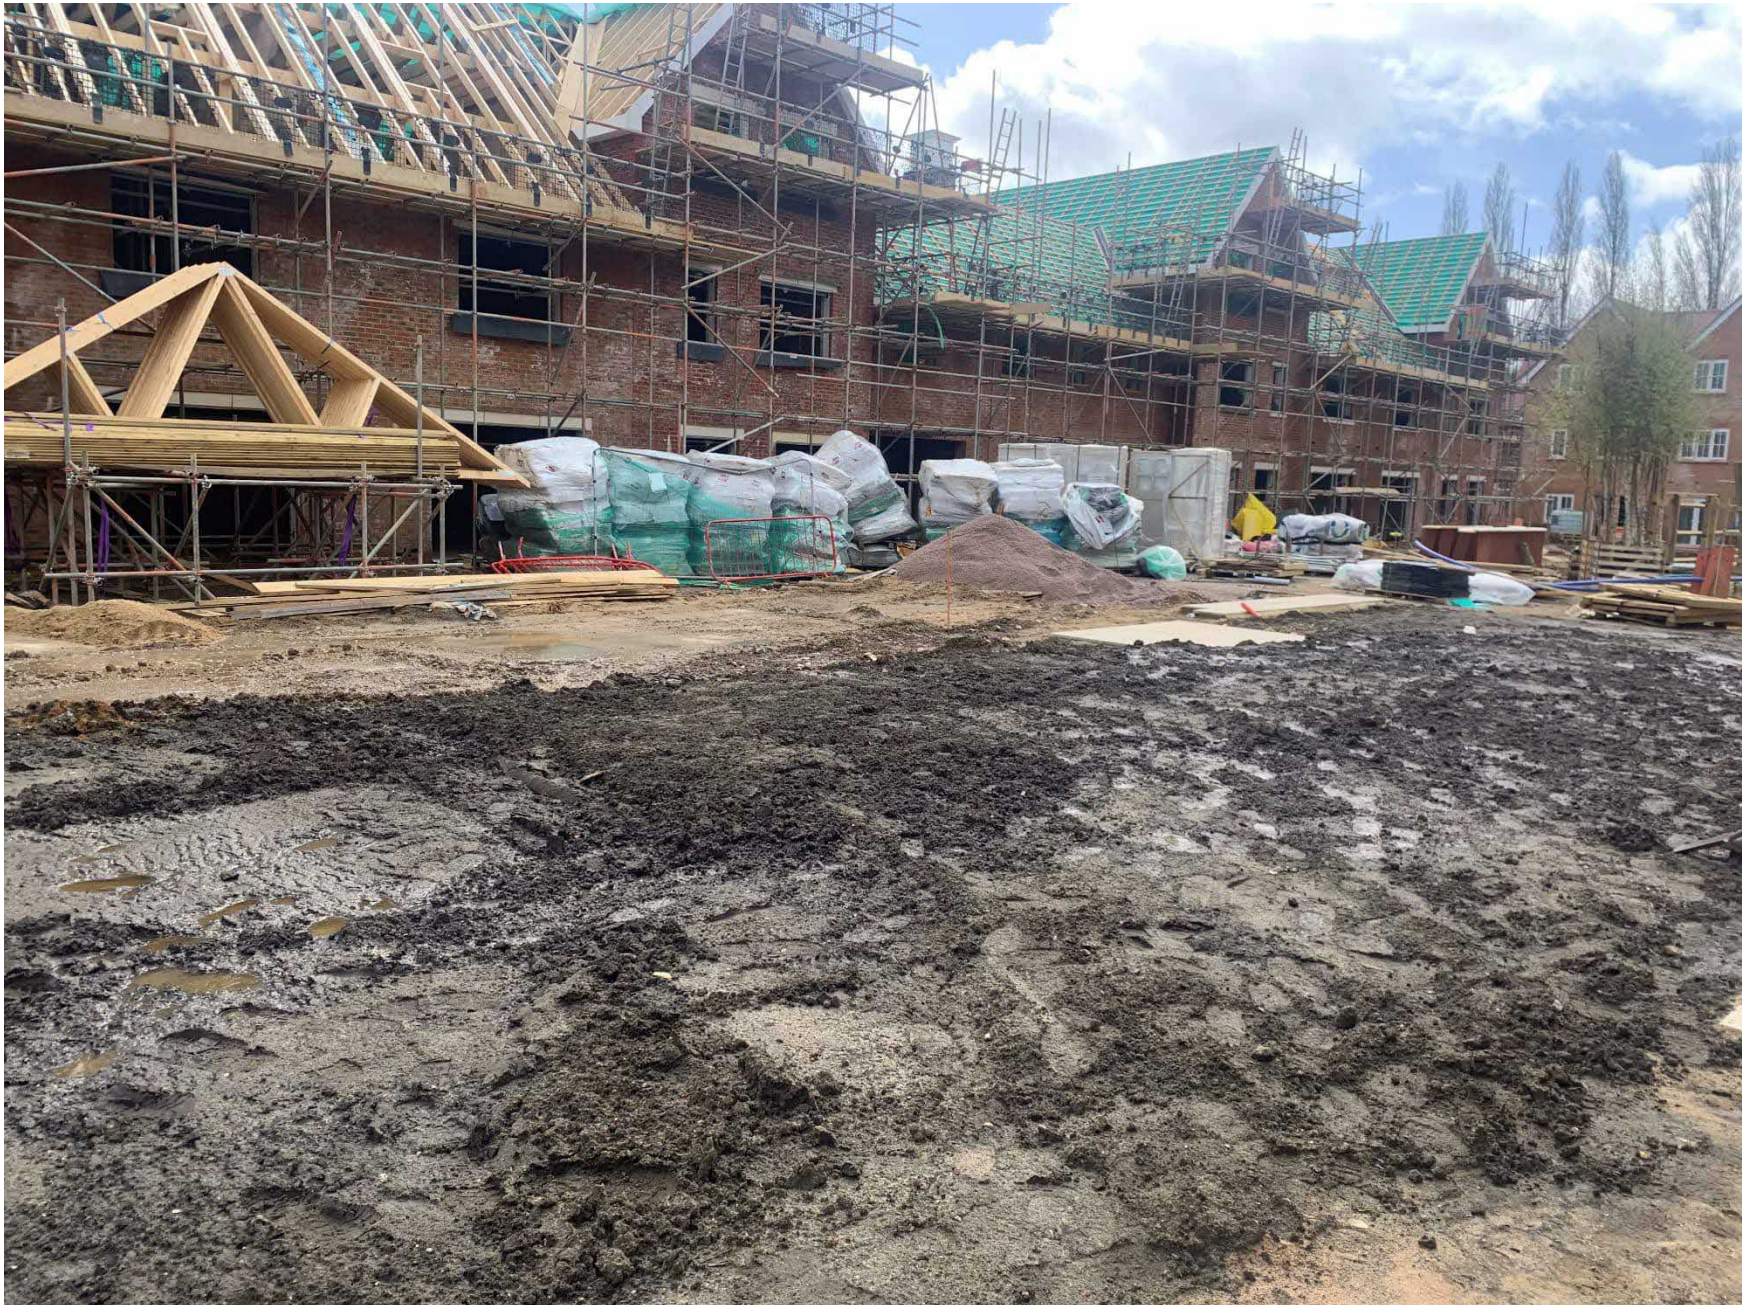
Photo 5 shows the rear gardens of Plots 27-30.

Photo 5: Plots 27-30 Rear Gardens showing the topsoil layer.

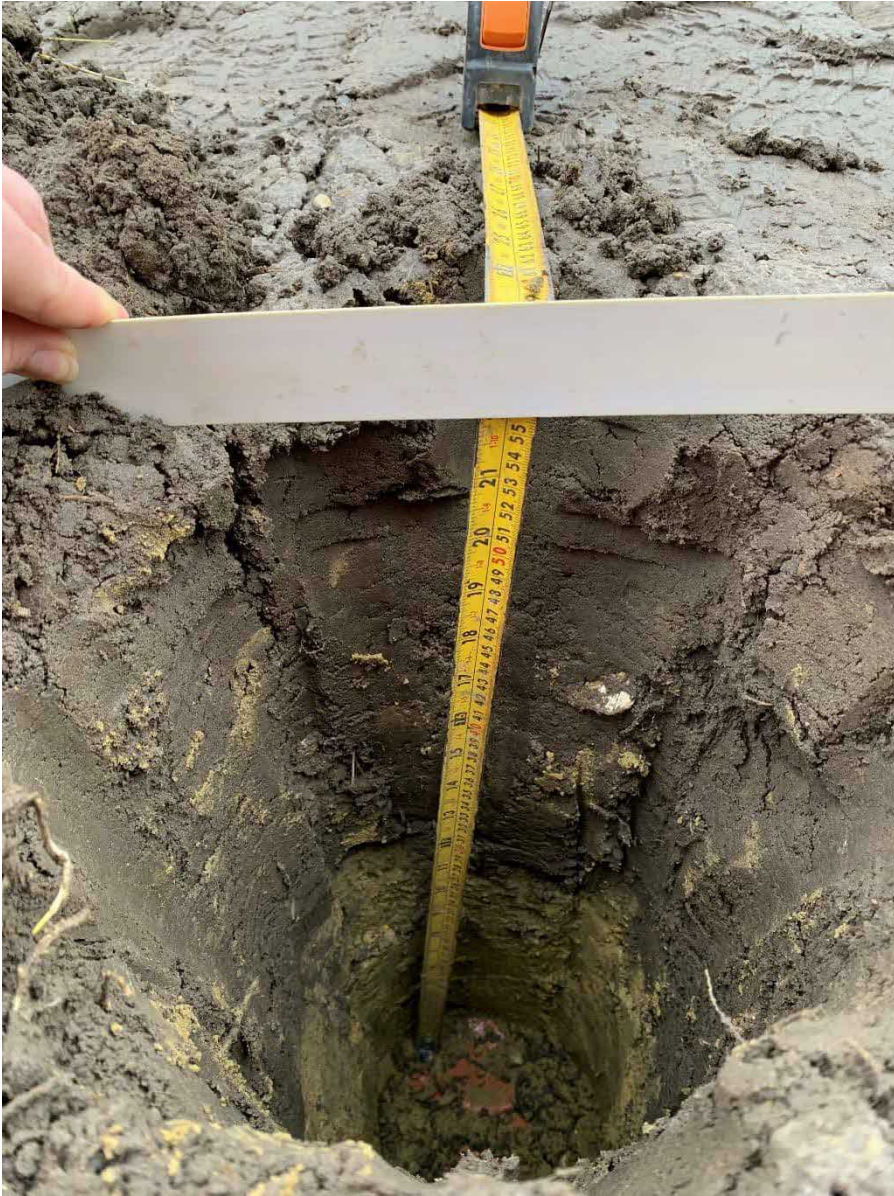
Plot 50 front garden has 0.25 m topsoil and 0.30 m subsoil with geotextile visible at 0.55 m bgl. Topsoil was sampled at 0.15 m bgl and scheduled for heavy metals, speciated PAH, TPH CWG, asbestos, SOM and pH. Refer to Photo 1 in the Appendices.

Photo 1: Plot 50 Front Garden showing depth to geotextile.

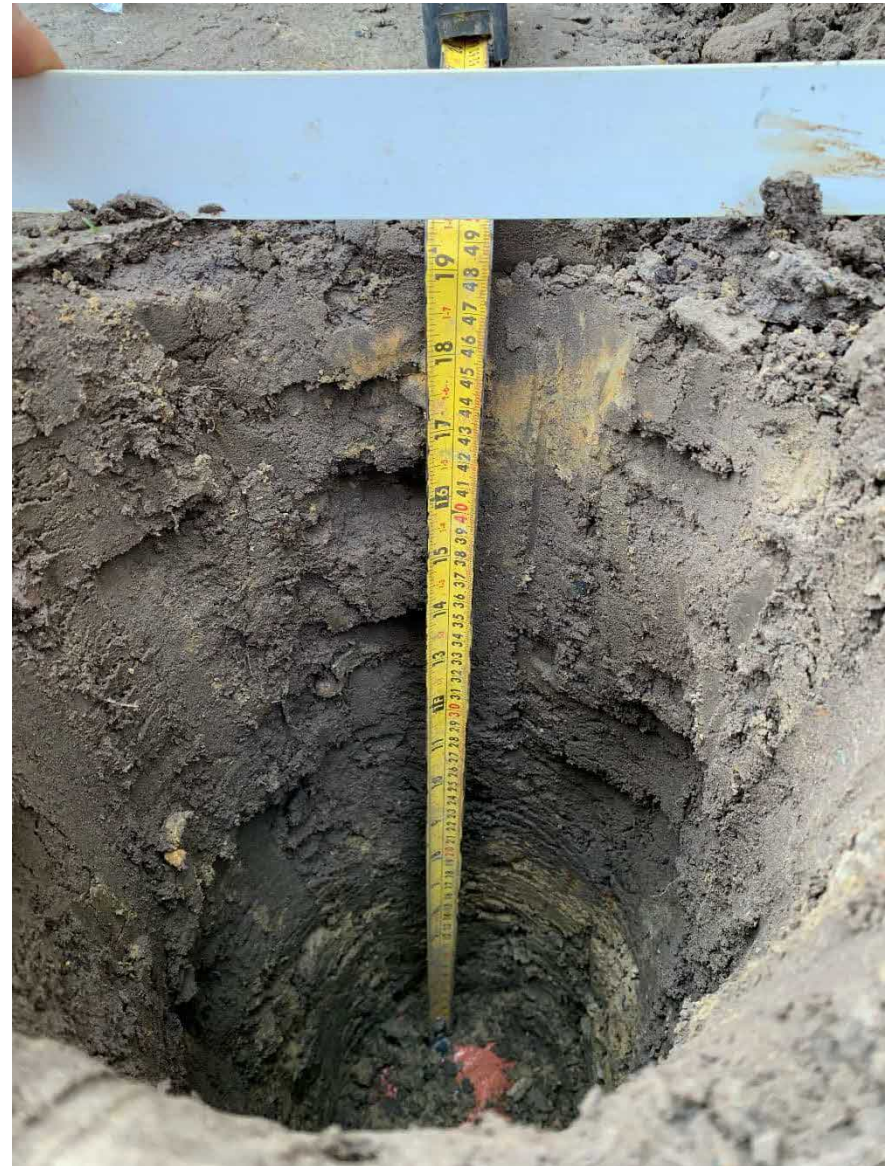
Plot 48 front garden has 0.35 m topsoil and 0.15 m subsoil with geotextile visible at 0.50 m bgl. Subsoil was sampled at 0.40 m bgl and scheduled for heavy metals, speciated PAH, TPH CWG, asbestos, SOM and pH. Refer to Photo 2 in the Appendices.

Photo 2: Plot 48 Front garden showing depth to geotextile.

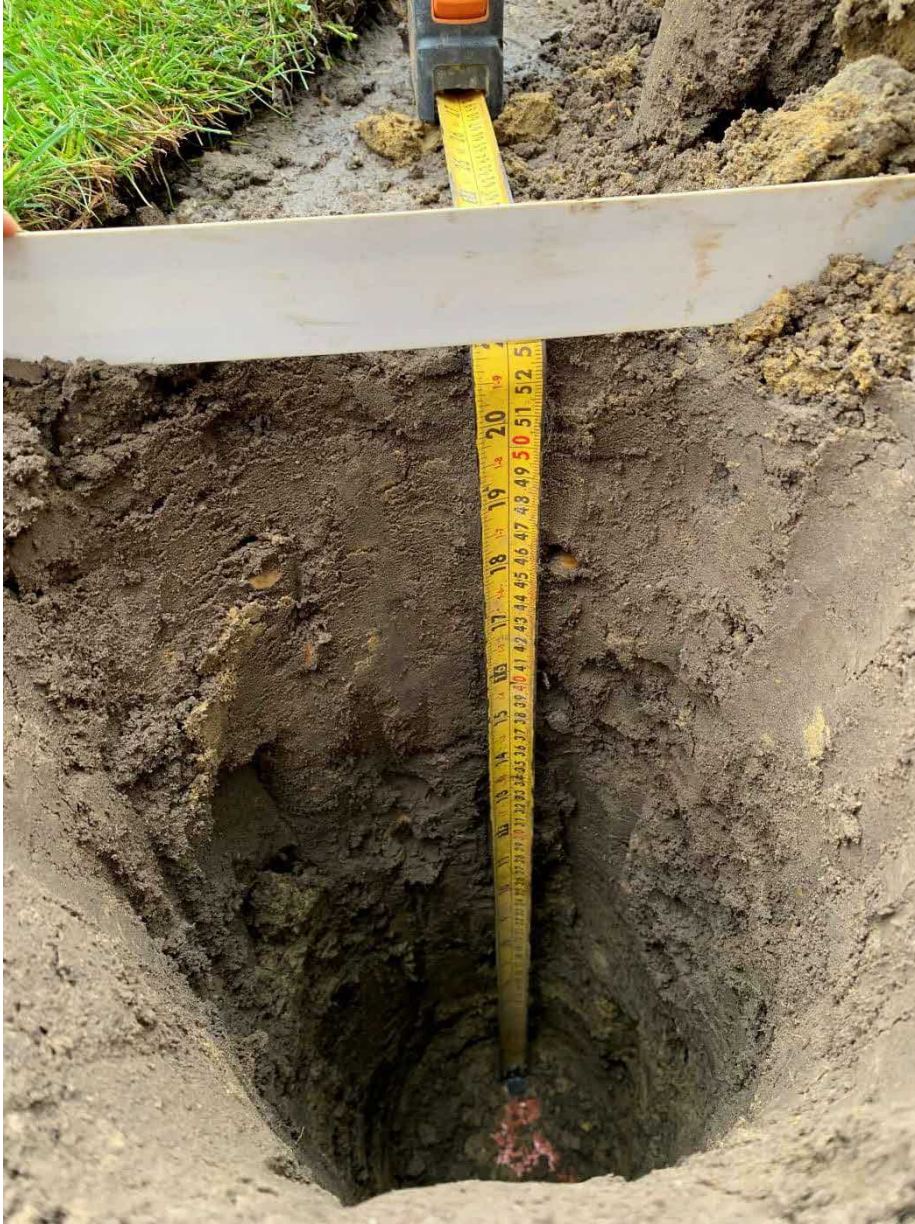
Plot 47 front garden had 0.30 m topsoil and 0.23 m subsoil with geotextile visible at 0.53 m bgl. Topsoil was sampled at 0.10 m bgl and scheduled for heavy metals, speciated PAH, TPH CWG, asbestos, SOM and pH. Refer to Photo 3 in the Appendices.

Photo 3: Plot 47 Front garden showing depth to geotextile.
