RECORD OF SITE VISIT

JNP GROUP
CONSULTING ENGINEERS

Site: Bridge Road, Ascot

Job No: M41977

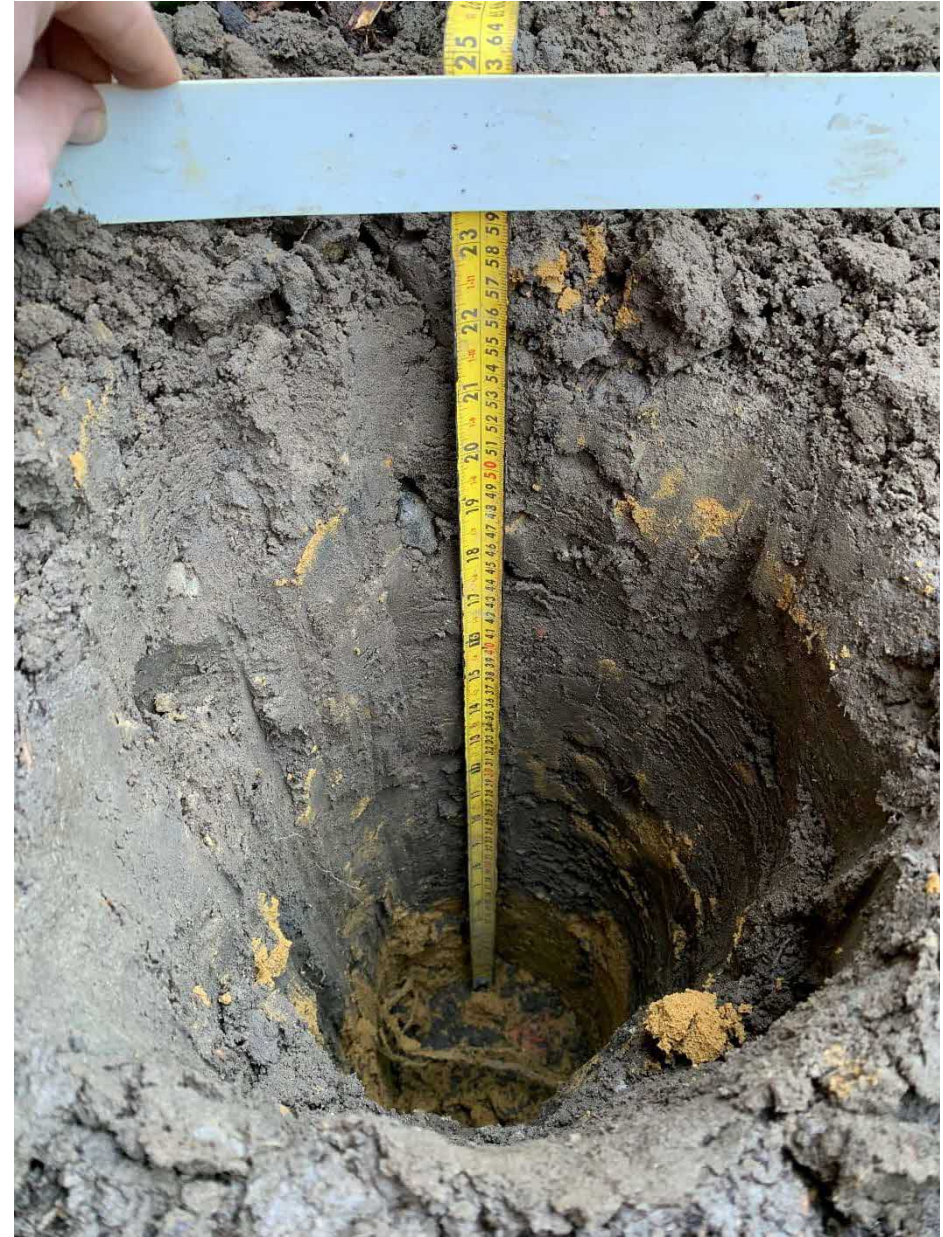
Plot 44 front garden had 0.40 m topsoil and 0.20 m subsoil with geotextile visible at 0.60 m bgl. Subsoil was sampled at 0.50 m bgl and scheduled for heavy metals, speciated PAH, TPH CWG, asbestos, SOM and pH. Refer to Photo 4 in the Appendices.

Photo 4: Plot 44 Front garden showing the depth to geotextile.

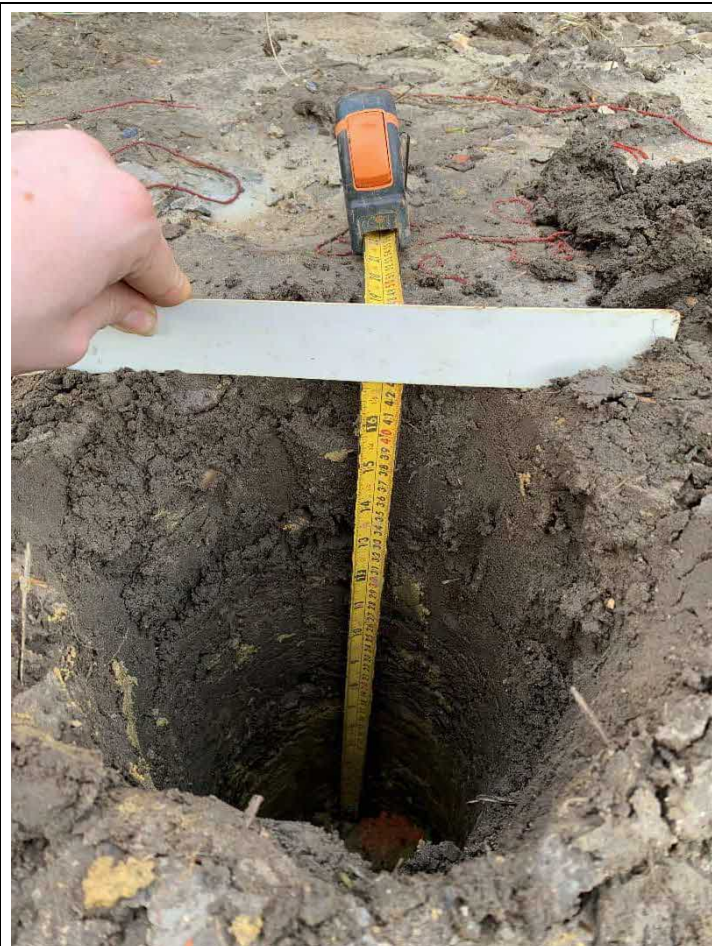
Plot 51 front garden has 0.30 m topsoil and 0.15 m subsoil with geotextile visible at 0.45 m bgl. Subsoil was sampled at 0.40 m bgl and scheduled for heavy metals, speciated PAH, TPH CWG, asbestos, SOM and pH. Refer to Photo 1 in the Appendices.

Photo 1: Plot 51 front garden showing depth to geotextile.

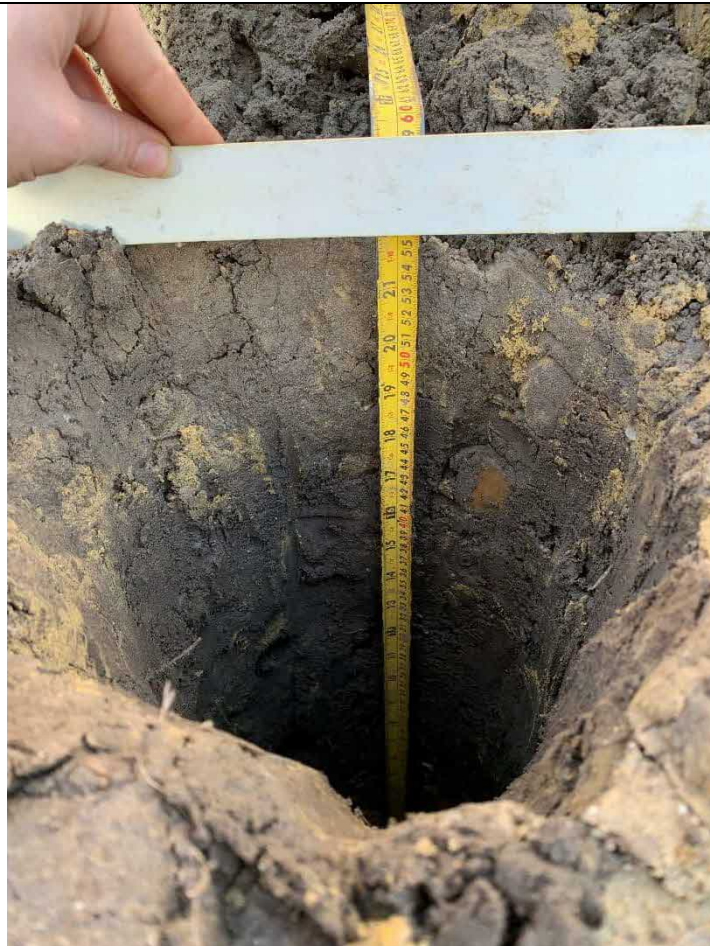
Plot 53 front garden has 0.40 m topsoil and 0.15 m subsoil with geotextile visible at 0.55 m bgl. Topsoil was sampled at 0.25 m bgl and scheduled for heavy metals, speciated PAH, TPH CWG, asbestos, SOM and pH. Refer to Photo 2 in the Appendices.

Photo 2: Plot 53 front garden showing depth to geotextile.

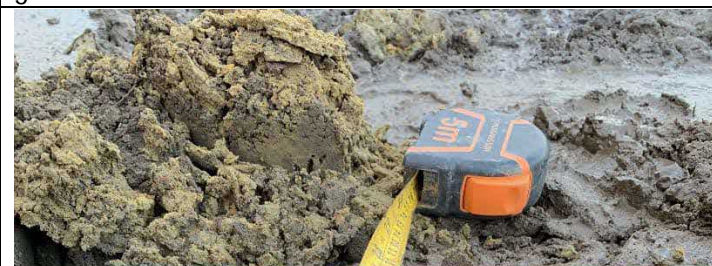
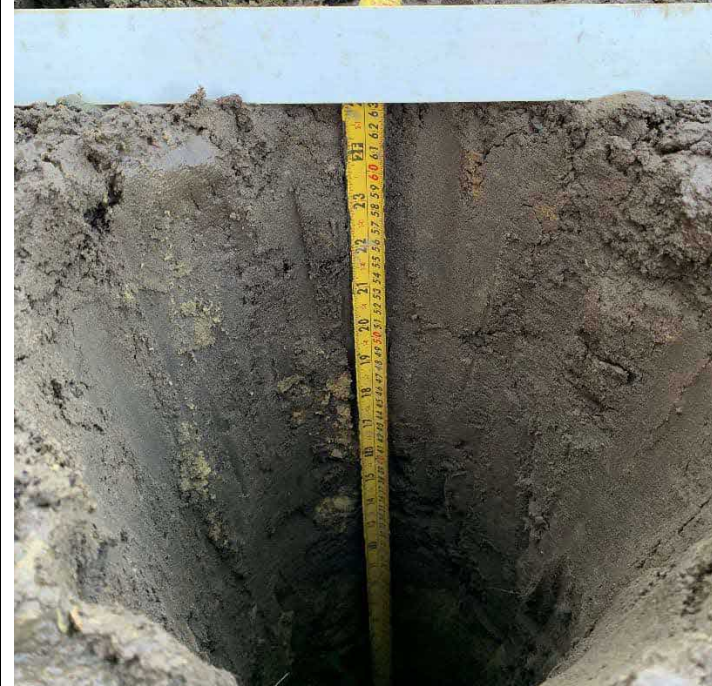
Plot 52 rear garden has 0.40 m topsoil and 0.25 m subsoil with geotextile visible at 0.65 m bgl. Topsoil was sampled at 0.20 m bgl and scheduled for heavy metals, speciated PAH, TPH CWG, asbestos, SOM and pH. Refer to Photo 3 in the Appendices.

Photo 3: Plot 52 rear garden showing depth to geotextile.

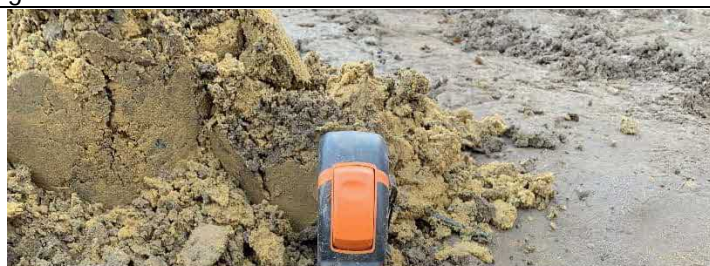
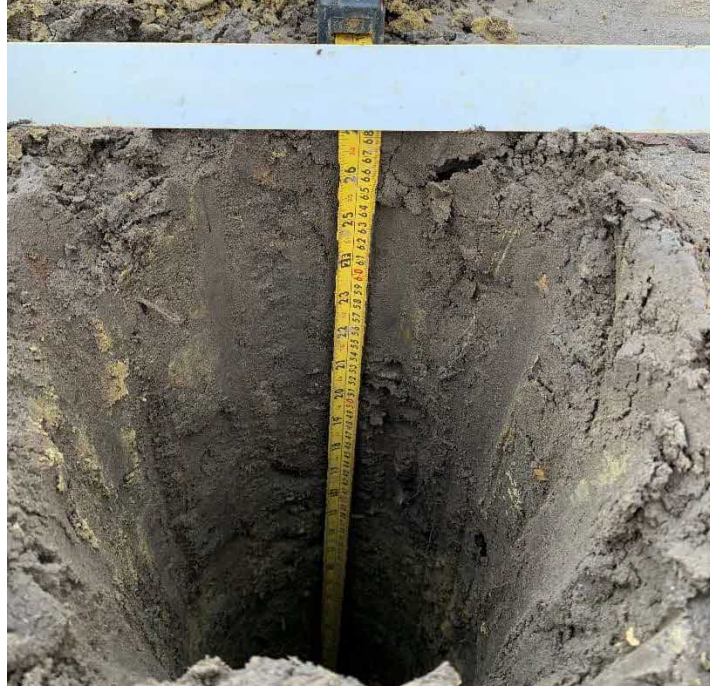
Plot 53 front garden has 0.40 m topsoil and 0.30 m subsoil with geotextile visible at 0.70 m bgl. Subsoil was sampled at 0.50 m bgl and scheduled for heavy metals, speciated PAH, TPH CWG, asbestos, SOM and pH. Refer to Photo 4 in the Appendices.

Photo 4: Plot 53 rear garden showing depth to geotextile.

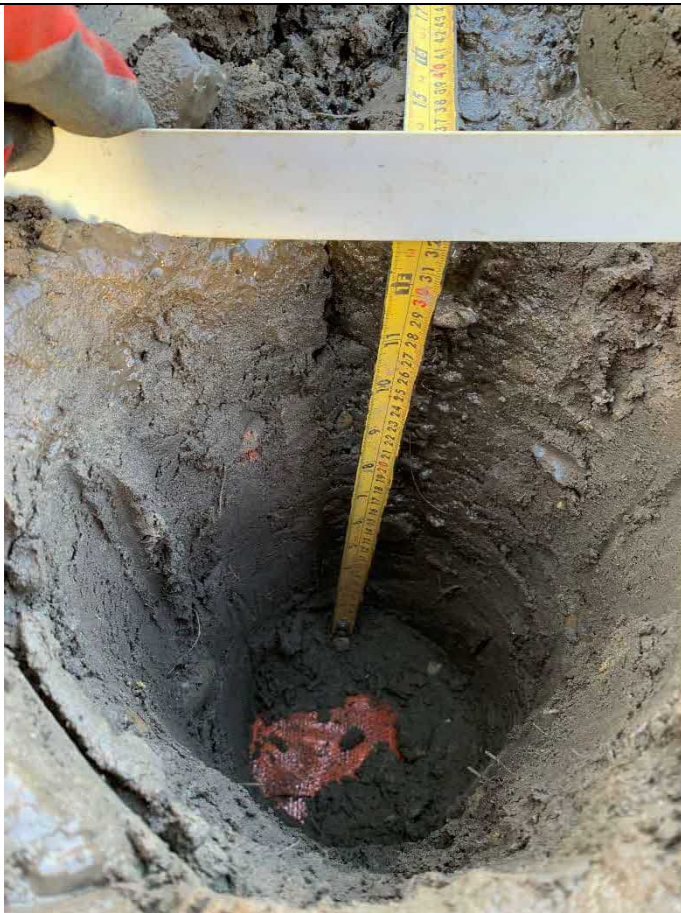
The landscaping area has 0.30 m topsoil with geotextile visible at 0.30 m bgl. Topsoil was sampled at 0.15 m bgl and scheduled for heavy metals, speciated PAH, TPH CWG, asbestos, SOM and pH. Refer to Photo 5 in the Appendices.

Photo 5: Block G landscaping area showing depth to geotextile.

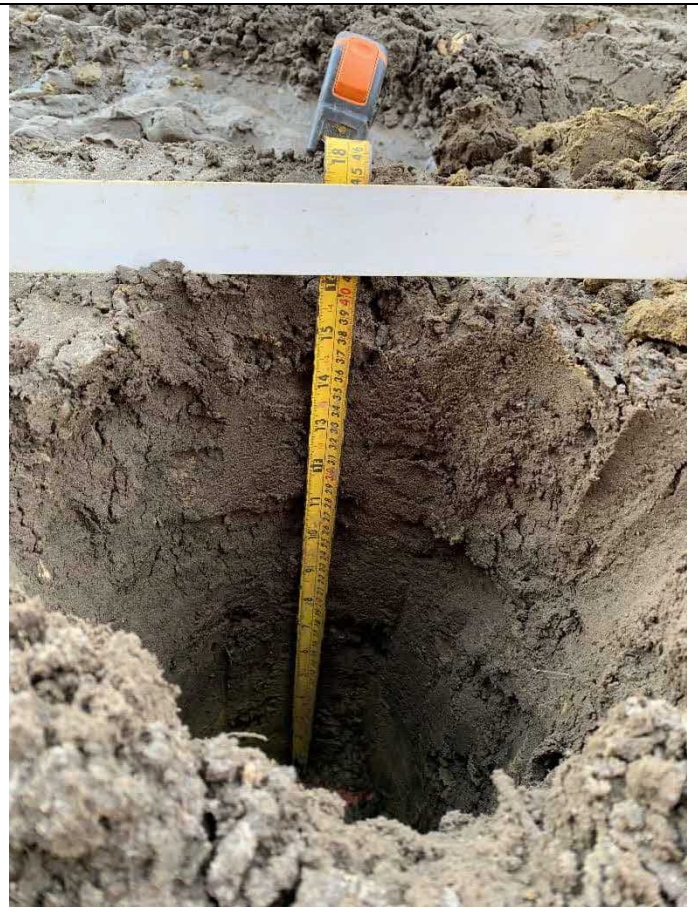
The garden area has 0.30 m topsoil and 0.10 m subsoil with geotextile visible at 0.40 m bgl. Topsoil was sampled at 0.20 m bgl and scheduled for heavy metals, speciated PAH, TPH CWG, asbestos, SOM and pH. Refer to Photo 6 in the Appendices.

Photo 6: Block H landscaping area showing depth to geotextile.

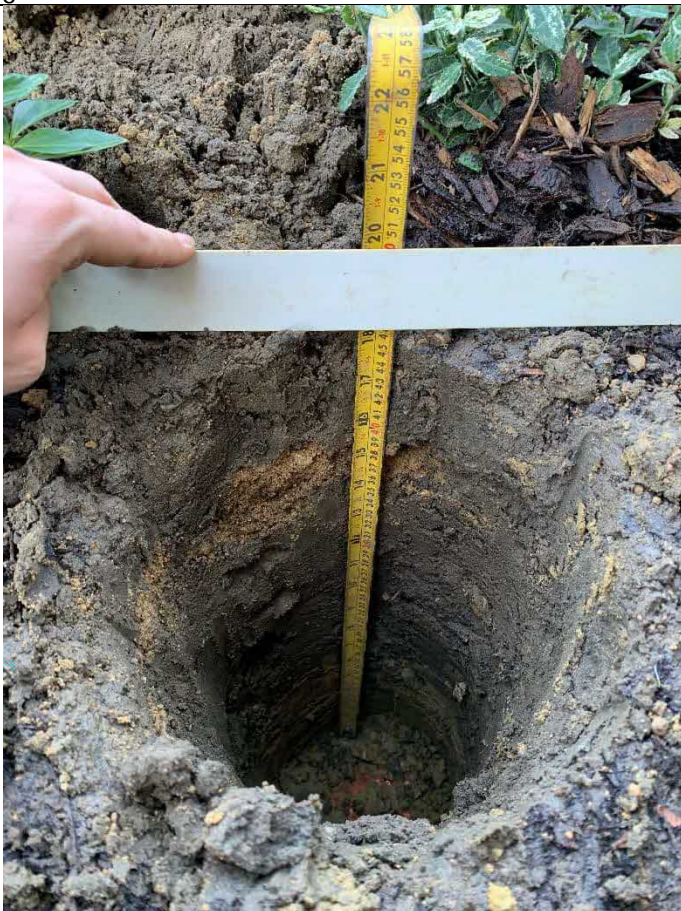
Plot 64 front garden has 0.30 m topsoil and 0.15 m subsoil with geotextile visible at 0.45 m bgl. Topsoil was sampled at 0.15 m bgl and scheduled for heavy metals, speciated PAH, TPH CWG, asbestos, SOM and pH. Refer to Photo 7 in the Appendices.

Photo 7: Plot 64 front garden showing depth to geotextile.

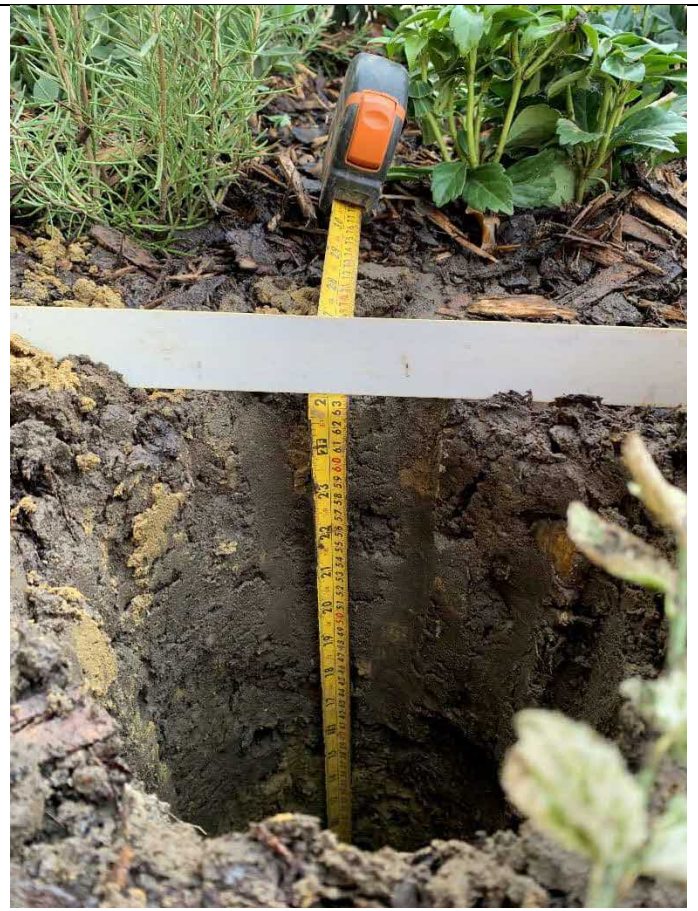
Plot 67 front garden has 0.30 m topsoil and 0.30 m subsoil with geotextile visible at 0.60 m bgl. Refer to Photo 8 in the Appendices.

Photo 8: Plot 67 front garden showing depth to geotextile.

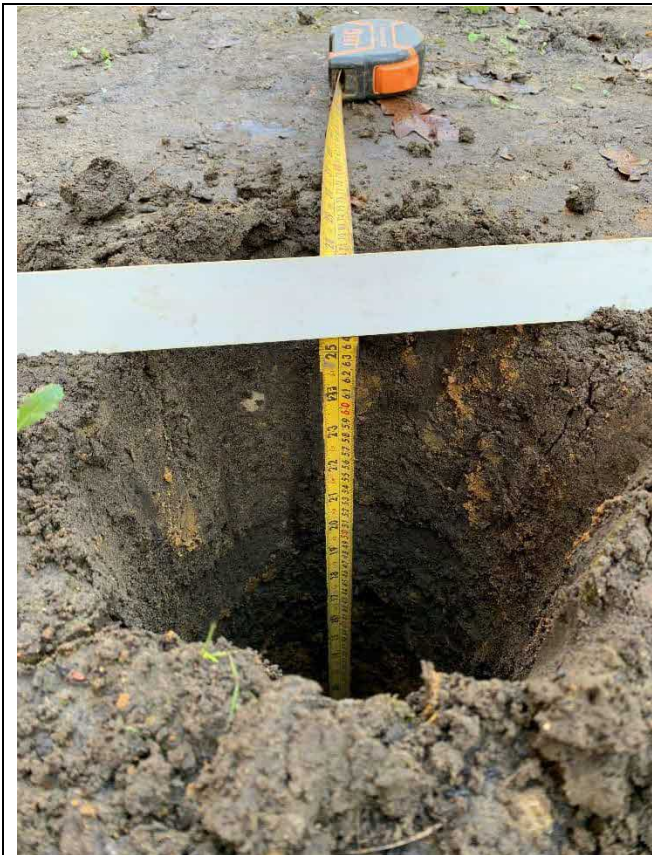
Plot 64 rear garden has 0.40 m topsoil and 0.25 m subsoil with geotextile visible at 0.65 m bgl. Subsoil was sampled at 0.50 m bgl and scheduled for heavy metals, speciated PAH, TPH CWG, asbestos, SOM and pH. Refer to Photo 9 in the Appendices.

Photo 9: Plot 64 rear garden showing depth to geotextile.

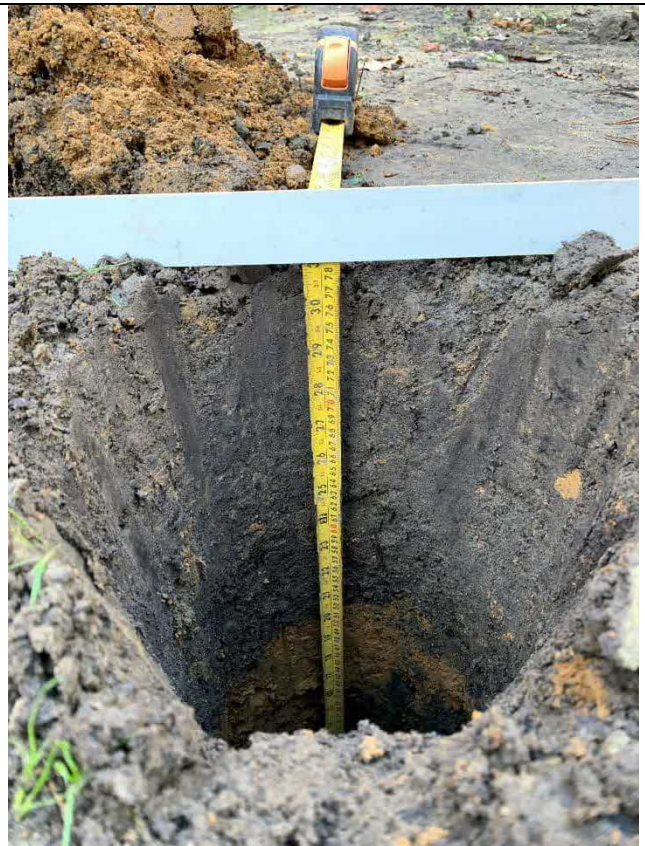
Plot 66 rear garden has 0.30 m topsoil and 0.50 m subsoil with geotextile visible at 0.80 m bgl. Topsoil was sampled at 0.25 m bgl and scheduled for heavy metals, speciated PAH, TPH CWG, asbestos, SOM and pH. Refer to Photo 10 in the Appendices.

Photo 10: Plot 66 rear garden showing depth to geotextile.

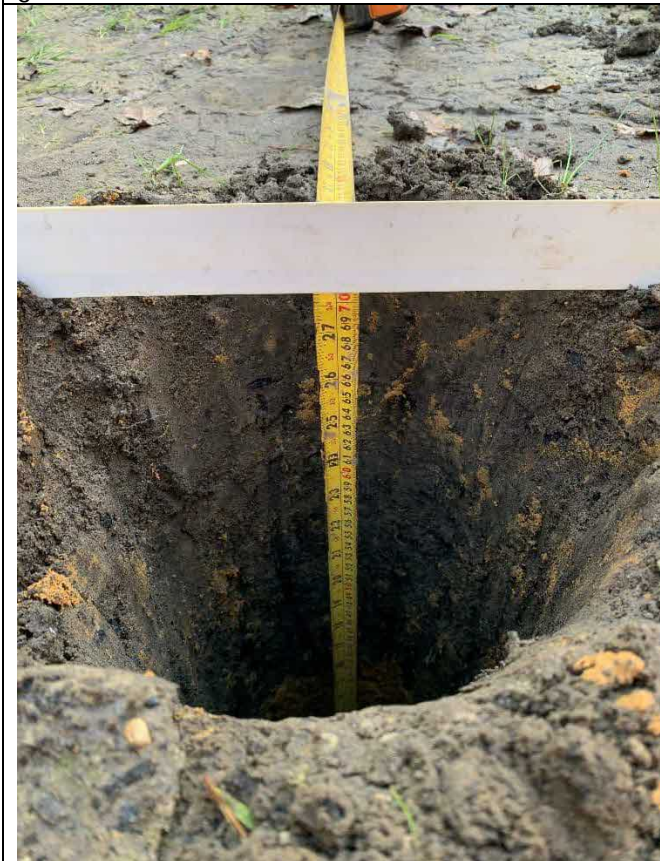
Plot 67 rear garden has 0.40 m topsoil and 0.30 m subsoil with geotextile visible at 0.70 m bgl. Refer to Photo 11 in the Appendices.

Photo 11: Plot 67 rear garden showing depth to geotextile.

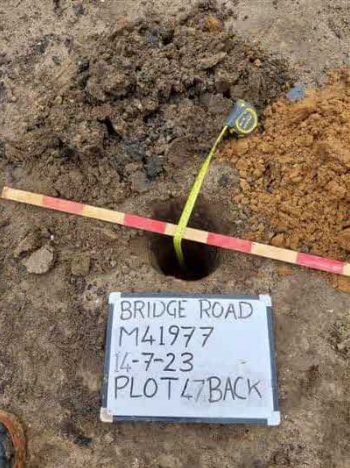
<p>1. Plot 47 Back Garden</p>

Plots 47 and 50 rear gardens topsoil consisted of dark brown loamy slightly gravelly sandy SILT, underlain by orangish brown slightly gravelly Sand. Both were sourced from Warfield. In line with the JNP Group Options Appraisal and Remediation Strategy Report (M41977 RE003 Rev G, 14 October 2019). Turf had not yet been laid on any of the visited plots, making the reinstatement easier. The summary of inspection pit depths and topsoil and subsoil thicknesses from the front gardens are given in the below table.

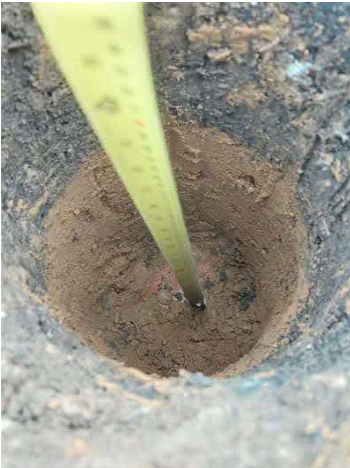
<p>1a Base of Inspection Pit</p>

Plot	Depth to Geotextile (mm)	Thickness of Topsoil (mm)	Thickness of Subsoil (mm)	Sampled at (mm)
47	650	300	350	500
50	500	300	200	400
C 15/16	300	300	none	200

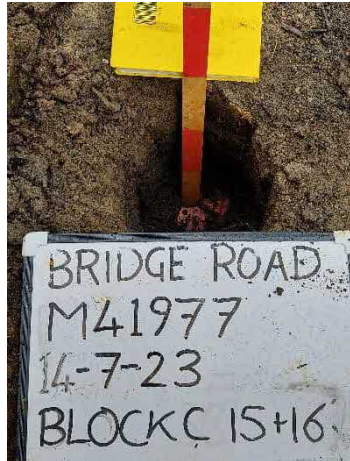
<p>3. Block C 15/16 Garden</p>

Subsoil was sampled from Block C 15/16 at 0.2m and scheduled for heavy metals, speciated PAH, TPH CWG, asbestos, SOM and pH.
