GROUND INVESTIGATION REPORT

FOR 73 NEW STREET, CHELTENHAM, GL50 3ND

Report No. 5254

**GROUND INVESTIGATION REPORT FOR 73 NEW STREET,
CHELTENHAM, GL50 3ND
PREPARED FOR CAPE HOMES LIMITED**

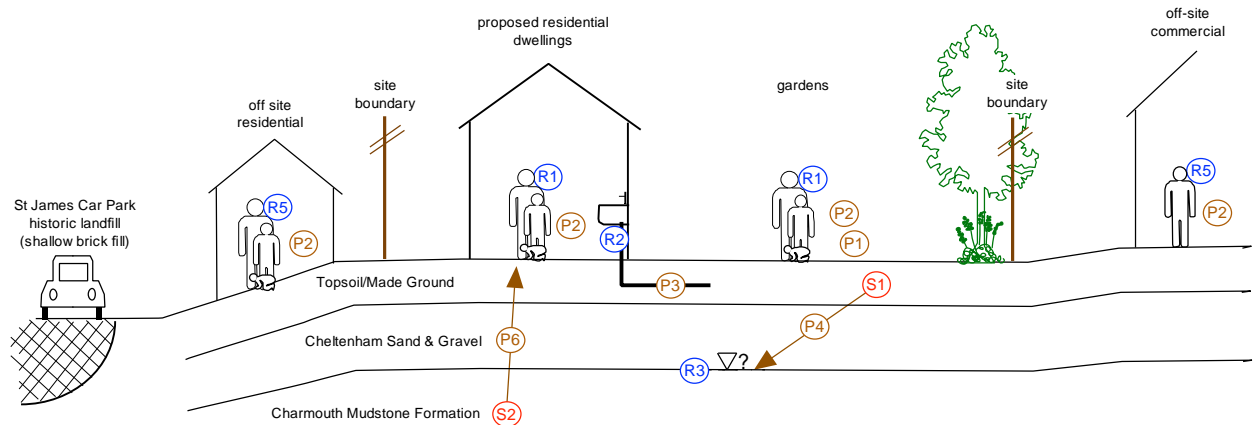
FIGURE 1: PRELIMINARY CONCEPTUAL SITE MODEL (NTS)

5.4 The above information is converted into the preliminary Conceptual Site Model shown in Figure 1 below, and the **potential pollutant linkages** involving future site users, proposed services and local environmental receptors are discussed in Table 3, with appropriate risk levels:

9.1 In view of the above discussions the preliminary conceptual site model has been refined as shown in Figure 4 and Table 9 below.

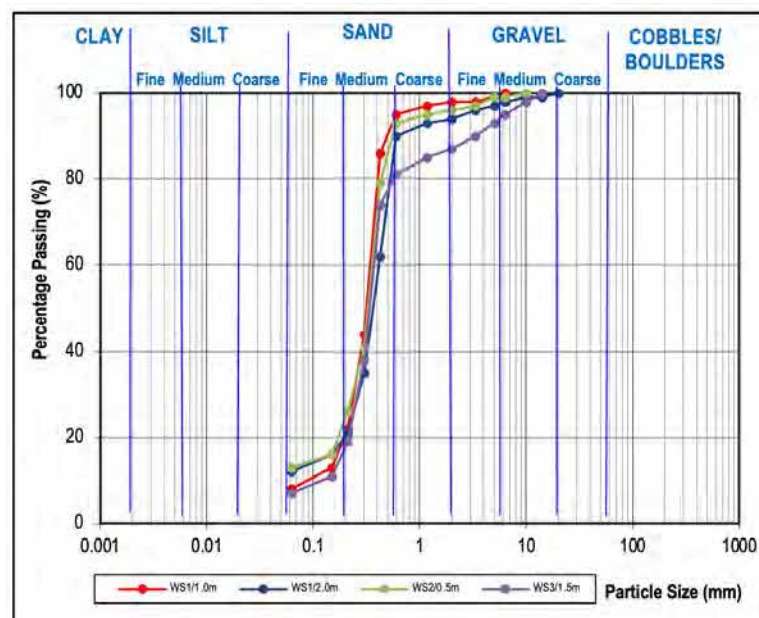
FIGURE 2: PARTICLE SIZE DISTRIBUTION CURVES

Sample Ref	Depth (m)	Sample Composition (%)			Classification (as per EN ISO 14688-2:2004)
		Gravel	Sand	Fines	
WS1	1.0	2	90	8	Slightly silty fine to coarse SAND
WS1	2.0	6	82	12	Slightly silty fine to coarse SAND
WS2	0.5	4	83	13	Slightly silty fine to coarse SAND
WS3	1.5	13	80	7	Slightly silty, gravelly fine to coarse SAND

- 6.4** A number of disturbed samples were taken for routine geotechnical classification testing, comprising moisture content, PSD grading of the CHSG sand and a single plasticity determination of the ChM clay at depth, along with classification to the Unified Soil Classification Scheme (USCS) and NHBC Standards, plus acidity and sulphate analysis to BRE Special Digest 1 requirements. Results are tabulated below.

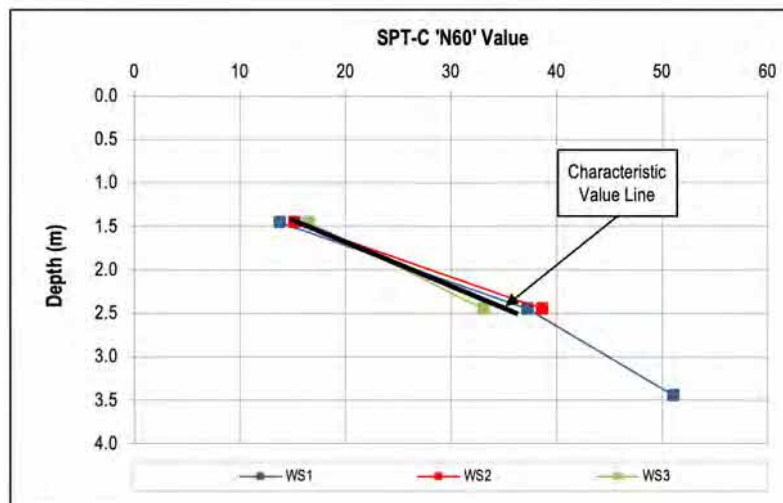
FIGURE 3: SPT-C 'N60' VALUES -v- DEPTH

- 7.2 Corrected SPT-C N_{60} data has been plotted in Fig. 2. The granular soils of the CHSG from 1.45mbgl are considered a suitable material to found on. Given the SPT data using a characteristic value at 1.45mbgl a bearing resistance of 160kN/m^2 compared to a (presumed) design load of 60kN/m^2 should be more than sufficient. Although in-situ SPT testing only commenced below 1.0m the sand is logged as medium dense from 0.7mbgl, and which depth an approximate bearing resistance of 155kN/m^2 compared to a design load of 53kN/m^2 should also be sufficient for traditional 450mm or 600mm strip/trench fill.

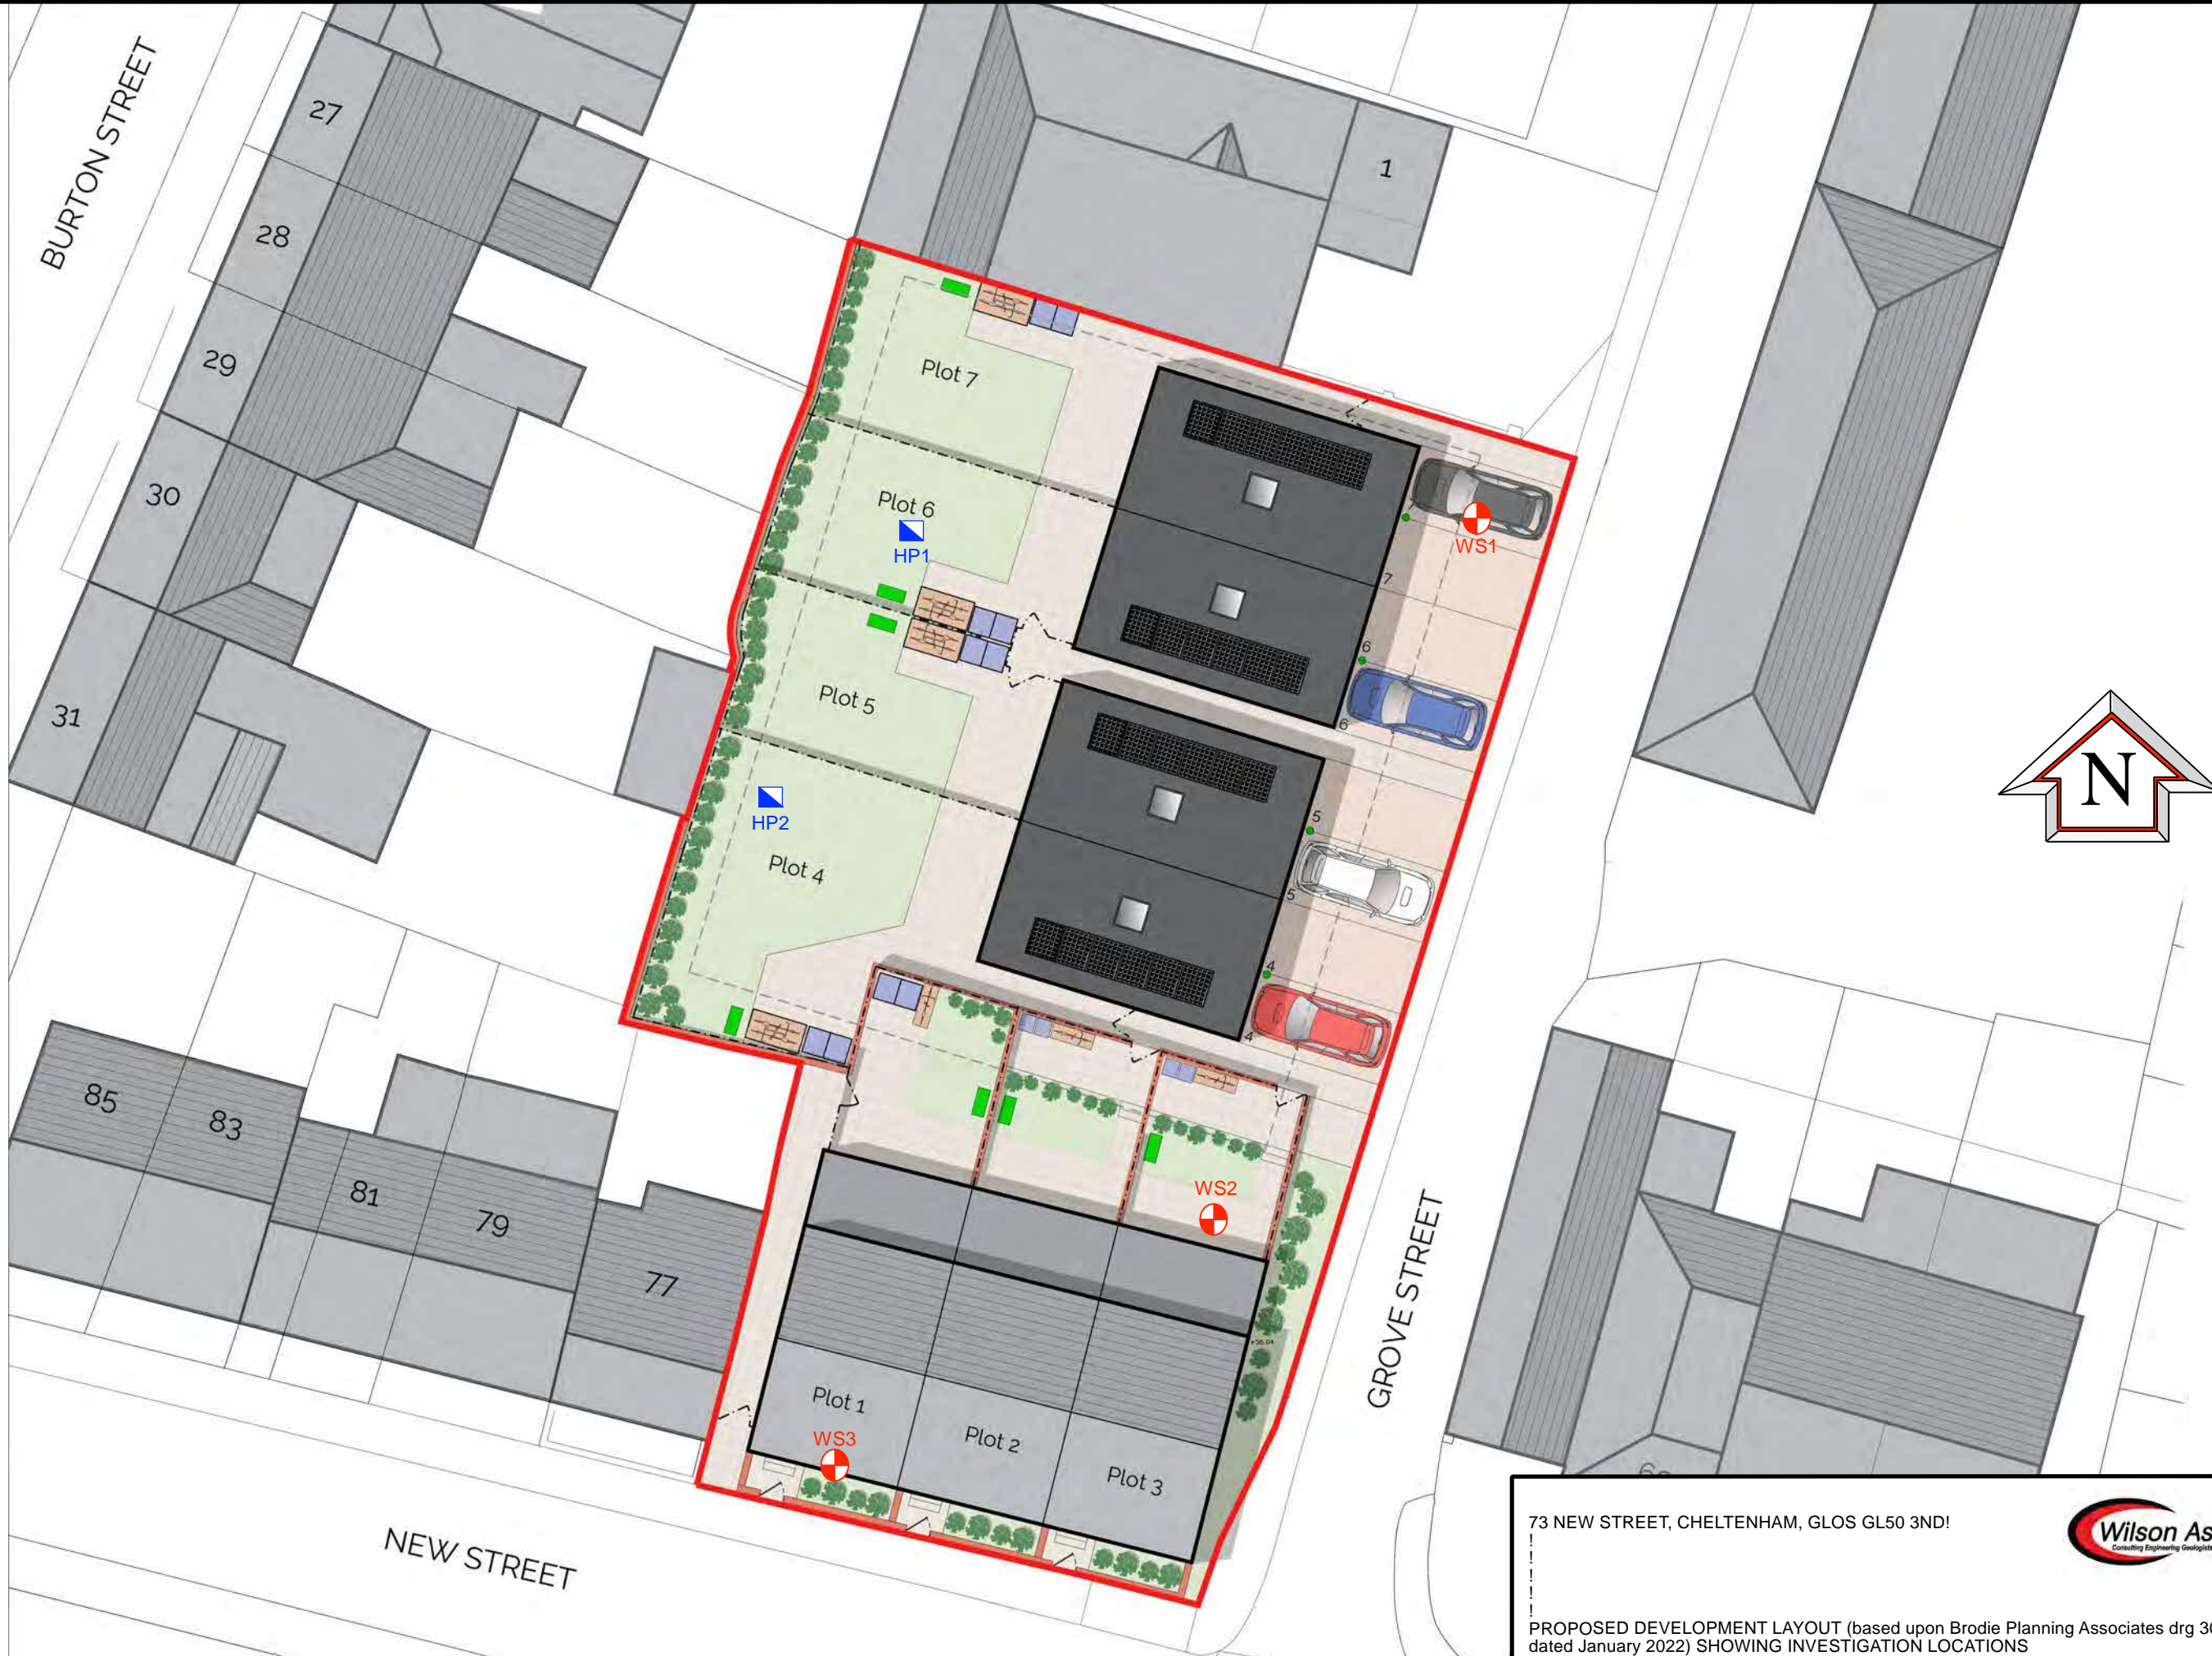
Job No. 5254	Drawing No. 5254/3	Scale: 1:200@A3	Date: 14-12-23
-----------------	-----------------------	--------------------	-------------------

PROPOSED DEVELOPMENT LAYOUT (based upon Brodie Planning Associates drg 3025-150, dated January 2022) SHOWING INVESTIGATION LOCATIONS

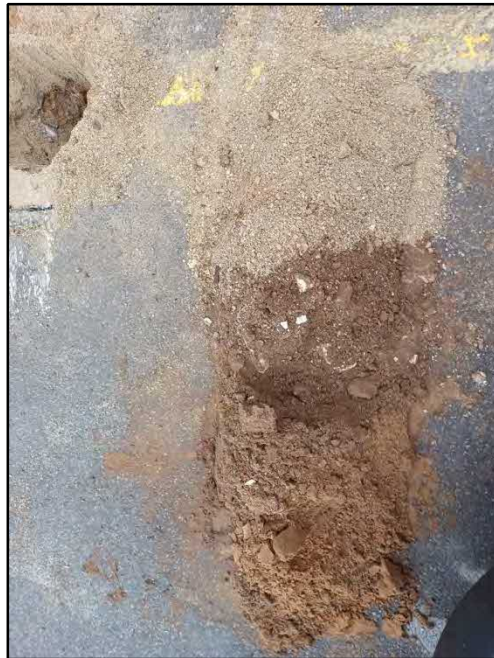
Project 73 NEW STREET, CHELTENHAM, GLOS GL50 3ND	Borehole No. WS2
Job No. 5254

Starter pit arisings: 0.0-1.2m

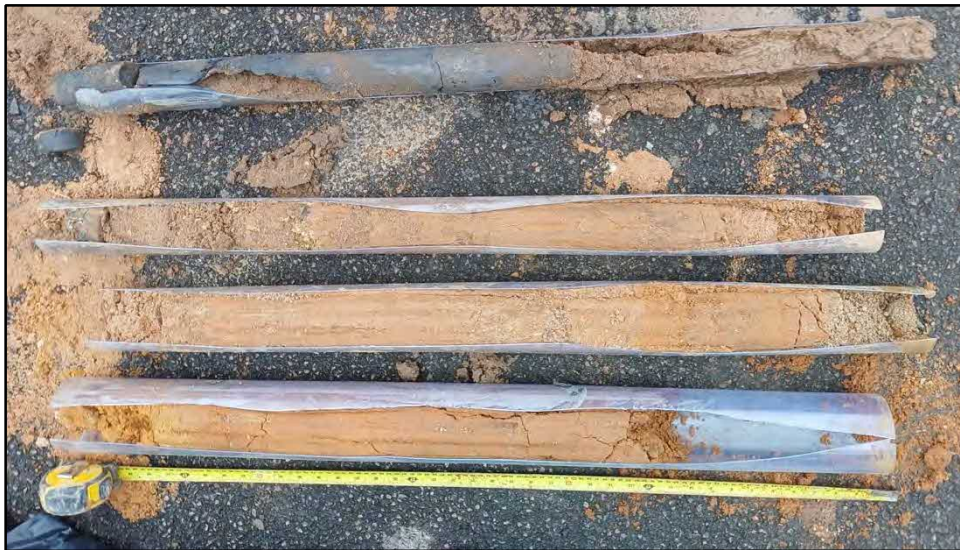
Borehole Core: 1.2-5.0m

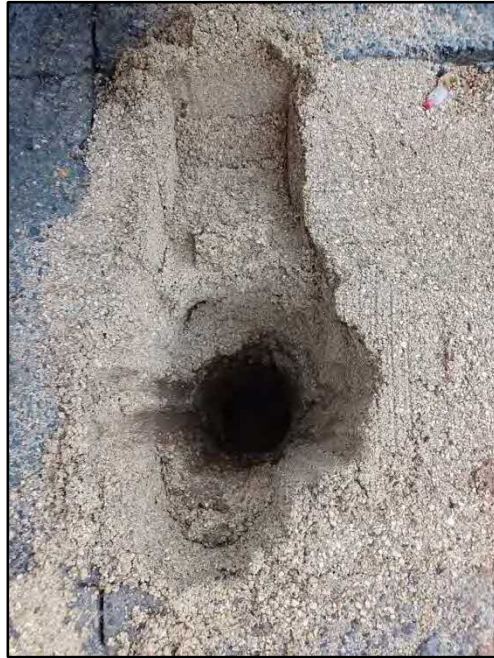
Project 73 NEW STREET, CHELTENHAM, GLOS GL50 3ND	Borehole No. WS1
Job No. 5254

Starter pit arisings: 0.0-1.2m

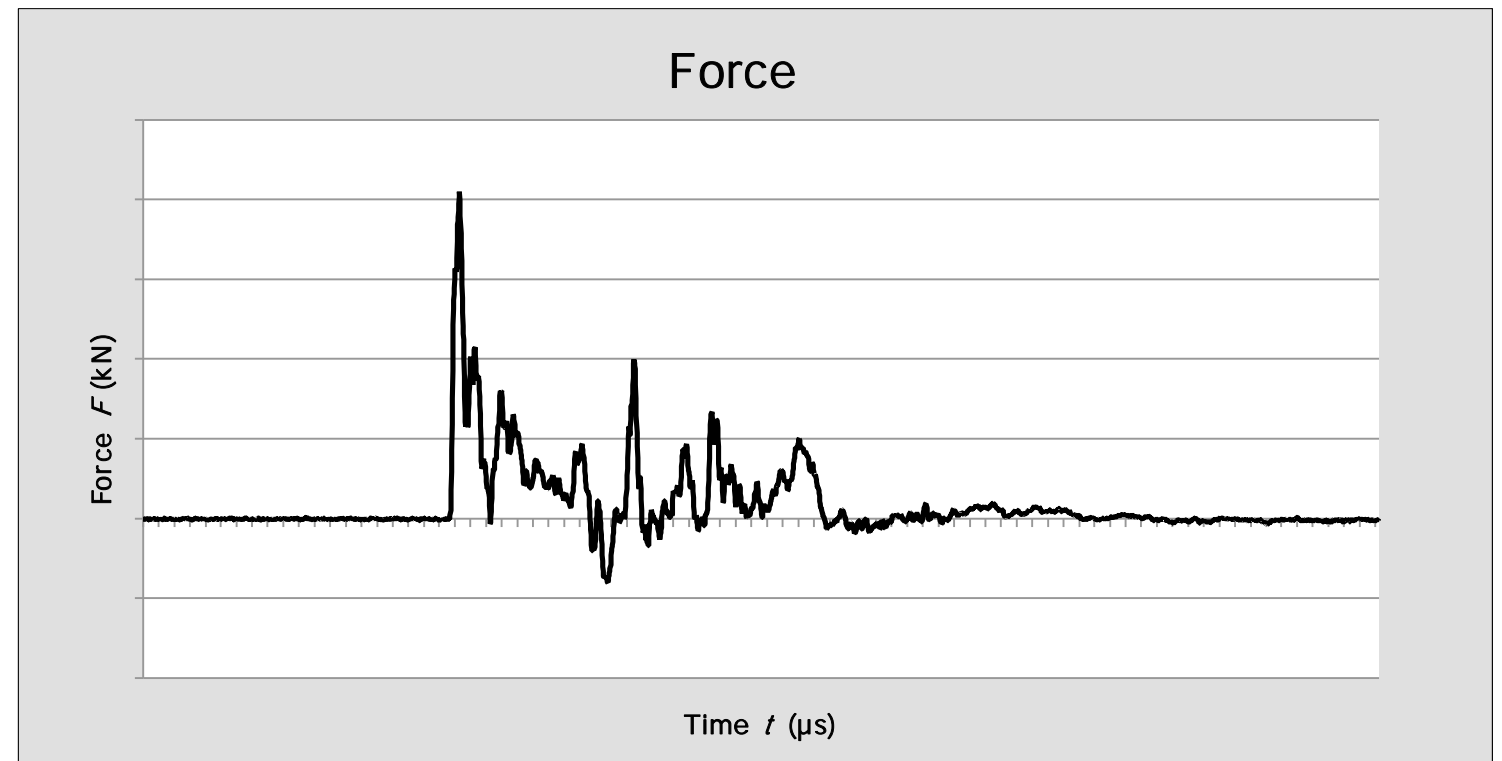
Energy Ratio (E_r) = $\frac{E_{\text{meas}}}{E_{\text{theor}}}$ **82.88%**
 © COPYRIGHT 2023

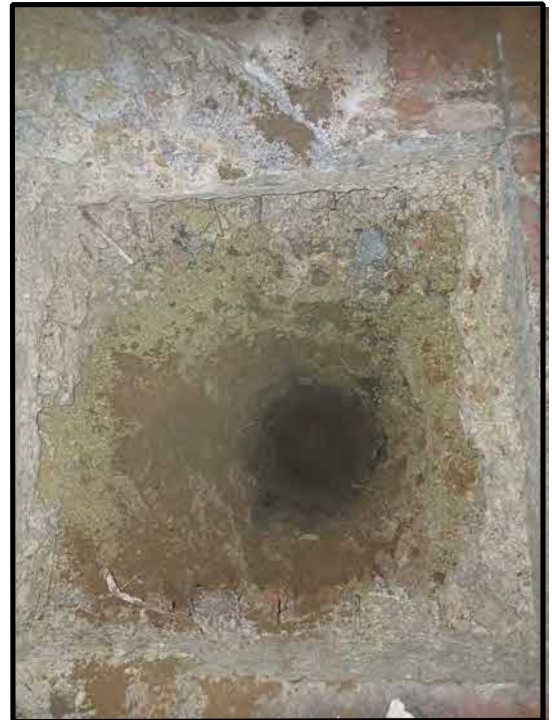
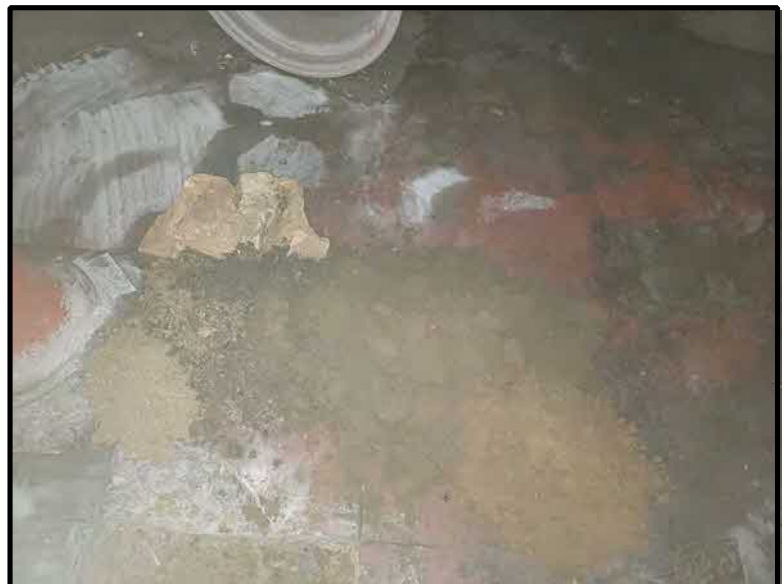
Site: 73 NEW STREET, CHELTENHAM, GLOS GL50 3ND				TRIAL PIT No.
Job No. 5254	Date 12-12-23	Ground Level (c.m, AOD) 58m	Co-Ordinates (c.) E 394,377 N: 222732	HP1

- ! A! CONCRETE SLAB: 6mm rebar at 110mm !
- ! !
- ! B! MADE GROUND: loose yellowish brown, sandy!
- ! gravel of sub-rounded to sub-angular, fine to coarse!
- ! brick/concrete/oolitic limestone!
- ! !
- ! C! MADE GROUND: loose black/dark brown!
- ! sandy gravel of sub-angular, fine to coarse!
- ! brick/oolitic limestone!
- ! !
- ! D! SAND: loose, mid brown, silty SAND!
- ! (CHELTENHAM SAND & GRAVEL)!
- ! !
- ! E! SAND: medium dense, orangey brown, fine!
- ! grained SAND!
- ! (CHELTENHAM SAND & GRAVEL)!
- ! !
- ! !
- ! !

- ! !
- ! 1! Pit logged from surface!
- ! !
- ! 2! Pit dry and stable !
- ! !
- ! 3! No roots encountered!
- ! !
- ! 4! Soil samples taken at 0.4-0.5m and 0.7-0.8m depth!
- ! !

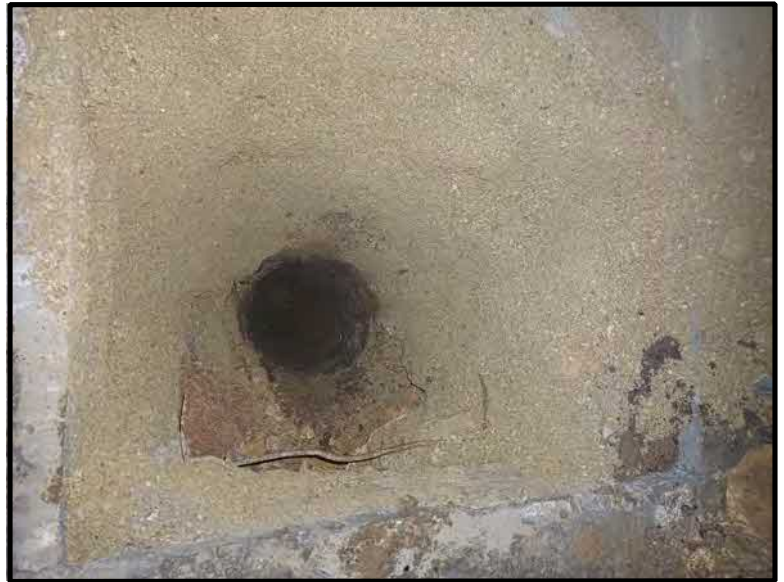
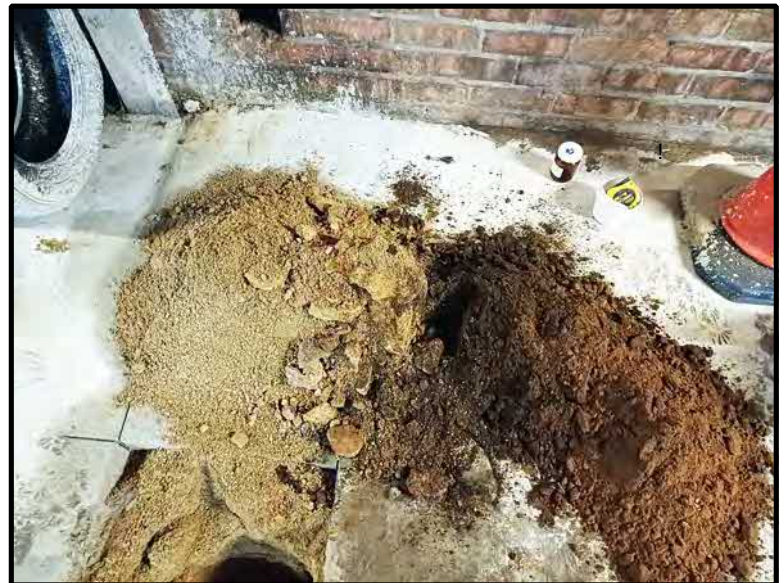
Site: 73 NEW STREET, CHELTENHAM, GLOS GL50 3ND				TRIAL PIT No.
Job No. 5254	Date 12-12-23	Ground Level (c.m, AOD) 58m	Co-Ordinates (c.) E 394,377 N: 222723	HP2

- ! A! CONCRETE SLAB: 4mm rebar at base !
- ! !
- ! B! MADE GROUND: yellowish brown, sandy!
- ! GRAVEL of brick/concrete/oolitic limestone cobbles!
- ! !
- ! C! MADE GROUND: loose mid brown/black gravelly!
- ! SAND. Gravel is sub-angular, fine to coarse!
- ! brick/concrete/oolitic limestone!
- ! !
- ! D! SAND: medium dense, orangey brown, fine!
- ! grained SAND!
- ! (CHELTENHAM SAND & GRAVEL)!
- ! !
- ! !
- ! !
